Report A-015/2010

Accident involving a PIPER
PA 25-260 aircraft, registration
EC-CVD, operated by Aviación
Agrícola J. Carreño, S.L., in the
municipality of Aldeanueva
de Barbarroya (Toledo),
on 29 May 2010

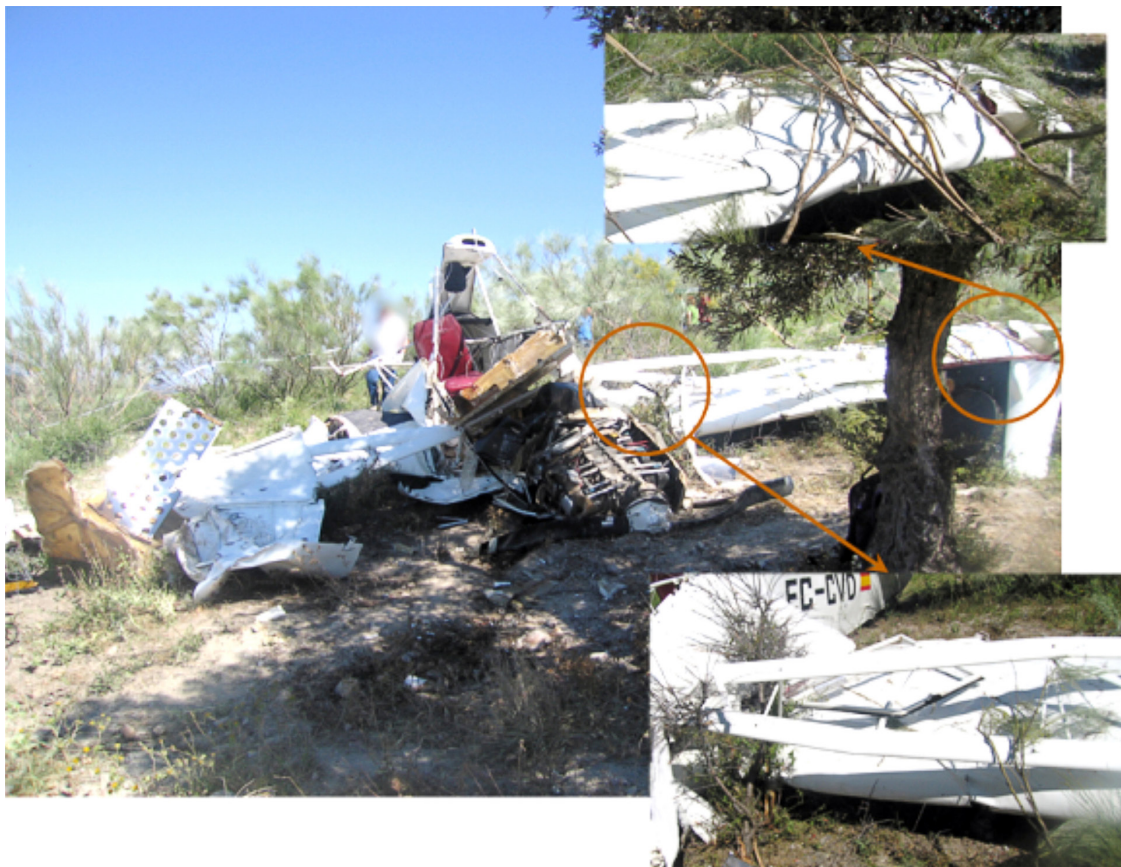
Figure 2. Aircraft wreckage

The damage to these components was as follows: on the left wing, the wingtip was bent upward, the frame area, where the braces are anchored, had collapsed and the same braces arched downward. See Figure 2.

The area housing the engine and the hopper was collapsed. The engine and propeller were shifted left from the centerline of the fuselage and the right wing exhibited significant creasing along its leading edge and upper surface.

The indication from the wreckage was that the aircraft touched the ground with its left wingtip, causing it to pivot about this wingtip and to strike the ground with the front engine section at a high nose-down attitude. The structure then collapsed, resulting in the leading edge of the right wing impacting the ground.

As for the arrangement of the wreckage on the ground, the offset between the frame's longitudinal axis and that of the engine compartment, as well as the lateral impacts to the cockpit, indicate the direction in which the aircraft was flying.

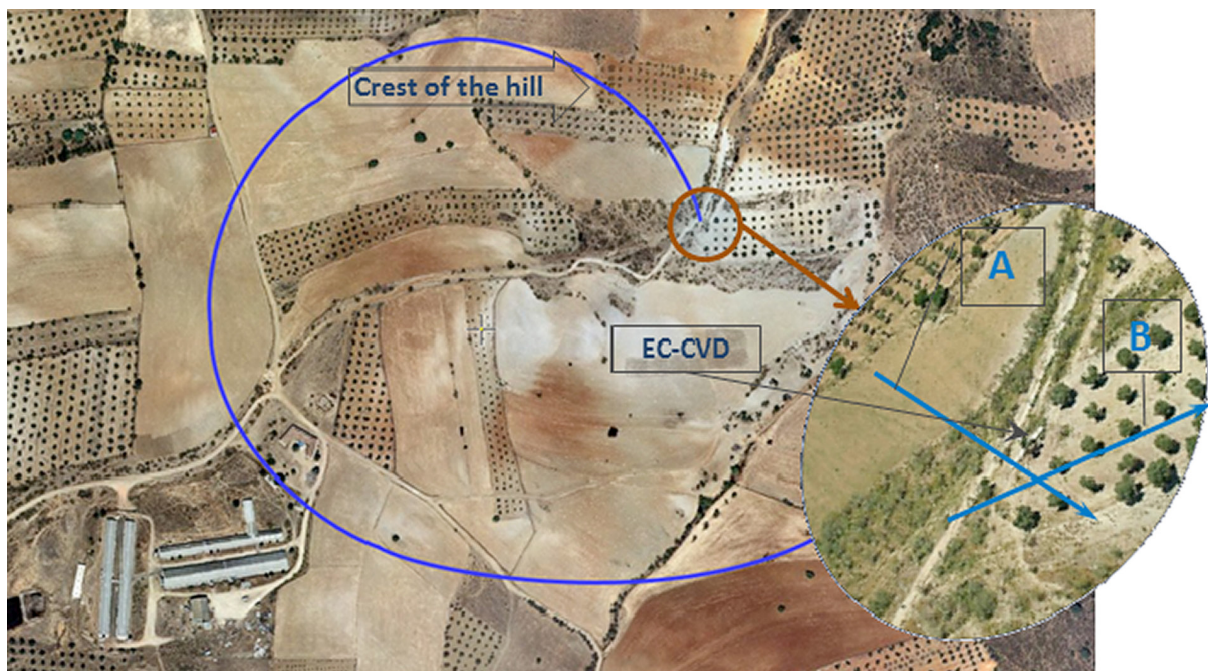
Figure 3. Estimated trajectory

As Figure 3 shows, the aircraft was turning to the right. The pilot flew over the crest of a hill and started to descend on the course indicated by line A in an effort to line up with the direction of the field, line B. The maneuver required losing altitude in a nose-down and left bank attitude. At that time the aircraft's flaps were extended one notch and its engine was at near maximum power.

In keeping with the above, it is believed that the pilot attempted to simulate a spraying run over the field and that he crashed to the ground as he tried to correct his course to align the aircraft with the field. The pilot may also have overestimated the distance that separated him from the ground, a task further hampered by the increased difficulty of making an approach over sloping terrain.
