Report A-025/2015

Accident involving a WSK PZL-M18B aircraft, registration EC-FBJ, operated by Servicios Aéreos y Tratamientos Agrícolas S.L., in Castro Caldelas (Ourense-Spain) on 27 August 2015

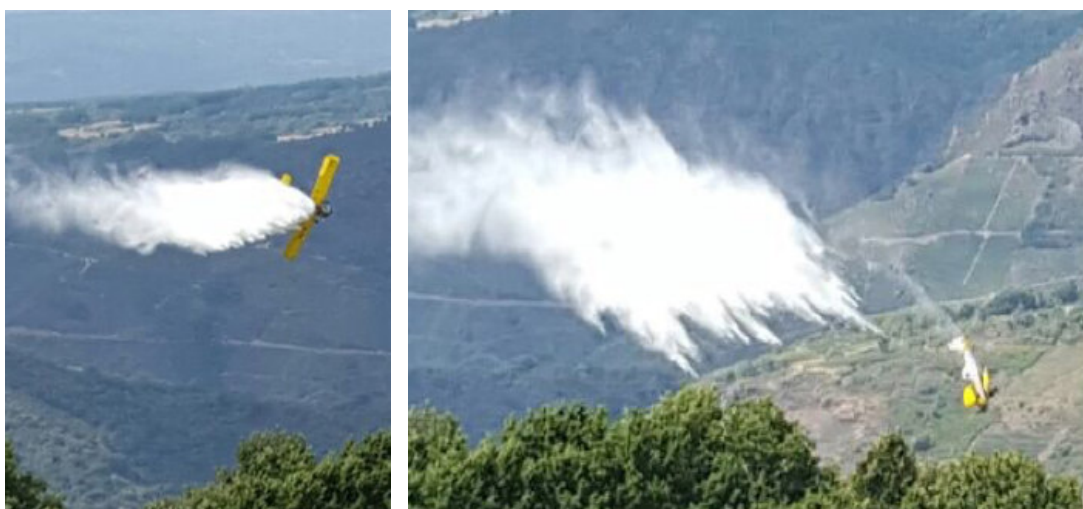
Figure 1. Photographs⁷ taken by the eyewitness in Castro Caldelas

At 15:45, an eyewitness located in Castro Caldelas (9 km southeast of the base) saw the two aircraft flying by the town, the first of them fairly higher than the second. The next information on the status of aircraft EC-FBJ comes courtesy of two photographs taken by the same eyewitness shortly before the impact. The first photograph shows the aircraft at a steep left bank angle while dropping the water. In the second photograph, the aircraft is upside down on a nearly vertical trajectory. The aircraft crashed to the ground seconds after this second photograph was taken.

Figure 1 shows the two photographs taken by the eyewitness, the first on the left and the second on the right. Figure 2 shows a view of the terrain where the accident took place. Indicated on the figure are the position of the eyewitness, the impact point and the estimated flight path, based on the photographs taken by the eyewitness.

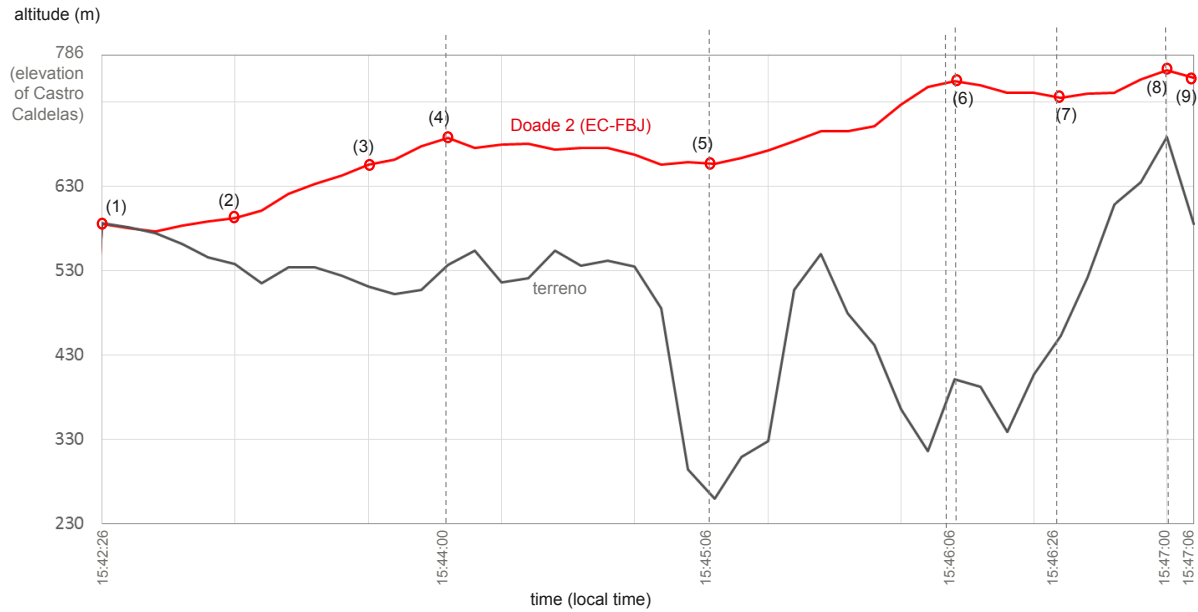
Figure 3. Flight profile of aircraft EC-FBJ (Doade 2)

- Segment 7-8: Increase in altitude and speed and course change to the left.
- Segment 8-9: loss of altitude, sudden drop in speed (from 162 to 142 km/h) and new course change to the left.

The figures show a total of 10 important points on the flight path. The first nine are from data recorded by the fleet tracking system, and the tenth is the crash site.

The progress of the flight after takeoff showed, as noted earlier, that one minute and a half after takeoff, the aircraft stopped climbing. From then on, not only did it not gain altitude, it actually lost altitude over the next minute. When it was over the Sil River, after descending, the aircraft climbed again, taking it to point 6 (Figure 4), located a little over 2 km away from Castro Caldelas. The lead aircraft, Doade 1, was above the elevation of Castro Caldelas by the time it reached point 6, and thus had no problem clearing the mountains that Doade 2 crashed into. Doade 2, in contrast, was 30 m below that elevation. Despite this, the pilot continued with the flight and kept losing altitude as he neared the mountains. This shows how already from an early phase in the flight, the aircraft was below the altitude necessary to clear the first obstacle, which was 200 m higher. And yet the pilot continued with the flight. In his statement, the pilot said he was aware of the problem he was having gaining altitude and that at one point, he thought he would not be able to resolve it. His assessment of the situation was correct, but he acted too late, especially in light of his limited speed.

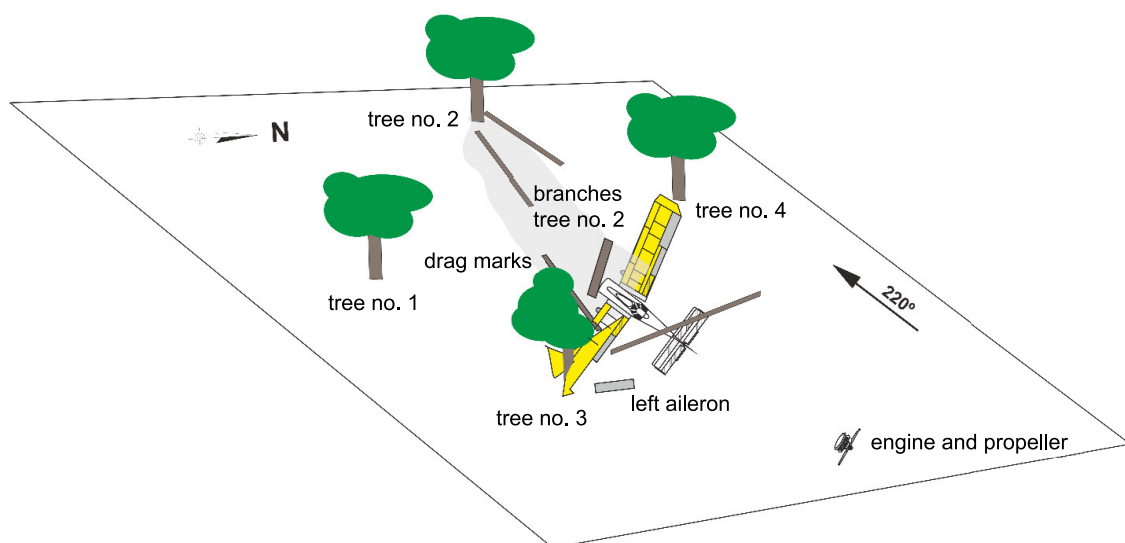
Figure 5. Debris field of aircraft EC-FBJ

The second impact was against a birch tree (no. 2 in Figure 5), 15 m away from the first tree and at a higher elevation. The tree consisted of several vertical branches sprouting practically from a common trunk on the ground. Just four of these branches were torn off. Two of the branches were found next to the tree, and the other two next to the aircraft, one driven into the front of the aircraft and the other underneath the left wing.

The next impact was against the ground, next to tree no. 2. The impact left deep marks in the ground, indicative of a hard impact. Between this spot with the hard impact and the place where the main aircraft wreckage was found there were shallower marks indicating that the aircraft had slid along the ground.

As the aircraft slid downhill from the birch tree, the outer edge of the left wing struck another tree (no. 3 in Figure 5), penetrating almost halfway through the wing and bending the wingtip upward. The aileron from that wing detached and was found 5 m downhill. The aircraft's cockpit was in good condition, with no apparent damage. The cockpit compartment was not breached and the window glass (front and side) was intact.

The aircraft stopped at that point, next to trees 3 and 4, with the right wing practically detached from the structure and rotated with respect to its longitudinal axis. The left wing was in better condition than the right and remained attached to the fuselage. The left wingtip had practically separated from the wing due to the impact with tree no. 3. The engine and propeller were found down the hill, stopped against a tree trunk.

The front of the fuselage (the nose), which was the part closest to the ground, then impacted tree number 2. One of the branches on this tree pierced and was embedded in the engine bay. This impact had two effects: it reduced the aircraft's speed, and it caused a rotation that slightly straightened out the aircraft longitudinal axis. This is probably also the impact that damaged the engine mount.

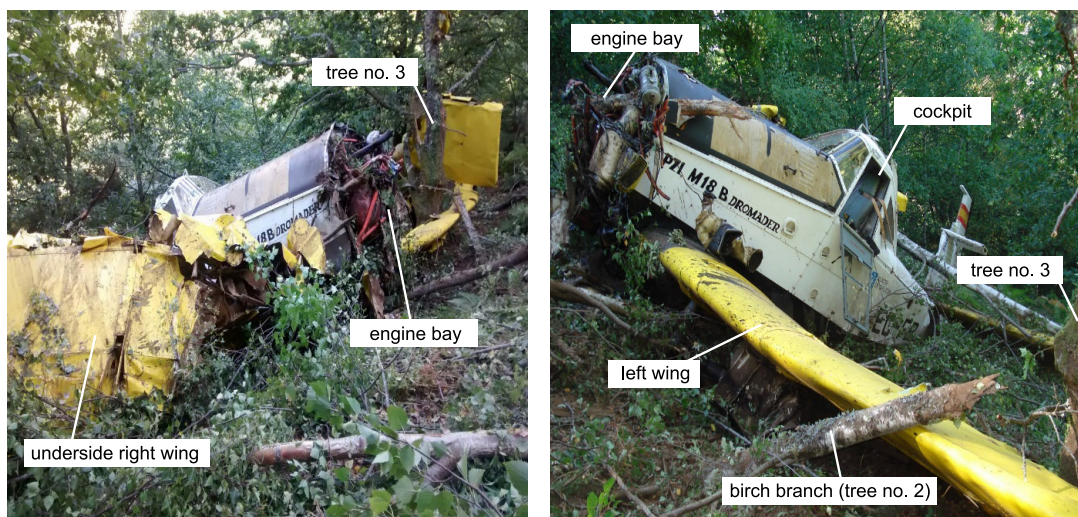
Figure 6. Aircraft EC-FBJ after the impact

The aircraft was destroyed by the impact. For the most part, the damage affected the front and right side of the aircraft. The engine detached, the right wing was almost completely separated from the fuselage, the left wing lost an aileron and its wingtip was punctured. The bottom of the fuselage and the tail assembly exhibited significant damage, but less than the front of the aircraft. The cockpit seemed to be intact.

- There was continuity in the rudder and elevator controls. The rudder cables were stuck and the bar on the elevator was bent, which made it impossible to move. In the left wing there was continuity in the bank controls up to the point where the wing was broken.

- The left side of the rear of the fuselage was in better condition than the right side.
- The bars in the tail assembly were broken and bent by the impact.

- The left horizontal stabilizer and the left elevator were in better condition than their counterparts on the right side.
- The vertical stabilizer was broken from the middle to the end.

- The seat did not exhibit any damage.
- The seatbelts were in perfect condition.
- Inside the cockpit, the ELT light indicated the ELT was armed and activated, the emergency fuel pump was OFF, the fan, lights and generator were ON, magnetos 1 and 2, propeller pitch was at maximum and the throttle control in GAS.

- The engine detached when its mount broke.
- Three of the four blades showed bending and marks consistent with an impact at power. The fourth blade was not bent but it did have marks.
- The fuel pump shaft rotated freely.
- There was continuity in the carburetor actuator connections.
- The engine ignition wiring showed nothing out of the ordinary other than wires broken by the impact. The connections to the spark plugs were intact.
- The exhaust system and the intake manifold were crushed or broken, and their detached parts were scattered along the path of the aircraft, all as a result of the impact.

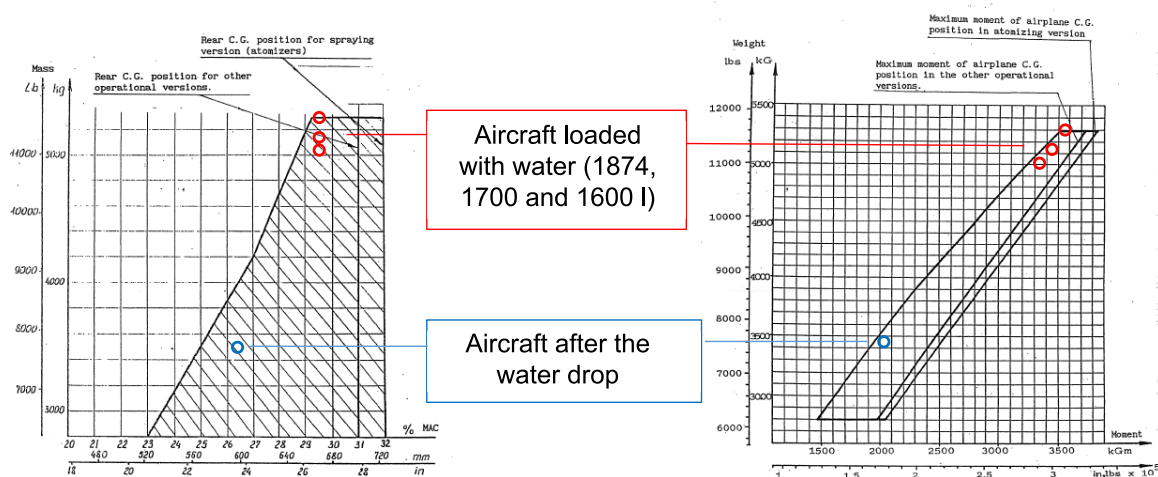
Figure 7. Change in the position and moment of the center of gravity during the flight

water that could be loaded onto aircraft EC-FBJ without exceeding its MTOW. For example, with 100% fuel load, the operator allowed a maximum of 1874 liters of water to be loaded⁴³.

- The aircraft's weight⁴⁴ was used to calculate the variations in the weight, the position of the center of gravity (left) and the moment of the center of gravity (right) in two scenarios: at takeoff with three quantities of water (1874, 1700 and 1600 l)⁴⁵ and after the water drop⁴⁶. In every situation, the aircraft is within the envelope.
