Report A-029/2012

Accident involving a Cessna 500,
registration EC-IBA, operated
by AIRNOR, on approach
to the Santiago de Compostela
Airport (LEST) (A Coruña, Spain),
on 2 August 2012

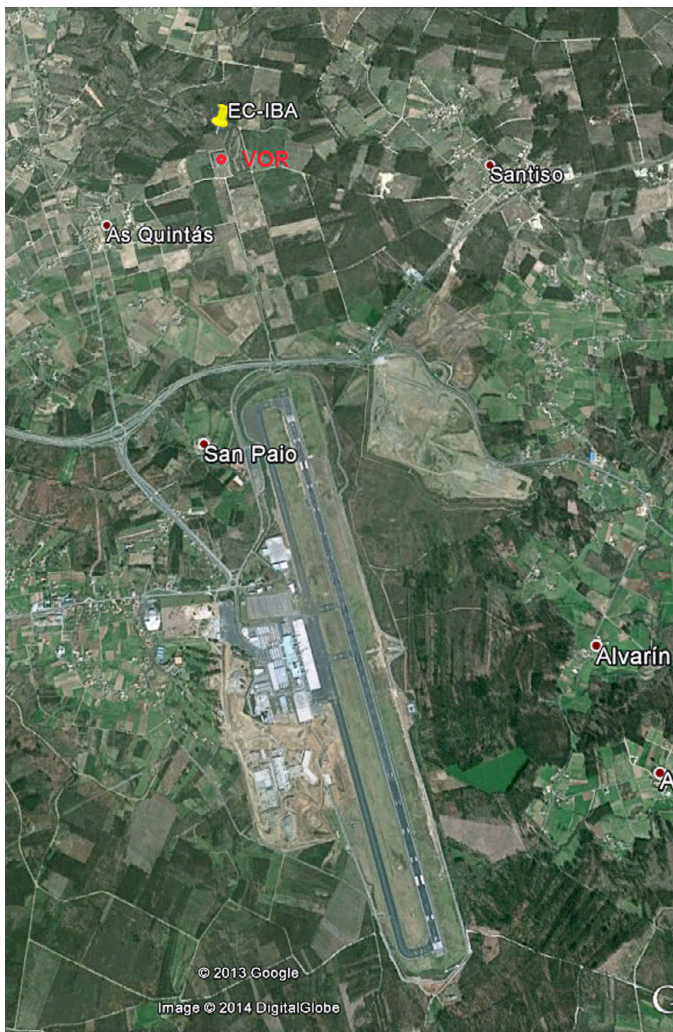
Figure 1. Location of the aircraft wreckage in relation to the Santiago Airport⁹

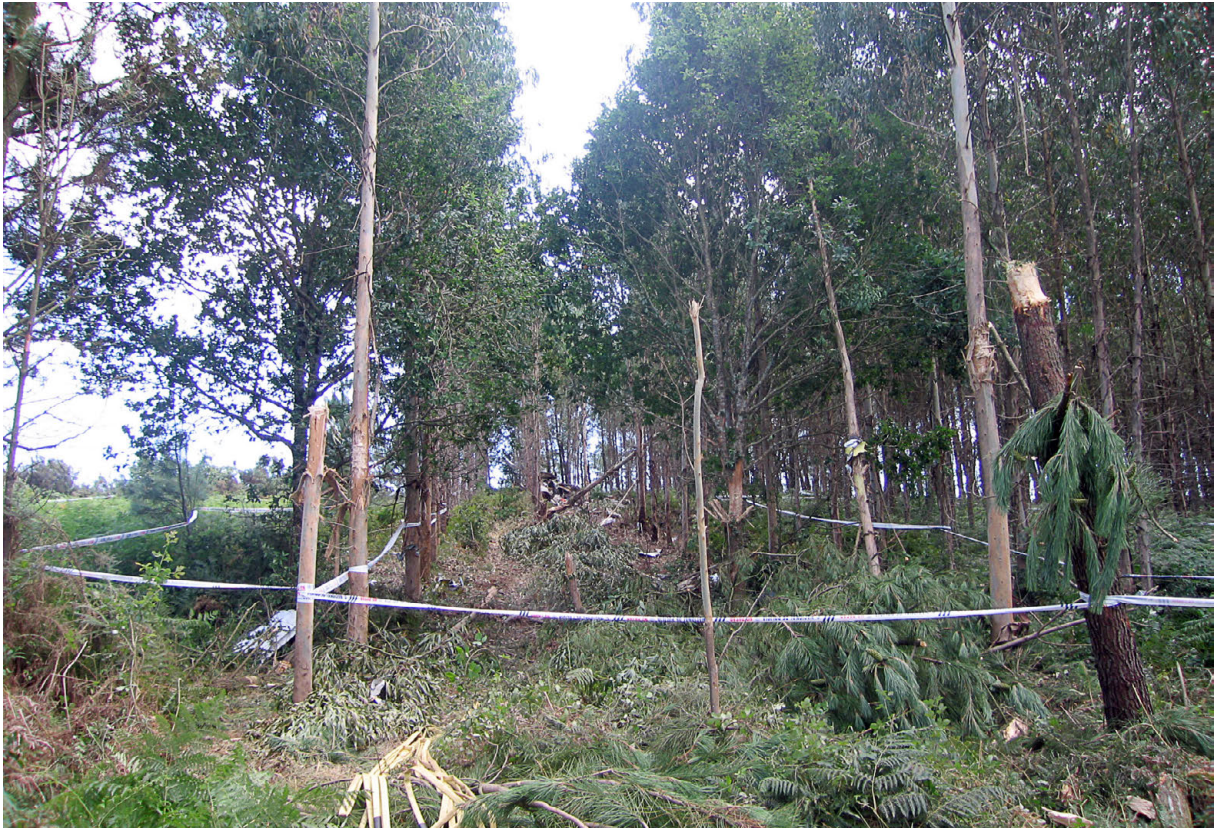
Figure 8. Impact trajectory

some pine trees before shearing a line of these trees that flanked the north side of a local road. On the other side of the road was a slight incline populated by eucalyptus trees. Along its 40 m long impact trajectory starting at the beginning of the road, as it impacted these more robust trees, the aircraft began losing parts of its wings from the tips to the root, the landing gear and the right engine.

Finally the cockpit impacted one of the eucalyptus trees. The airframe was turned sharply by the force of the impact, ending up oriented toward 230°. The left engine remained attached to the airframe (see Appendix C). The cockpit was destroyed. The instruments on the control panel were found buried in the ground below the remains of the airframe. The first officer was found ejected from his seat. The harness was not fastened though it was verified to still be attached to the seat and that the fastening system worked properly.

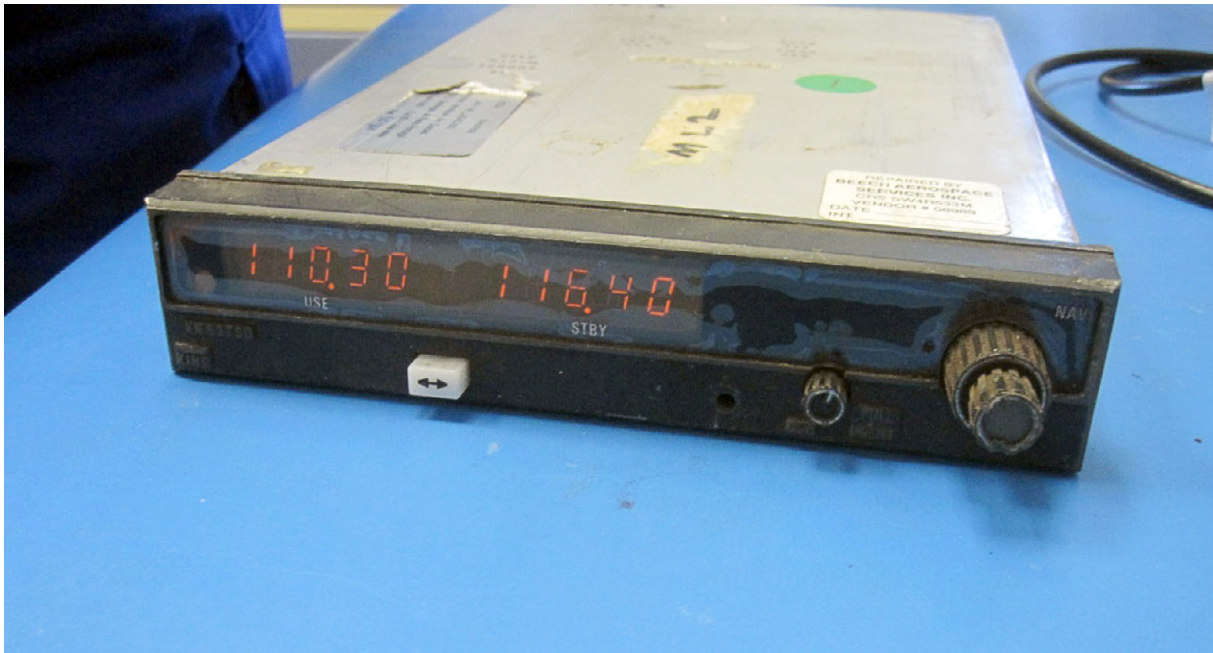
The NAV1 unit was energized to see the frequencies selected by the captain at the time of the accident. The active frequency was 10.30 MHz (the ILS frequency), and the standby frequency was 116.40 MHz (the Santiago VOR).

Figure 9. Frequencies selected on NAV1 (captain)

This model of navigational unit has the glide slope converter in the unit itself, meaning the quality of the glide slope signal being received by the NAV1 unit could be evaluated. The centering, deflection and flag activation parameters were checked with their respective tolerances and found to be working properly.

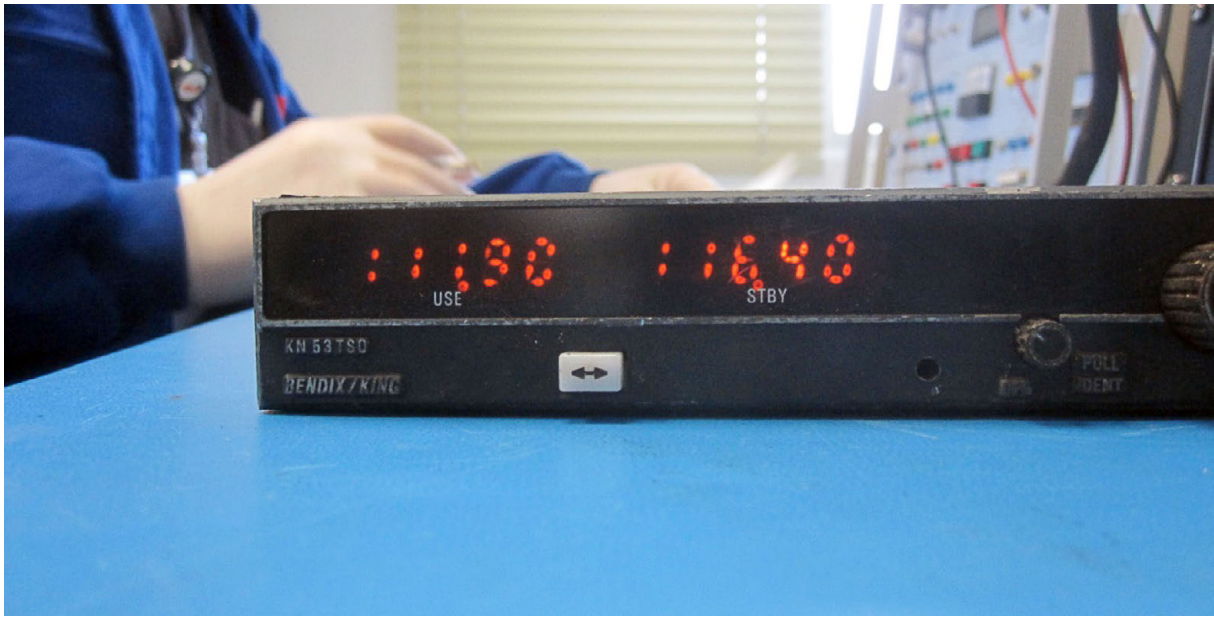
The NAV2 unit was likewise energized to see the frequencies selected by the first officer at the time of the accident. In this case the display was of worse quality. The legible active frequency was 111.90 MHz (not associated with the ILS frequency) and the standby frequency was 116.40 MHz (Santiago VOR). The active frequency did not correspond to any known frequency. The signal quality was evaluated and it was determined that the actual frequency selected (though the reading on the display was not clear) was 111.30 MHz. The closest frequency to this was 111.35 MHz, in use at the Biarritz Airport, which was not included in the crew's planning and does not have 24 hour service. As with the other unit, the proper frequency was selected (110.30 MHz) and the centering, deflection and flag activation parameters were checked with their respective tolerances and found to be working properly.

Figure 10. Frequencies selected on NAV2 (copilot)

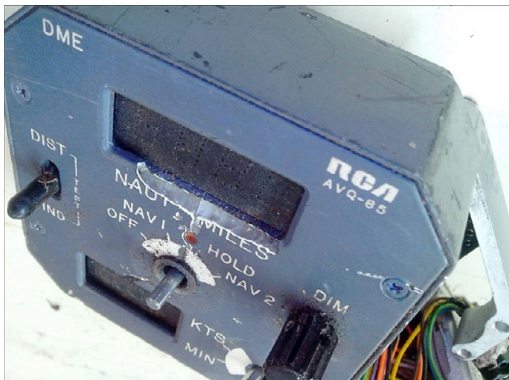
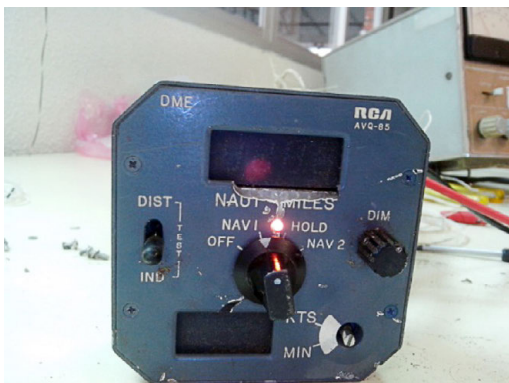
Figura 11. Inspection of the DME unit

The wiring diagram was used to check the various positions on the switch for the DME unit (NAV1-HOLD-NAV2). All had continuity. The OFF position did not give a signal, since there was no continuity. In other words, the switch worked correctly.

During the inspection the control used to select the various switch positions was one position out of phase, meaning that when it was set to OFF, it was in reality set to NAV1, and when it was in the NAV1 position it was actually in HOLD (see photograph). The switch was disassembled and the shaft on which it rotated was slightly scuffed by the fixing screws. This can occur if the switch is forced to either extreme, and leaves it out of phase with the actual position on the switch.
