DATA SUMMARY

Date and time	Sunday, 2 October 2011 at 16:14 h¹
Site	Sayerri Peak, in Borau (Huesca)

Registration	OH-1000
Type and model	Schempp-Hirth Flugzeugbau DUO DISCUS Glider
Operator	Private

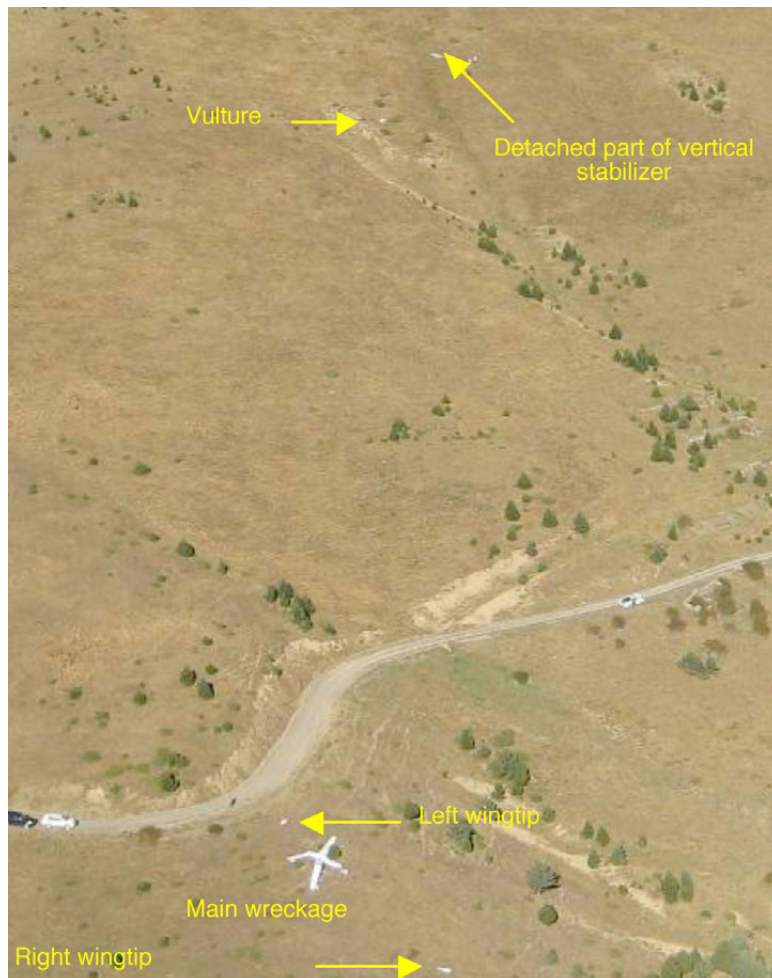
Figure 1. Wreckage at accident site

Both occupants died and their bodies were ejected from the glider found next to the aircraft wreckage. They were found in the vicinity of the wreckage. The aircraft was severely damaged as a result of the impact with the ground.

The part of the tail assembly that had detached was found at a higher elevation on the same hillside, over 300 m away from the main wreckage. The remains of a griffon vulture were found nearby.

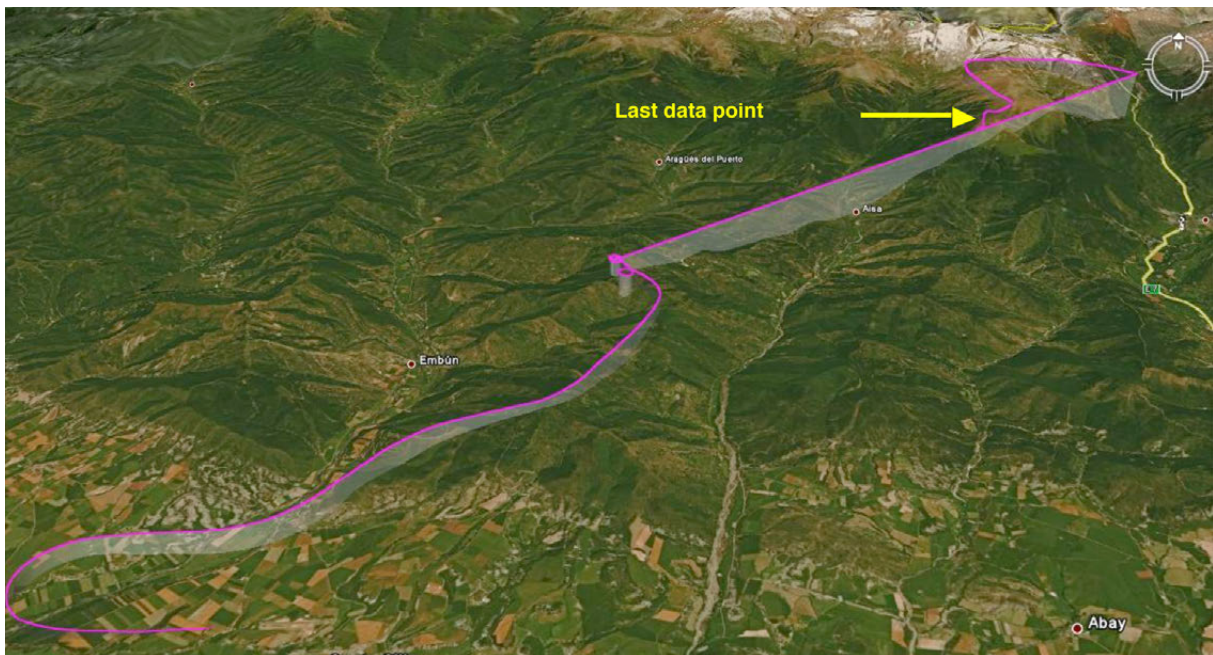
Figure 2. Final moments of the trajectory

At 16:14:19, the aircraft was near Sayerri Peak at an altitude of 2,200 m heading southeast at a speed of 132 km/h (see figure 2).

Just then it encountered an updraft and its speed dropped to 122 km/h. At 16:14:24, while at coordinates 42° 41' 32" N - 00° 32' 35" W, the glider started a sharp descent at a vertical speed of up to 52 m/s until it impacted the ground at 16:14:44.

The data taken from the logger indicated a sudden change in the glider's flight attitude, presumably at the time of impact, and the subsequent loss of control. These same data also show that the collision took place as the glider was flying in a straight line on a southwesterly heading.

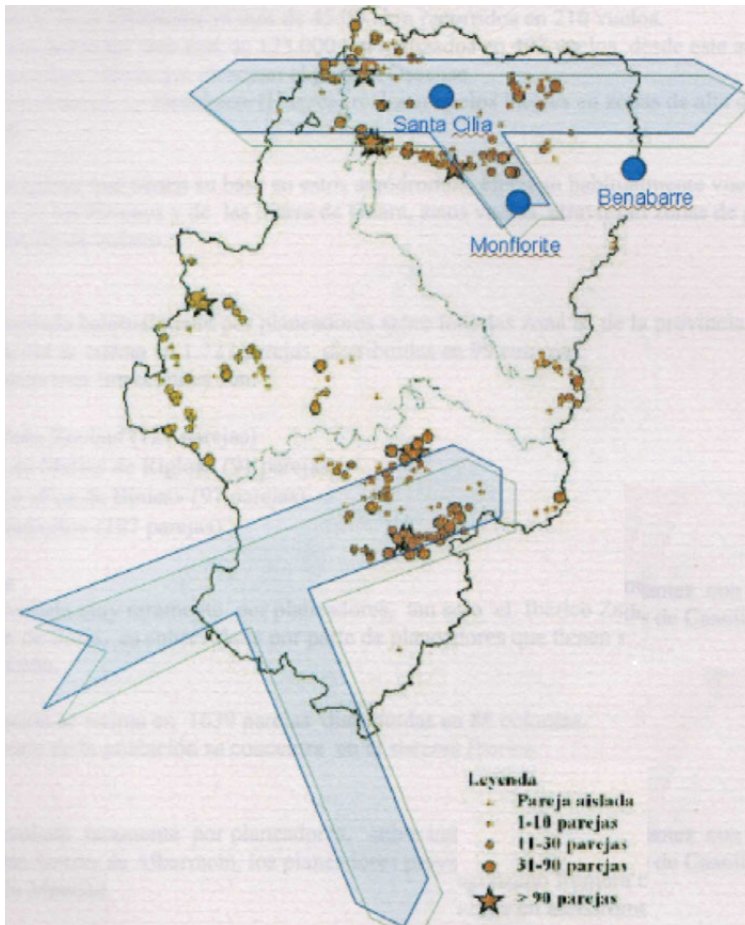
Figure 5. Vulture colonies and flying areas in Aragon

In the specific case of Huesca, the main colonies are found in the northwest of the province, in the mountain ranges on either side of the Gallego River middle course, on the border with Zaragoza and very close to the aerodromes at which most gliding activities take place (see figure 5).

The flight took place in an area where there are large colonies of griffon vultures and during the mid-day hours, when the updrafts are more frequent and intense, meaning that there were probably a large number of specimens flying at this time. This, along
