TECHNICAL REPORT

A-033/1997

Accident occurred
on 25 June 1997 to
Aircraft SUKHOI 26M,
registration RA01295,
in Barberá del Valles
(Barcelona)

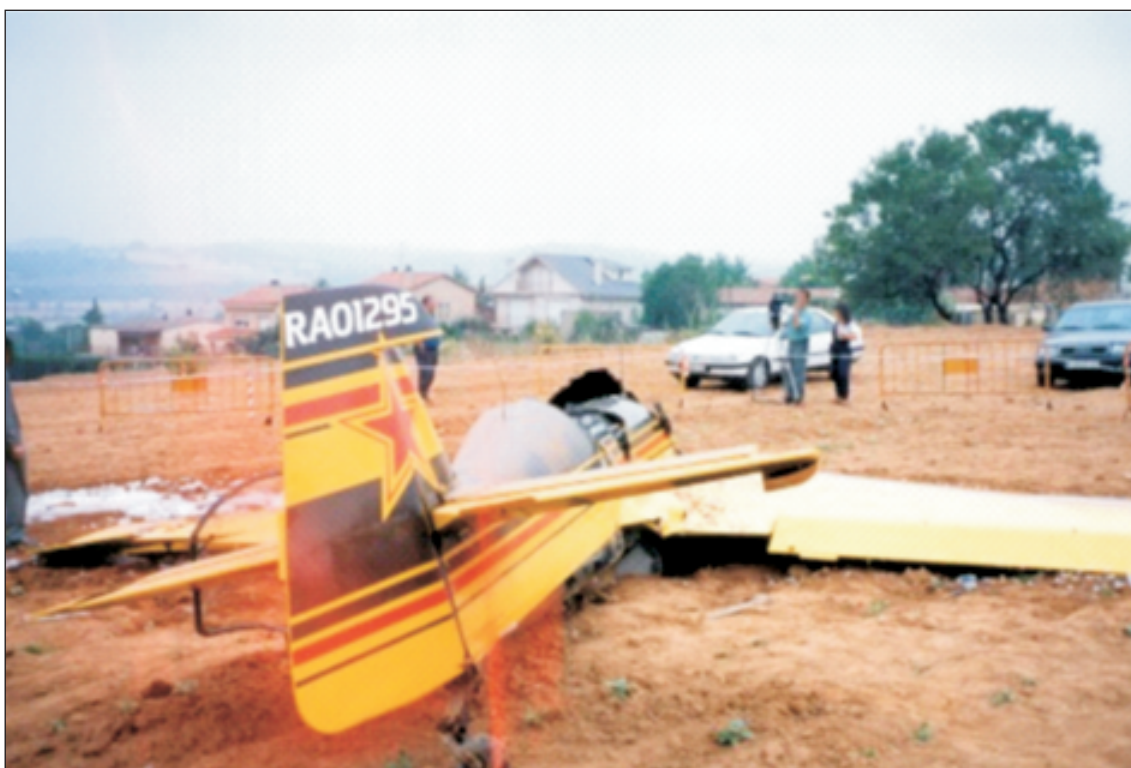
Photograph 2. *Back aircraft view*

The tail area, as well as the tail wheel, did not suffer any breakage.

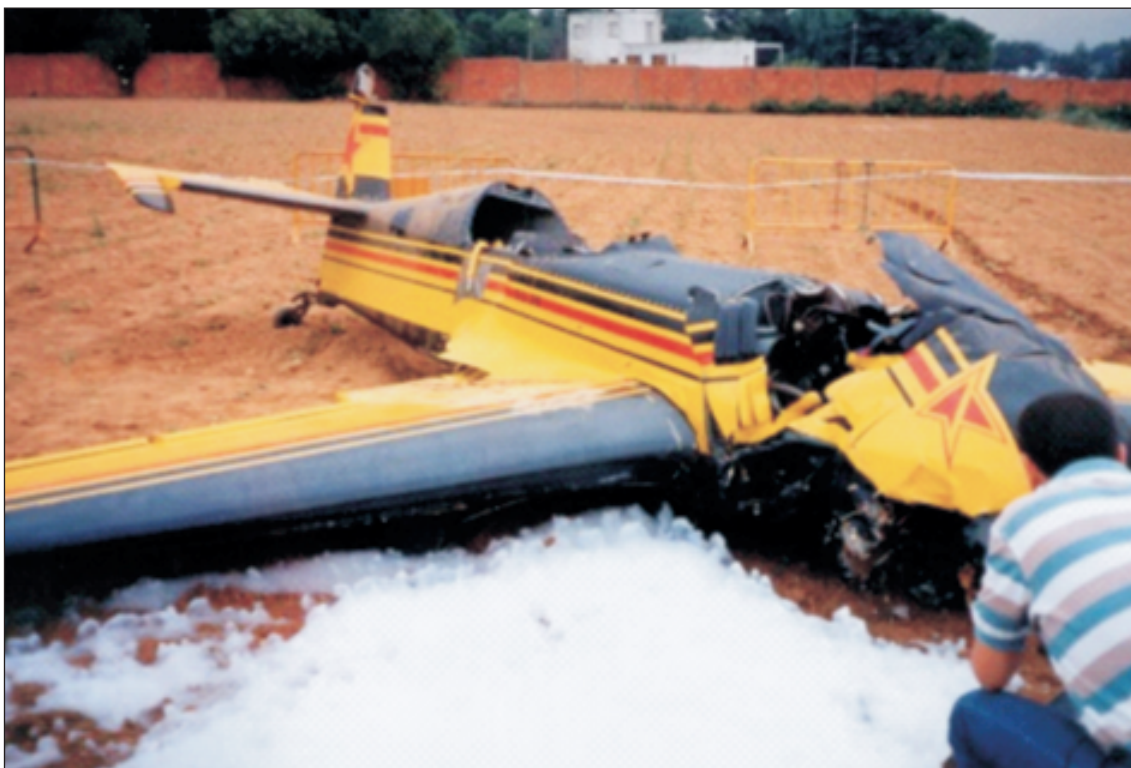
Photograph 3. *Front aircraft view*

The three-blade propeller had two blades broken and laying on the ground while the third blade was practically intact, which indicates that it was not turning at the moment of impact.

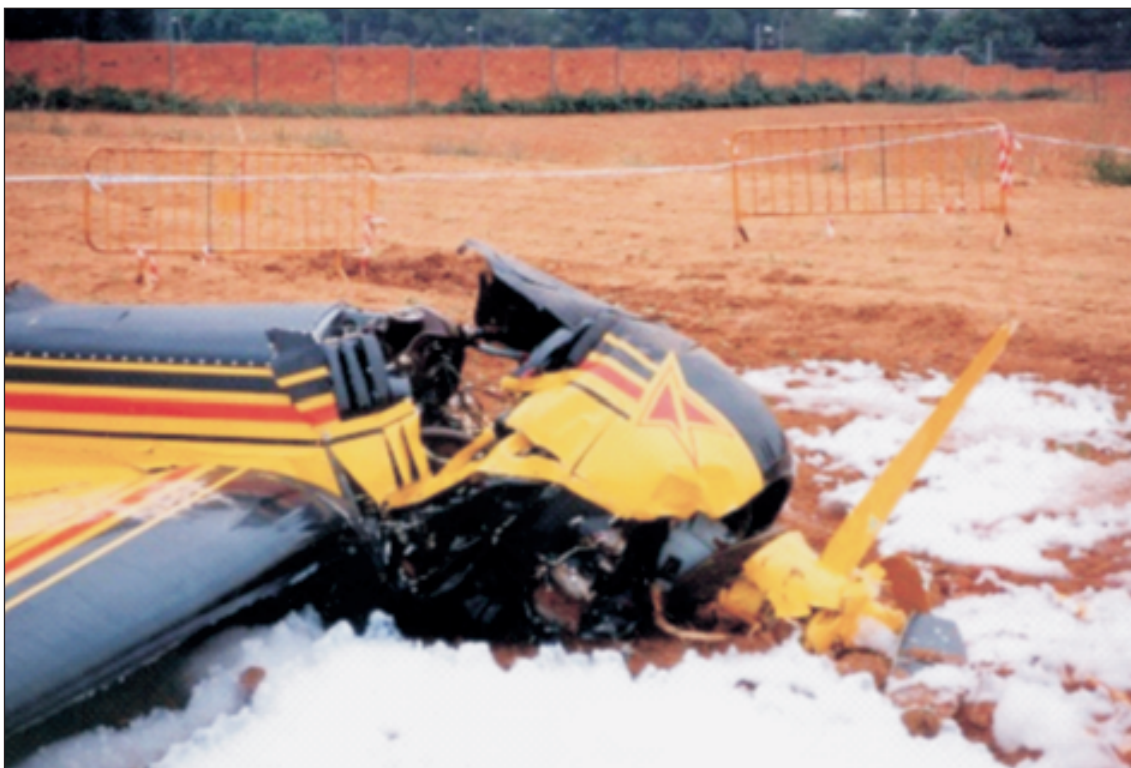
Photograph 4. *Powerplant detail*

During the impact, the engine mount broke. It was found split in two at the height of the firewall.

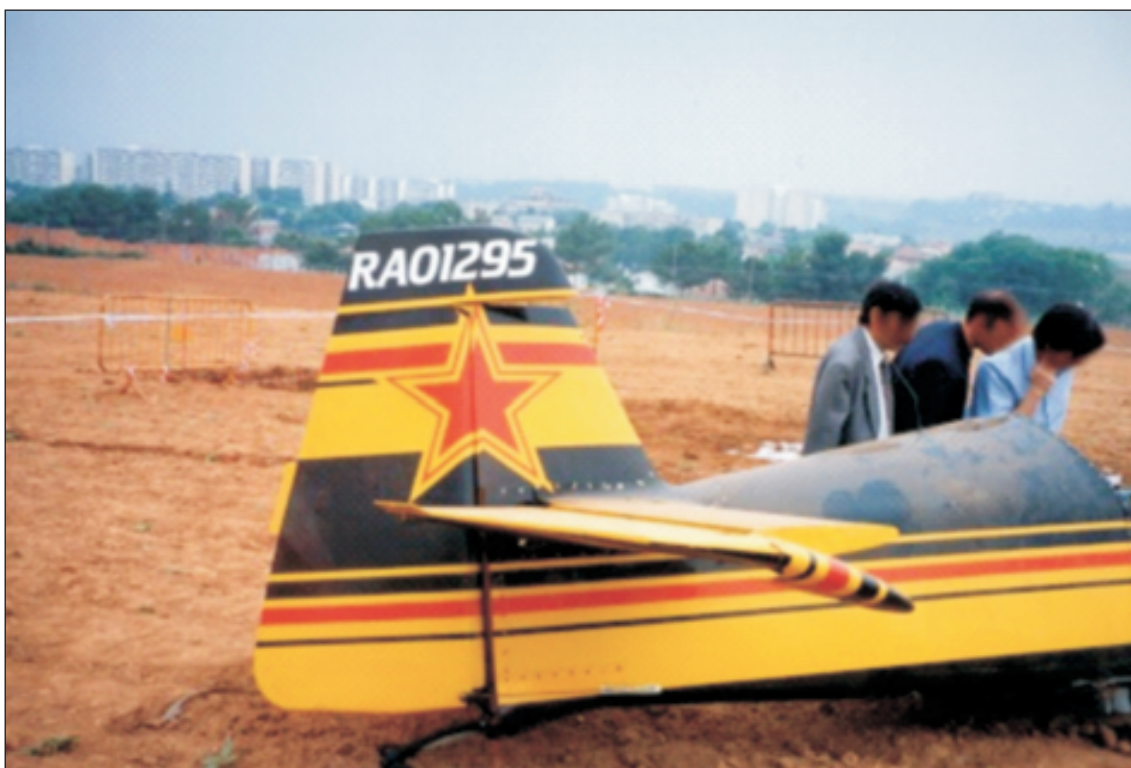
Photograph 5. *Aircraft wing detail*

The main landing gear had yielded until the wing hit the floor and the wing root area cracked through the upper side.

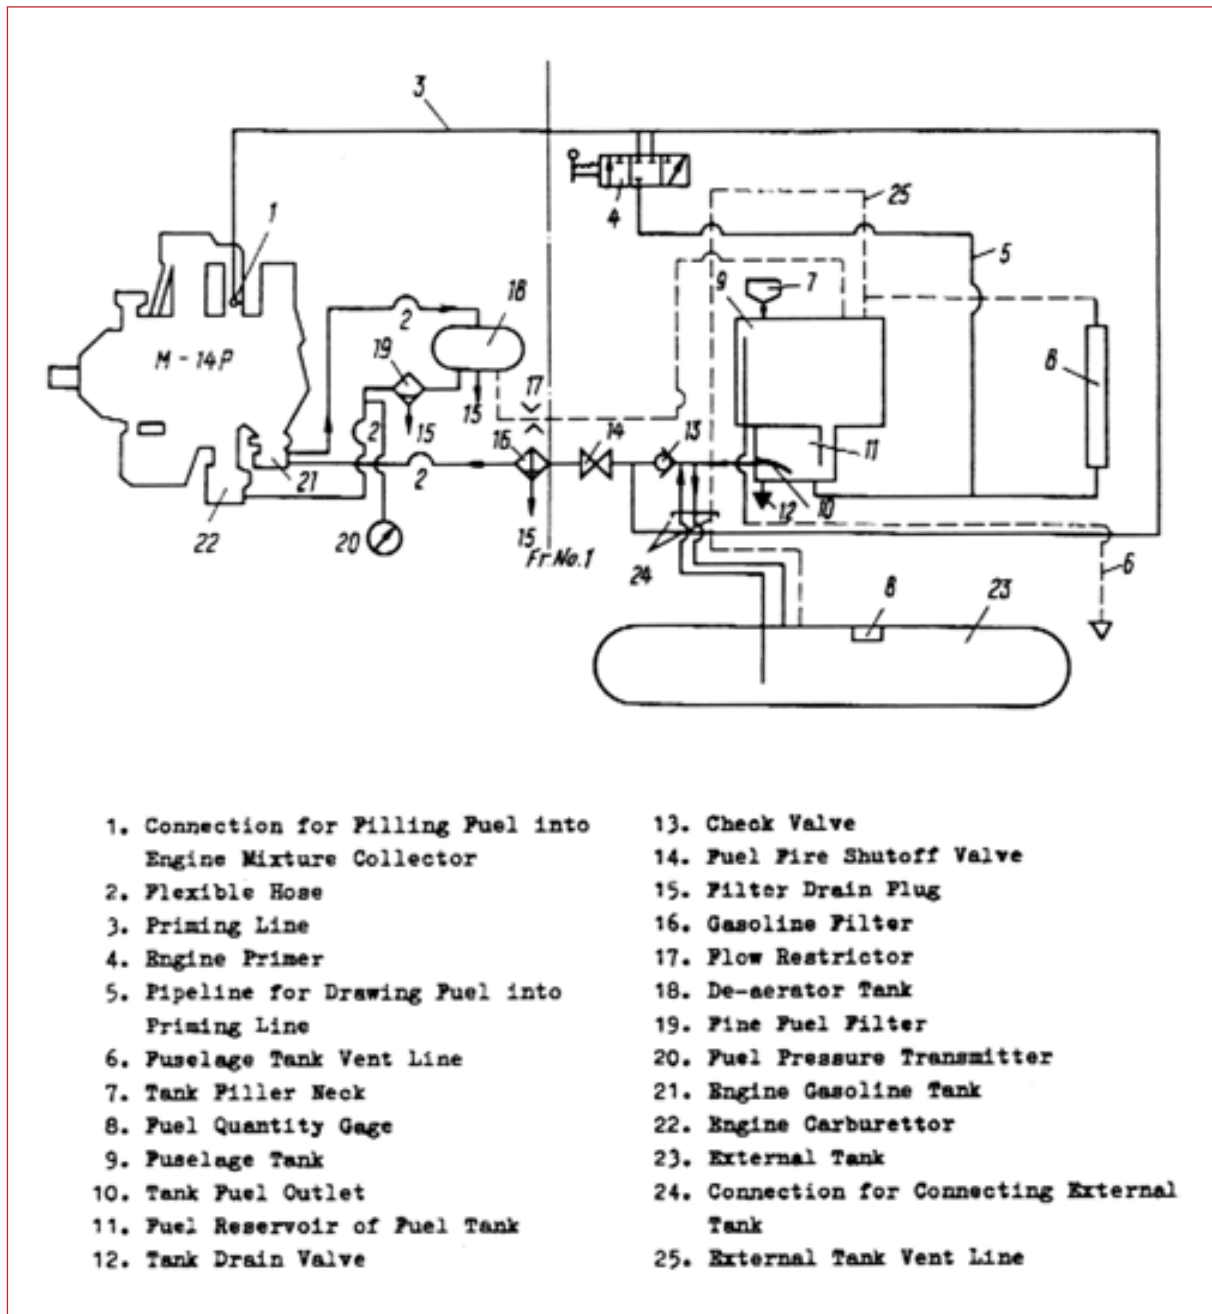
Fuel system. Functional schematic

Lastly, the fuel tank was dismounted and it was verified that the fuel tank inlet flexible hose was plugged up by the rubber which had worn out and was obstructing the flow of fuel.

The removal of the fuel tank showed that the flexible inlet hose for feeding the engine circuit had been obstructed by its own rubber, which had worn out, preventing the fuel from flowing from the fuel tank.

The probable cause of the accident was the engine stopping due to a lack of fuel feed produced by the plugging up of the flexible inlet hose from the main tank to the feed circuit.
