A-039/1997

TECHNICAL REPORT

**Accident involving SCHEMPP-HIRTH NIMBUS 4DM
aircraft, registration D-KDWA, in Fuentemilanos
(Segovia) on 27 July 1997.**

COMISIÓN DE INVESTIGACIÓN
DE ACCIDENTES E INCIDENTES
DE AVIACIÓN CIVIL

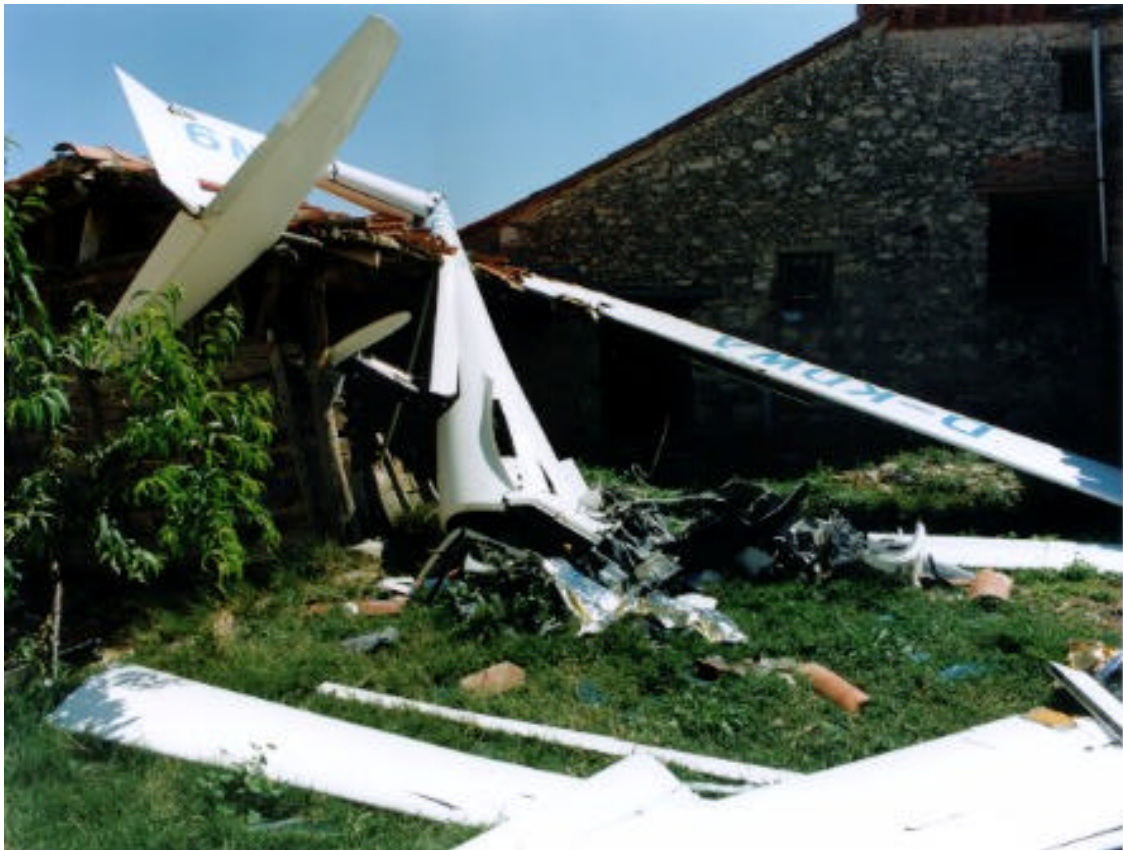
The impact was practically vertical such that the nose and the cockpit were totally destroyed. The main wreckage was concentrated in a 40 square metre area, which is the area of the backyard where the plane fell. Given the large wing span of the aircraft, the right plane broke off and fell on the street adjacent to the backyard. The left plane broke similarly but remained within the residential building's backyard. Lastly, the back part of the fuselage broke after the impact, but did not come apart from the rest of the fuselage. It remained leaning against the roof like the rest of the aircraft's tail.

Photograph #1 Aircraft wreckage

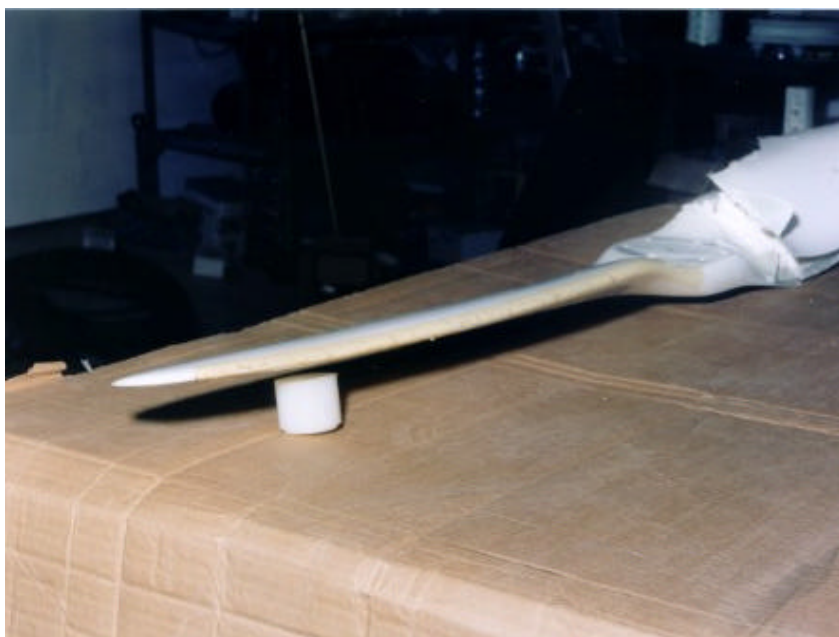
The motorglider propeller was unfolded in working position and the tips of the blades were intact. One of the blades was dented as a result of the impact.

During the inspection of the aircraft wreckage, the propeller was found unfolded in working position and with the tips of the blades intact. Only one of the blades was damaged due to the impact with terrain. This last observation indicates that the propeller was not turning at the moment of impact and, consequently, that the engine was stopped.

Photograph #2 Detail of propeller blade

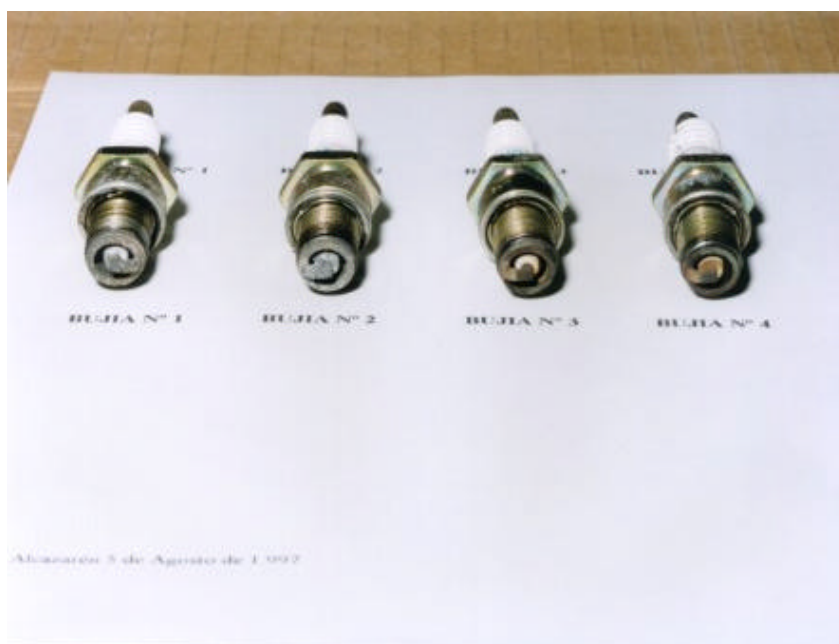
Once the head was disassembled, it was observed that the piston of cylinder #1 had a continued hot spot that had produced a crater in its crown. This piston had released melted aluminium particles that had deposited on the head, on the cylinder walls and on the two spark plugs of the same cylinder, thus short-circuiting their electrodes.

This shows that a knocking phenomenon took place in this cylinder and so a situation developed in which there was no spark between the electrodes of the two spark plugs, causing the cylinder to stop working as a result of lack of ignition.

Photograph #3 Spark plugs 1 and 2 with aluminium remains

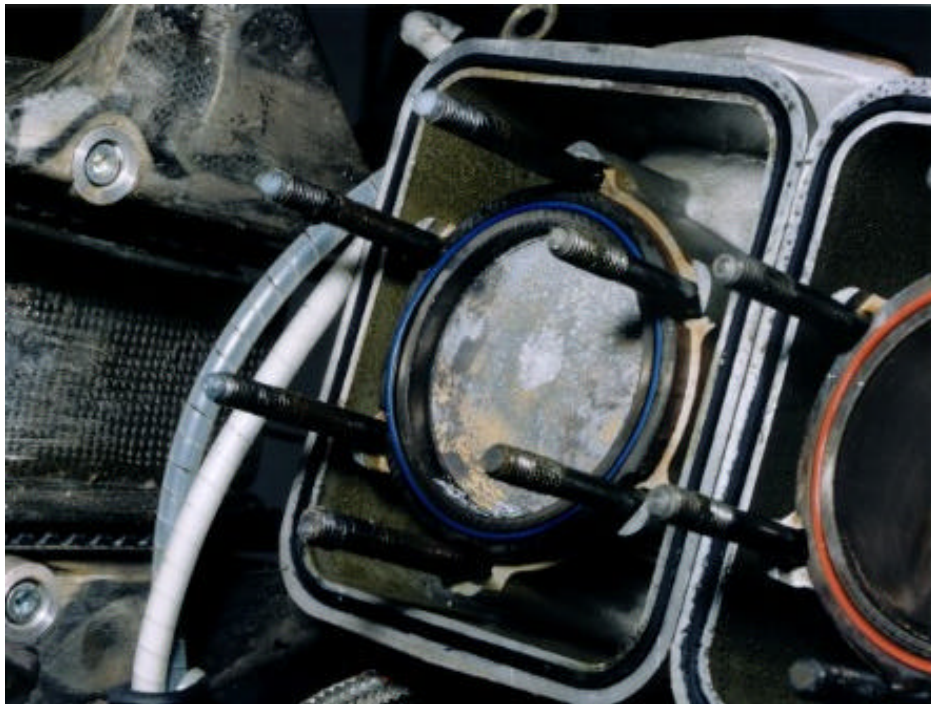
1. Piston #1 had a hot spot with a pronounced crater on its crown.
2. Deposits of molten aluminium were found in the head, on the walls of cylinder #1 and between the electrodes of spark plugs #1 and #2 corresponding to cylinder #1, which were short-circuited as a result.
3. The #1 and #2 head gaskets were of a different colour, #1 was blue and #2 was red. The manufacturer uses red head gaskets, so it can be affirmed that cylinder #1 had been repaired.

In addition, it was observed that the head gaskets were of a different colour in each cylinder: #1 was blue and #2 was red. The manufacturer uses red head gaskets. It can be deduced from this that cylinder #1 had been repaired, most likely in order to better its compression ratio.

Although the proportion of oil in the mixture that was being used at the time of the accident is unknown, it is likely that the detonation in cylinder #1 was produced as a result of using a mixture with an excess of oil, and consequently, having an octane number lower than required. Another factor that could probably have contributed to the occurrence of this phenomenon is the fact that this cylinder had a higher compression ratio after the repair work done on it.

Photograph #4 Piston #1 with crater and blue head gasket

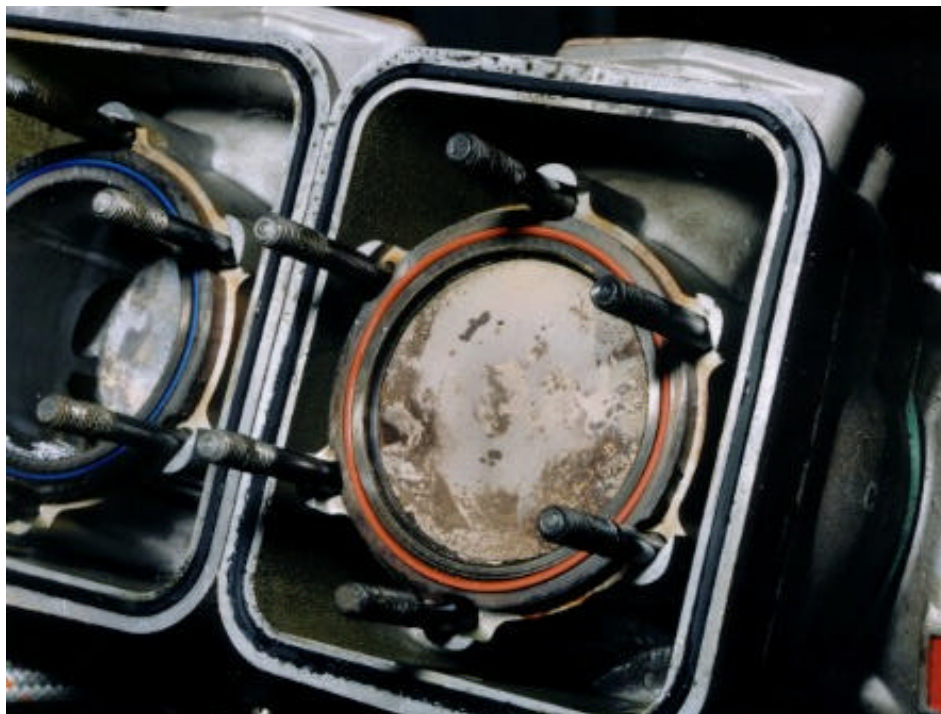
Photograph #5 Piston #2 without any sign of damage with red head gasket

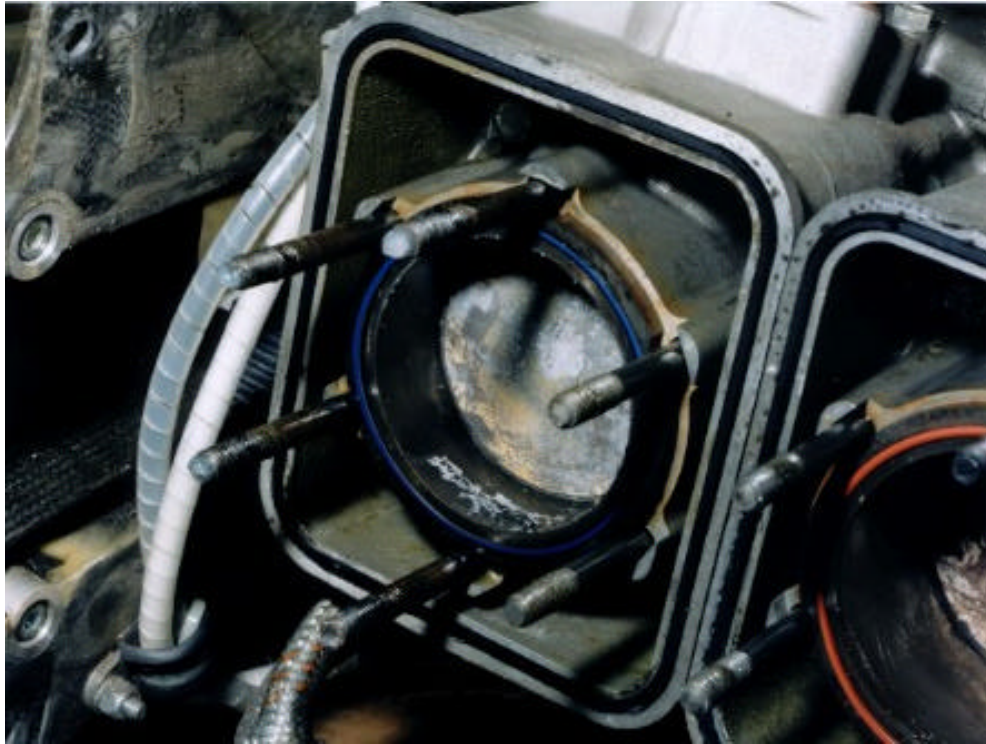
Inside the cylinders, the knocking can produce high local temperatures, giving rise to the “hot spots” or zones that reach such high temperatures that the material of the cylinder heads melts and produces craters of greater or lesser size. The detached material tends to deposit on the cylinder walls, in the heads and in the spark plugs, possibly short-circuiting the electrodes of the latter.

Photograph #6 Detail of aluminium deposited in cylinder #1
