Technical report

A-014/1998

**Accident involving Akrotech G-202 aircraft,
registration F-WSLB, near Girona Airport
on 3 May 1998**

COMISIÓN DE INVESTIGACIÓN
DE ACCIDENTES E INCIDENTES
DE AVIACIÓN CIVIL

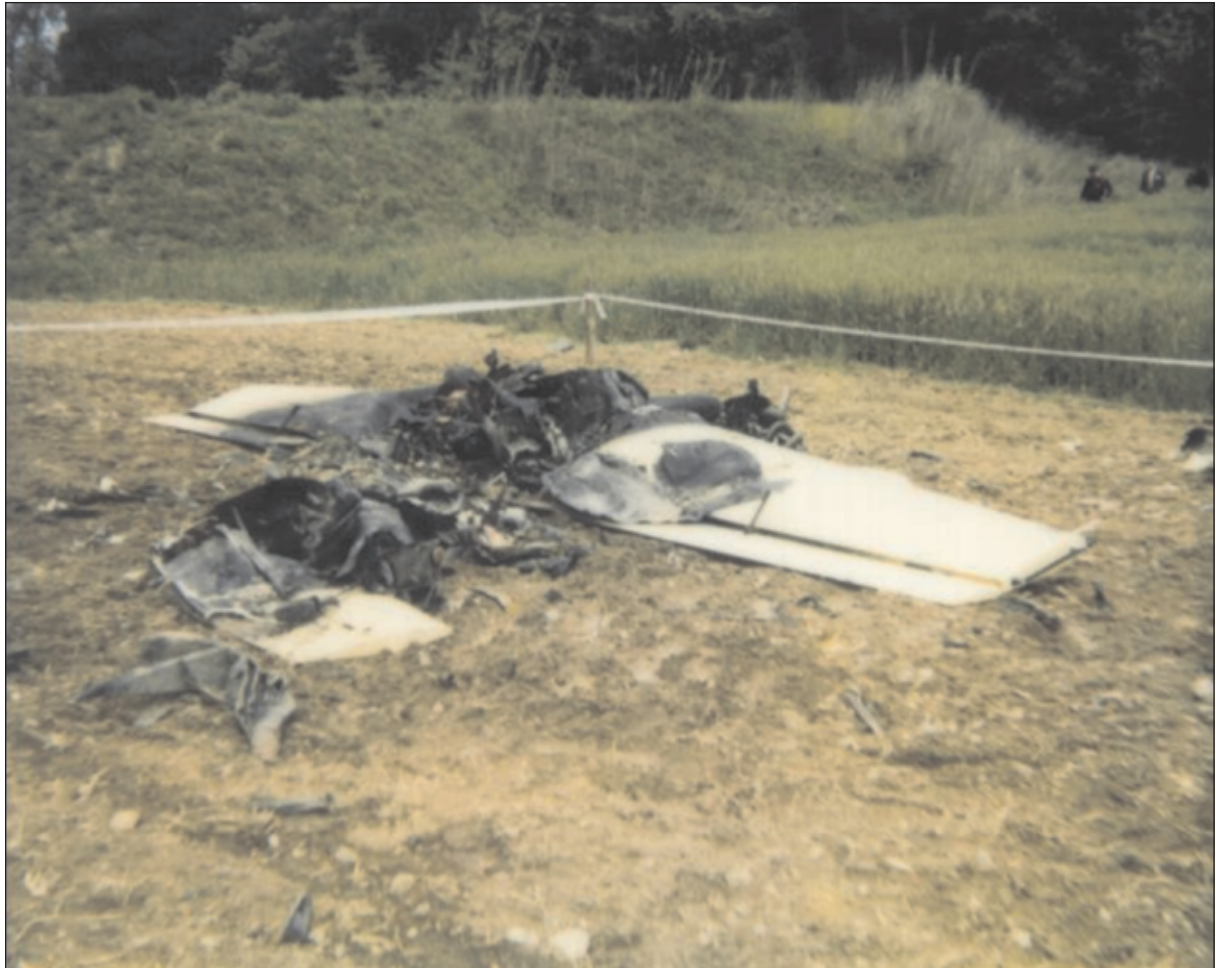
PHOTOGRAPH N.º 2

Right rear view with an angle of 45°
