TECHNICAL REPORT

A-055/1998

Accident involving
a CESSNA 172 N
aircraft, registration
D-EEYH, in Sierra
Bermeja, near Casares
(province of Malaga)
on December 8, 1998

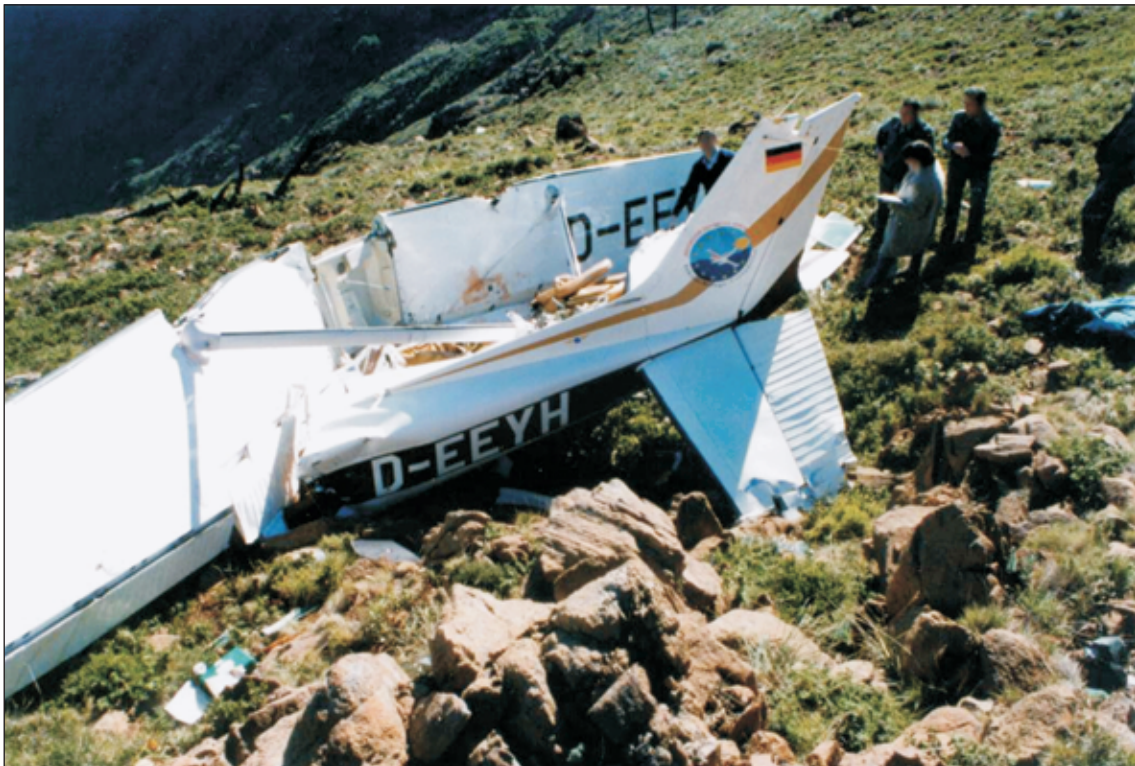
The first impact was with the right wing, causing it to break away from the fuselage and making the aircraft swing round on its vertical axis so that it finished in a position practically opposite to the direction of flight. As the aircraft swung round the engine broke away, ending up some 20 metres from the forebody; the fuselage crashed into the wing, partially breaking up, and the undercarriage broke away at its socket.

The impact was on the right wing against a rock, causing the aircraft to swing round on its vertical axis, with the wing breaking off from the fuselage and the engine coming away and being thrown a distance of 20 metres, as indicated in section 1.3. The figures in Appendix B show photographs of the wreckage.

View of the aircraft wreckage

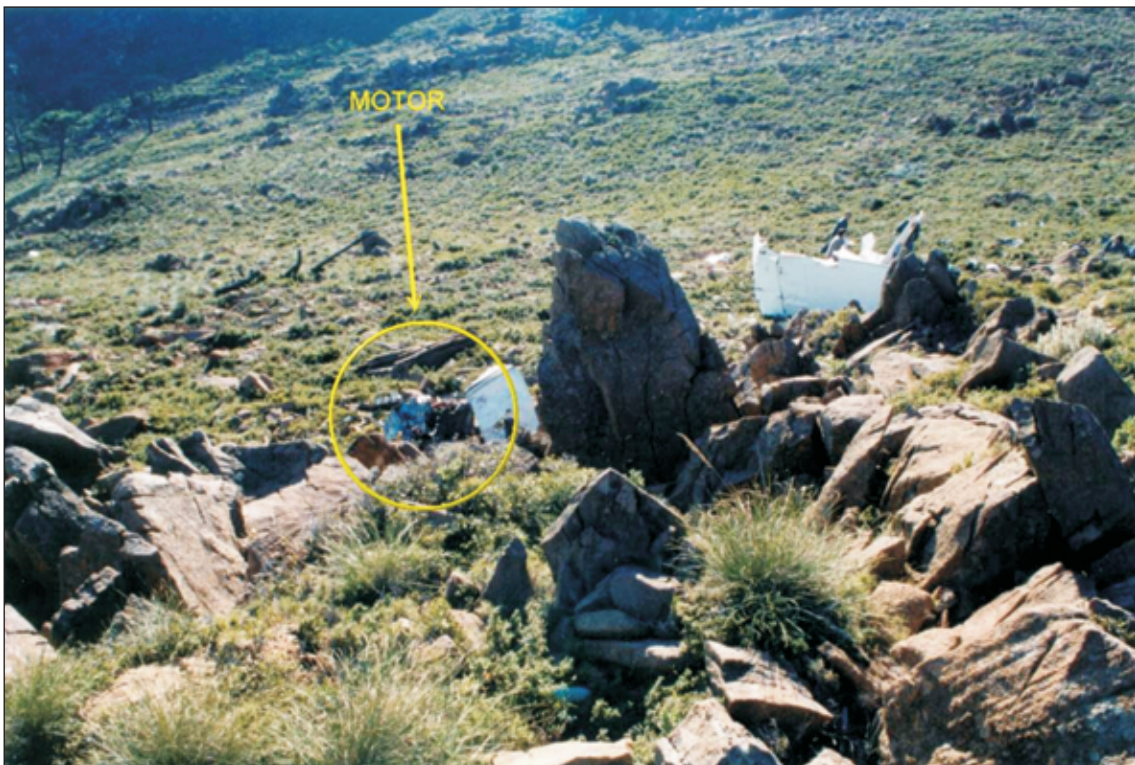
Position of the engine
