## **TECHNICAL REPORT**

**A-035/1999**

Accident to aircraft  
Aero Vodochody L-29  
«Delfin», registration  
ES-YLW, on 17 July 1999  
near «Monte Sayoa»,  
in Baztán-Eugui  
(Navarra)

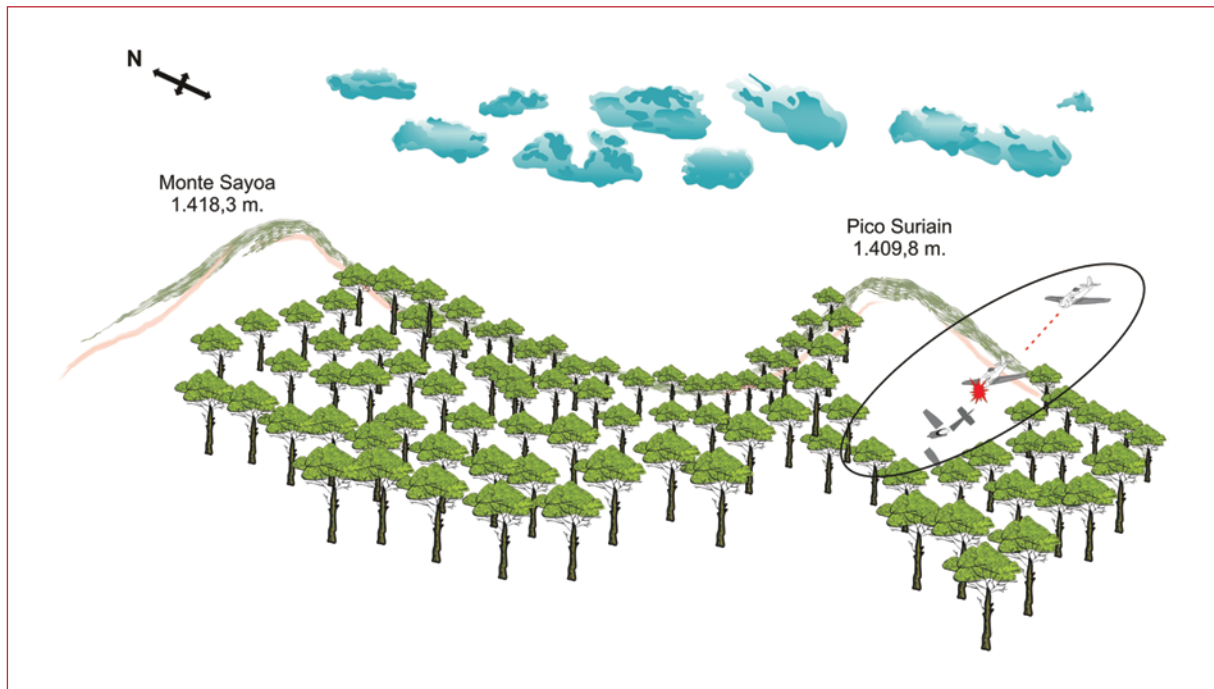
The accident occurred when the aircraft was flying low, even «very low» according to some witnesses. It must have scraped the tops of the trees (some of them up to 15 m high), continuing its descent cutting the trunks of a number of trees and finally colliding with the ground, producing a crater of some 6 per 3 m, the wreckage being scattered as indicated in previous sections.

*Final path of the aircraft*

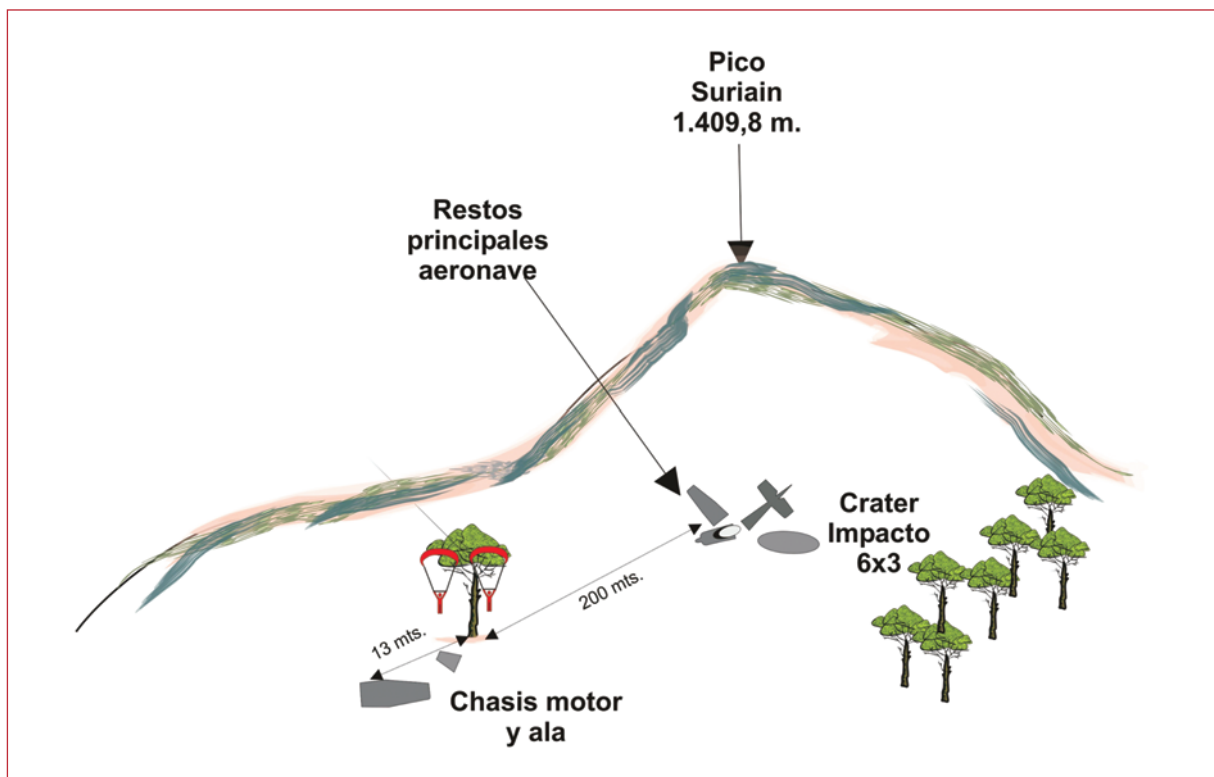
In its low-level final flight stage, the aircraft first scraped the tops of several trees at a height of around 15 m, continued its descent, cutting the trunks of some trees, and finally collided with the ground, producing a crater of some 6 per 3 m, where a part of the wings and the fuselage remained. A part of the engine was found some 25 m away at the top of a ravine, and at the bottom of this, with a height difference of over 75 m in a descent of some 150 m, the considerably injured bodies of the two crew members were found, dead and hanging from their parachutes, but lying on the ground. The parachutes were hanging from the branches of the trees. The situation (parachutes open, some scattered wreckage and a severed limb near a part of the engine) indicates that the crew ejection system was activated during the accident.

*Wreckage layout*

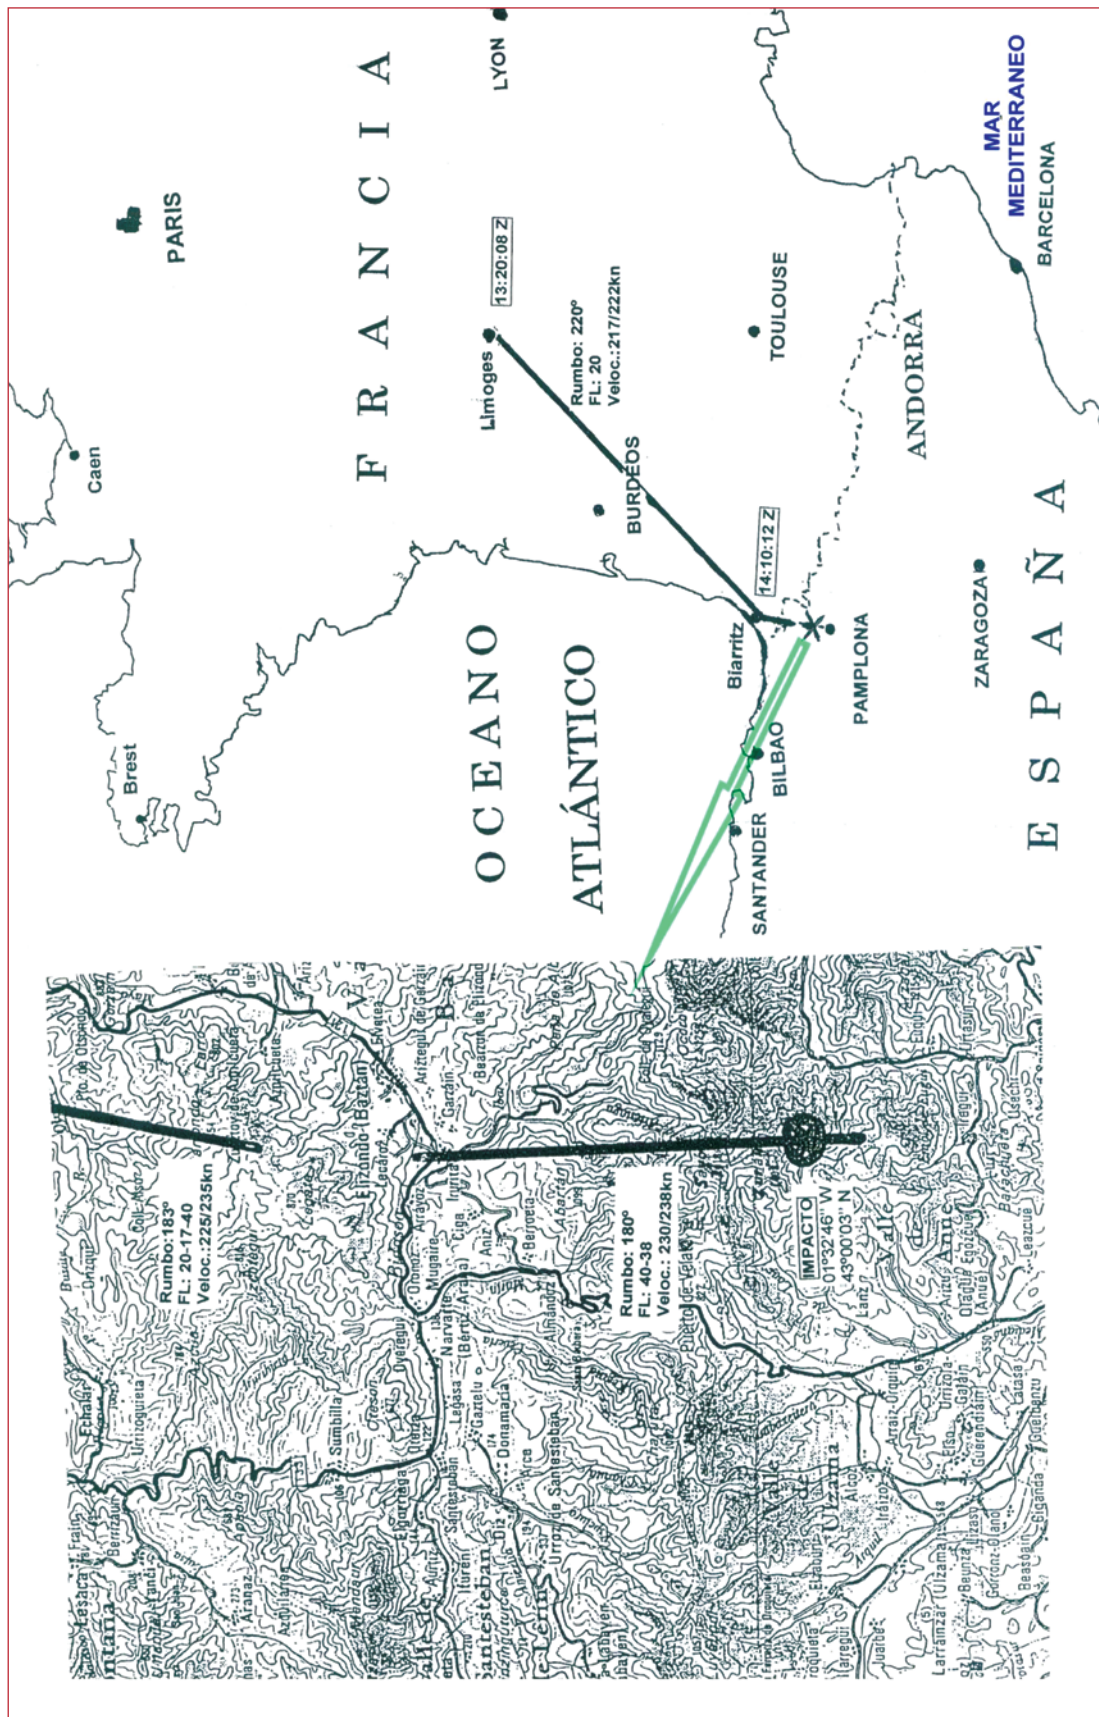
### **Location map and radar track**

This level, course and flying speed were maintained for almost a minute (until 14:18:21 h), at which moment the pilot commenced a descent, reaching level FL 38 at 14:18:53 h, which he maintained until the last real reading before the accident at 14:19:09 h, the last estimated radar position available being at 14:19:25 h. At that moment, the course was 179° and the speed had increased to 239 kt.
