## **TECHNICAL REPORT**

**A-036/1999**

Accident of the powered  
glider GLASER-DIRKS  
DG-600/18 M,  
registration D-KGLG,  
in Borja (Zaragoza)  
on 19 July 1999

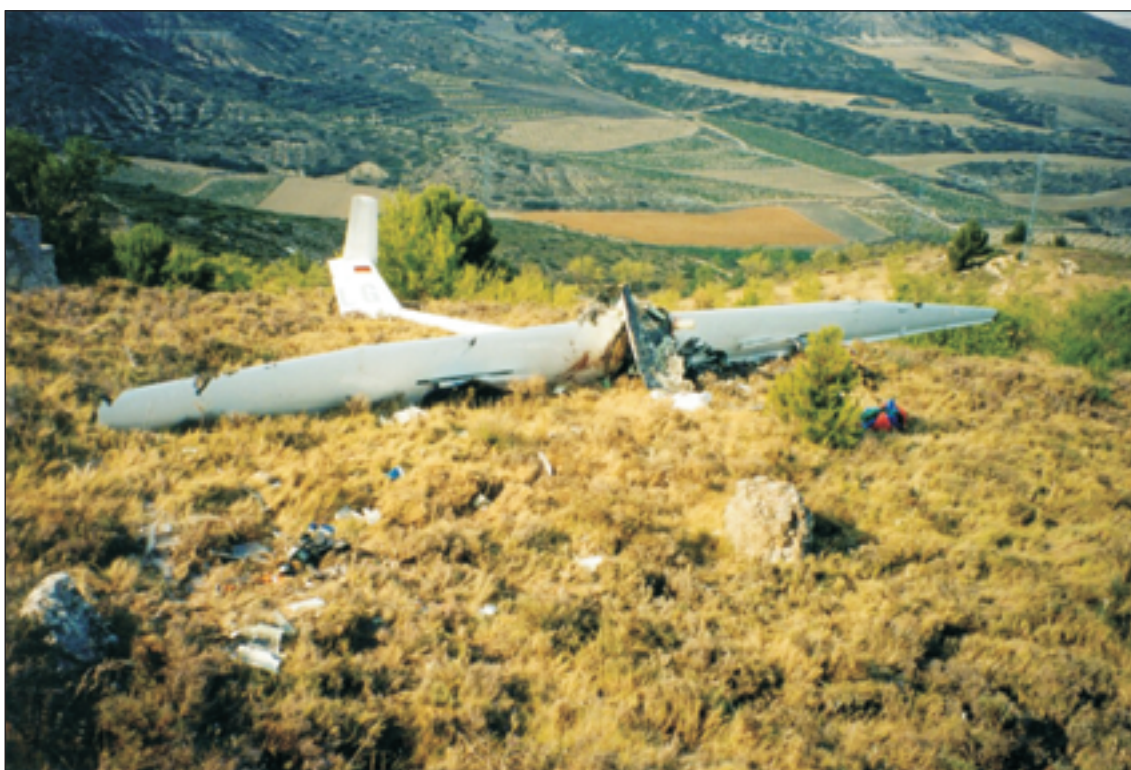
Inspection of the accident site revealed several traces aligned in a northerly direction. The first mark on the hillside was a small hole about 15 cm in diameter and 6 cm deep, caused by the initial impact of the left wingtip. The tip extension of the left wing, separated from the wing assembly, was lying 2 m away in a horizontal position, with its bottom surface upwards (See distribution of wreckage in photos 2, 3 and 7).

The impact of the leading edge of the wing against stones and bush and the ground itself produced cracks and local damage seen in photos 2, 4 and 7. In addition, there was a uniform bending of the leading edge along its entire span towards the bottom surface, clearly seen in photos 4 and 6. Also, the effect of this impact distributed along the leading edge made the wing rotate leading edge up from the dive position to its final resting position close to the vertical plane, resting on its trailing edge. However, the wing spar withstood the impact, and the wing as a whole remained intact.

Photo 2. *The wreckage, viewed in the direction of the impact. In the foreground, the trace and hole of the impact of the front fuselage can be seen*

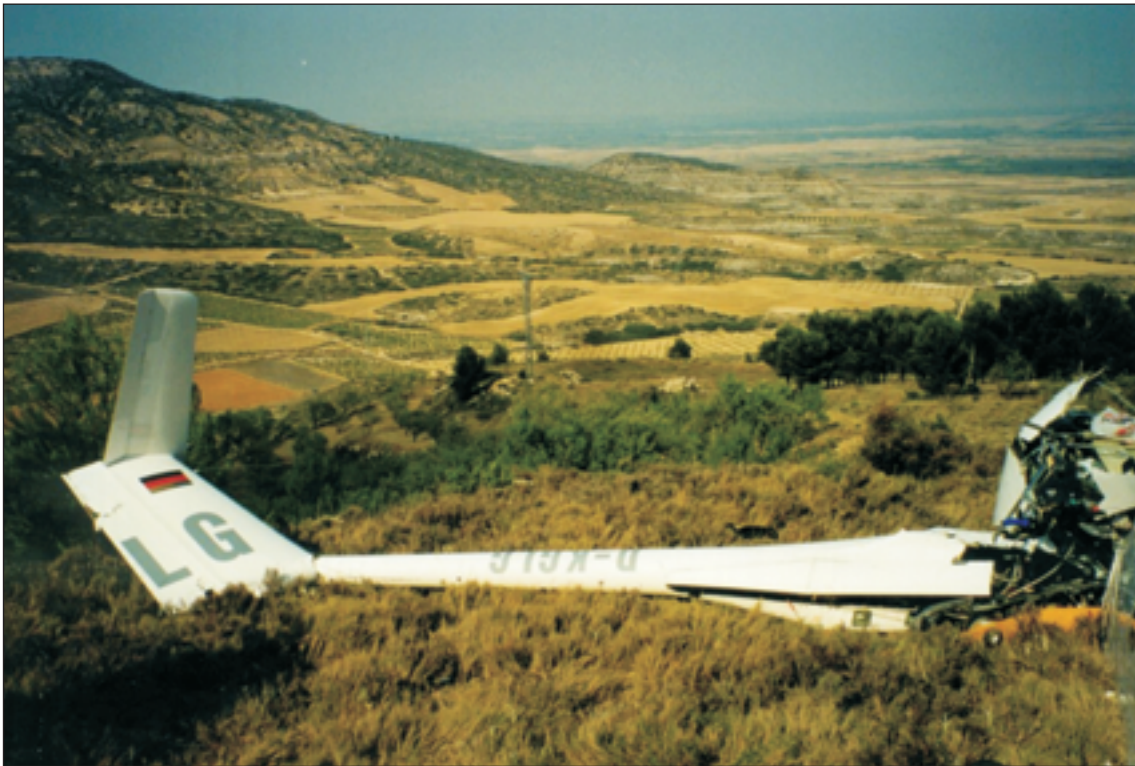
The entire rear fuselage, from the support point of the pilot's seat, flipped over the wings, with the landing gear, engine, propeller and fuel tank, and came to rest in an inverted position. The end of the rear fuselage shows a fracture in the narrow section at the root of the tail unit. The tail unit was not inverted like the rest of the fuselage; it remained in one piece and was in a normal flight position, leaning slightly to the left and joined to the fuselage only by the rudder and elevator control cables.

The fracture of the fuselage at the point next to the tail unit, which occurred when the tail was in the air, suggests the possibility that this was the cause of the accident. With the fuselage broken at this point, the aircraft would lose control and plummet to the ground.

Inspection of this break could not clarify the cause of it. Nevertheless, we believe that the very slim fuselage could not split without extremely high maneuvering loads or gusts of wind, which were not probable on that day and at that altitude.

Photo 3. *Final position of the fuselage and tail. Inverted fuselage. Fracture of fuselage at tail joint*

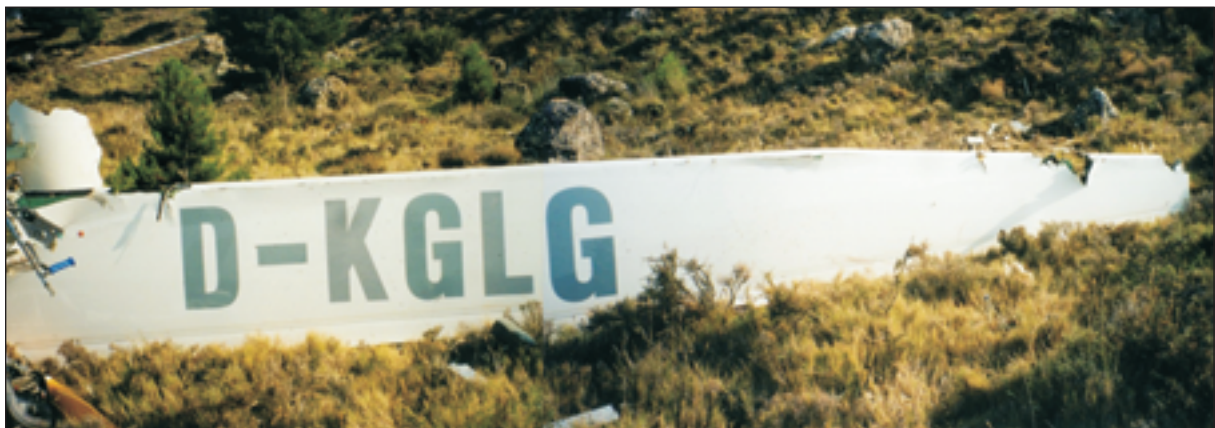
Photo 4. *Bottom surface of left wing*

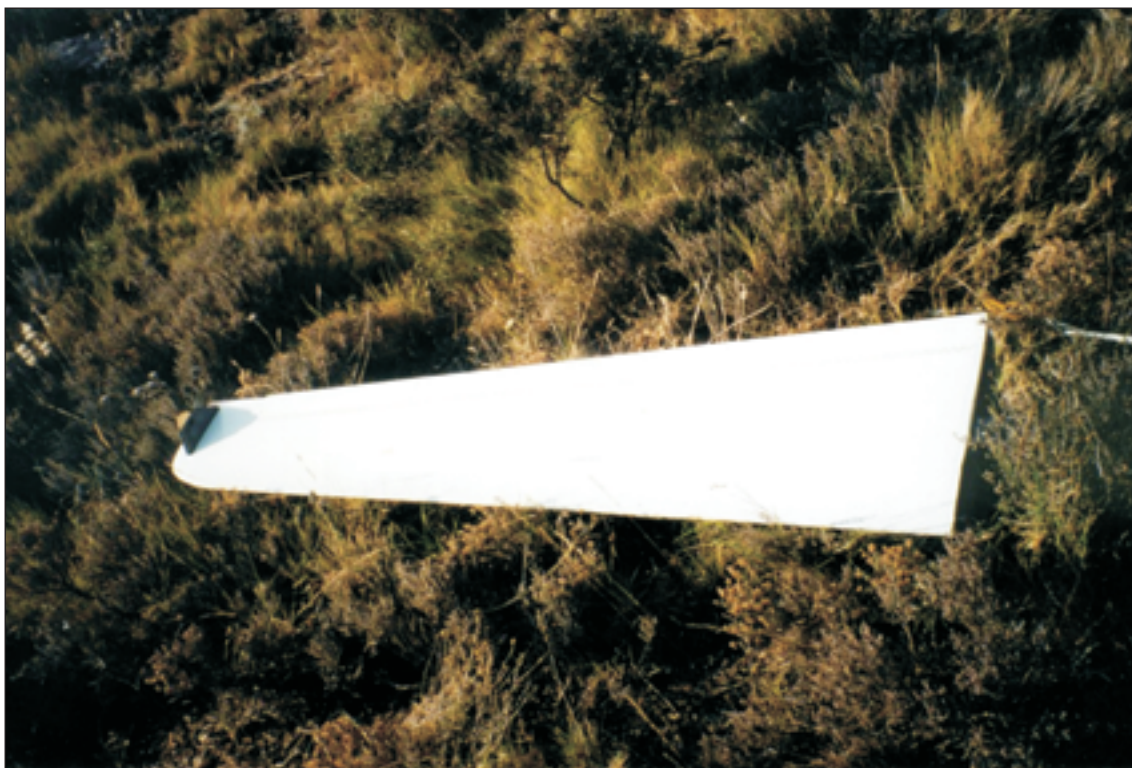
The initial impact of the end of the left wing separated the left wingtip extension, breaking its normal fixings, without absorbing a large amount of energy. The wingtip extension was found lying in a horizontal position with its bottom surface upwards, and otherwise undamaged.

Photo 5. *Left wing tip*

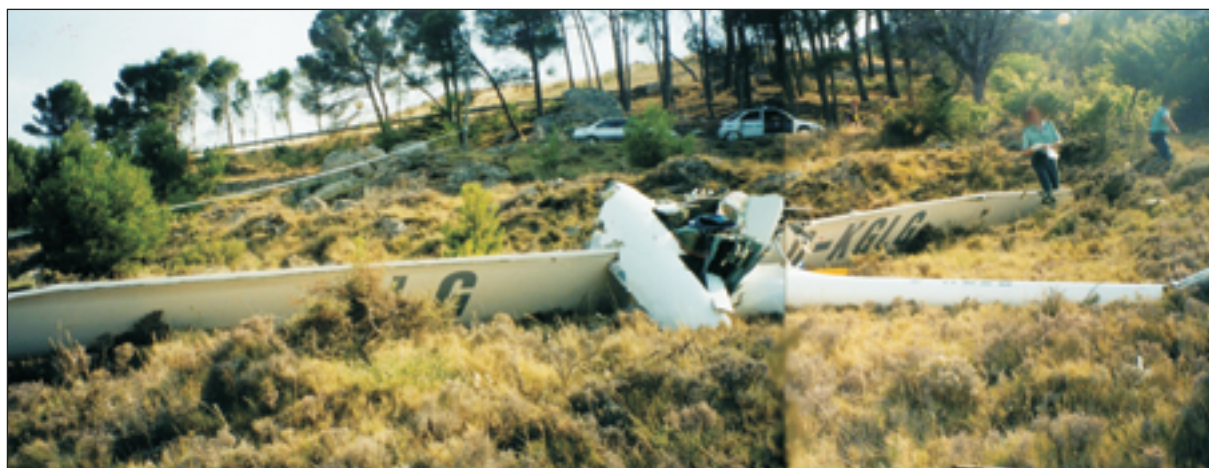
Photo 6. *Complete wreckage, looking south*

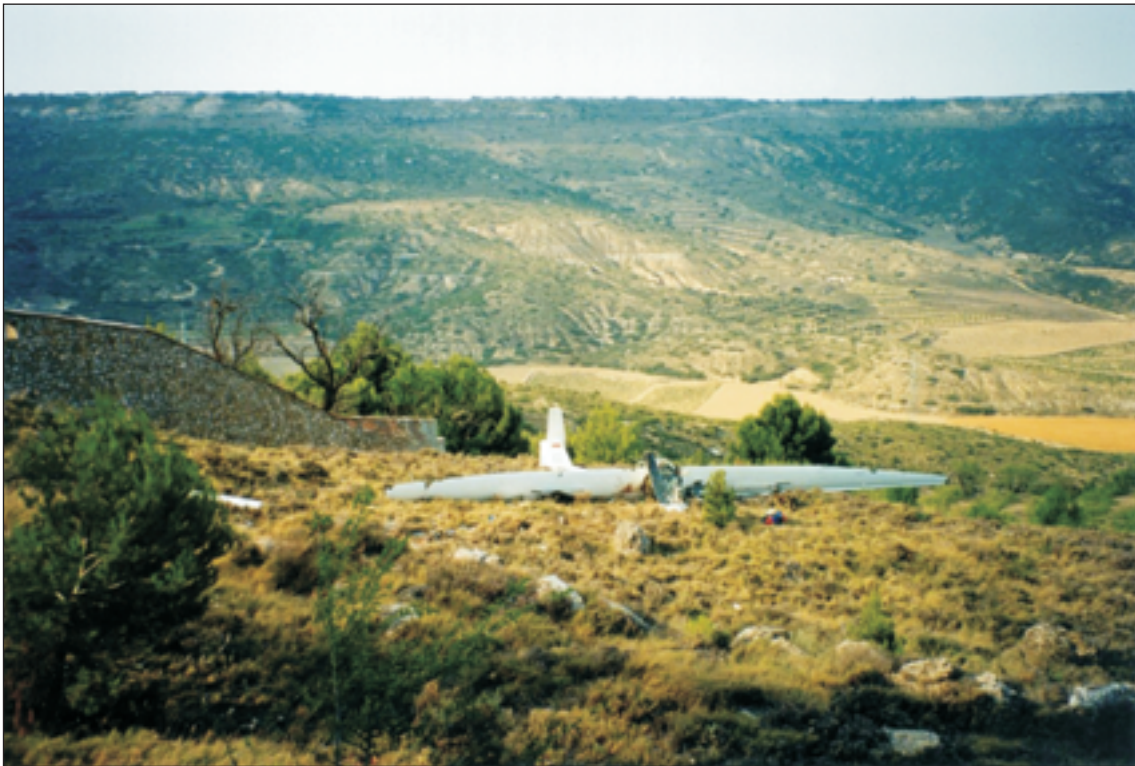
Photo 7. *Complete wreckage, looking north. Hills in background of 730 m height. Let wing tip separated from its wing*

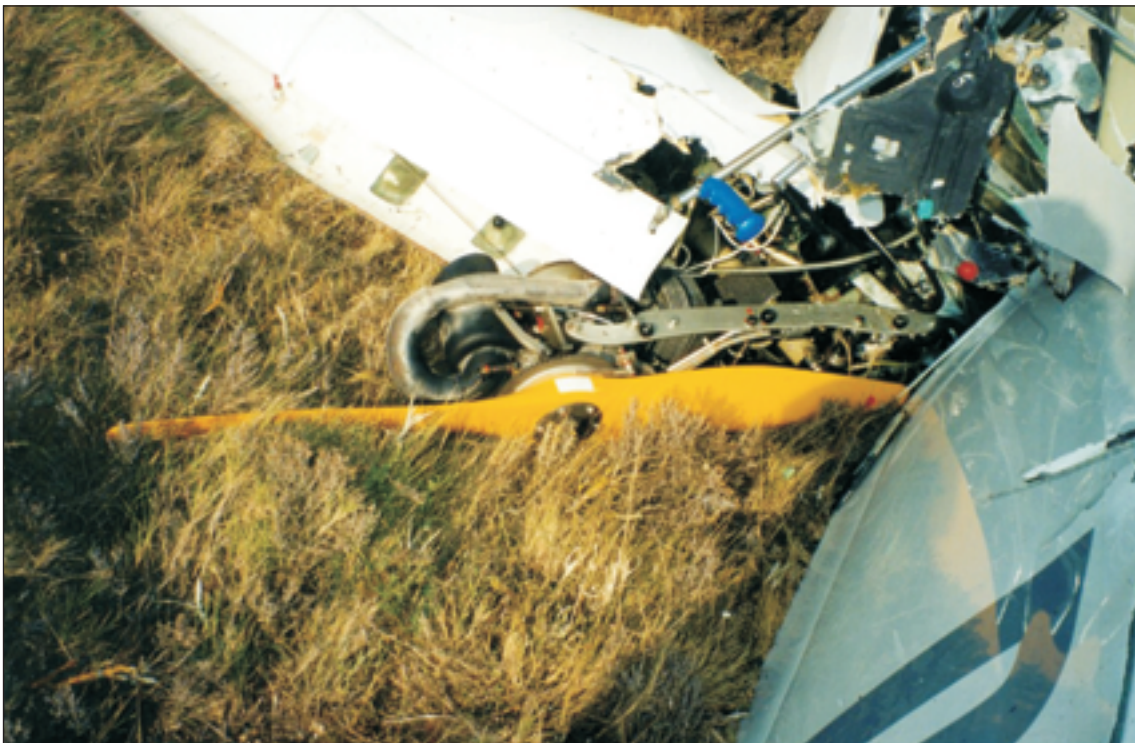
Photo 8. *Engine and propeller ejected from their compartment*

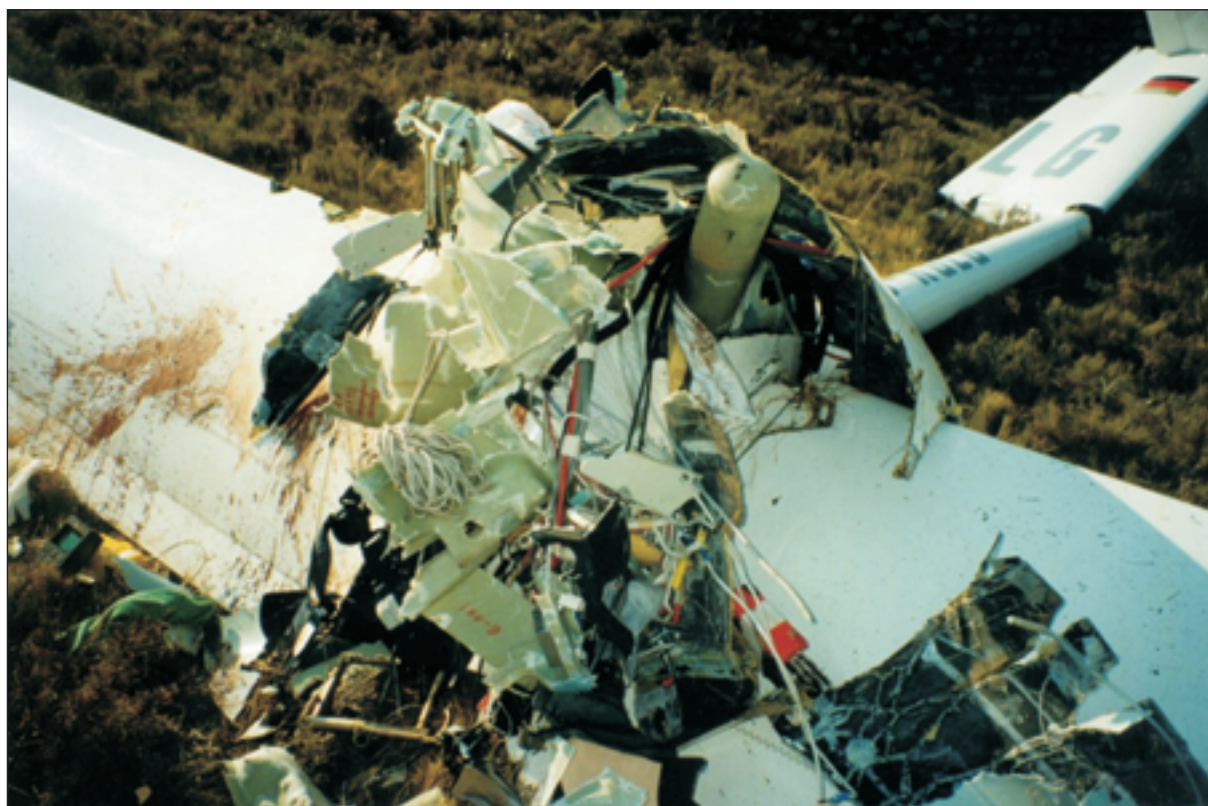
The wreckage of the aircraft did not catch fire; the fuel tank remained intact and airtight (Photo).

Photo 9. *Wreckage of front fuselage and detail of fuel tank*

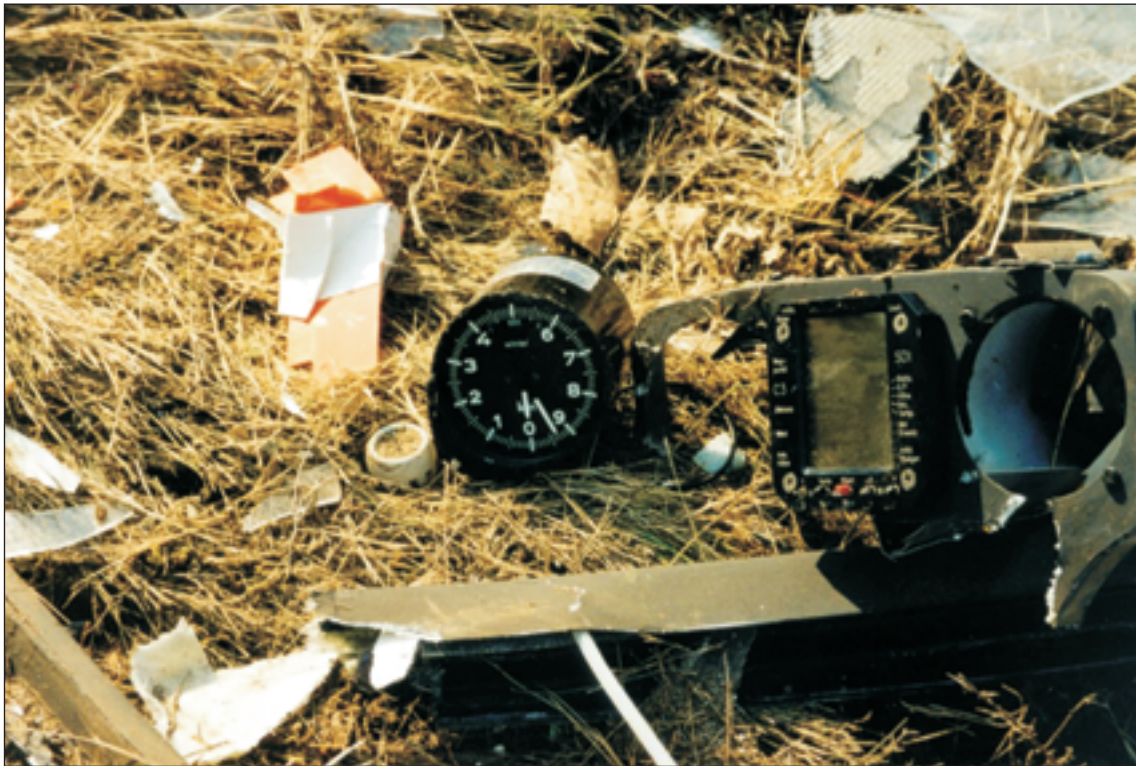
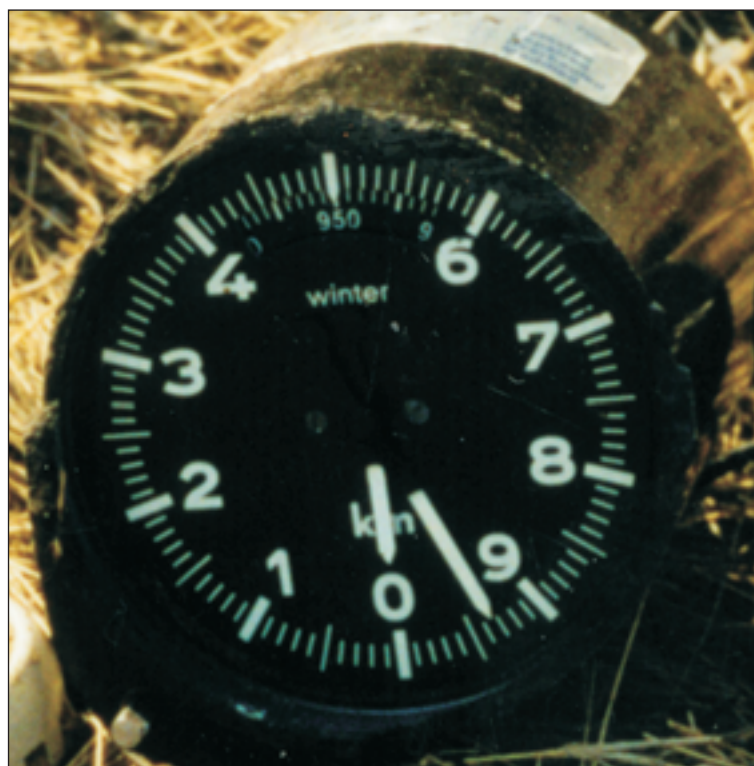
The altimeter recovered from the wreckage was set at 950 mb and showed a reading of -65 m in height. Bearing in mind that the METAR of Saragossa on the day and time of the accident gave a QNH of 1016 mb and that each millibar represents some 8.5 m, the altimeter reading allows us to estimate that the altitude of the point where the accident occurred was 500 m.

Photo 10. *Altimeter set at 950 mb, reading -65m.  
General view and detail*

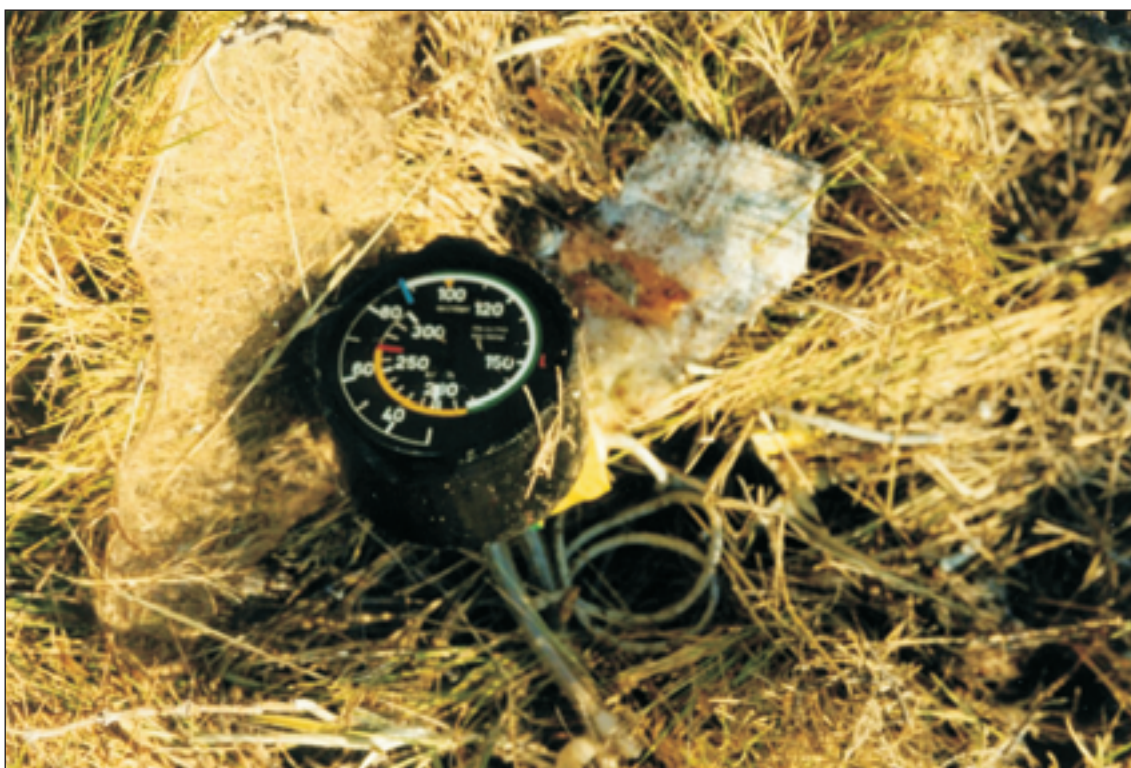
The anemometer was found set, showing a reading of 202 km/h.

The flying height at the moment of stalling was some 150 m, which was necessary for the glider to accelerate from the approximately 80 km/h airspeed in a stall situation to the 202 km/h indicated by the set anemometer found after the crash.

Photo 11. *Anemometer reading 202 km/h*
