Technical report

A-059/1999

**Accident involving Hispano Aviación HA-1112 M1L
«Buchón» aircraft, registration G-BOML, near
Sabadell airport on 25 Sep 1999**

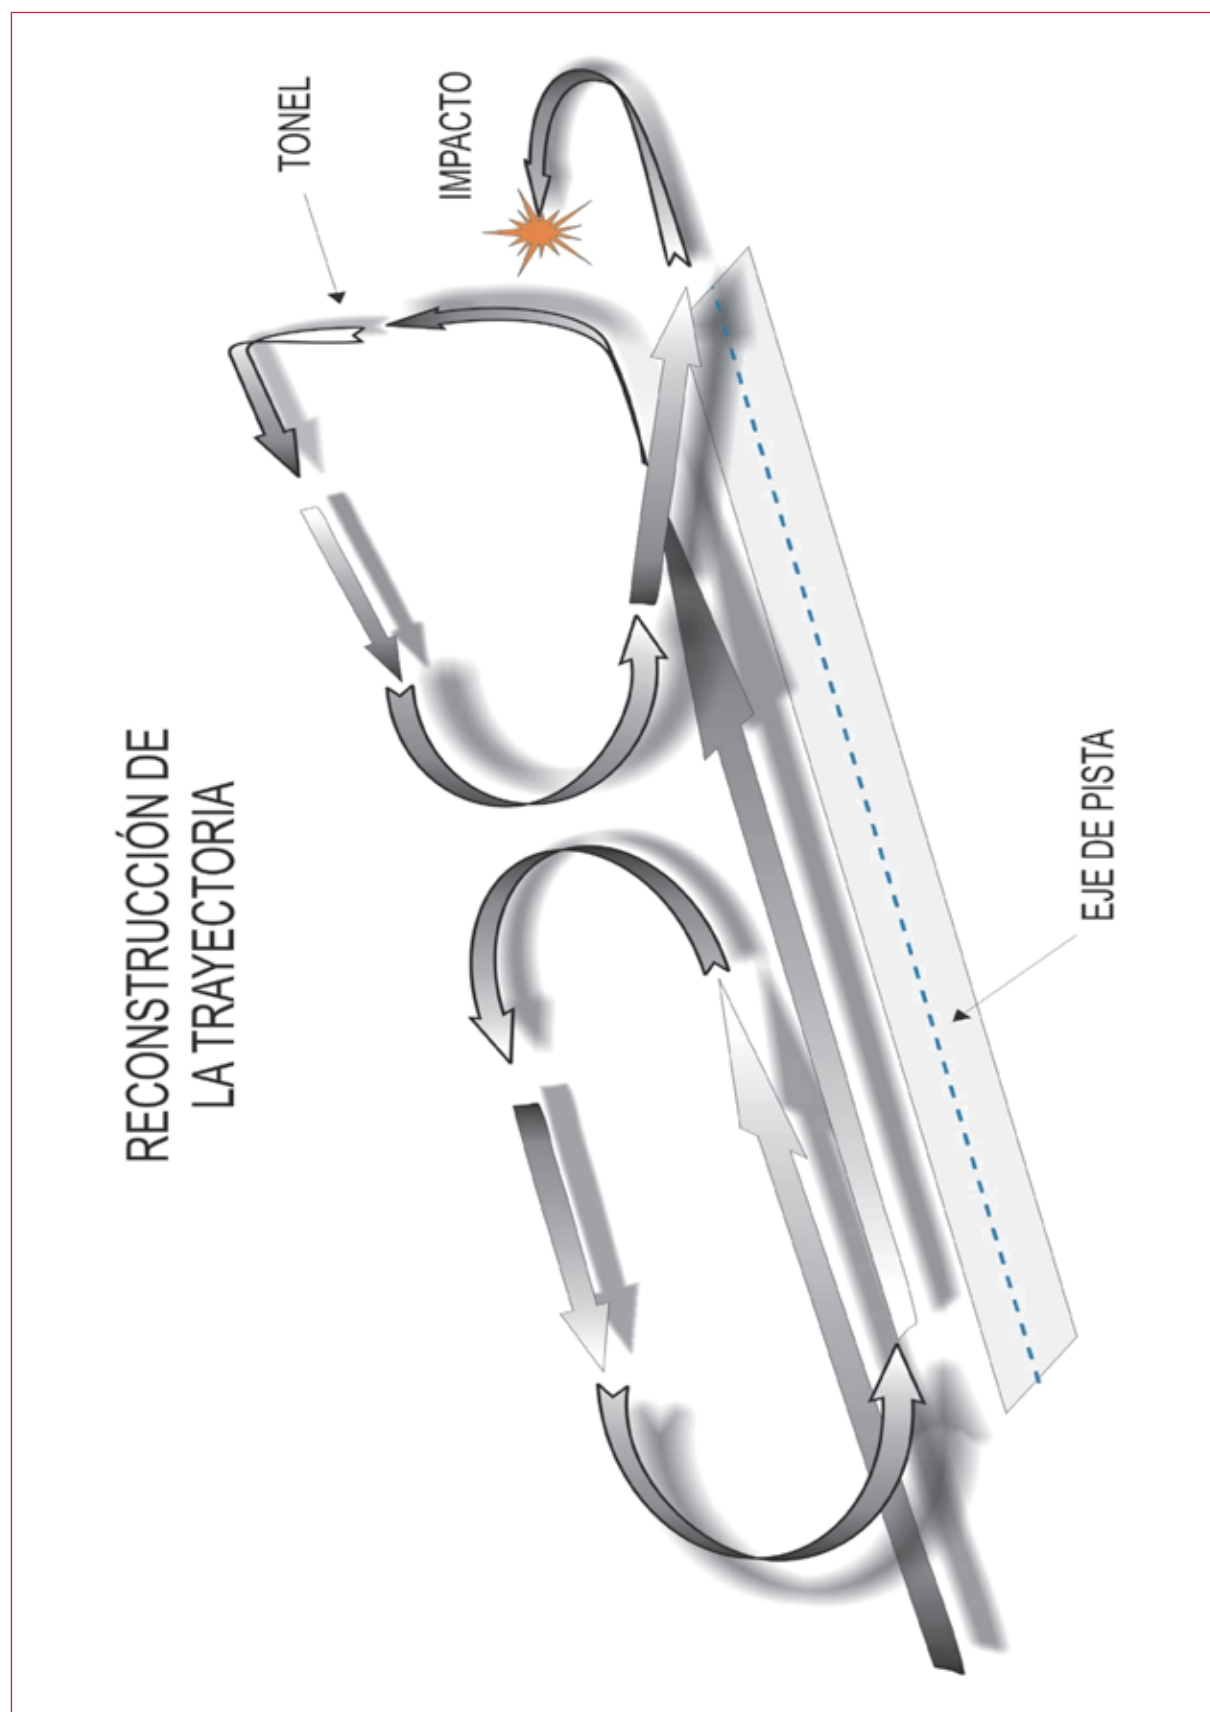
APPENDIX A
Reconstruction of the aircraft trajectory
over Sabadell Airport

All the available data, witnesses testimonies, the times stated by the tower controller and the images on the aforementioned fan videotape, lead to conclude that the final turn of the manoeuvre to face runway end 13 was too tight, possibly because the aircraft had overshoot the runway threshold and the pilot, wanting to be positioned for the landing, had to look back. According to the pilot's relative, the manoeuvre should have been made with 35-40 banking degree, while the controller estimates it to have been between 50-60 degrees.

The result was that the aircraft suffered a left wing-drop during the manoeuvre, losing height quickly. Although the pilot tried to recover it by increasing power and stepping on the right rudder to the maximum, he was able to climb a little, but not enough to avoid the accident.

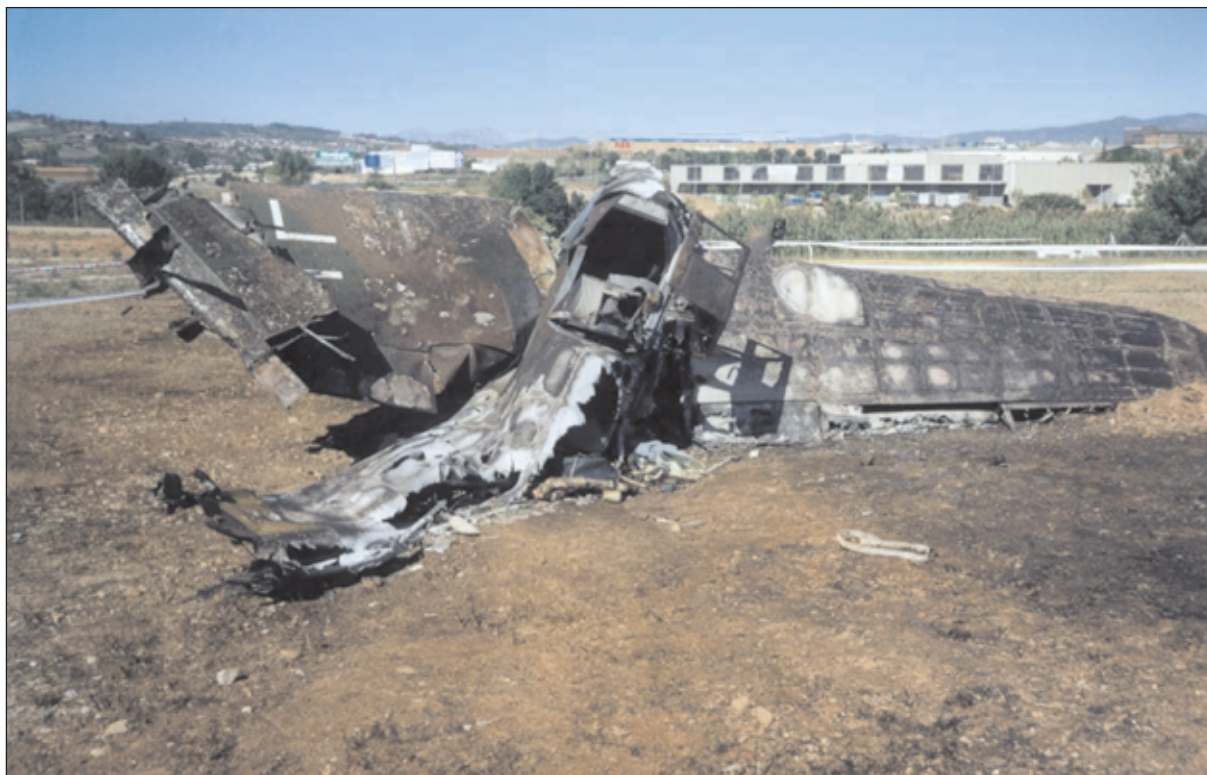
The aircraft made impact with its left wing and slid across the ground, resulting in a fuel explosion and subsequent fire.

The wing assembly remained mounted in position; the left wing was deformed and damaged, while the right wing was almost intact, damaged only by the fire. The right slat could move in and out while the left one was deformed and bent with the wing box during impact. Both slats remained in place.

The fuel tank located under and behind the pilot's seat had exploded outwards, melting the frame due to heat action, while the lower wall and floor of the cockpit were left intact.

The structure of the cockpit area, the windshield and the dome apparently didn't show any sign of distortion, the cockpit dome could open and close/lock, the transparencies were intact and the levers and controls were in normal positions (throttle and propeller pitch levers full forward, etc.). The landing gear was in place, with the gear down and locked.

Aircraft wreckage

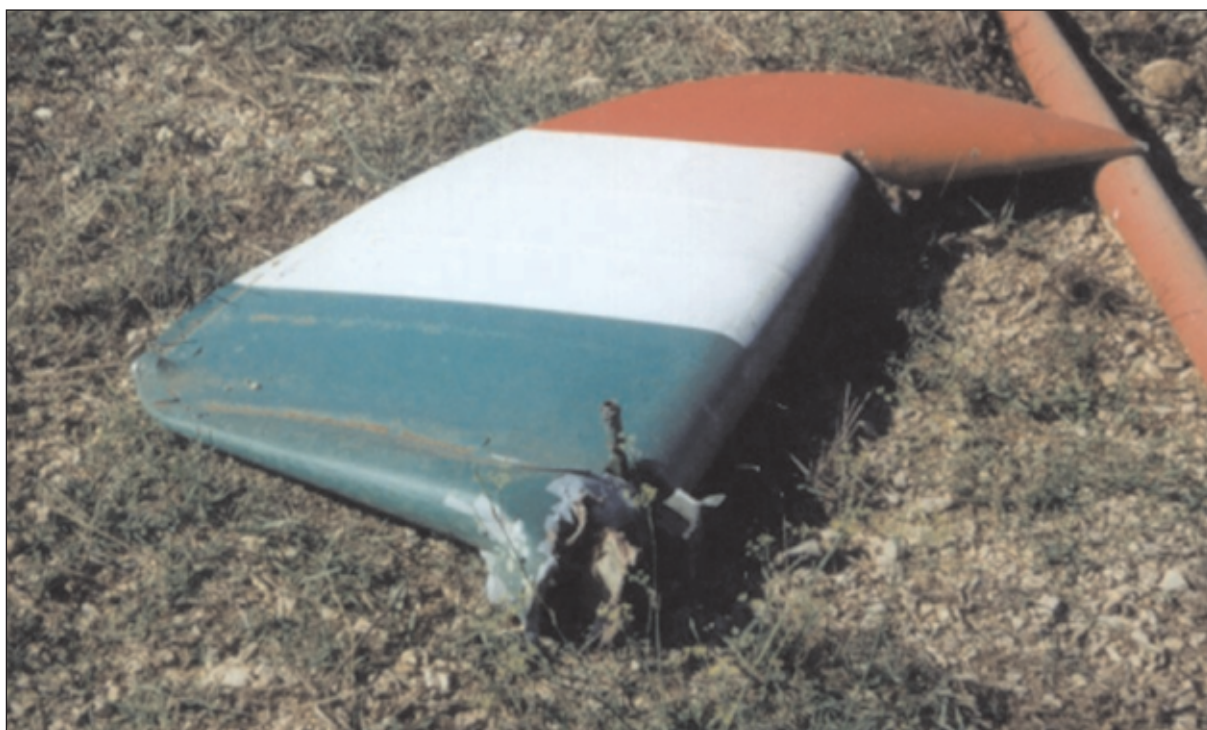
The tail, engine and propeller had come off from their position. The rudder and elevators were detached and were located at the aircraft point of impact, a propeller blade was broken by the root and was embedded in the bank, the engine was still joined

Rudder wreckage
