Technical report

A-062/1999

**Accident involving Piper PA-24-250 aircraft,
registration SE-EOU, near Lugo on 23 Oct 1999**

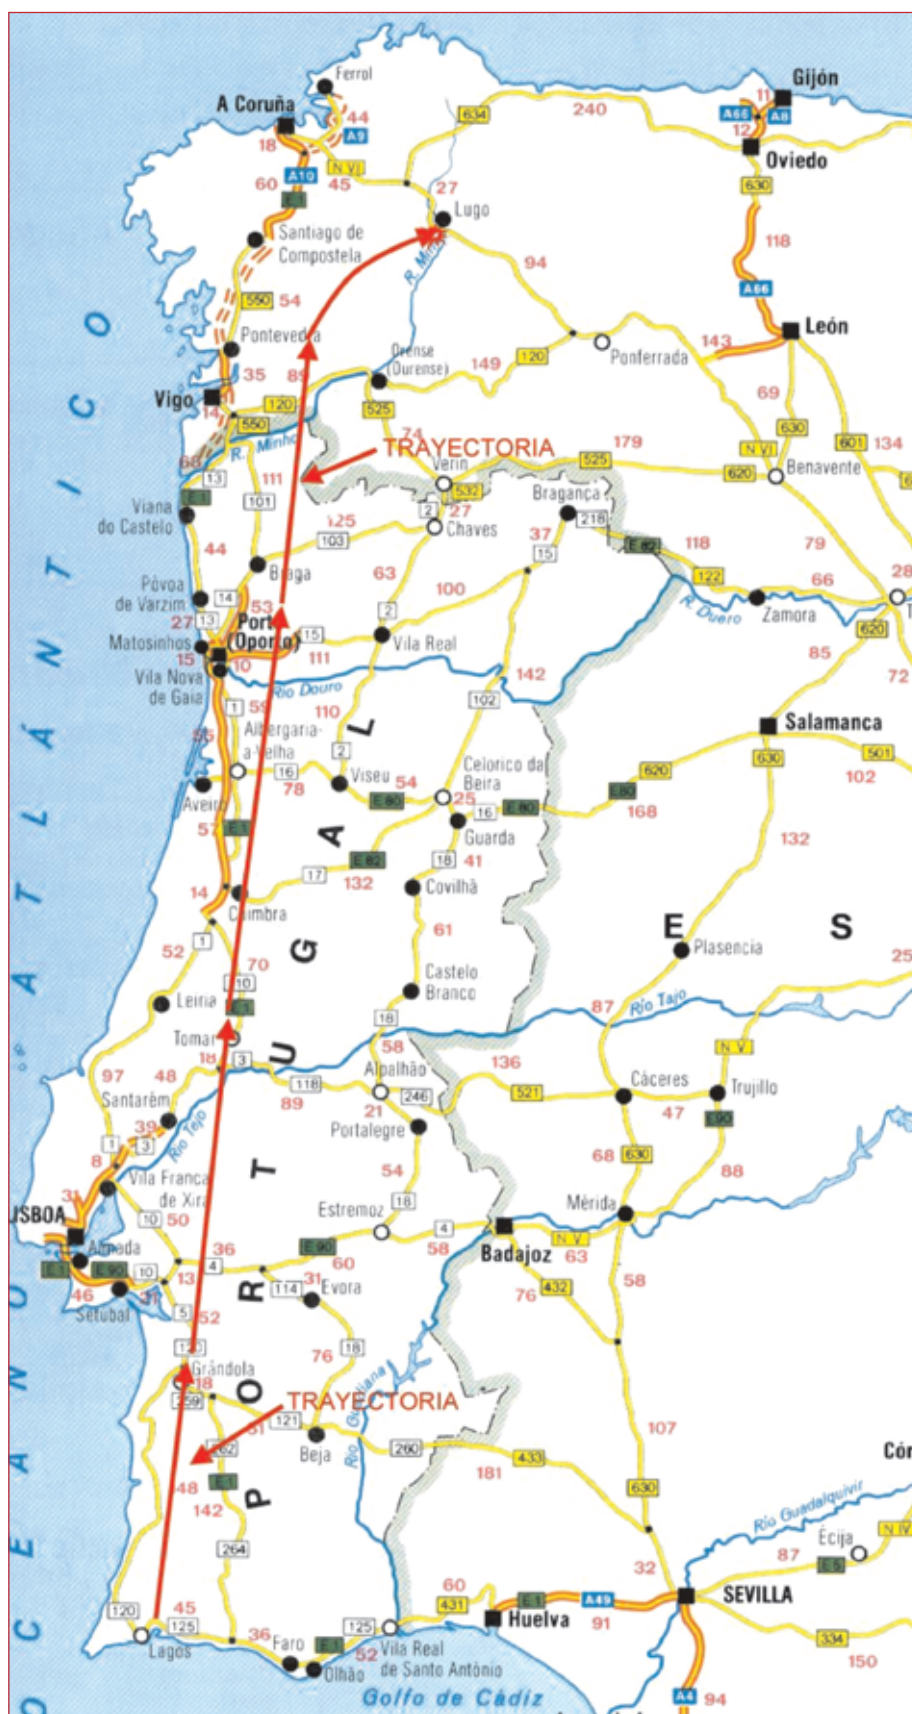
Aircraft Trajectory

According to the RADAR data record, the displayed trajectory was normal, in accordance with the foreseen route, at FL'93 and with a NE direction, until it began to turn NW descending to FL 88 without communicating the change to the control tower. Afterwards, the bearing was adjusted to NE going down to FL 50, again without communicating the change. Thirty seconds later it disappears from the RADAR screens after having travelled around 0.8 NM.

In the same records and related to the trajectory followed by the aircraft, it can be observed that from time to time, without any regularity, the aircraft veered to port in a rather wide curve, immediately corrected, returning to the right bearing. Just when it was recuperating the bearing toward the ASTUR (NE) point, during one of the widest turns toward the NW, the loss of altitude and the RADAR echo fading occurred, as described in the previous paragraph.

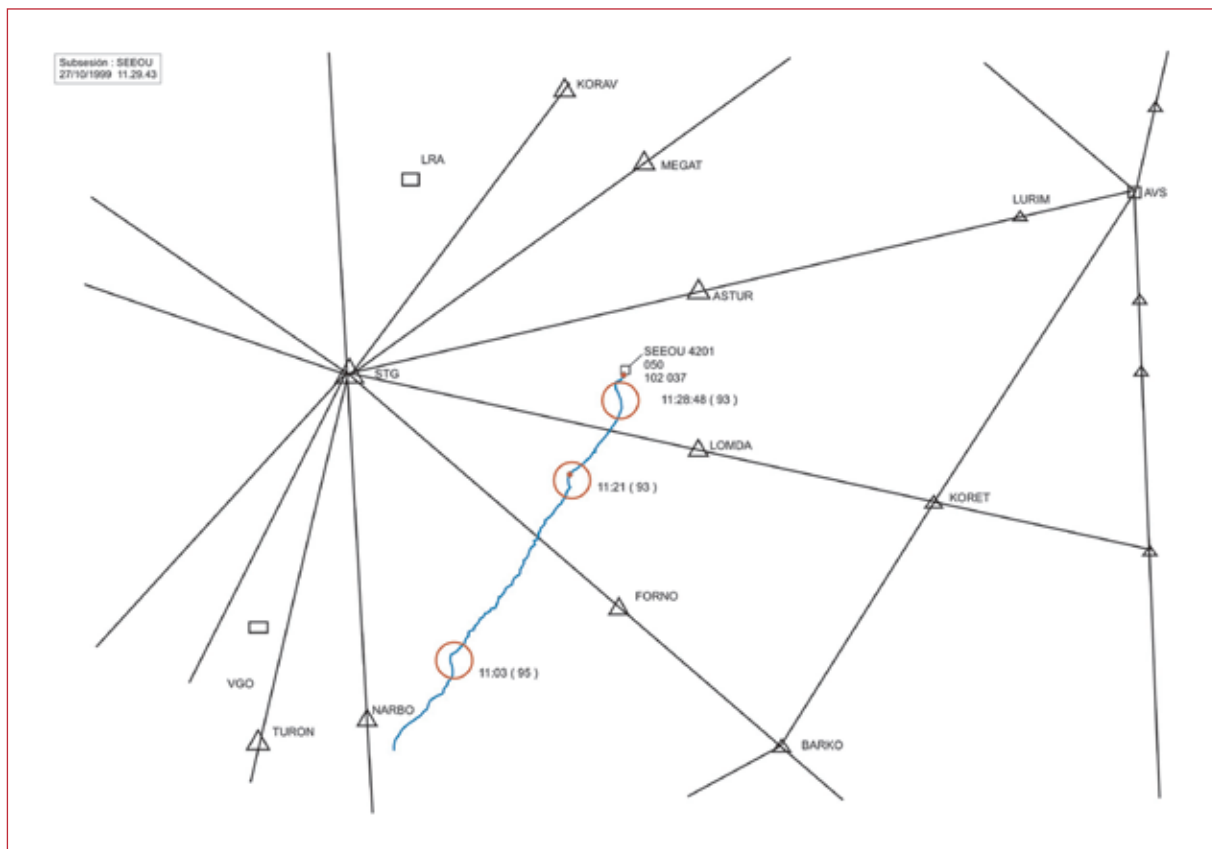
APPENDIX B
Radar Data Records from the Last Part
of the Trajectory

According to the RADAR data records, once the aircraft took off from Portimao at 9 o'clock, it maintained a flight altitude at FL 95 until 11:28:48. At this time it descended to FL 88 in 5 seconds, and then 20 seconds later to FL 50, remaining there for 30 seconds. The RADAR echo was lost at this last position.
