TECHNICAL REPORT

A-005/2000

Accident of aircraft
YAK-52, registration
LY-EST, in El Alamo
(Province of Madrid)
on 10 March 2000

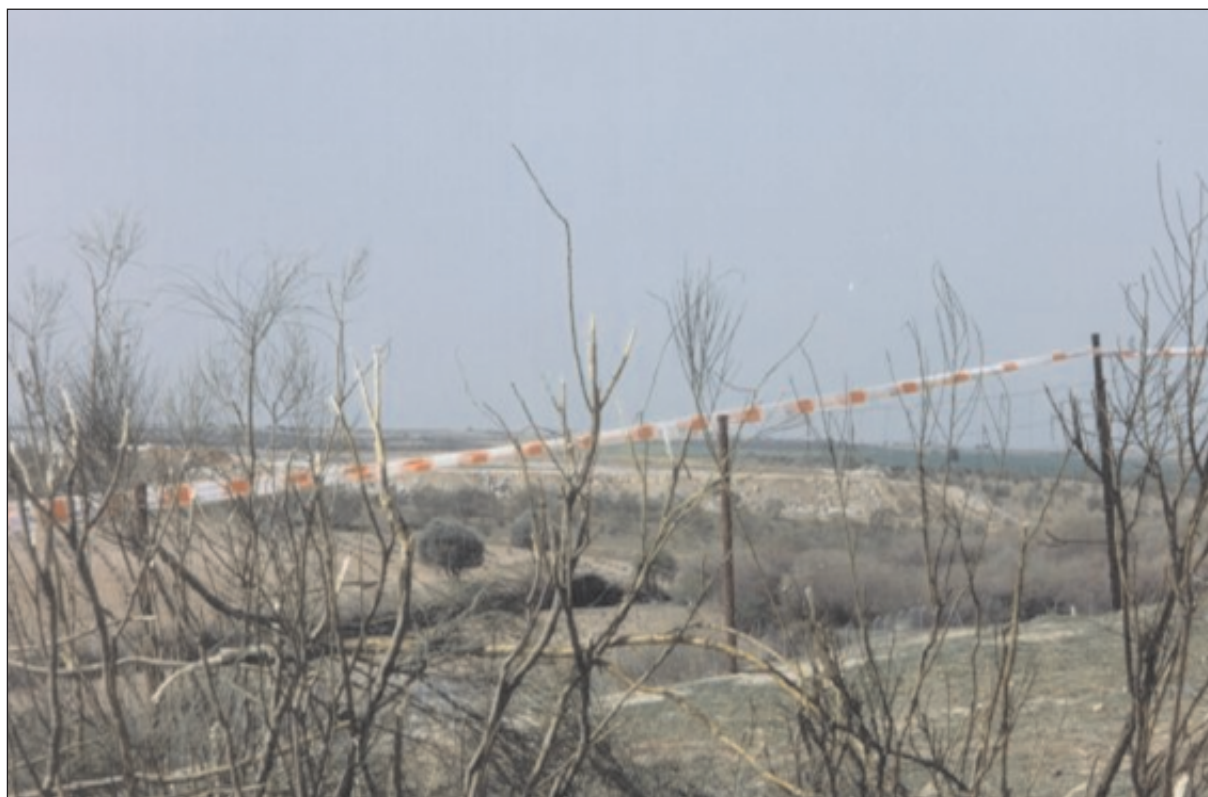
To the east of the aerodrome, the ground descends abruptly from the edge of the runway area towards a valley bottom. Then it rises gently towards the Fría hill (the site of the accident), which has an altitude similar to that of the aerodrome, and which is in the immediate vicinity of the town of El Alamo (Madrid), one kilometer further to the south-east. (See location map and photo 2.)

Before crashing, the aeroplane broke the tips of a number of broom shrubs in the area. The angle of the aircraft's descending trajectory, measured by the height of the broken branches and the distance from the first signs of impact, was some 15° from the ground, and the slope of the terrain was roughly 10°. The angle of the aircraft's trajectory from the horizontal plane was thus about 25°. (See photo 2.)

A shepherd who witnessed the accident stated that the aircraft had been making passes for some time and that he did not see it make any strange maneuver as he watched it fly straight into the ground. (See photo 2 and diagram 2.)

Photo 2. *Threshold of the runway, on the other side of the valley bottom, seen from the point of impact. Wire fence and nearby broom shrubs overflown by the aircraft*

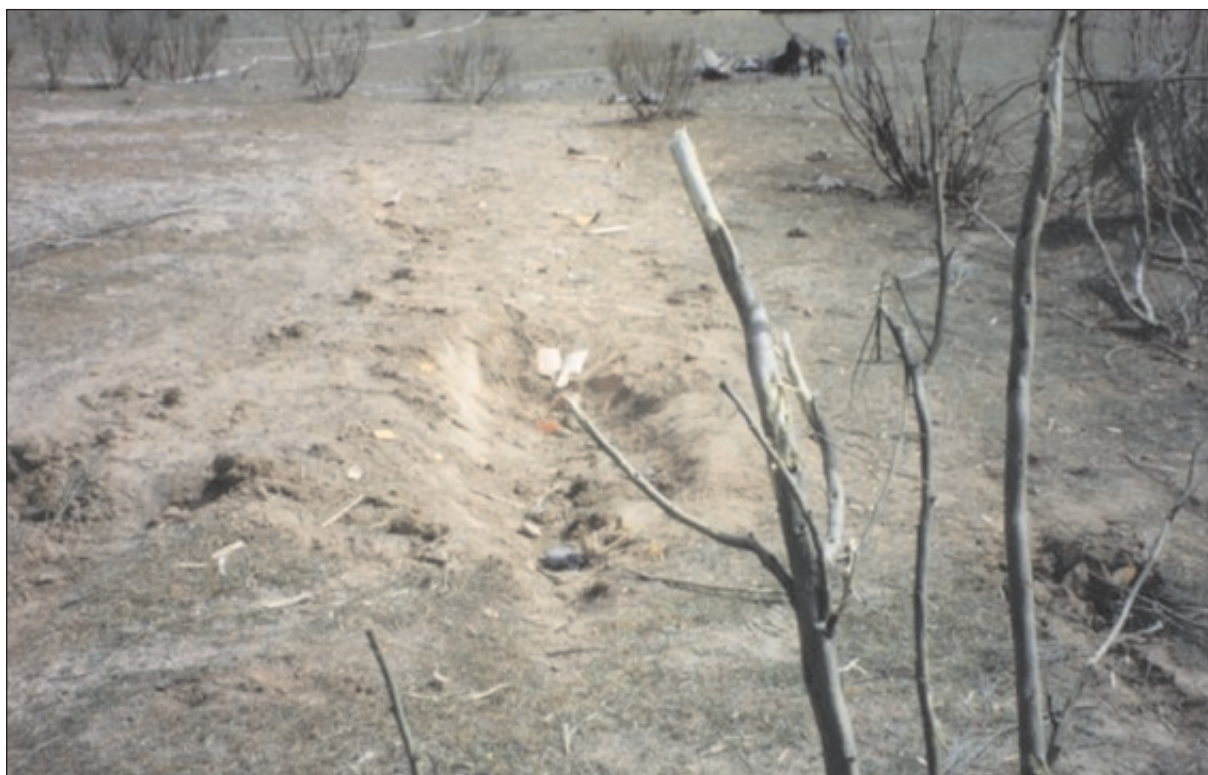
The first impact was hard, on a terrain which slopes slightly to the right, leaving a mark some two meters long, one meter wide and twenty centimeters deep. The perpendicular mark of the wing could be distinguished all across it, as well as various marks made by the three semi-concealed wheels of the landing gear. (See photo 3.)

Photo 3. *First impact*

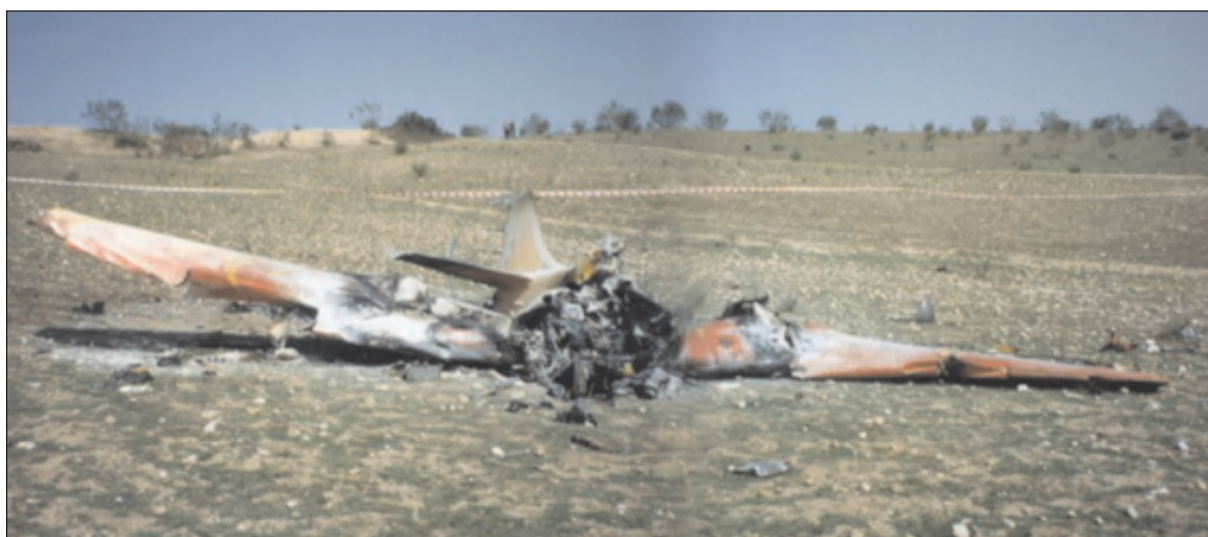
The aircraft was completely destroyed as a consequence of the impact with the ground and the resulting fire of the remains. (See photos 3, 4 and 5.)

Photo 4. *Main bulk of remains*

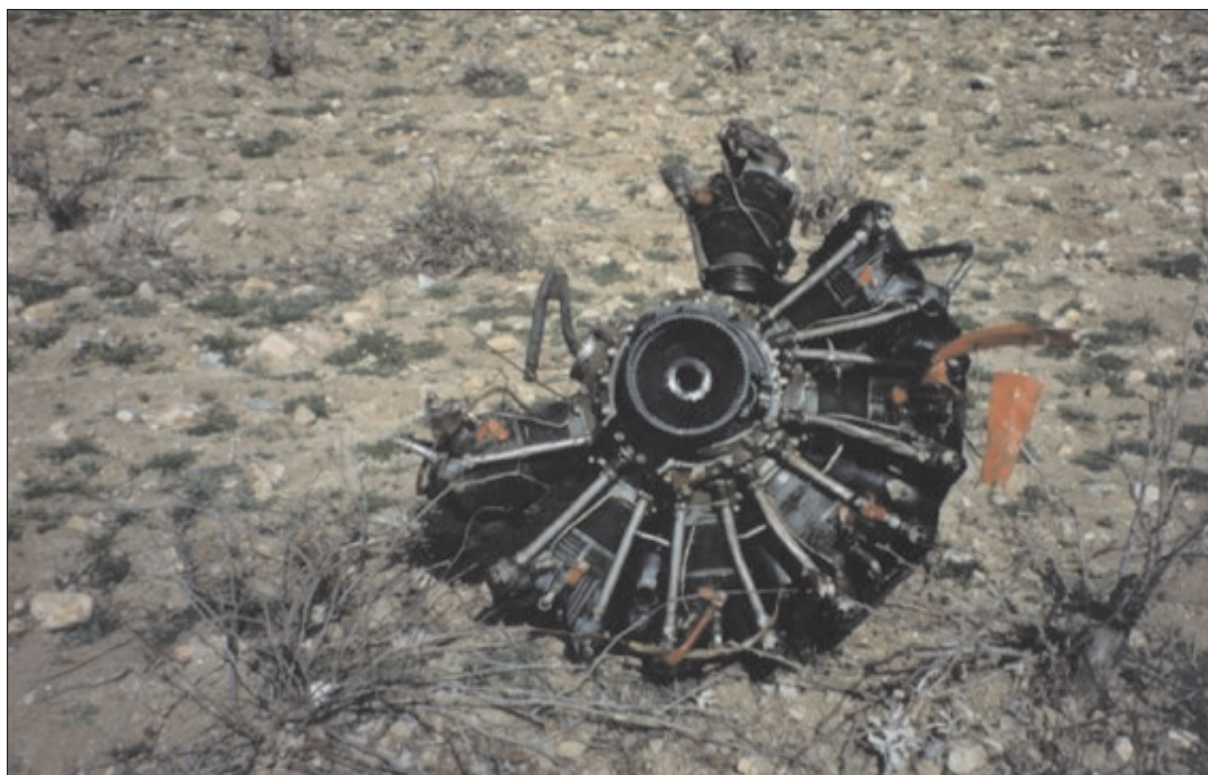
The remains of the radial engine showed its two lower cylinders detached. The first impact occurred with the nose-down attitude. (See photos 6 and 7.)

Photo 5. *Remains of the engine*

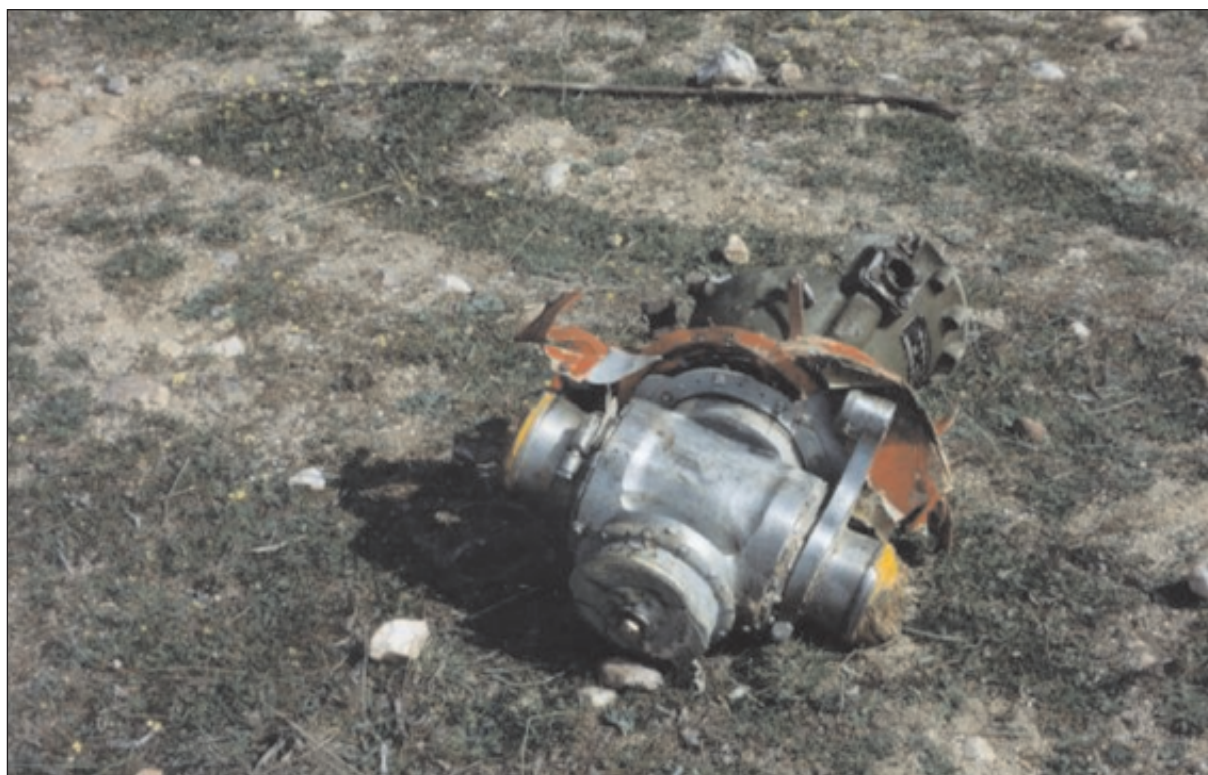
The two wooden blades of the propeller, broken at their root in the hub, indicate engine power on impact. The tracks and marks in the last pinions of the reduction gear confirm fast rotation at the last instant. The remains of the blades were recovered twenty-five meters to the left and ahead of the first impact.

Photo 6. *Propeller shaft*

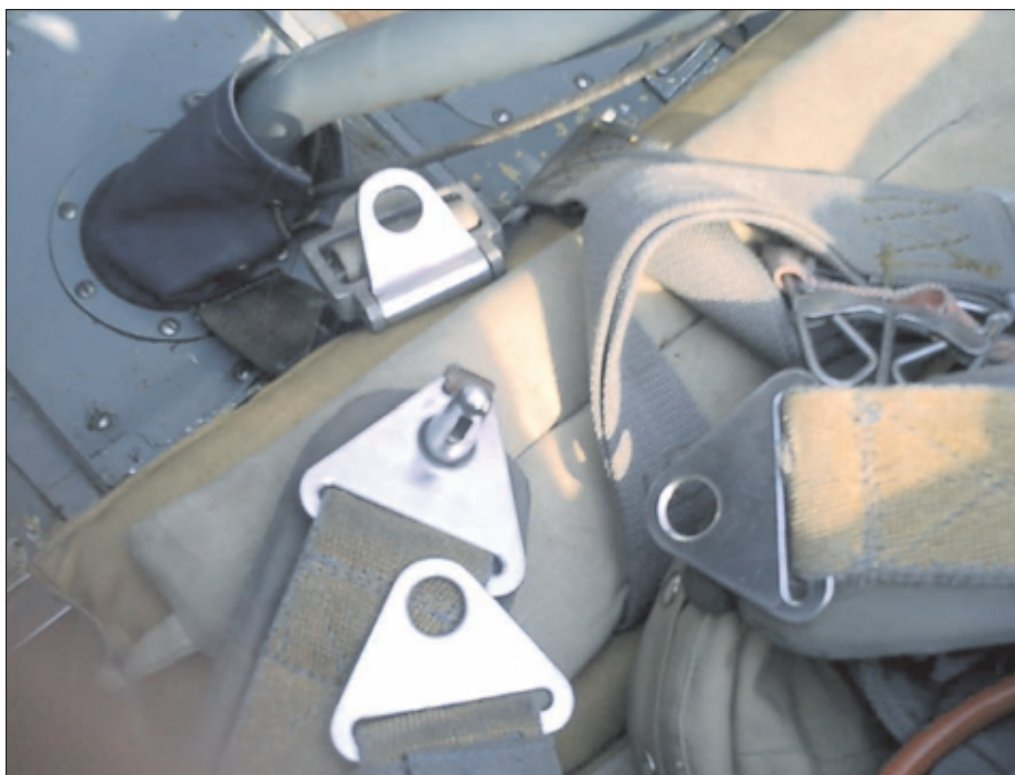
- Two belts: left and right,
 - Two shoulder straps, and
 - A central inner leg strap.
- (See photo 7 and diagram 3.)

The anchor points of the pilot's shoulder straps were intact, while the anchor point of his central inner leg strap was broken, leading to the deduction that the pilot was secured at only three points: the two waist straps and the central inner leg strap.

The passenger's harness showed the anchor points broken and the inner leg strap fastening deformed, indicating that he was fastened at all five points.

Photo 7. *Harnesses of the type installed in the accident aircraft*

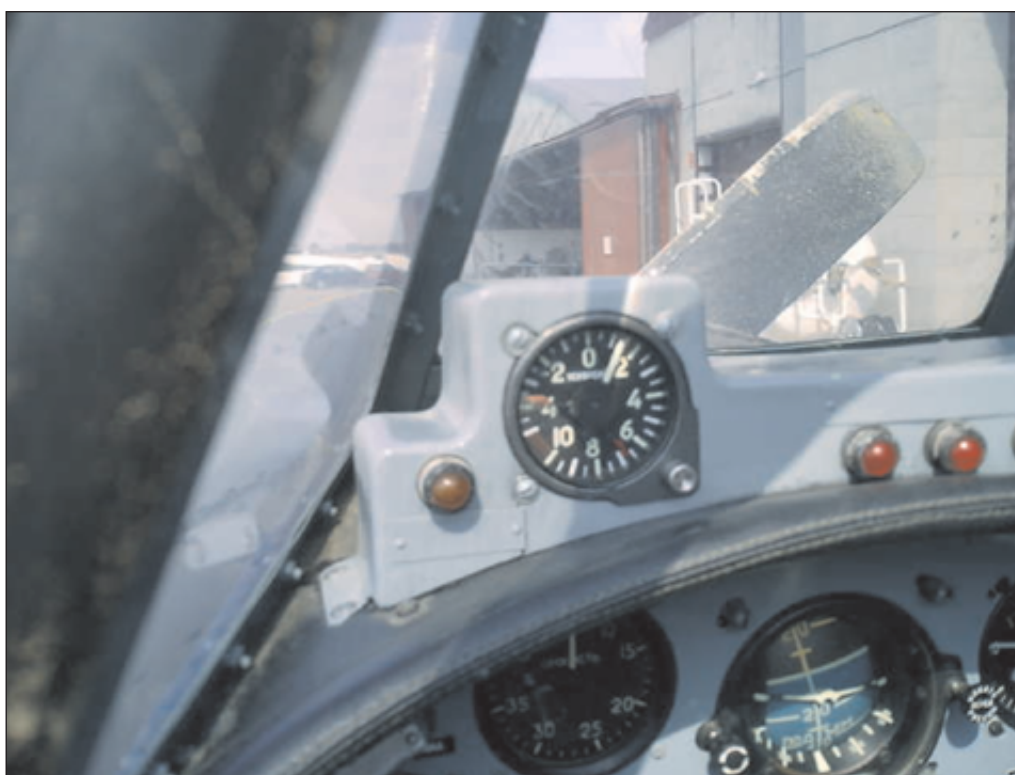
The G indicators were recovered from the remains of the accident, indicating maximum accelerations reached of +4 g's and -4 g's. These acceleration readings do not tell us the duration of the loads nor the moment when the maximum values were reached. (See photo 8 for information on the type of instrument.)

The g indication instruments have vanes which record the maximum accelerations, both positive and negative, during the flight. The values shown were +4 g and -4 g.

Photo 8. *Indicator of the type carried by the accident aircraft*

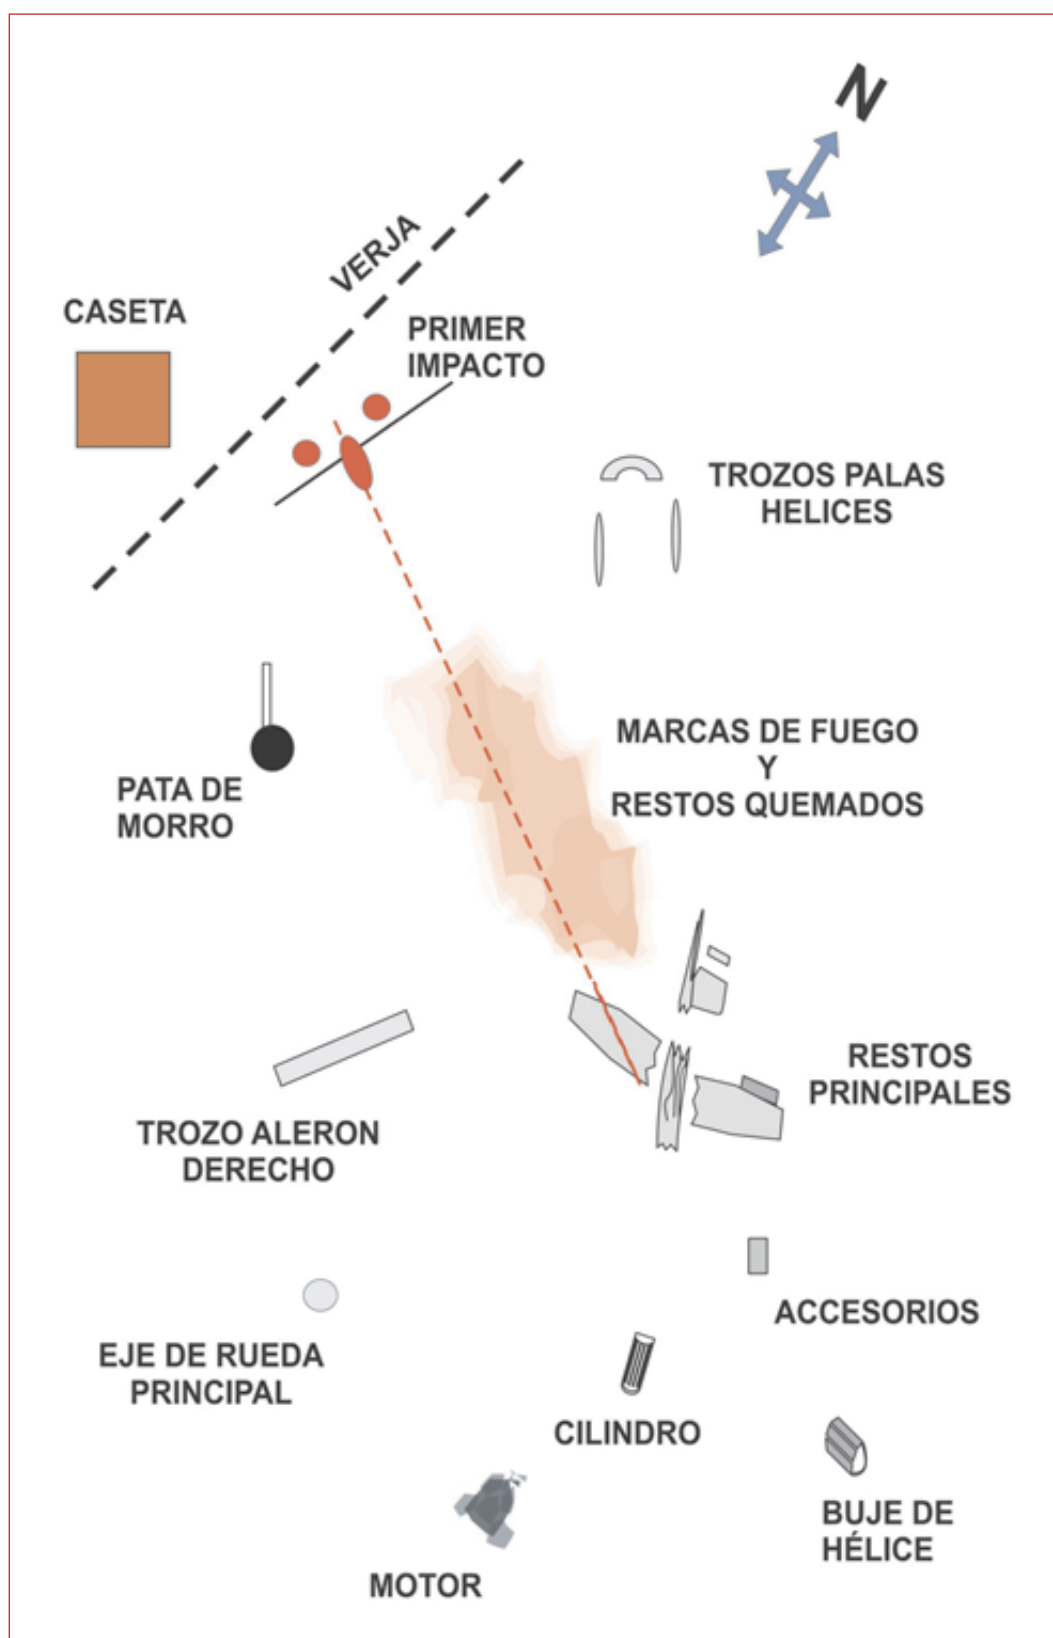
The order in which the remains were scattered in the 200-meter slide following the crash as follows:

- Nose leg, in the center-right.
- Piece of the right aileron, to the right
- Pieces of the propeller blades, some 25 m. to the left.
- Main bulk of the remains with a final trail of fire marks and burnt remains of some four meters. These remains finally came to rest 125 m from the first impact point, with a southward orientation.
- Main wheel axle, to the right and ahead of the aircraft.
- Accessories and propeller spinner to the left and ahead of the aircraft.
- Engine and engine cylinder ahead of the aircraft. These finally came to a stop some 100 meters ahead of the principal remains.

The pilot's body was dragged along with the remains of the aircraft for the last fifty meters and finally came to rest outside the aircraft, under the right wing. (See photos 1 to 7 and diagram 1.)

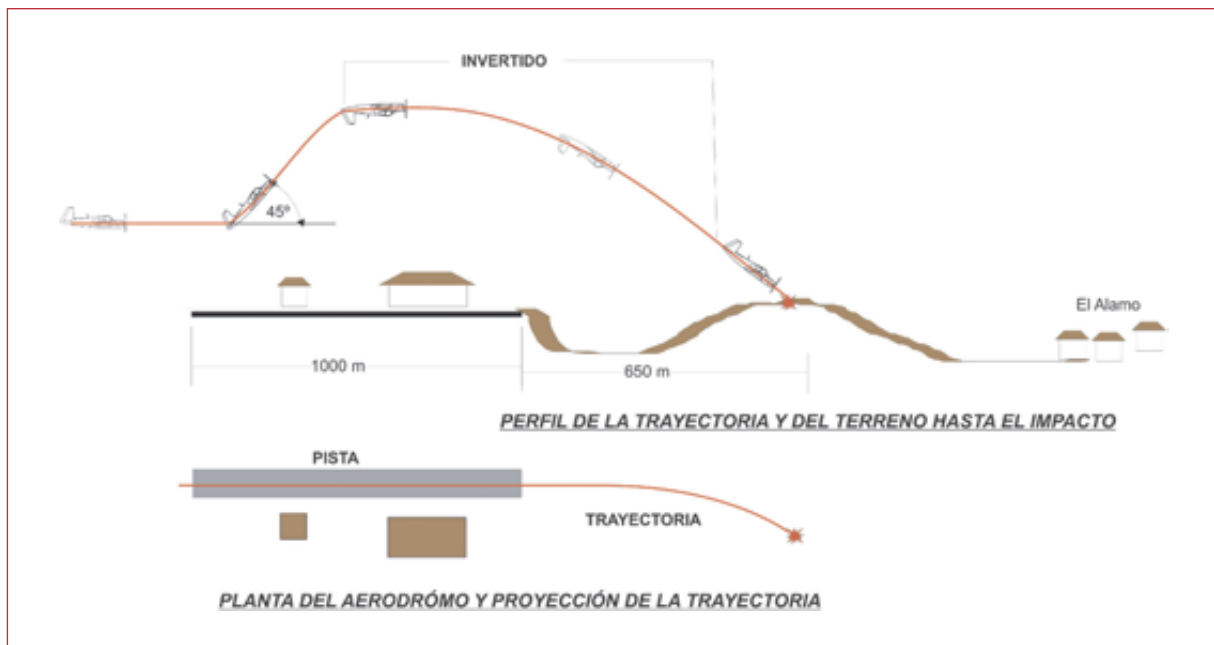
Diagram 2. *Trajectory of the impact*

The testimony of a pilot in flight and of several witnesses at the aerodrome and in the vicinity of the crash point indicate that the aircraft made a low-altitude pass over the head of runway 08, then immediately began a steep climb, at an angle of some 45°, reaching a height of some 300 m (1000 ft) above the field, then leveled out into horizontal flight. The aircraft executed a half-roll and remained in an inverted position for some 25 to 30 seconds, during which it gradually lost height, following a course aligned with the axis of the runway. Then, at a height of very few meters, it completed the roll, returning to the normal flying position, but immediately crashed into the ground at a point some 650 m to the east of the head of runway 26. The aircraft slid some 125 meters down a gently sloping hillside and caught fire before stopping.
