CIAIAC

TECHNICAL REPORT

A-028/2000

Accident to the
aircraft Nimbus 4DT,
registration G-929,
at Campillo de la Jara
(Toledo), on 31st
July 2000

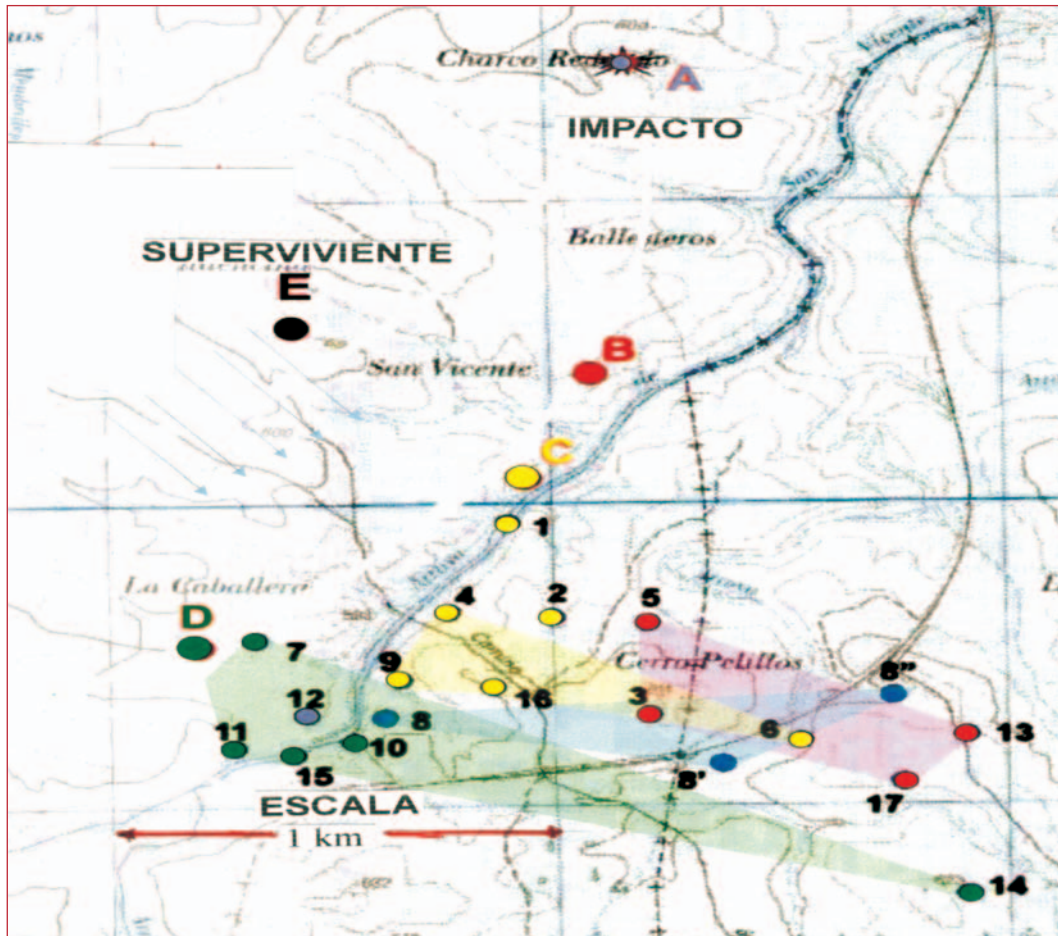
Table 1.12.2. Wreckage distribution zones

The wreckage was spread over an area of some 1,800 m in diameter, accumulated in four Zones D, C, B and A, aligned in a SW-NE direction. A mass of minor remains, pieces of covering, fragments of plastic and small items were found to the SE of the line of Zones A, B, C and D.

The main wreckage, comprising fuselage and part of the left internal wing, were located in Zone A, the northernmost area. The second pilot's dead body and his red unfurled parachute were found under some of the largest pieces of this wreckage.

Zone A	Area with main wreckage: fuselage and left internal wing.
Zone B	Pieces of left wing and aileron.
Zone C	Piece of right wing (> 8 m) and piece of aileron (> 1,5 m).
Zone E	The survivor's parachute.
Zone D	Far right wing (> 6 m), aileron (> 1.5 m) and other minor wreckage.
Numbers	Small pieces.

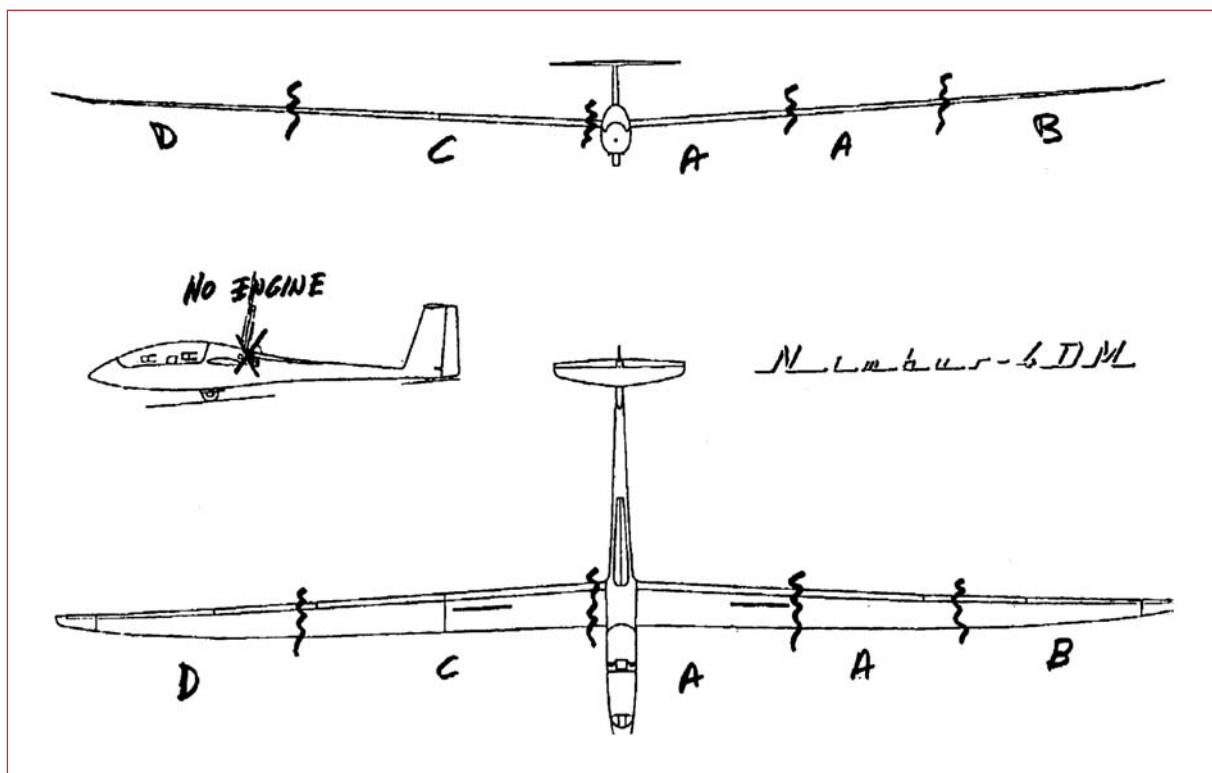
Figure 1.12.3. Position of the broken wing sections

- The wing structure showed faults due to bending in four stations of its span.
- Figure 1.12.3 and Table 1.12.4 show the stations in which the four breakages occurred. The resulting five broken wing pieces are marked on the Figure with the letter of the Zones A, B, C or D in which they were picked up, and which are also shown on the layout of Figure 1.12.1 and in Table 1.12.2.
- The appearance of the breaks shows no signs of possible manufacturing faults.

- Fracture in *external wing*, amongst the pieces found in Zones C and D.
- Fracture in *internal wing*, close to the wing-fuselage joint, C-A

- Fracture in *external wing*, between parts A and B.
- Fracture in the *internal wing-external wing* connection. A-A.

In effect, the right wing structure failed in a location at approximately 7 m away from the glider's symmetrical vertical plane, and this failure was caused by positive bending. The left wing also broke in a similar station on the opposite side. In addition, the right wing broke in a location close to the root of the wing, in a station some 3.5 m away from the restraint.

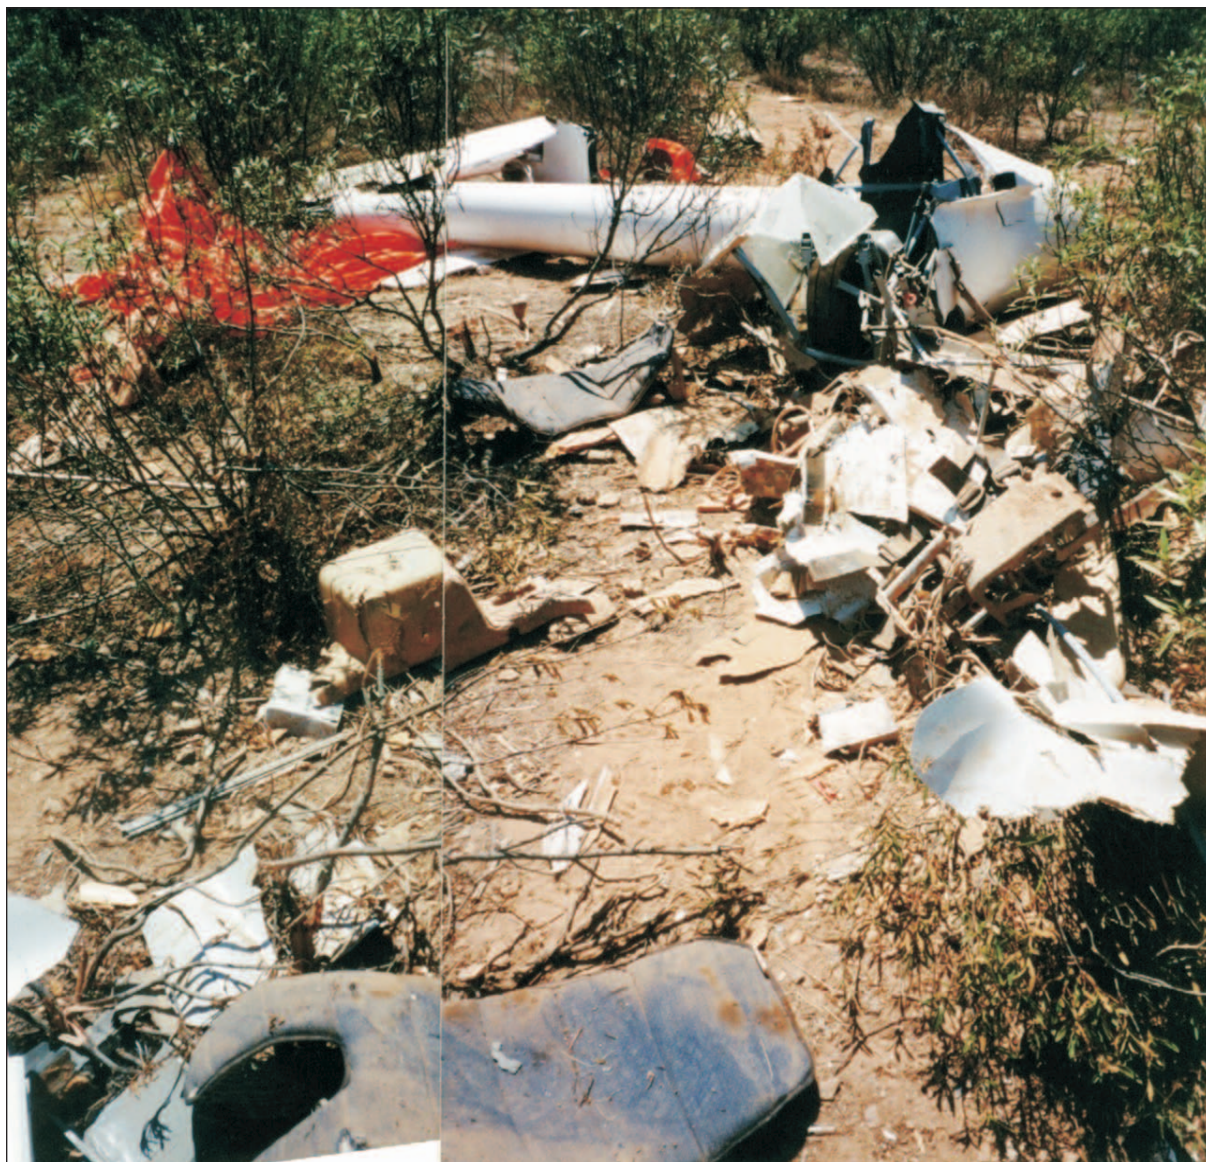
Figure A4. *Close-up of the fuselage and parachute wreckage*

As regards his companion, who also jumped out of the glider, the premature opening of the parachute caused the parachute canopy and cordage to get caught up in a part of the glider, which dragged him in its fall. The unfurled parachute, with the cordage caught up in the wreckage and the dead body joined to it, appeared at the point of impact. Given the severity of the injuries, survival was impossible and death must have been instantaneous.

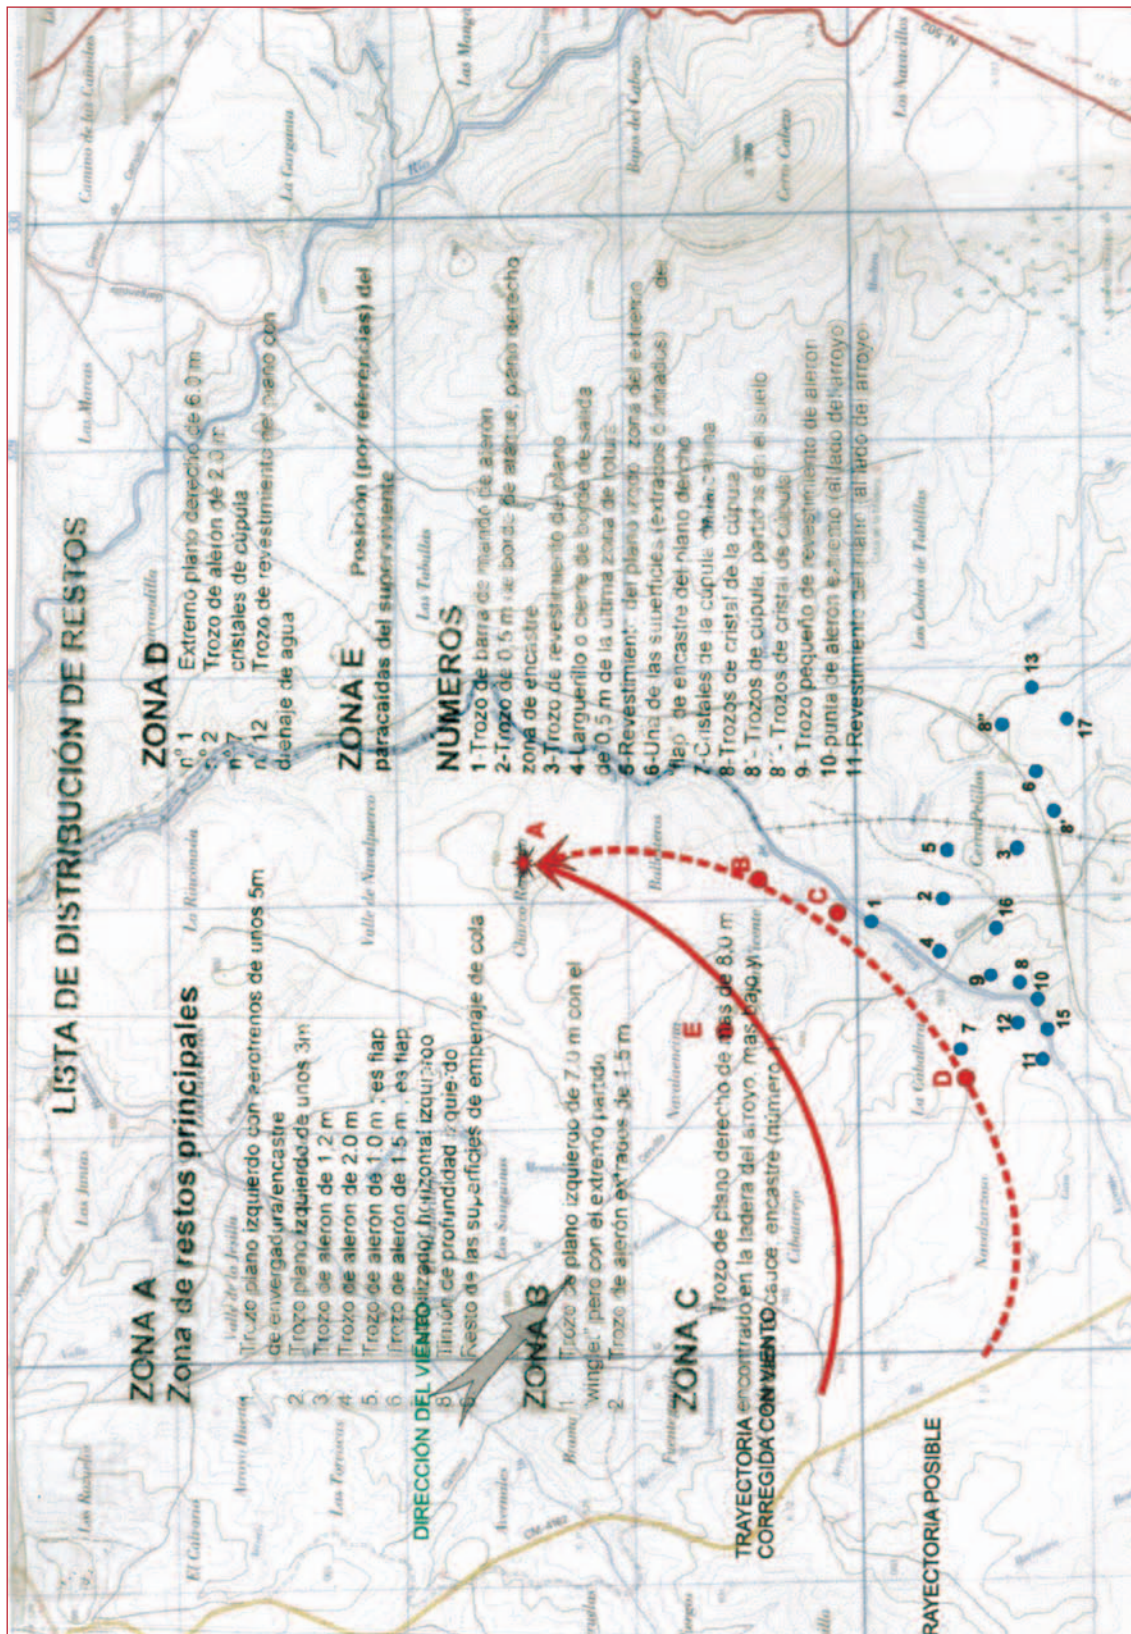
Figure B1. Drawing showing the wreckage layout. Explanatory list

The spreading of the wreckage over an area of 1,800 m in diameter confirms the pilot's statement that wing breakage occurred in flight at some considerable height. The different sections and loose fragments of the glider separated by the breakages followed different trajectories to the ground conditioned by their size, density, the moment of their separation and the action of the wind. Those of greatest density would have followed a ballistic trajectory established by their inertia and the acceleration of gravity. The descent of large pieces of average density would have also been influenced by their aerodynamic resistance. Those of least density and size could have gained height initially dragged along by the thermal current in which the glider was soaring, subsequently being carried by the wind for different time periods of the order of several minutes; these latter remains comprise the mass of small fragments indicated in Appendix B, Figure 1, separated by varying distances in a SE direction.

The major part of the wreckage, fuselage and the two sections of the left internal wing were found in Zone A, 1,800 m from the first Zone D. Due to the fact that the separated piece of the inboard part of the left wing was next to the other wreckage, it can be assumed that this breakage occurred in the impact with the ground.

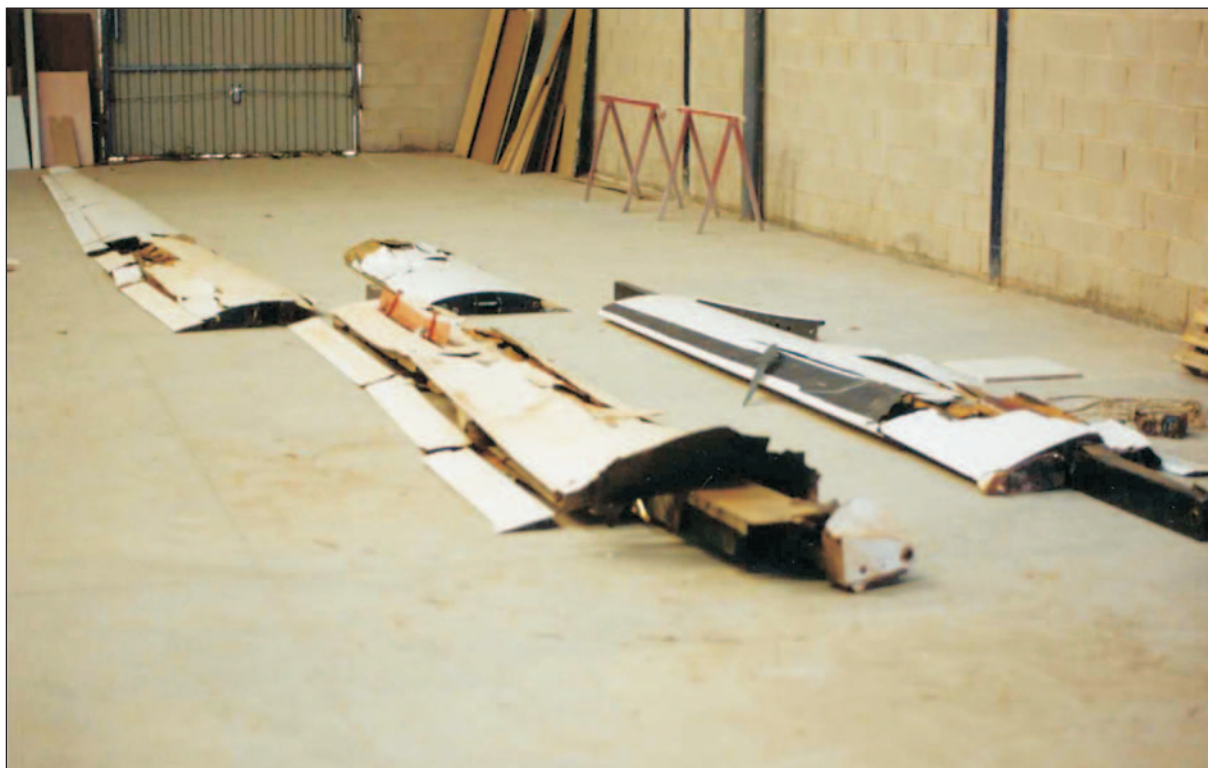
Wing breakages – General view of the wing

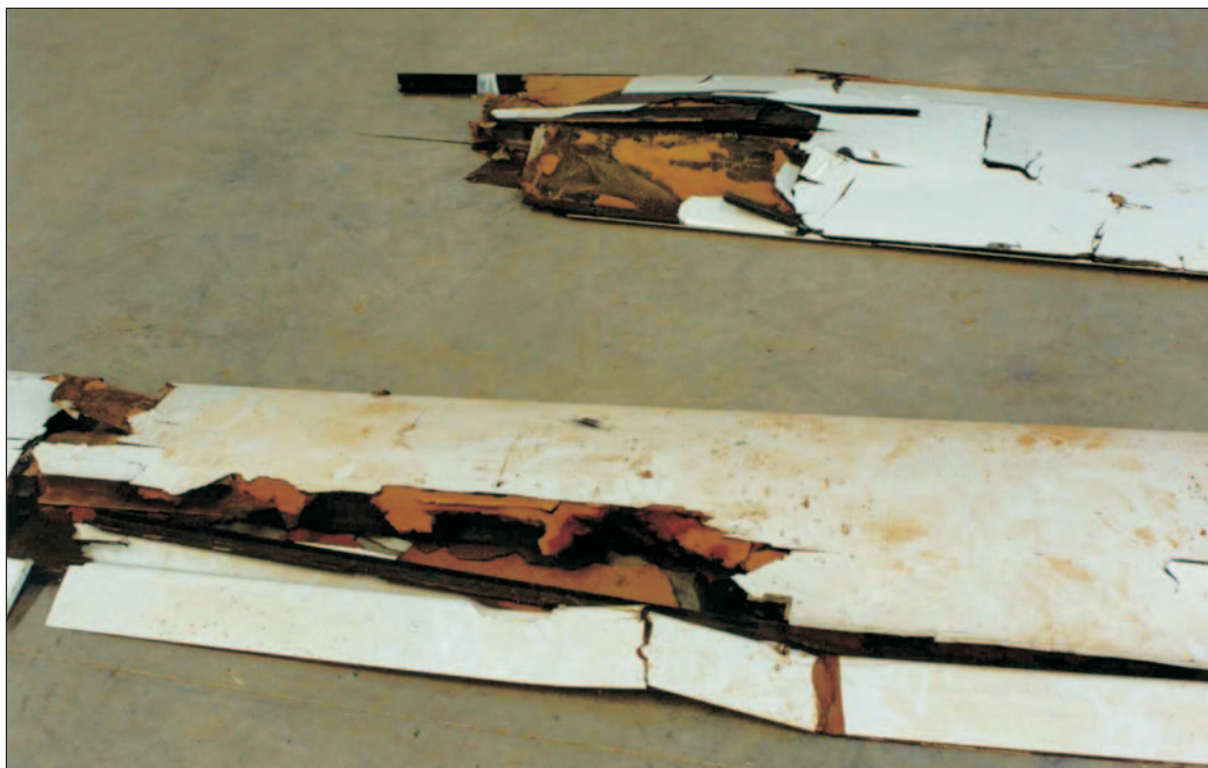
At a particular moment, the wing structure collapsed due to the enormous bending to which it was subjected. The wing's upper surface was stressed by compression and the lower surface by traction. This is further supported by the clean breakages of fibers in the lower surface and the loosening of panels and coverings of the upper surface's «sandwich» structures in the areas close to the primary failure sections, in the stations at 7 m in both wings.

External breakages of the wing – Upper surface

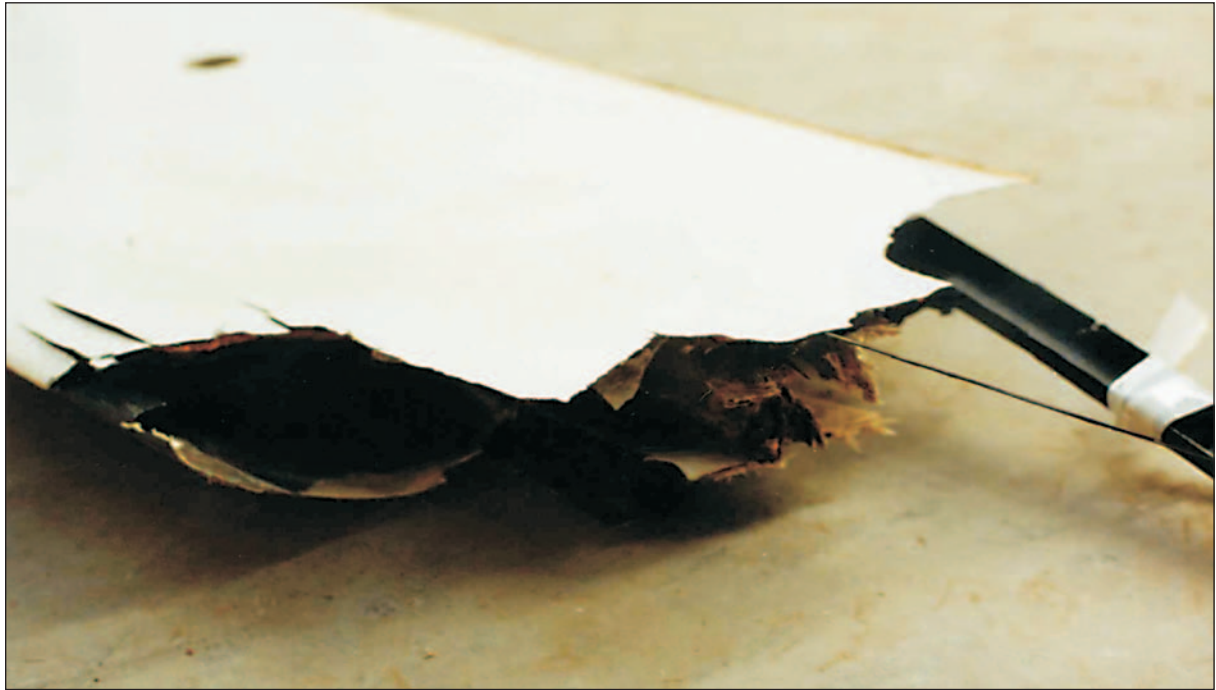
*External breakage to right wing – Bottom surface
(Breakage in the bottom surface is caused by traction, which is why it is cleaner)*

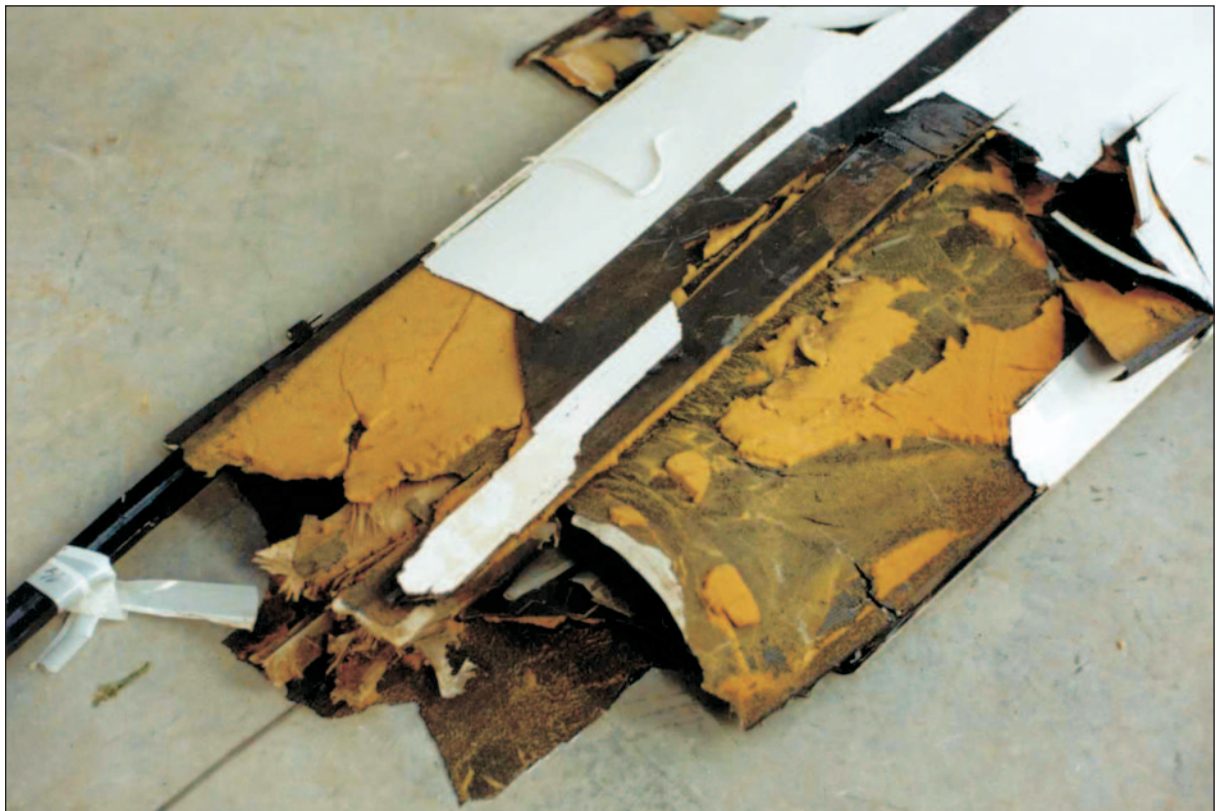
External breakage of right wing – Upper surface

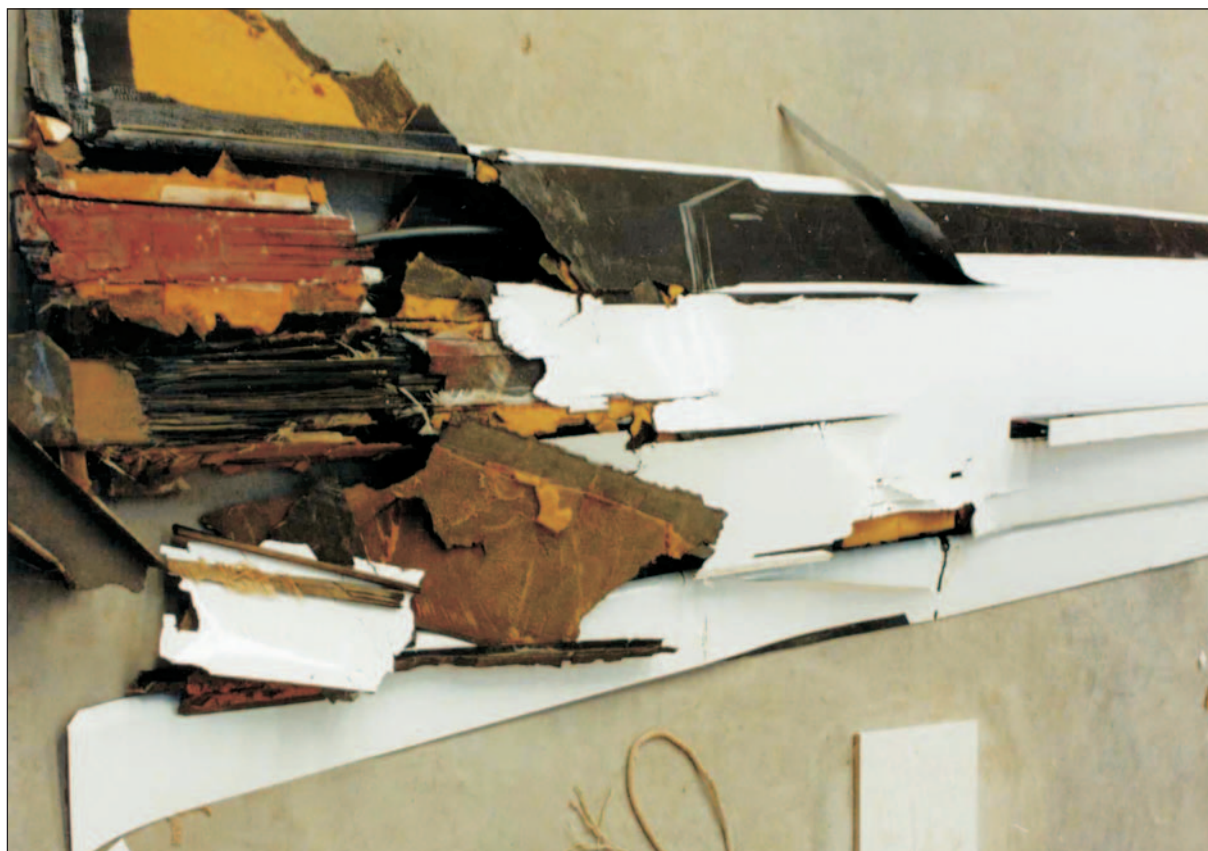
Although there are no conclusive data to firmly establish the failure sequence, the breakage of the right wing close to the fuselage could be explained by a mechanism of dynamic response and reaction of the remaining structure to the breaking off of the end of the right wing and the sudden alleviation of the aerodynamic loads transmitted by that part. This mechanism was studied by the NIAR, with the assistance of Finite Element Methods, as it would seem that it appeared in that accident.

Internal breakage of right wing – Upper surface
