DATA SUMMARY

Registration	EC-FJG
Type and model	PIPER PA-36-300

Operation	Aerial work – Commercial – Agricultural
Phase of flight	Manoeuvring – low flying

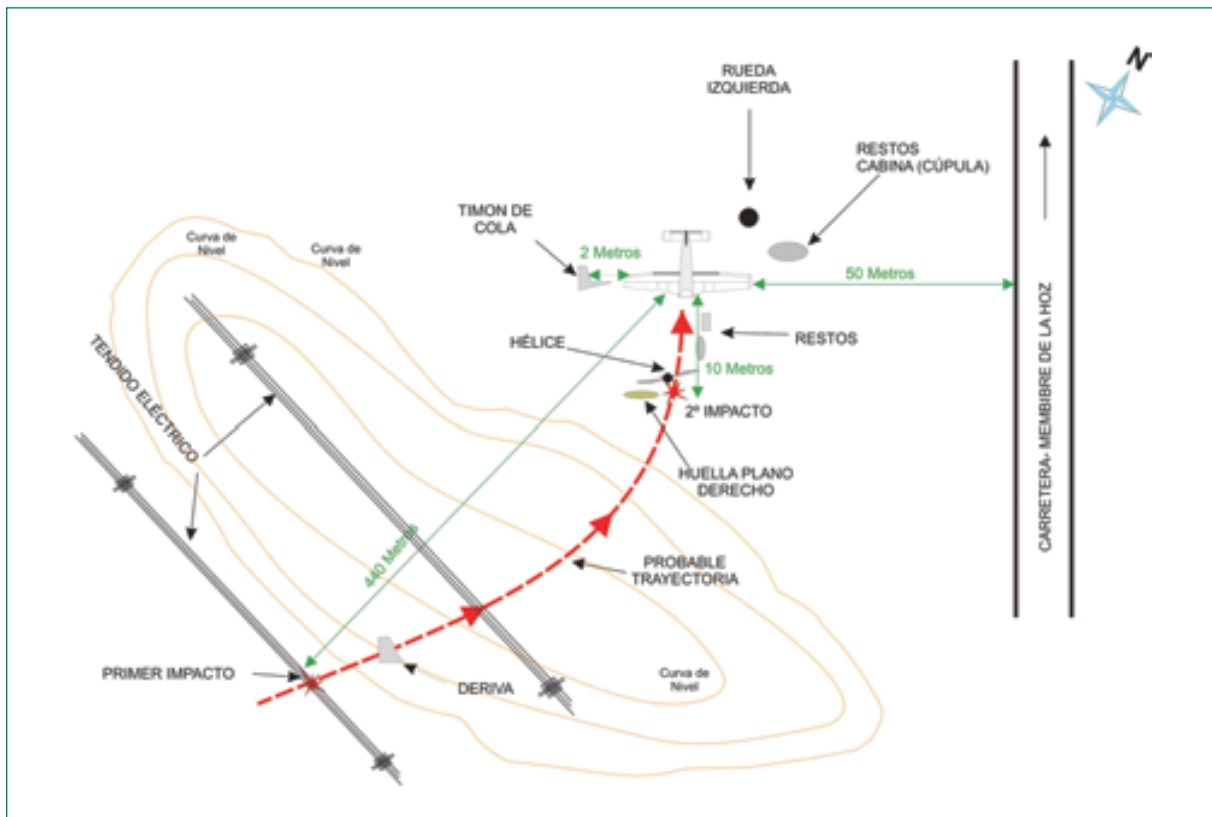
During what was supposed to be the last spray run, with the hopper practically empty, the aircraft impacted against the two lowermost wires of the three-wire power line that ran along the edge of the field being sprayed. These impacts were produced somewhere in between the protective cable that goes from the wire cutting sheet located in the front of the cabin to the uppermost end of the vertical stabilizer (fin).

Due to the impact with these two wires the fin and rudder were detached from the aircraft, although the latter remained linked to the fuselage through the control cables. The electric wires were left frayed and tangled, but remained in place without breaking completely.

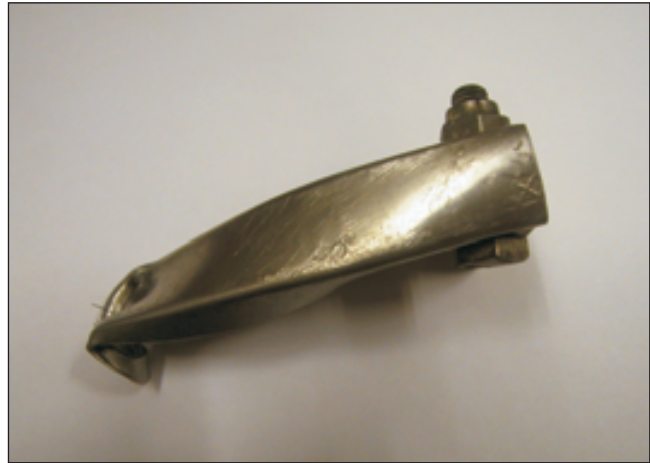
- b) One of the electric wires went above the sheet of the end of the wire deflecting cable and left scratches and other witness marks there.
- c) The catenary of the wire deflecting cable was deformed in such a manner that produced interference with the leading edge of the vertical fin from a point located half a meter below the fitting of the wire deflecting cable.

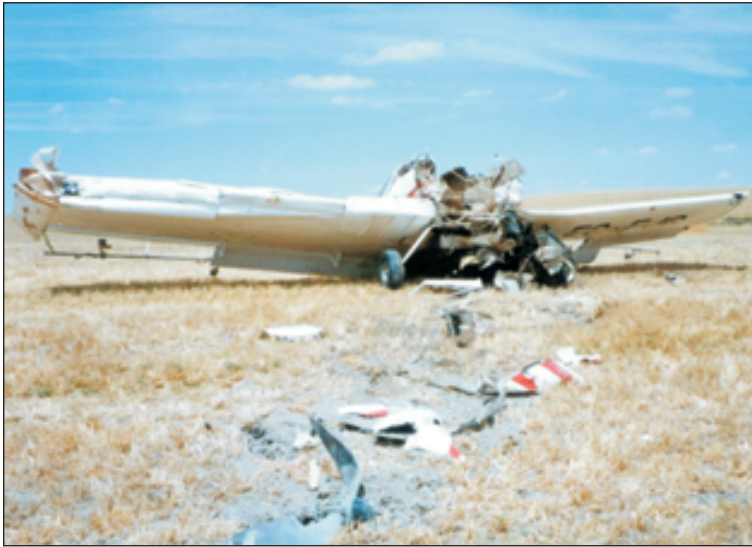
Consequently, the most likely hypothesis is that the first wire slipped over the wire deflecting cable and passed

above the vertical stabilizer. The fin and the rudder remained in place, but it is possible that the catenary of the wire deflecting cable increased and the sheet of the end of the cable was deformed and even the attachment of the fin to the fuselage was damaged.

The impact of the second electric wire eventually damaged the weakest fitting, in such a manner that the relative position of the rear end of the cable was changed. Due to this fact, the electric wire was trapped in the sheet of the deflecting cable cutting it at that point. At the same time, the increase of the catenary allowed the interference of the electric wire with the leading edge of the fin, in which it finally was locked producing the detachment of the fin from the fuselage.

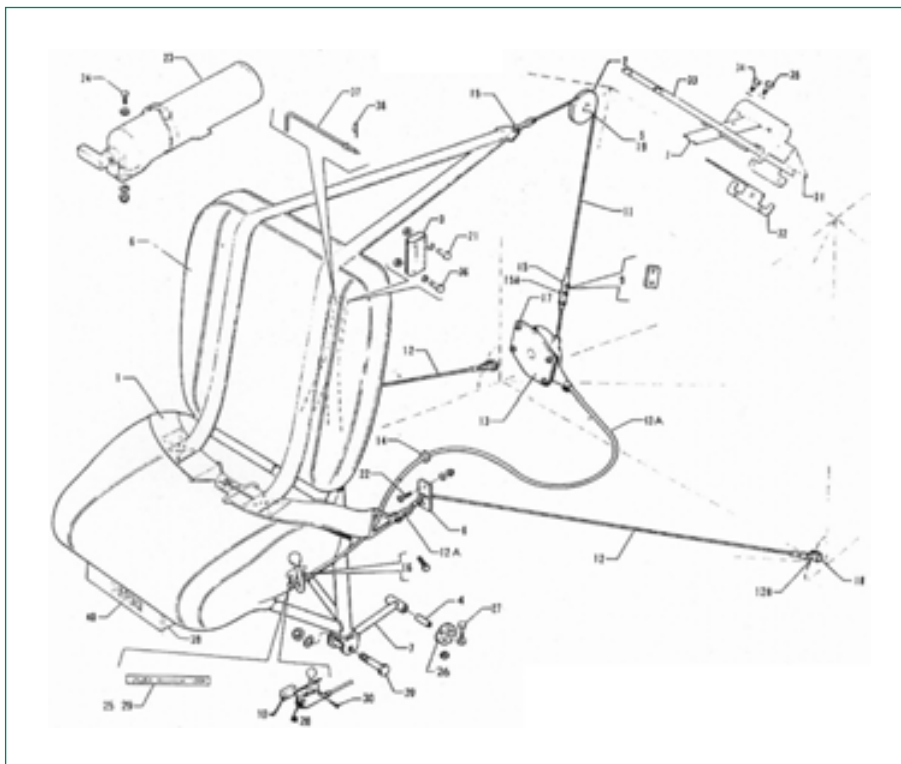
- Safety harness lap belt which is divided into two parts that are joined to each other through a buckle and that are attached to the structure of the aircraft. Sewn to the safety harness lap belt are two chest straps, one on each part, that make up the lower part of the shoulder straps.

- The upper part of the harness is formed by a single item that has each end joined to each one of the lower shoulder straps through a fitting that also adjusts the length of the strap. In the upper part it passes through the buckle that joins to a tightening cable so that when it folds over it forms the two upper chest semi-straps. This upper chest strap is sewn onto itself in the area next to the buckle.

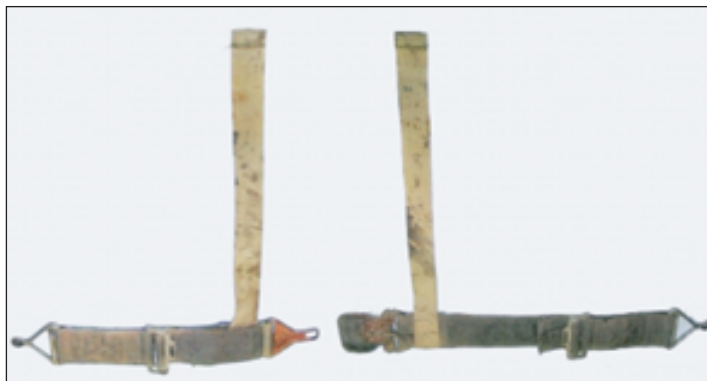
At the point where the chest strap is sewn to the lap strap, a hand-made stitch can be observed. A marked discoloration is also observed in the lower chest straps if, once the lap straps have been unsewn, the areas that have been exposed to the sun are compared to those that have not been. This discoloration suggests deterioration in the shoulder straps caused by ultraviolet radiation, although the deterioration is difficult to quantify based only on this fact.

In this regard, it must be taken into account that in addition to atmospheric agents, seat harnesses are also exposed to the chemical substances present in the treatment products used which could modify their properties without significantly altering their appearance.

It is considered definitive the fact that the results obtained were significantly lower than those stated in the aforementioned regulations, lead one to believe that the properties of the shoulder straps did not withstand the stresses to which they were designed.

REC 04/04. Due to the fact that the safety harness was degraded and was still in service in accordance with its maintenance schedule «on condition», it is recommended that the aircraft manufacturer, The New Piper Aircraft, and the Type Certification Authority, the FAA, study and set up new maintenance criteria of the safety harnesses of aircraft of this type, even with the goal of limiting their service life.

REC 05/04. Faced with the possibility that the safety harnesses of a majority of the aircraft fleet dedicated to agricultural work are in severe conditions of deterioration similar to those of this aircraft, it is recommended that the Civil Aviation Authority (Dirección General de Aviación Civil) carry out an inspection programme amongst such aircraft, in order to assess the condition of the installed safety belts, to determine their fitness for continued use, and, depending on the results, to establish service life limits if needed.
