TECHNICAL REPORT

A-049/2001

Accident of the
aircraft make Rolladen,
model LS 3A, registration
F-CESK, on August 29,
2001 in the Pasaje San
Salvador of Santa Cruz
de Serós (Huesca)

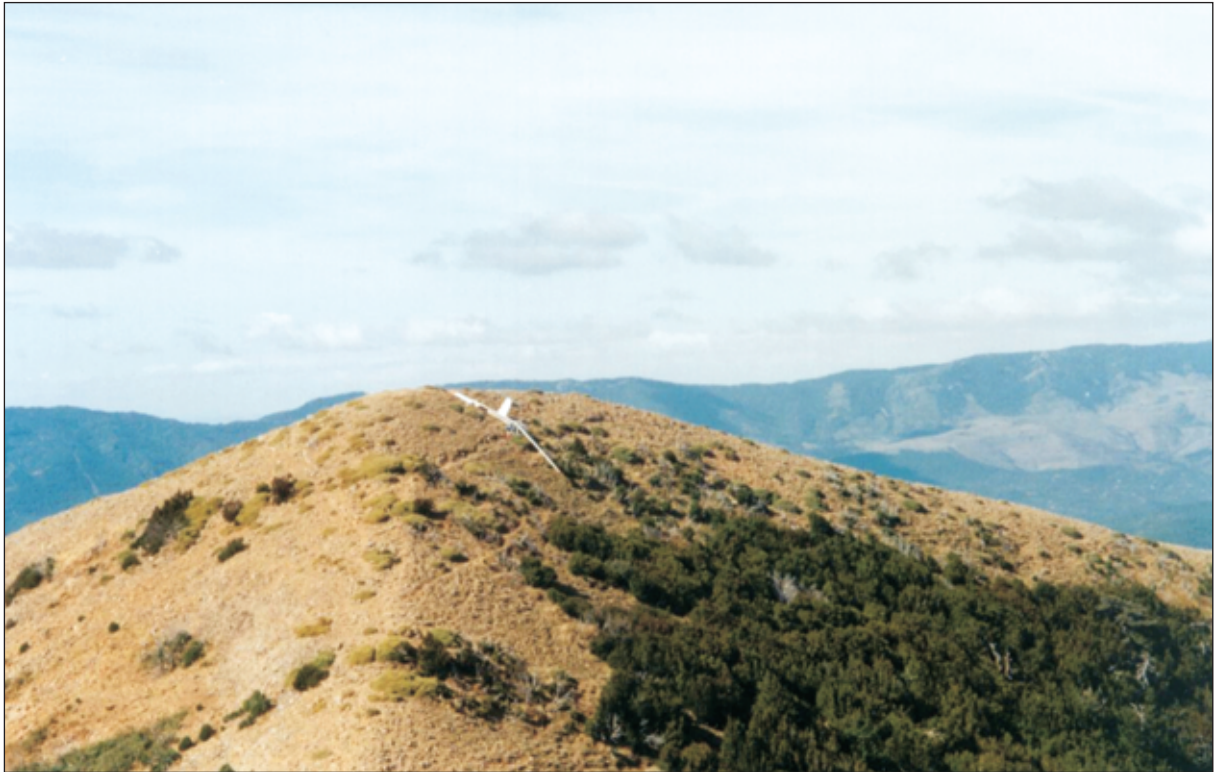
The wreckage of the aircraft was located in the Pasaje San Salvador, in the municipal district of Santa Cruz de Serós (Huesca) at the summit of a small, gently-sloping hill (see Figures in Appendix A).

Photo 1. *View of the accident place*

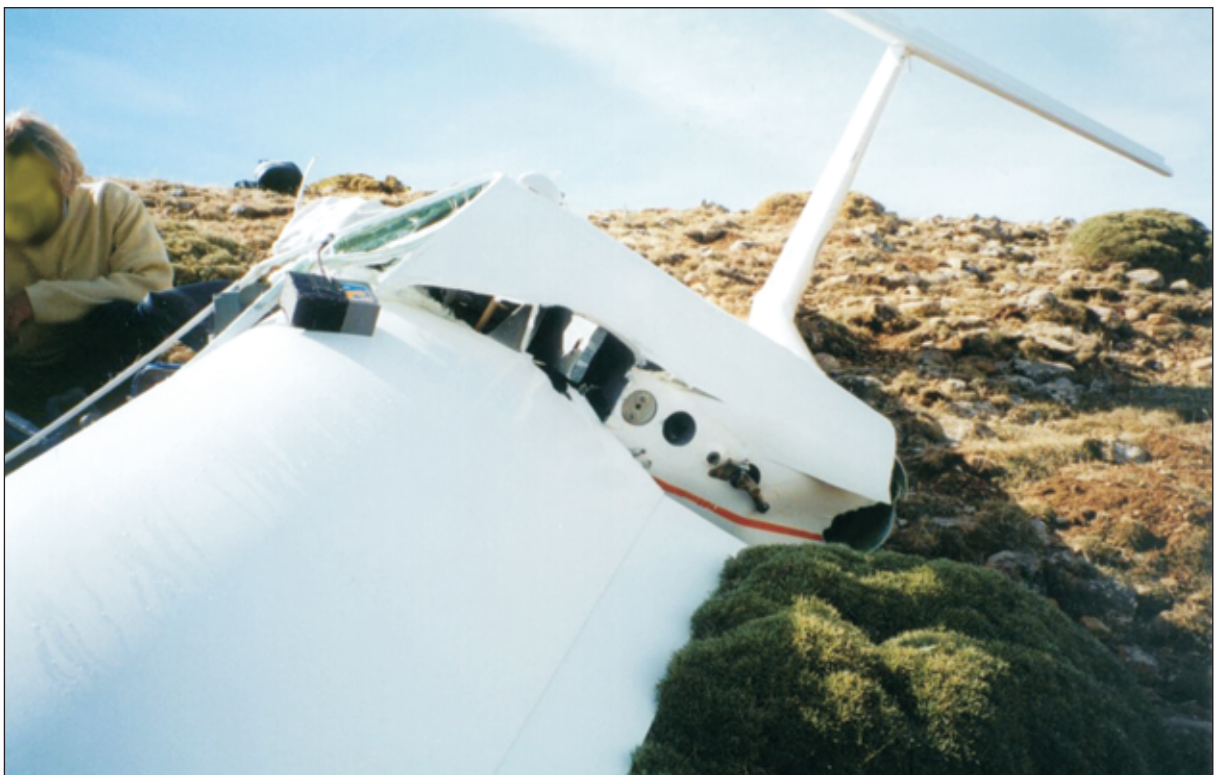
The angle of impact of the prow was not very pronounced, and it was slightly bent to the left. The nose was destroyed, with the skin ripped off and torn, as was the cockpit canopy. The pedals were bent and displaced, and the canopy frame and spars were also bent.

Photo 2. *Left view of the wreckage*

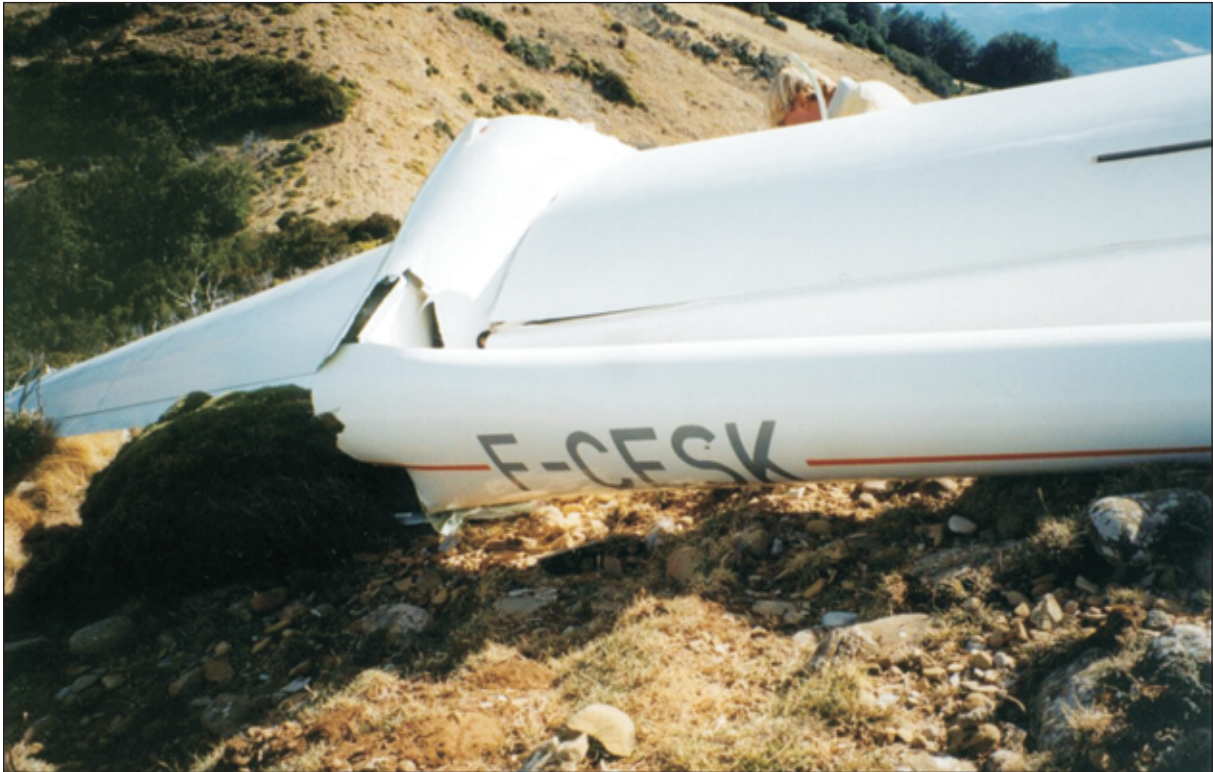
The rear fuselage had split at the wing support frame, around which it had turned 90° anticlockwise, taking the tail with it in this movement.

Photo 3. *Rear view of the wreckage*

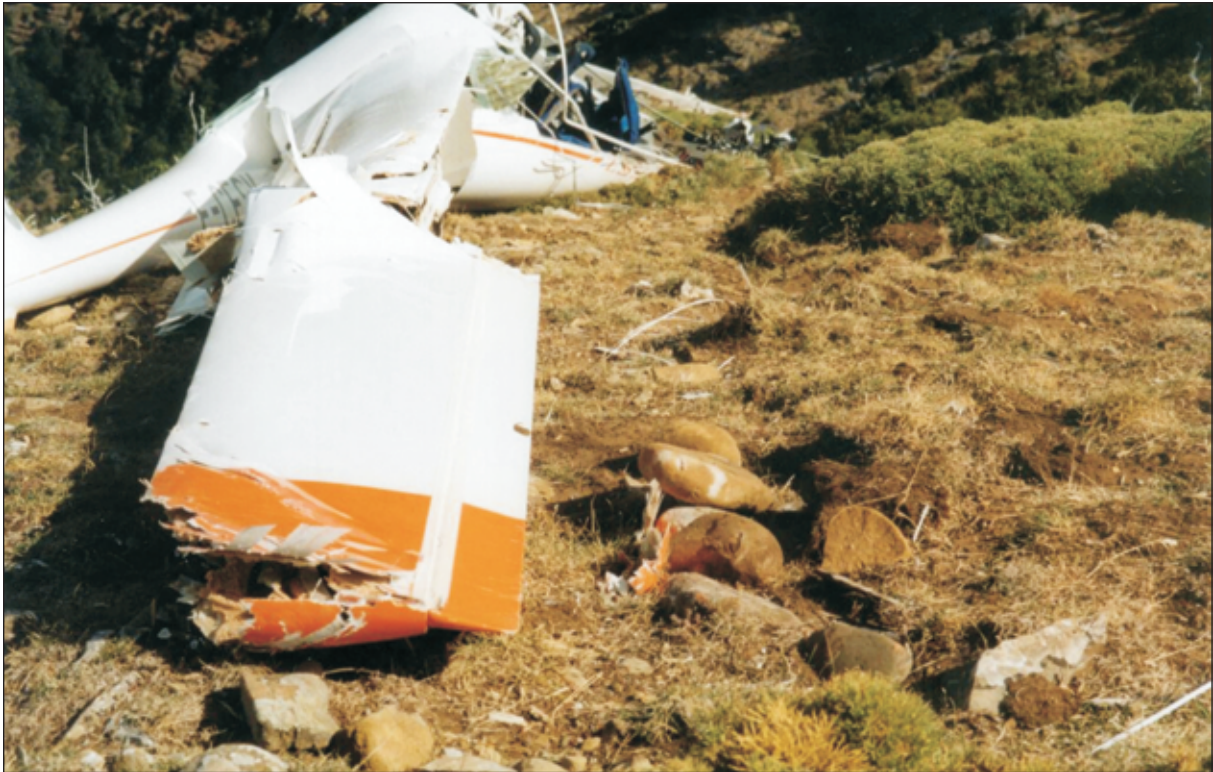
The wing was broken at the root by twisting force, basically maintaining its position with respect to the fuselage. The right semi-wing had broken and turned around its longitudinal axis (OY axis), in such a way that the trailing edge was in front.

- The low angle of impact and the position of the wreckage (right outer wing turned 180° on its OY axis, rear fuselage broken and turned 90° on its OZ axis, taking the tail with it) indicates that the aircraft was almost parallel to the ground at the moment of impact and was veering to the right at considerable speed.

Photo 4. *Detail of the right wingtip*
