DATA SUMMARY

Registration	D-EJUS
Type and model	CESSNA F172G

1.- FACTUAL INFORMATION

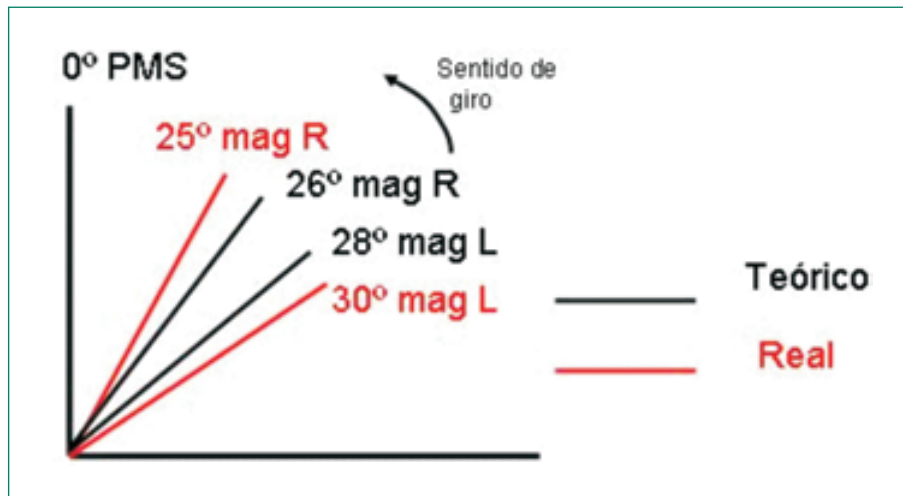
The setting of the magnetos was checked on the engine. It was observed that the right magneto, the one to feed the upper spark plugs, was set at 25 degrees, one degree below the 26¹ degrees established in the aircraft maintenance Manual. The left magneto, the one to energize the lower spark plugs, was set at 30 degrees, two more than the 28 degrees as established in same Manual.

The magnetos were dismantled and it was found that the left magneto contact breaker points were abnormally separated.
