CIAIAC

TECHNICAL REPORT

A-022/2002

Accident to aircraft
ROBIN DR 400-180,
registration number
D-ESCM, in Huetor
Santillán (Granada),
on 10 May 2002

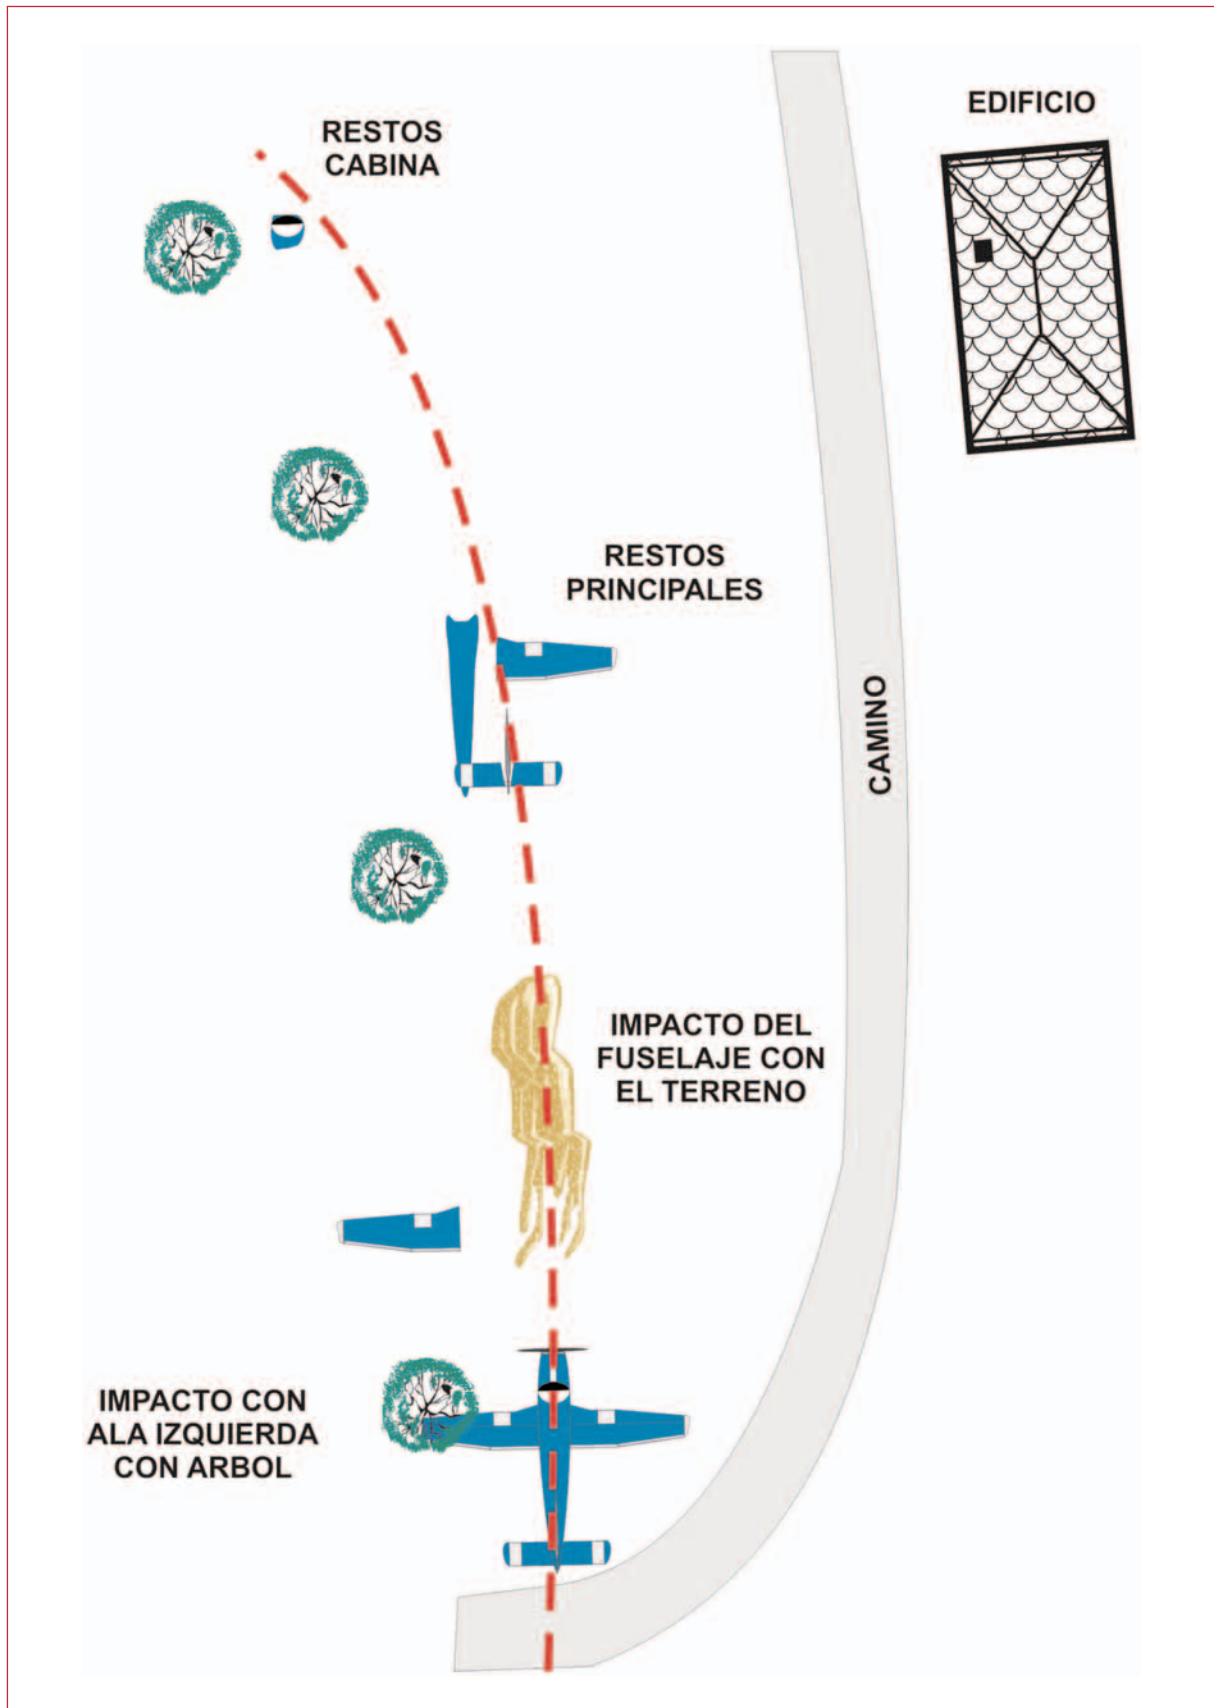
Wreckage scatter diagram

The aircraft wreckage was found over a distance of some 200 m on a strip of flat terrain with a gentle slope to the south and a sharp drop to the east, parallel to a path which provides access to a country house.

The major part of the left wing with its aileron was found amongst the branches of the first olive tree, which was completely destroyed.

Then there was an area of terrain that had been turned over and in which horizontal marks with the same distance between them were seen, which may have been caused by the propeller. The main impact occurred at this point in which the aircraft was destroyed, the wreckage of which slid along leaving smashed pieces of the structure along the way.

The rear part of the fuselage came to a halt next to another olive tree, together with the horizontal tail, right elevator, rudder, the propeller joined to the crankshaft flange and separated from the engine by the breaking of the crankshaft, one undercarriage leg and other elements difficult to identify due to the high degree of destruction in which they were found.

Finally, a bit further away, the cabin wreckage appeared.

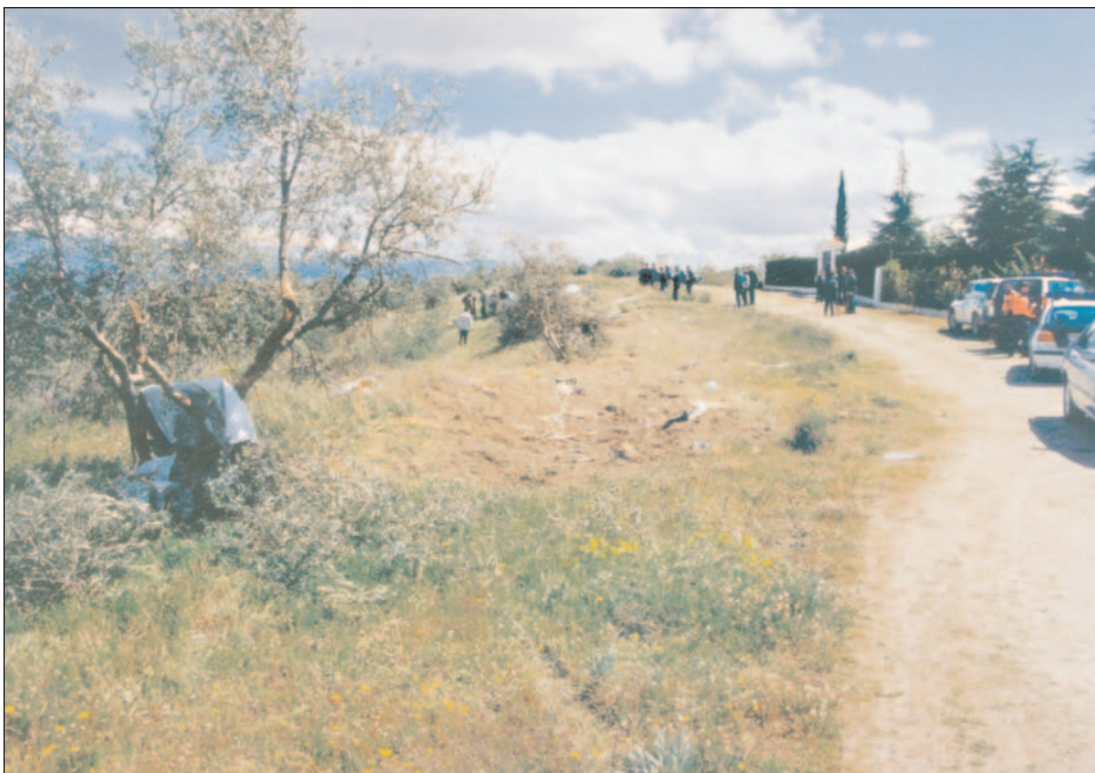
The first impact is caused by the left wing crashing into a small olive tree, causing it to break off and remain caught up amongst its branches. Immediately afterwards, and with a slight turn to the left, the main impact of the hub takes place, which causes the aircraft's disintegration and the sliding of the wreckage over the surface of the ground, following a slightly curving path to the left, aided by the terrain's slope towards the same side.

Photo 2. *Start of the aircraft's path along the ground*

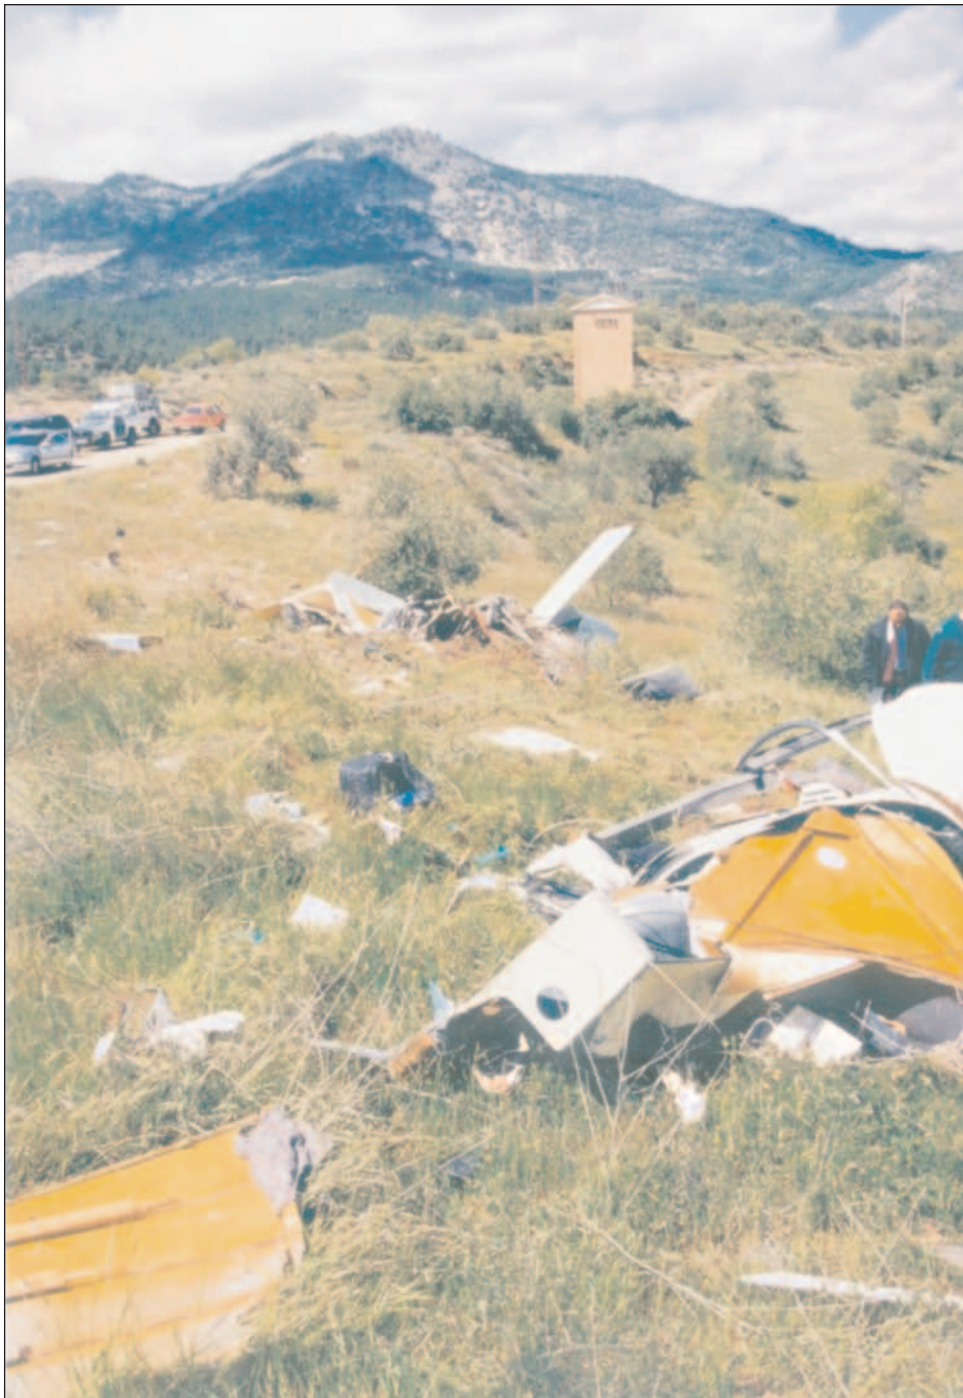
Photo 3. *Path along the ground, seen from the place occupied by the main wreckage*
