# CIAIAC

## **TECHNICAL REPORT**

**A-030/2002**

**Accident of the aircraft Air Tractor-802,  
registration EC-GOO, on June 14, 2002,  
in Barxeta (Valencia)**

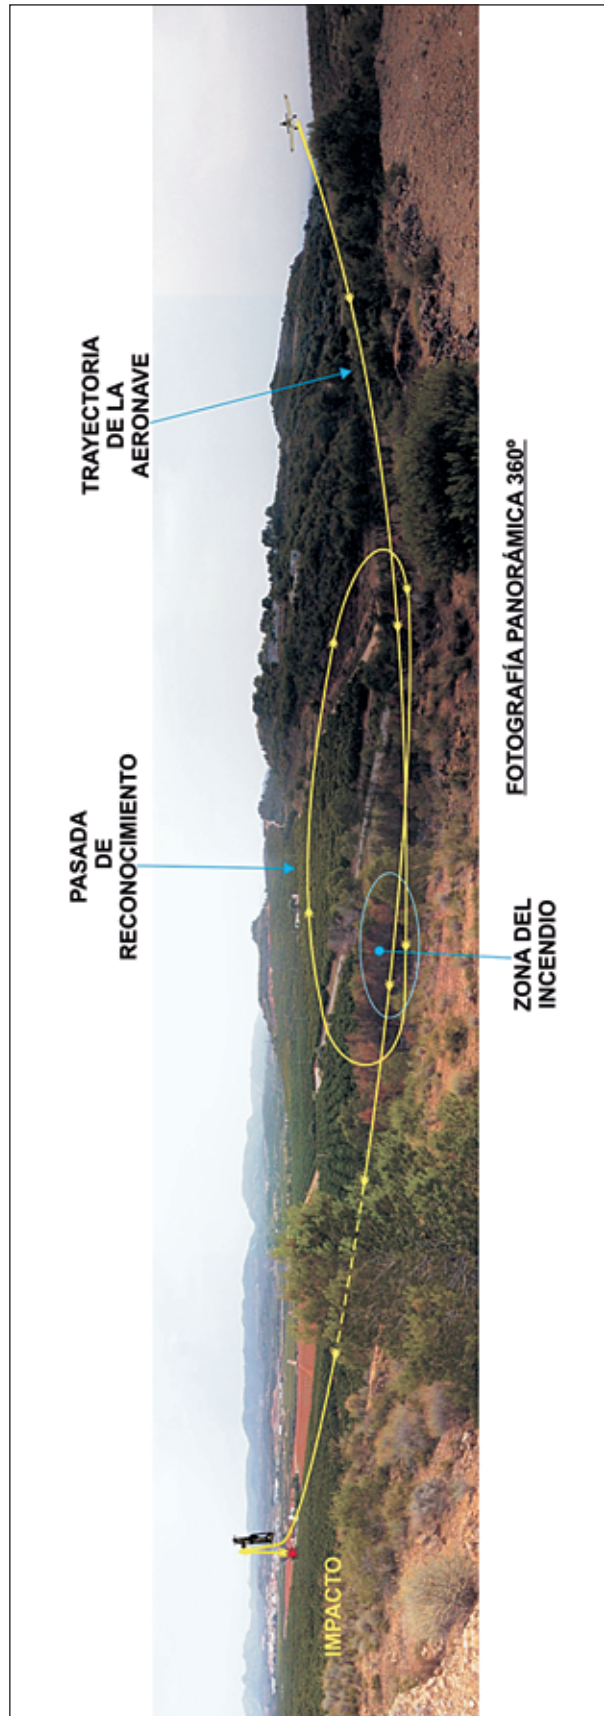
## **Trajectory followed by the aircraft**

Appendix A contains an estimation of the aircraft's trajectory. First it approached the fire area via a small valley. Then it made a reconnaissance pass to locate the fire and study the terrain. Then it turned 360° before immediately unloading.

Once it had unloaded, the aircraft ascended until it reached a vertical attitude with a pitching angle of 90° and almost came to a standstill at an altitude of between 150 and 200 metres. From this position it descended out of control and crashed into the ground.

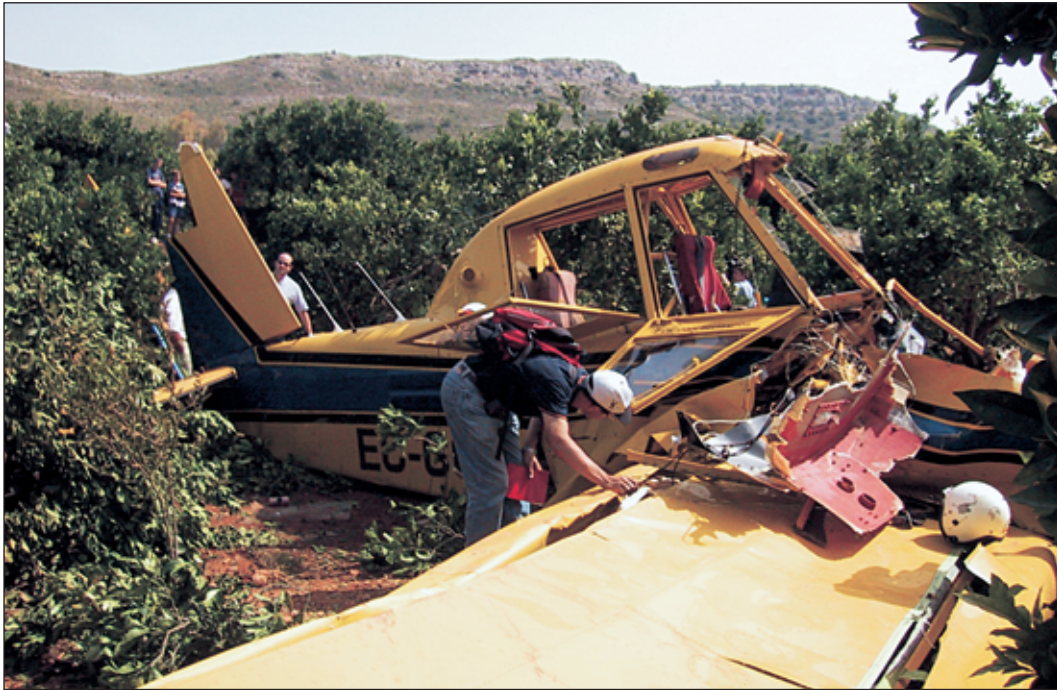
All the remains were distributed in a radius of 3 metres round the aircraft, indicating that it had mainly vertical speed.

Photo 1. *Aircraft involved in the accident*

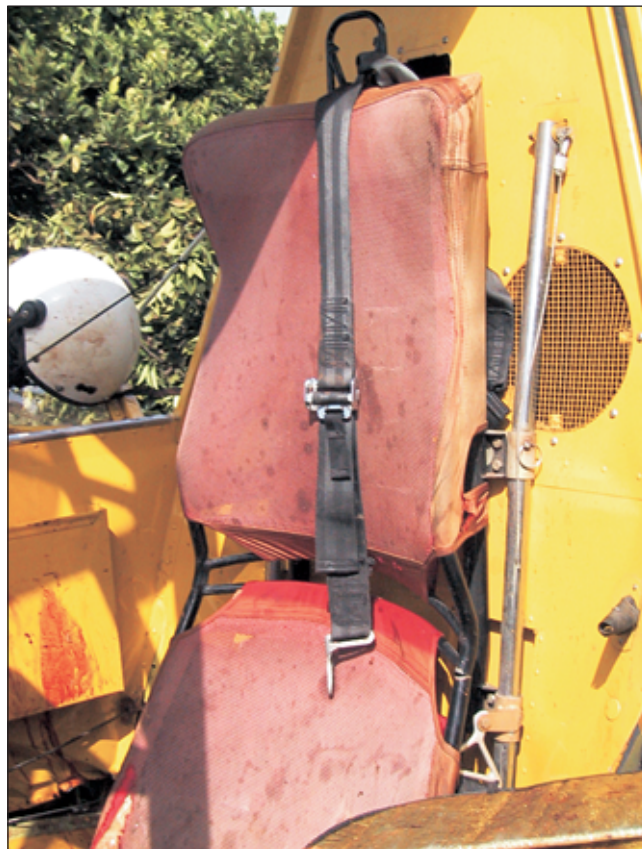
The motor pump operator's seat broke in two with the impact.

Photo 2. *Motor pump operator's seat*

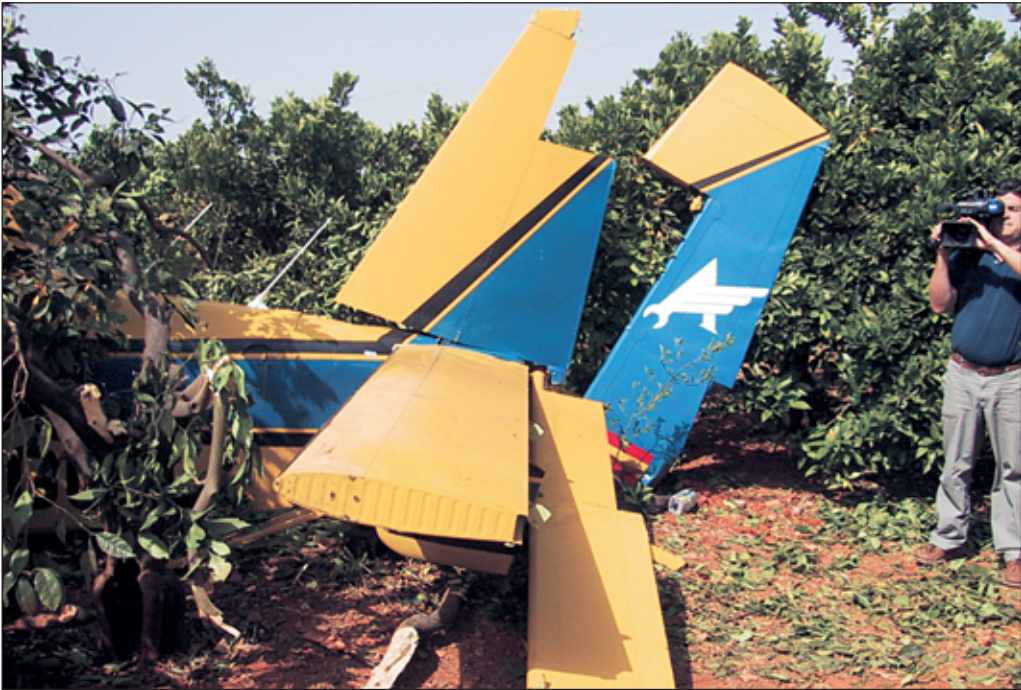
The rudder bar and elevator control column had broken away from the vertical tail fin and horizontal stabilizer, respectively. The wings were broken at their restraints with the fuselage and throughout their length.

Photo 3. *Rudder and elevator broken off*

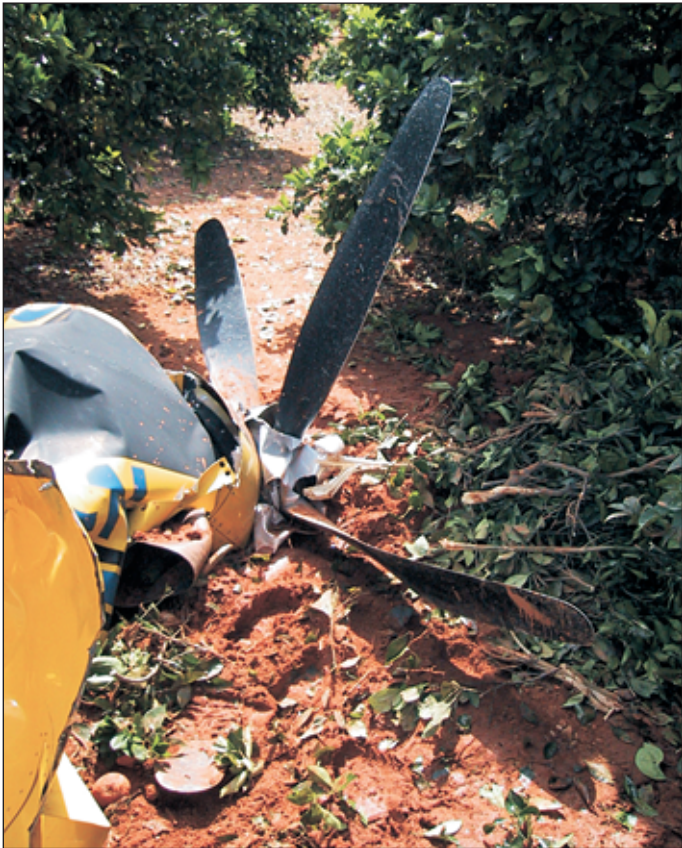
The most damaged part was the nose area. The engine had broken away, although it was close to the aircraft and of the 5 propeller blades, 2 were buried, 2 did not suffer any damage and 1 of them was bent.

Photo 4. *Detail of the propeller*

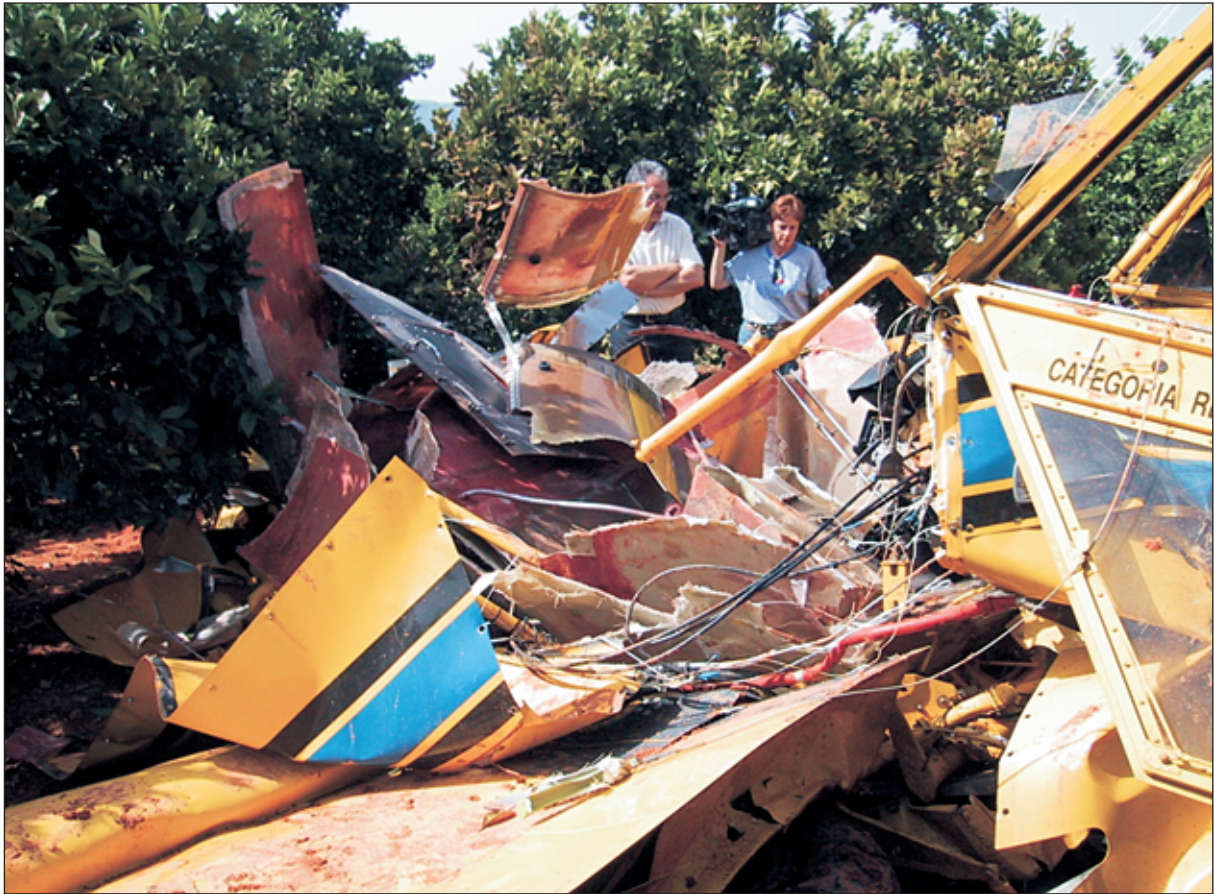
The hopper had been cut into several pieces.

Photo 5. *Front part of aircraft (hopper)*

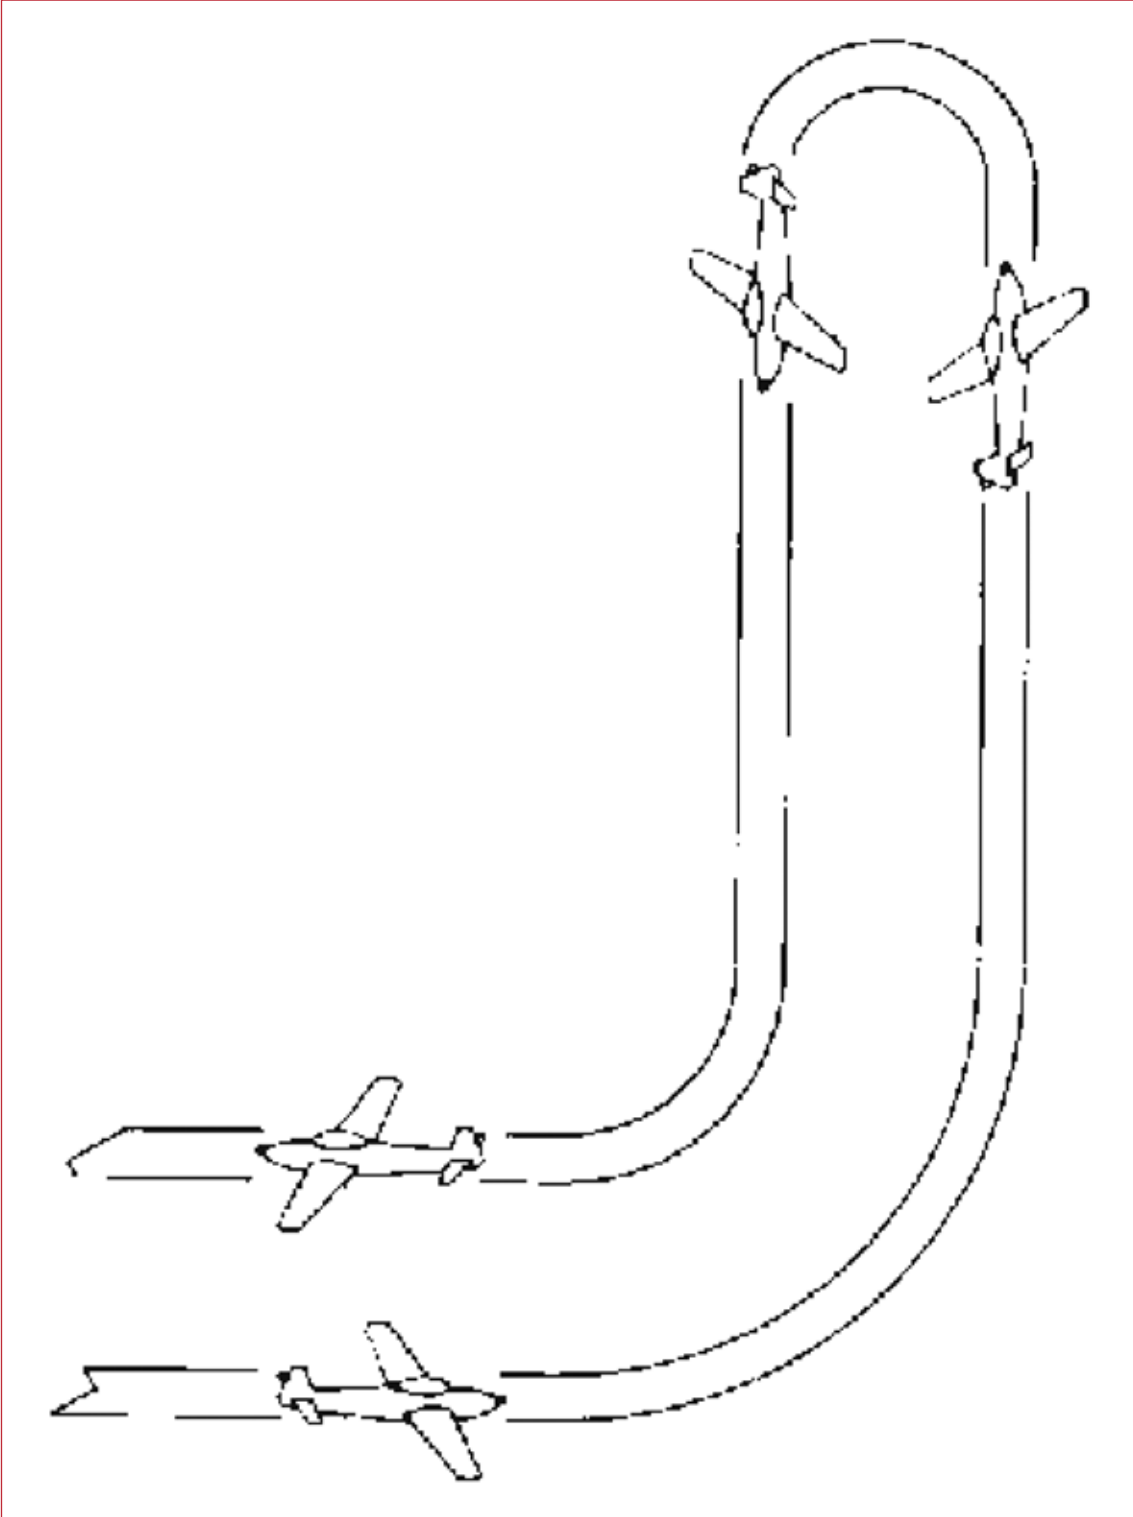
*Hammer head manoeuvre*

The hammer head, as it is known colloquially, is an acrobatic manoeuvre consisting of following a vertical upward path, gradually reducing engine thrust, until the upward speed is practically nil. At that moment, rudder control is applied and the engine power

is cut off, producing the aircraft's turn in the vertical plane described in the ascent and at a turning point situated very close to the tip of the right or left wing, depending on the direction rudder applied. The length of time that rudder control must be applied varies according to the type of aircraft.

After the turn, the aircraft adopts a 90° dive attitude, that is, it starts a vertical descent and finally recovers horizontal flight in the opposite direction to that of its entry into the manoeuvre. A diagram of this manoeuvre is given in Appendix C.
