DATA SUMMARY

Date and time	Sunday, 1 September 2002; 9:07 h local time
Site	Airport of Barcelona

Registration	G-EZYP	OK-BGQ
Type and model	BOEING B-737-300	BOEING B-737-400

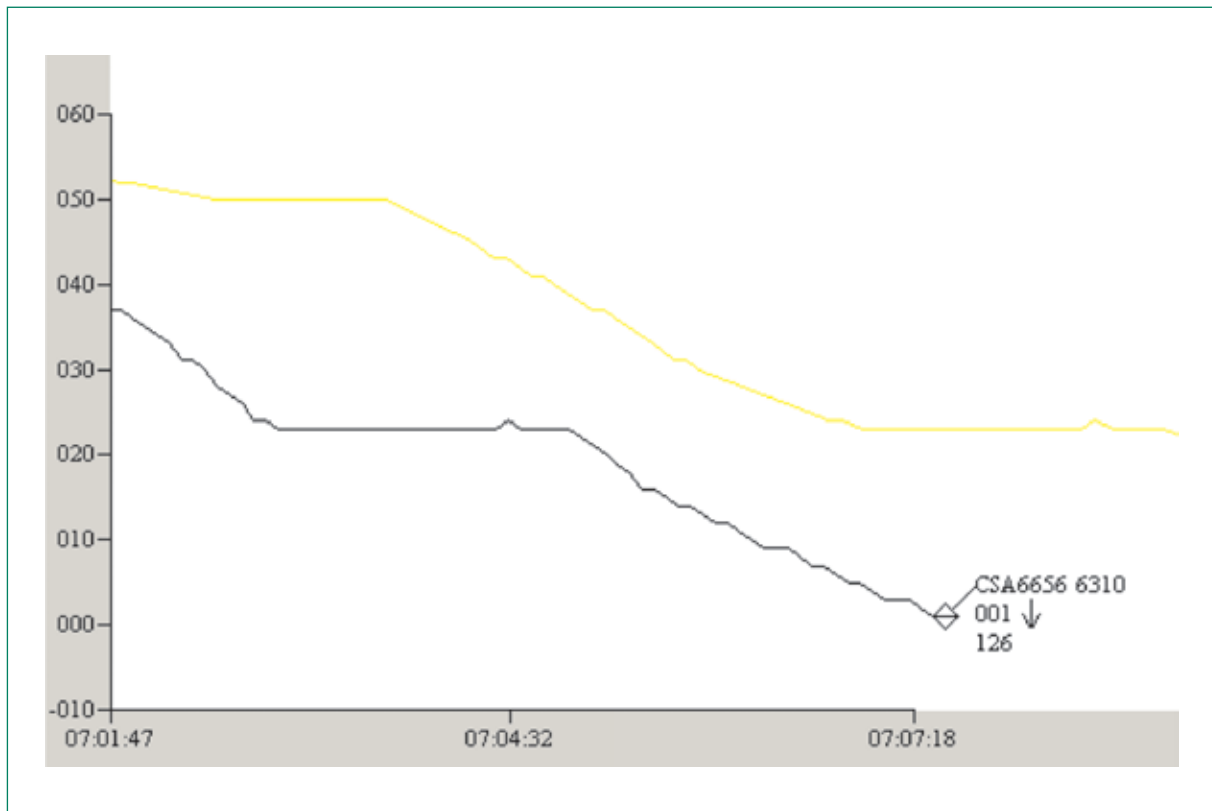
Figure 1. Vertical path of CSA 6656.

The recorded radar vertical trajectory of the aircraft is attached in Figure 1 until the moment the aircraft had 126 kt of ground speed and was below 100 ft of height. The horizontal trajectory of the aircraft is attached in Figure 2.

The height of CSA 6656 at those moments was around 150 ft (49 m) AGL, which means that the lowest point of OK-BGQ was approximately 115 ft (around 38 m) above the top of the vertical tail of G-EZYP when it passed above the other aircraft.
