TECHNICAL REPORT

IN-062/2002

Incident of aircraft
Airbus A-340
registration EC-IDF,
at Madrid-Barajas
Airport (Madrid) on
7 September 2002

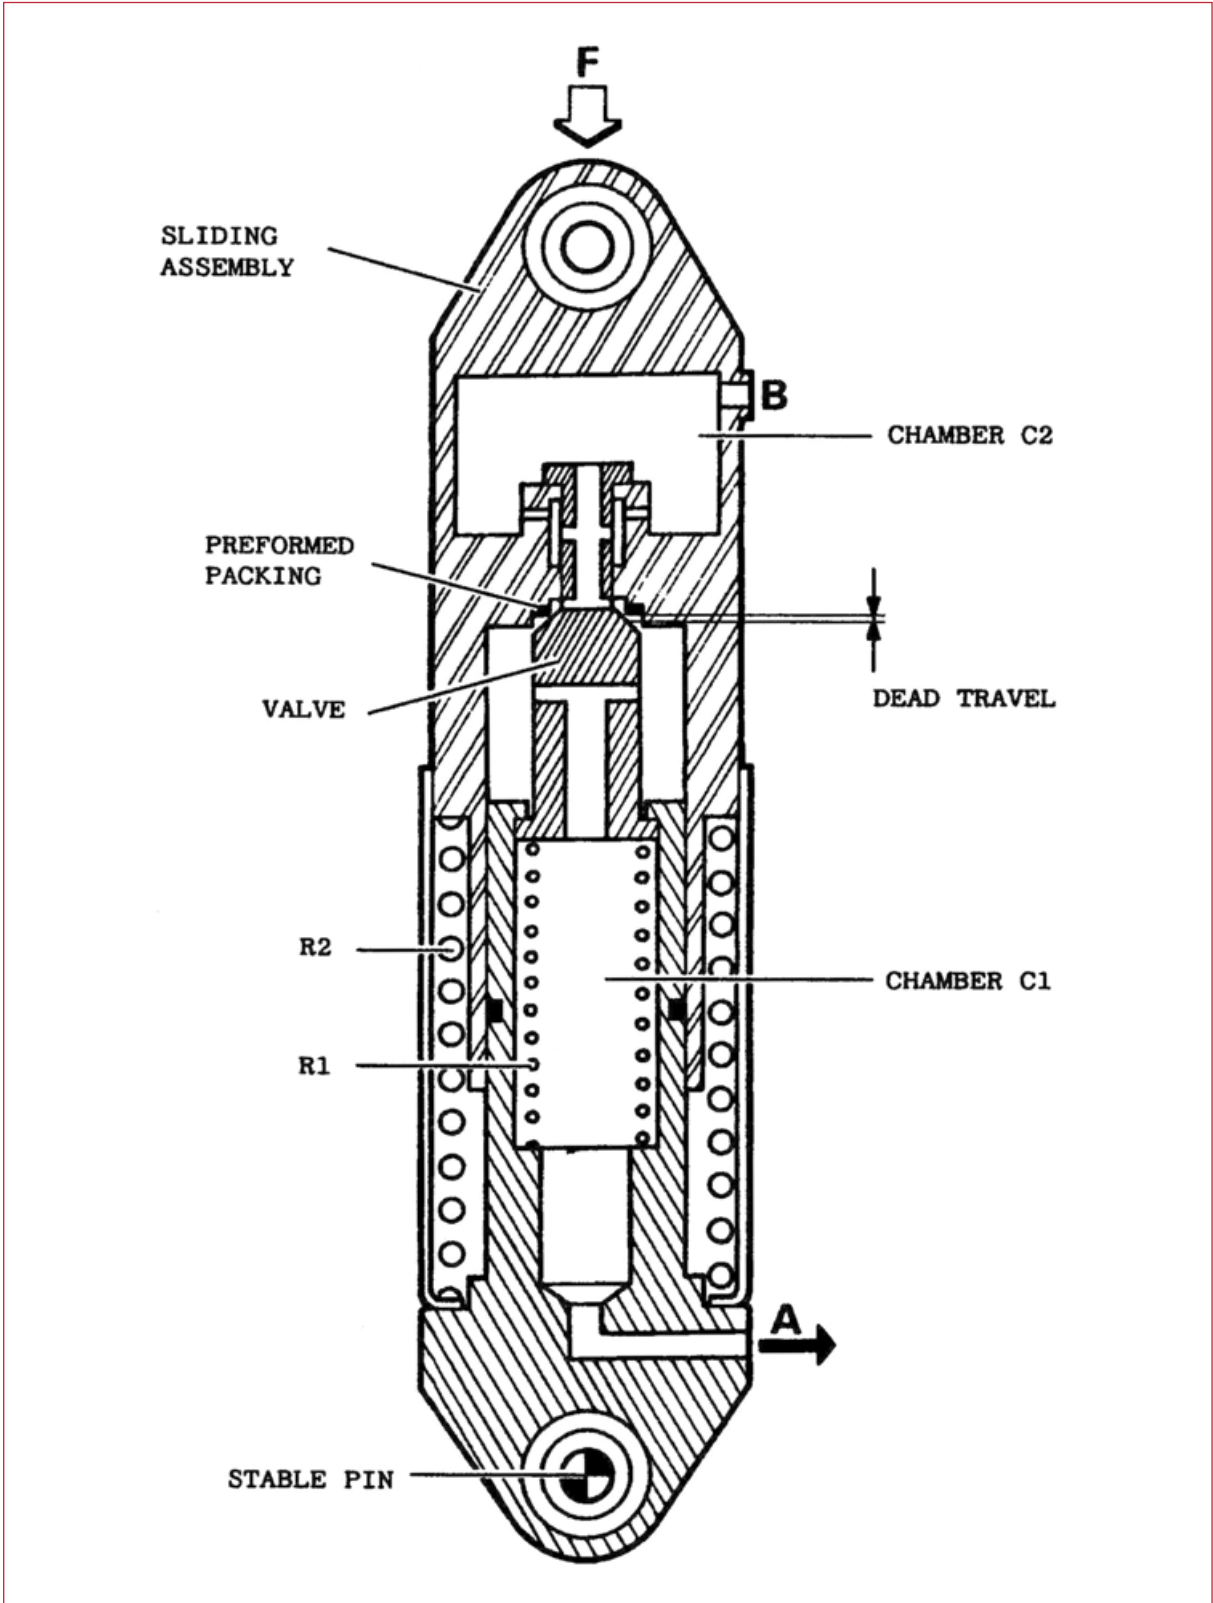
Figure 4. Drawing of the master cylinder. When the pedal is pressed, a force F is applied in the upper part of the cylinder

According to the Component Maintenance Manual (CMM) «Master Cylinder C24592020», dated 31 July 1992, the total length of the cylinder must be between 170.050 mm and 170.100 mm, and the dead band must be between 0.4 mm and 0.5 mm (there was a typo in the CMM, page 703, in which it is mentioned «*dead travel 0,4 to 05*»).

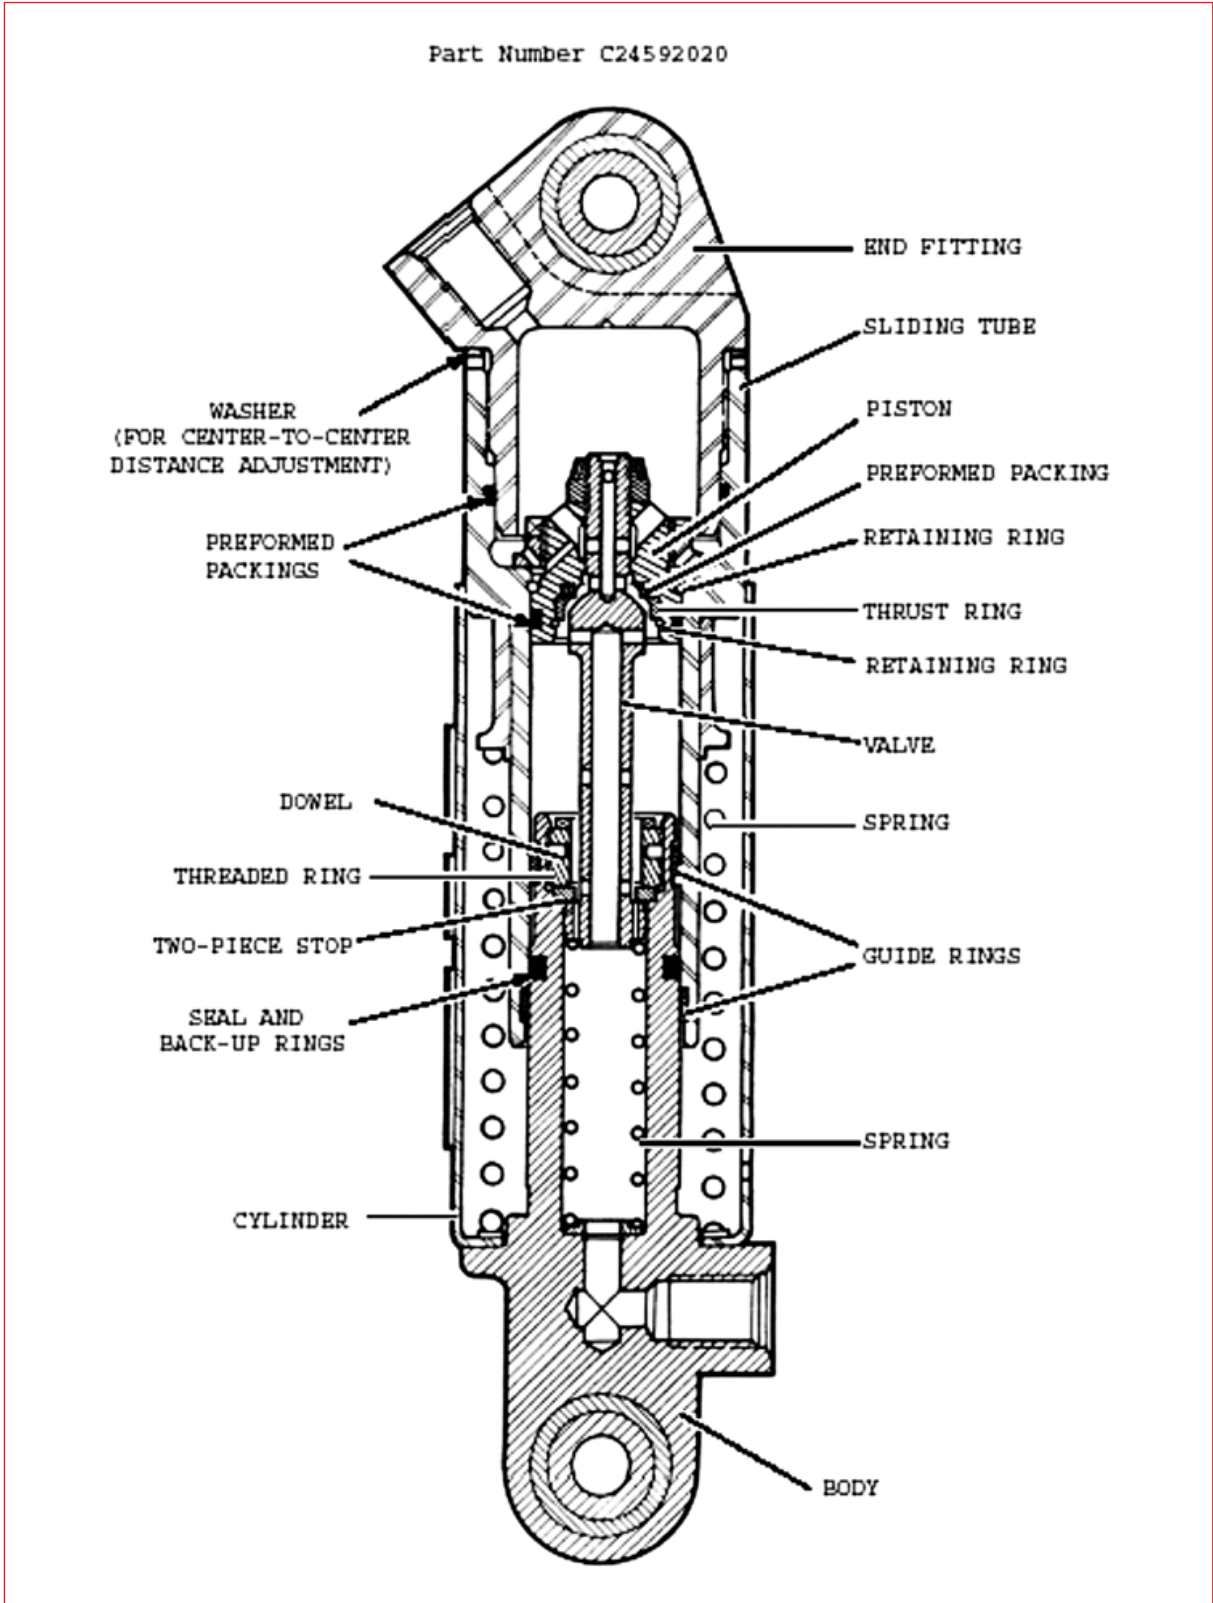
Figure 5. Detailed cutaway of the master cylinder

- The cylinder was disassembled and no noticeable defects were found. The different subcomponents were dimensionally checked and all of them were found inside tolerances except the «small» spring or spring valve (spring R1) that reached the nominal length with a load of 4 Nw instead of the 5 Nw of the specification. The specialists in the system considered this difference was not significant. The preformed packing of the valve was deformed because of the contact with the valve, and had no longer the squared section with which it was manufactured.

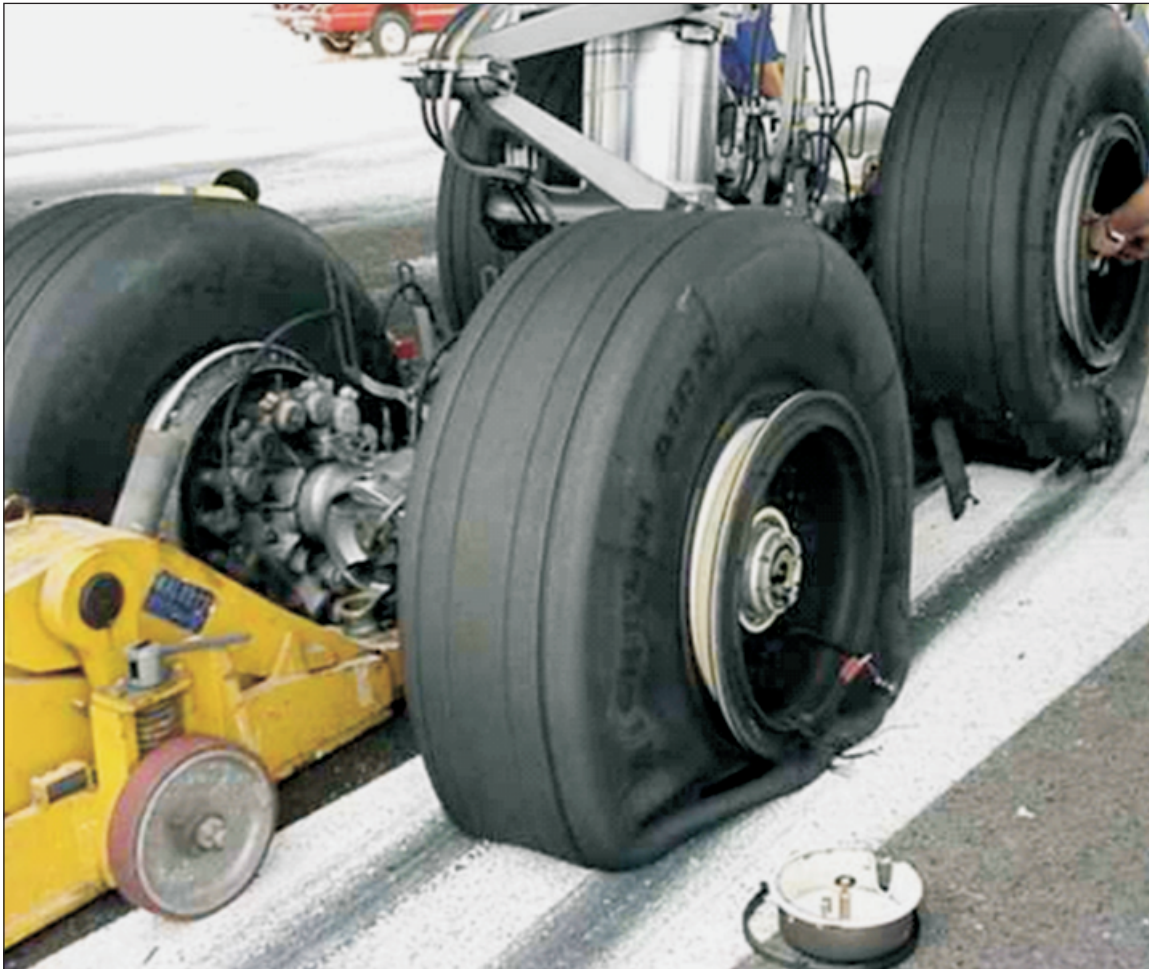
Wheel 4 had friction in the rim with loss of material and tire burst due to friction with the runway.

Wheels 7 and 8 showed tire burst due to friction with the runway but the rims did not have noticeable damage.

Figure 6. Wheels 3, 4, 7 y 8 (right leg; seen from the rear right angle) after the aircraft stopped on the runway. The white line is the runway side stripe marking of 33. Note the two narrow tracks of every wheel after they burst

The brake assemblies 1, 5 y 6 showed heavy rubbing with loss of material in the fitting and in the brake disks, due to friction with the runway.

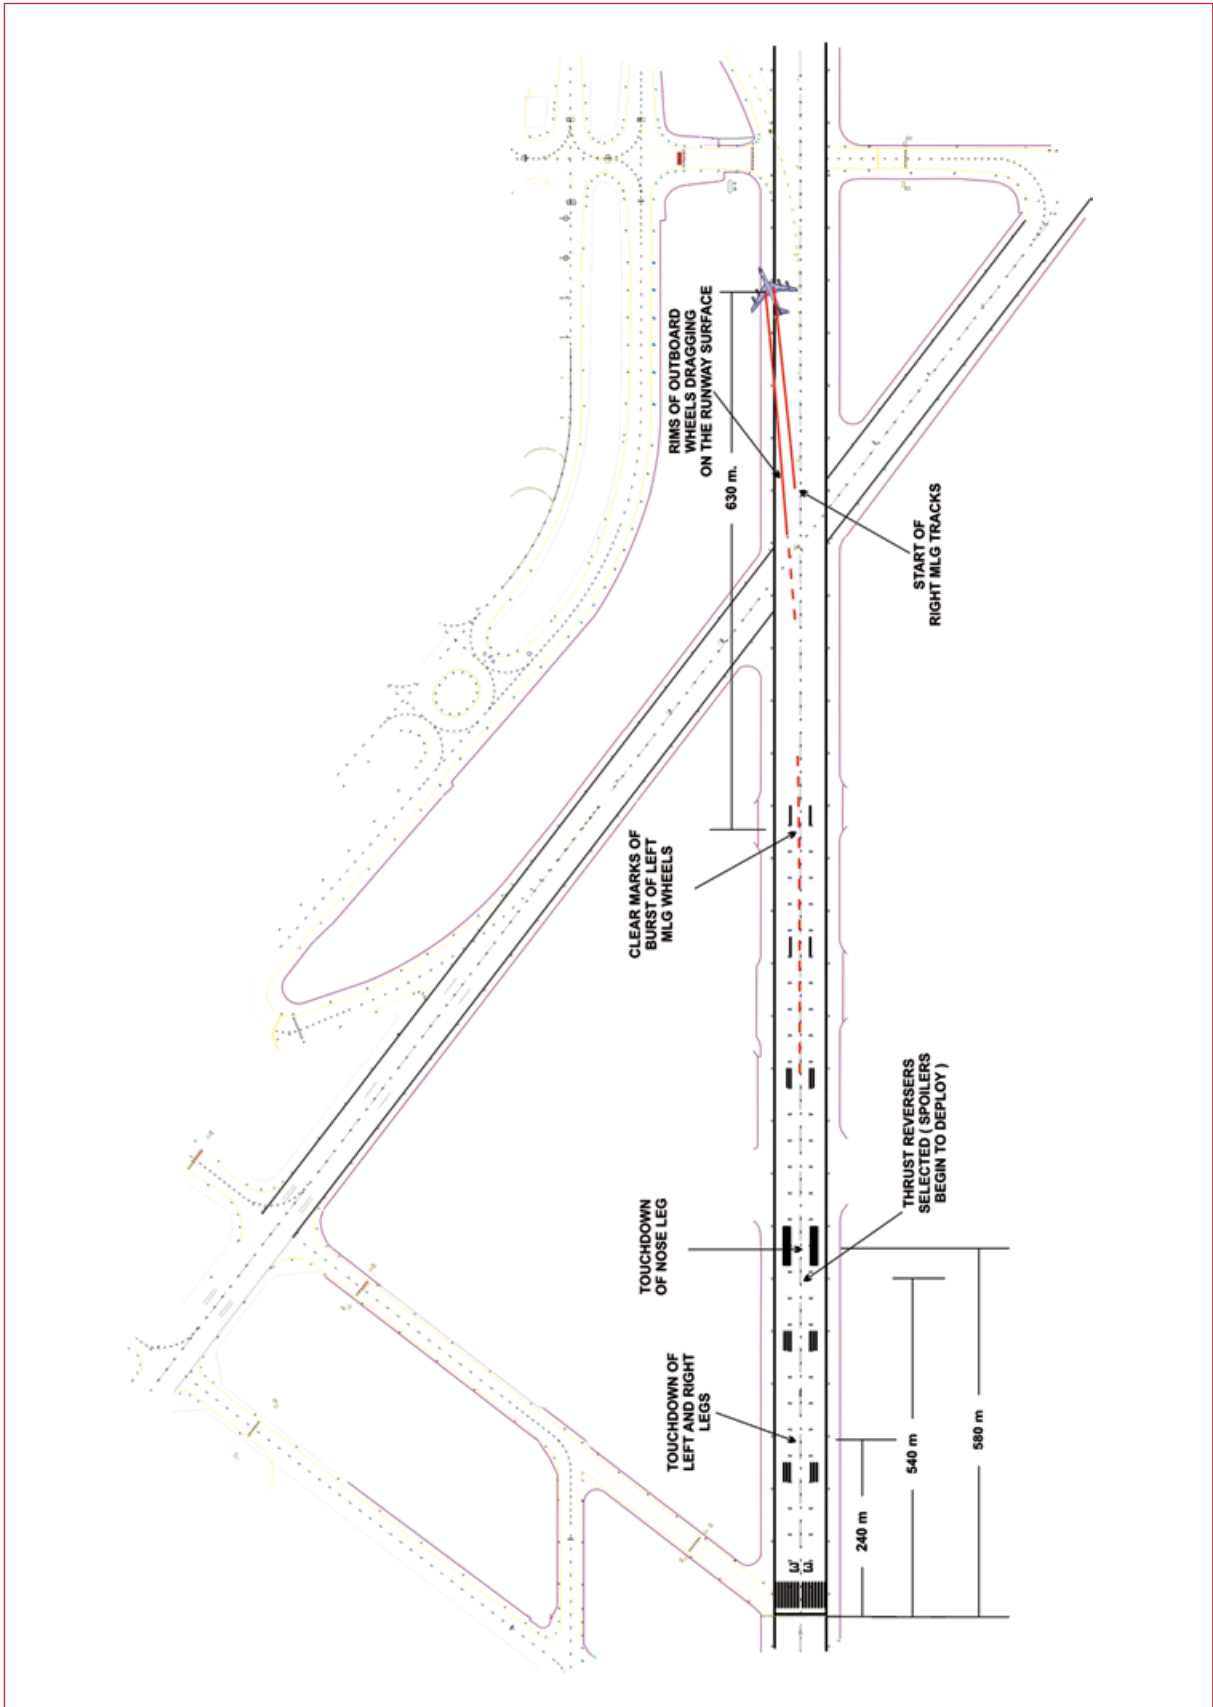
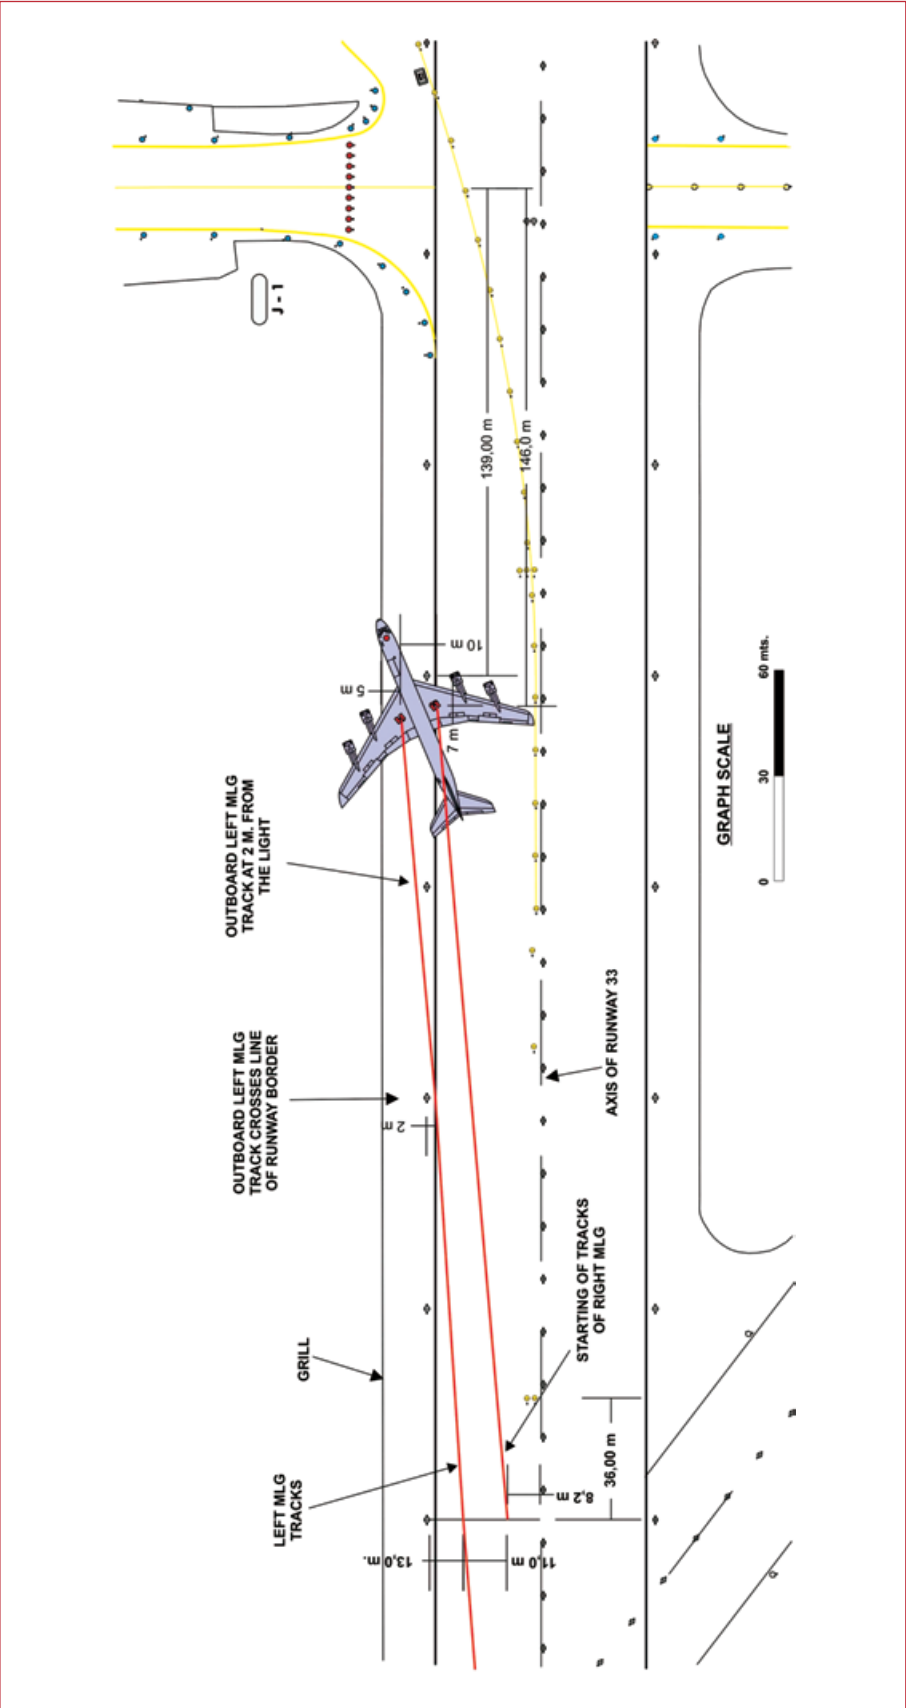
APPENDIX A
Diagram of tracks on runway 33
of Madrid-Barajas Airport

When the runway could be inspected, it was noticed that starting in the point the aircraft had stopped and coming back in the sense towards the threshold of runway 33 (i.e. going in the sense contrary to the movement of the aircraft during the landing roll), tracks of the wheels of the left and right MLG legs could be clearly noted. The tracks consisted of eight dark lines that corresponded to the sides of the tires showing that all the wheels had burst. At 60 m from the point where it was stopped, the track of the left leg crossed the runway edge lighting line (at 2 m from the next runway edge light), and 60 m backwards it crossed the white line of the runway side stripe. During the previous 60 m it could be seen that the wheel rims number 1 and 5 (both outboard wheels of the left leg) had dragged along the runway, although no appreciable grooves or other damage to the runway surface was noticed.
