DATA SUMMARY

Date and time	Sunday, 27 October 2002; 12:40 hours
Site	1 km from the aerodrome of Castellón

Registration	D-EIGB	EC-YQH
Types and models	MOONEY M-20E	Pow. microlight vehicle

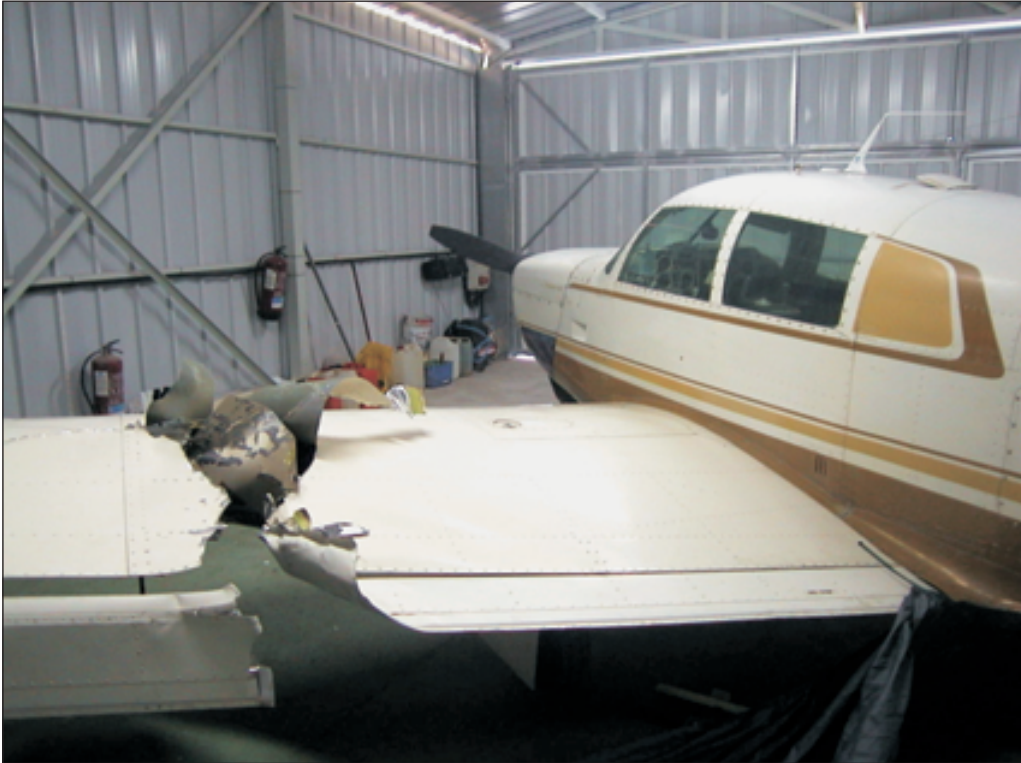
Aircraft D-EIGB sustained damage to the left wing consisting in a tear in the skin, on both the upper and lower surfaces, which affected almost all of the chord, from the trailing edge to the back part of the main spar, and breakages of the ribs and longeons over a length of approximately a metre and a half (see photograph 1). The tear began at the trailing edge of the flap of the left wing (approximately halfway along the span of the flap) and continued towards the leading edge of the wing, in a direction almost perpendicular to its span, until reaching the main spar of this wing. At this point the tear changed direction, continuing along the rear section of the core of the main spar towards the wingtip. This section was a little over half a metre long. In addition, the left wing showed blows and dents on the leading edge (see photograph 2).

Photography 1. Damages to the left wing. Aircraft D-EIGB

- The examination of the wreckage of the microlight and of the damage to the left wing of airplane D-EIGB shows that the microlight autogyro was very probably underneath the other aircraft at the moment of impact. The microlight's rotor blade struck the wing of the other aircraft from behind, cutting the flap and reaching the main spar of the wing. At that point it began to move along this spar towards the wingtip, until in its downward movement it fell out of the lower surface of the wing. This sequence only seems possible if the microlight was underneath the other aircraft and with the rotor blades rotating in a plane having an appreciable angle with the horizontal. This scenario indicates that the microlight may have been manoeuvring at the moment of impact. It cannot be determined whether this was a normal flying manoeuvre or if the pilot was attempting to avoid impact. Nor is it possible to determine the attitude of the microlight's fuselage with regard to the other aircraft because of the multiple possibilities offered by the flying characteristics of an autogyro.

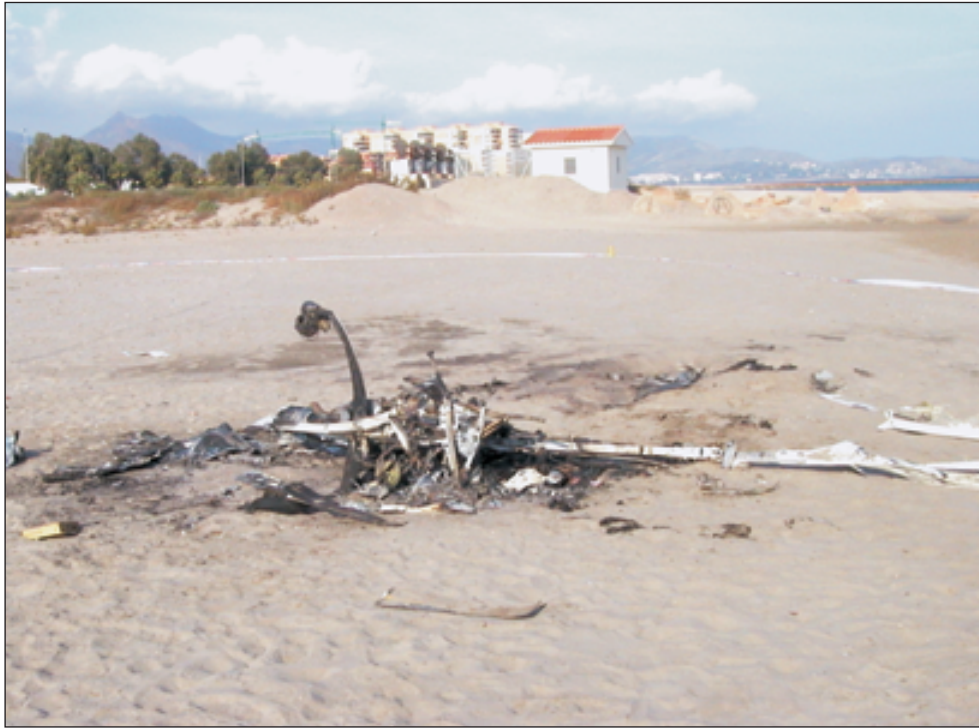
Microlight autogyro EC-YQH was totally destroyed and practically consumed by the fire that broke out after its collision with the ground (see photograph 3). The fire service of the city of Castellón proceeded to the accident site and had to act to fully extinguish the flames.

Photography 3. General view of the microlight
