## **TECHNICAL REPORT**

### **IN-076/2002**

Incident of the aircraft  
Airbus A-340-313,  
registered EC-GPB,  
at Salamanca Airport  
on 8 November 2002

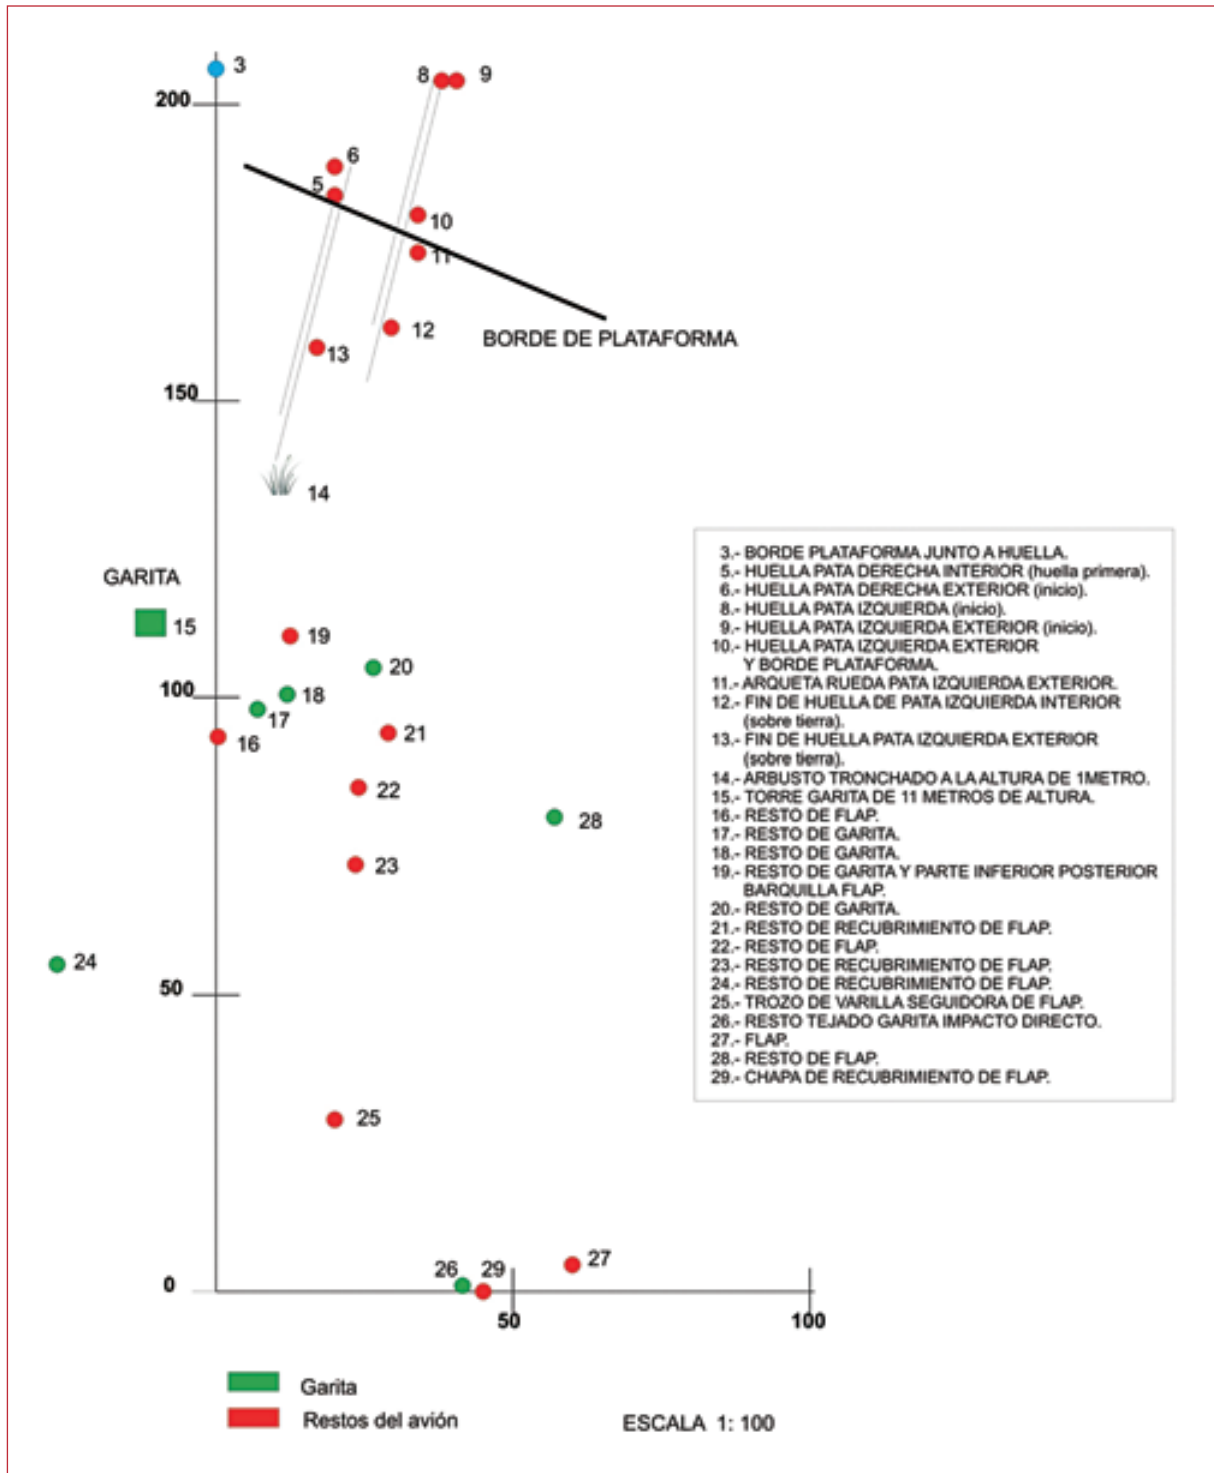
**APPENDIX A**  
**Debris diagram and tracks**  
**over the terrain**

Remains from the aircraft were found along approximately 120 m. They were found a part of the flap bar fairing, of 1.15 m of length, with a part of the guiding bar still attached, and a rectangular piece of the right outboard flap of 3 m per 0.9 m and a part of the flap skin, of 3.85 m per 0.42 m.

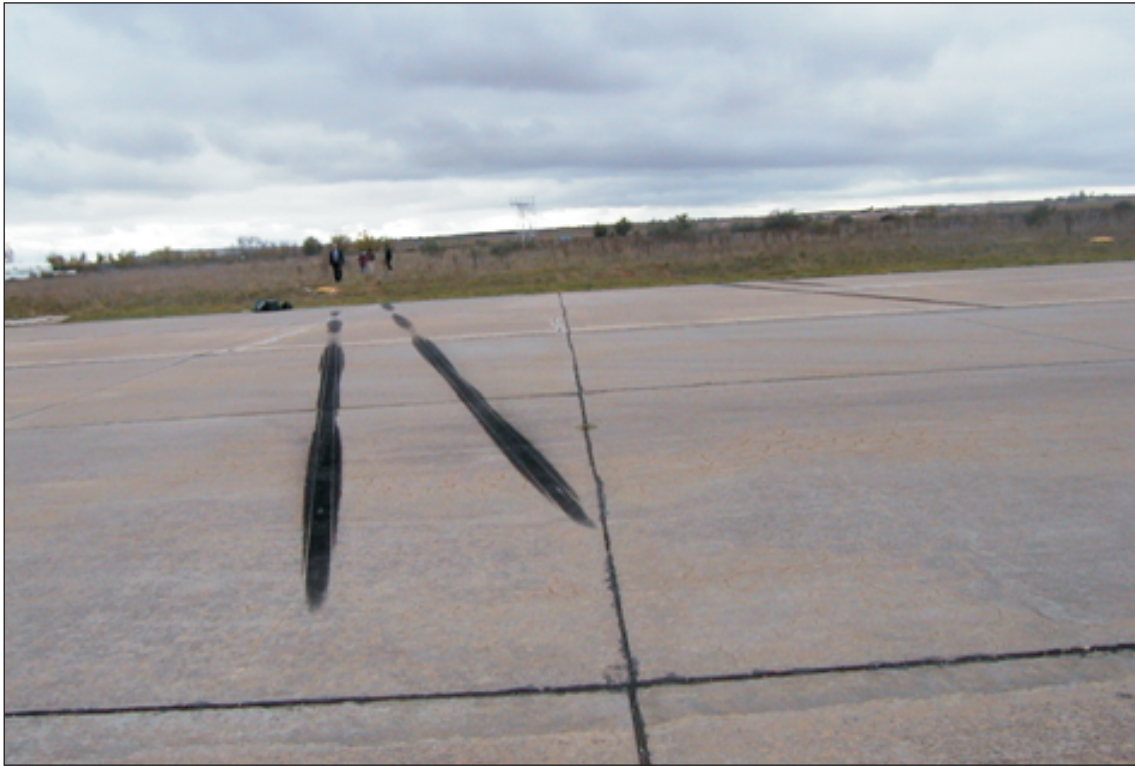
After touching down, left leg first and then right leg, the data of the DFDR indicate that both legs were compressed for less than a second, the wheels rolled and dragged over the apron (strong tracks of the tires were noted) and continued through the adjacent unprepared terrain along 50 m. The pitch angle increased up to 12.9°. The aircraft climbed while its speed was decreasing down to 136.5 KCAS. As soon as both legs were recorded compressed, the thrust levers were progressively advanced to TOGA within 3 sec, and when the aircraft was at 67 ft, they reached 85° of deflection and vigorous movements of the lateral and directional controls were made to produce a steep turn towards the left.

*General view of the tracks over the apron*

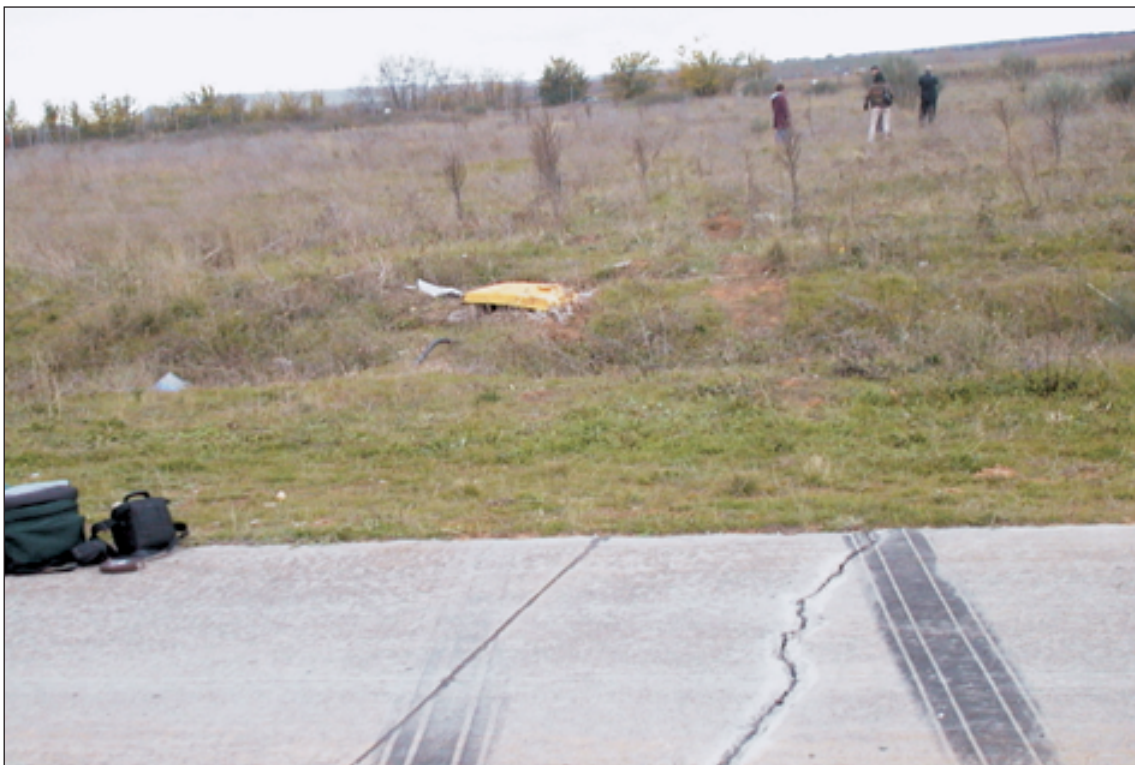
The aircraft, after touching down with the main left and right landing gear legs on the parking apron and the adjacent terrain at 15:01:48 h, broke with the left leg an elec-

*Detail of the tracks and lights well*

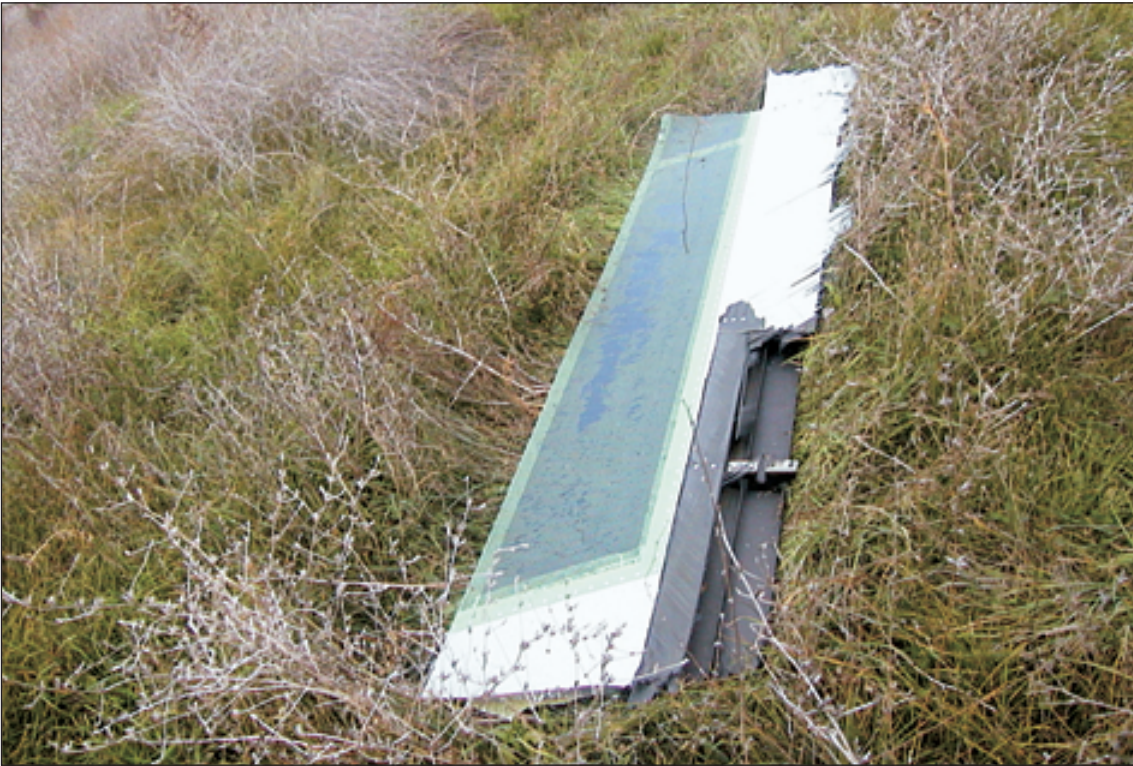
*Debris of the RH outboard flap*

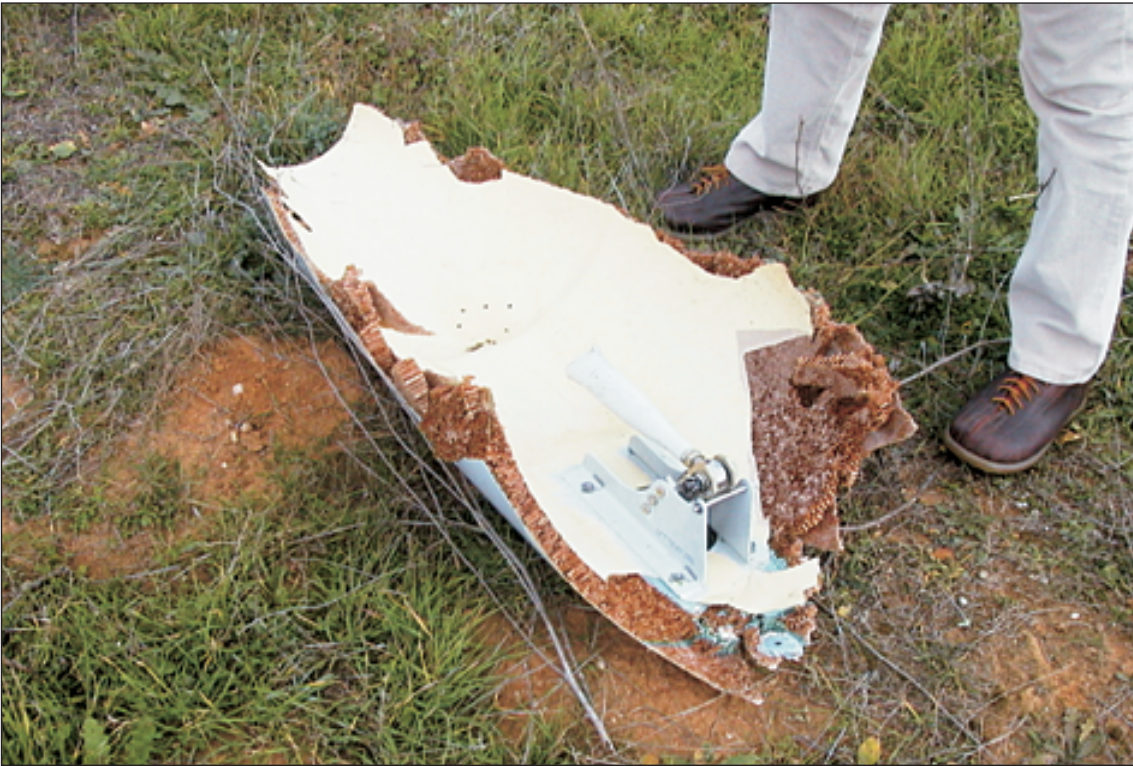
The impact was produced with the RH mobile flap pylon n.º 5. When it was inspected after the incident, the mobile support of de flap n.º 5 was broken, and several of its parts were missing. The guide bar of the mobile support of flap n.º 5 was also broken. A part of the trailing edge of the right outboard flap was also broken and missing. Two rivets of the right lower part of the flap bar n.º 5 were broken.

*Wreckage of the mobile support of the flap*

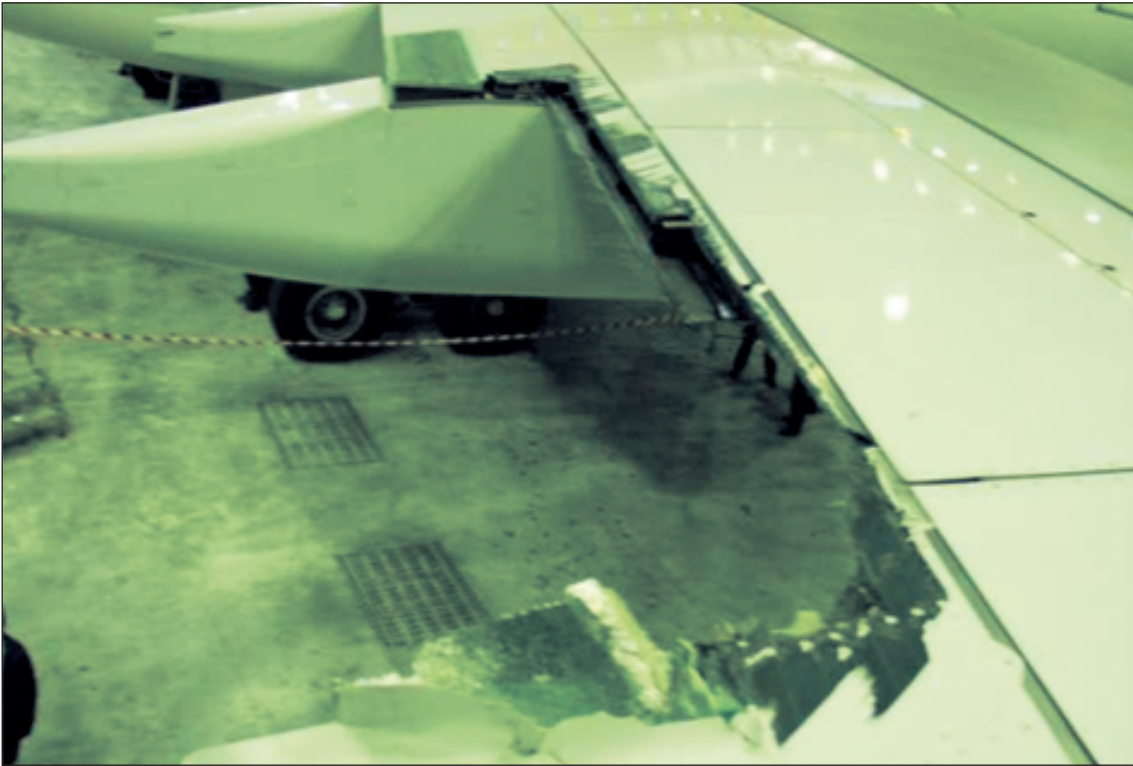
The aircraft suffered important damages to the area of the right outboard flap. The fittings of the flap bar nº 5 were found deformed. The mobile support of de flap nº 5 was broken, and several of its parts were missing. The guiding bar of the mobile support of flap nº 5 was also broken. A part of the trailing edge of the right outboard flap was also broken and missing. Two rivets of the right lower part of the flap bar nº 5 were broken.

*Flap exterior derecho. Vista superior*

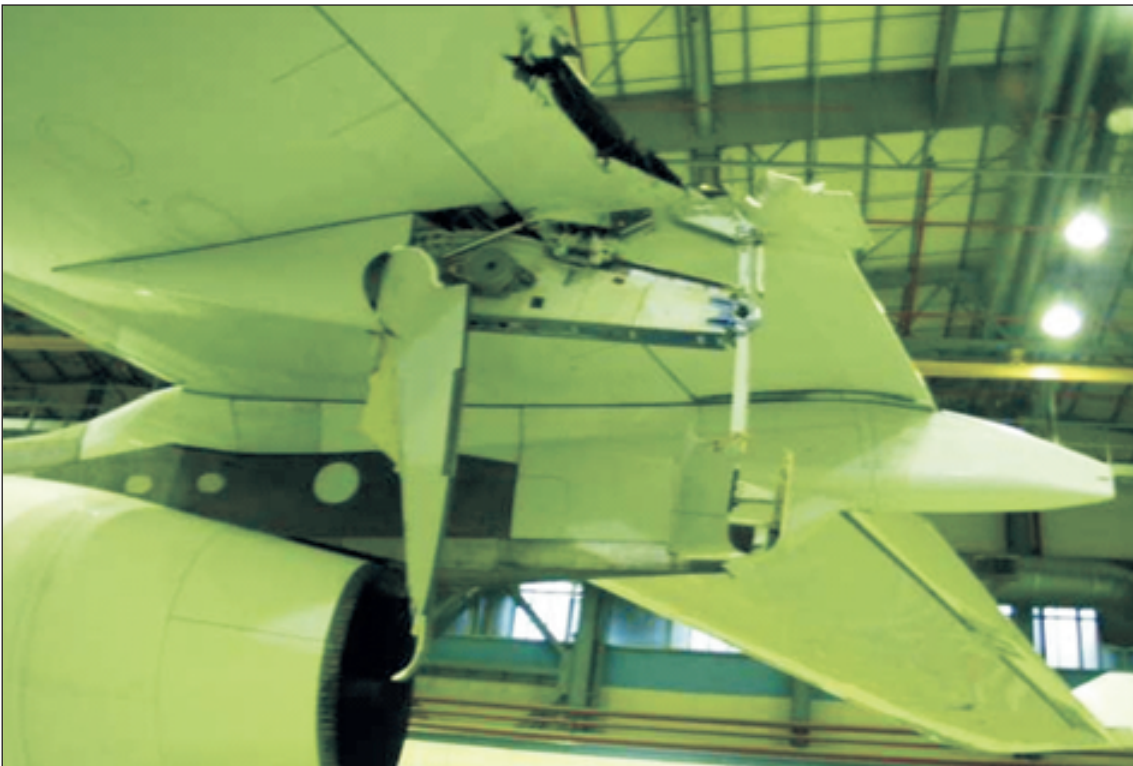
*Flap exterior derecho. Vista inferior*
