## **TECHNICAL REPORT**

**A-078/2002**

Accident occurred on 19  
December 2002 involving  
a PIPER PA-46-500TP  
aircraft (Malibu «Meridian»),  
N-53328, in Mount Mola  
of Son Montserrat, in the  
municipality of Bunyola  
(Balears)

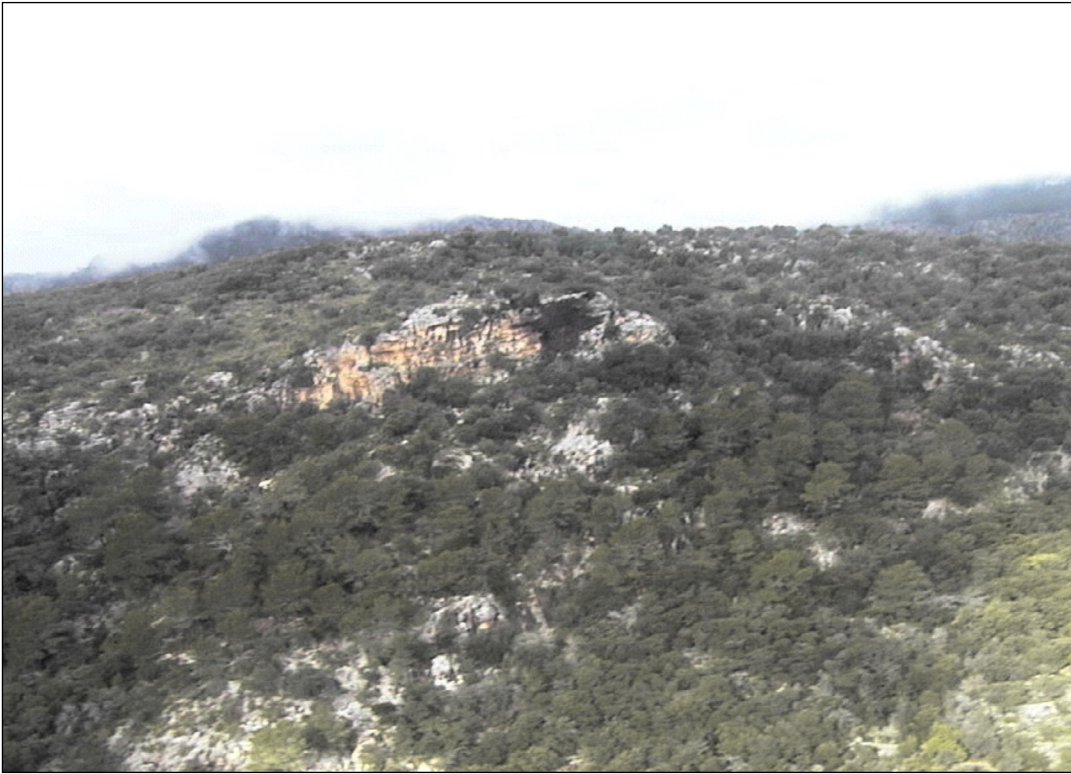
At the foot of the cliff, the side of the mountain descends with a 50% gradient and is covered with trees and shrubs. A shrub at the vertical of the point of impact was burned but without signs of possible direct impacts.

Figure A-1. *Panoramic view of the accident site*

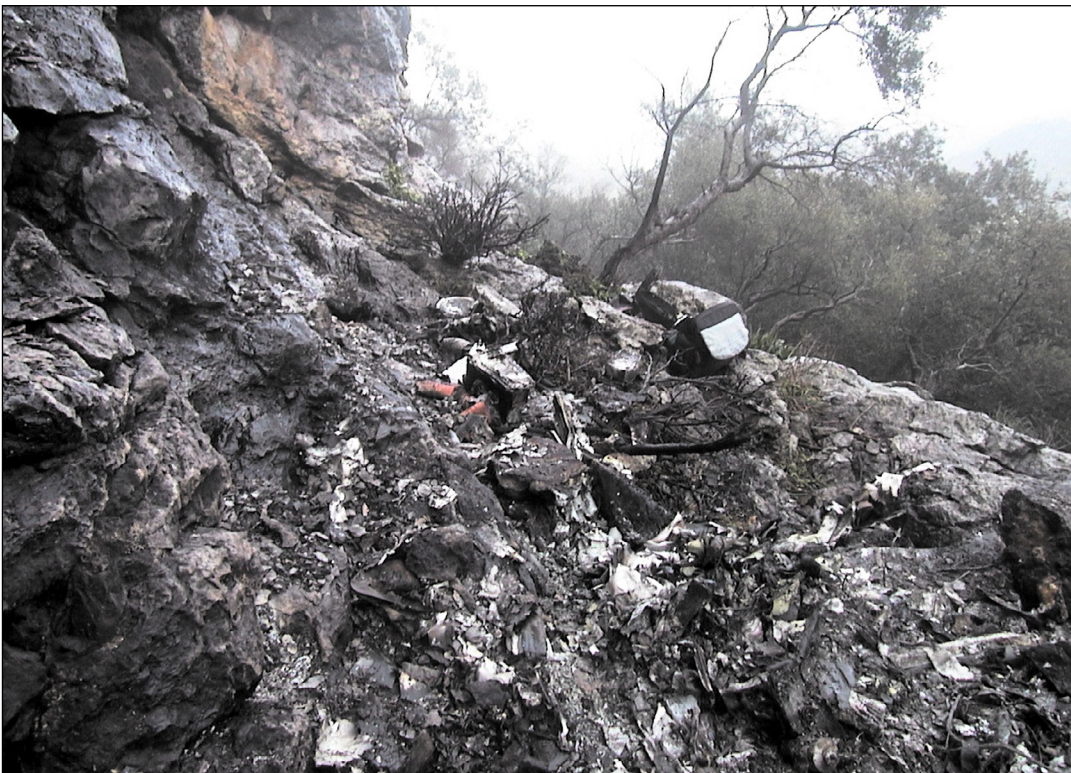
The main wreckage was found grouped together, very broken up and burned, on the slope, at the foot of the black mark left by the explosion on the cliff. The fire which started with the impact continued in the aircraft wreckage but without spreading to the surrounding vegetation.

Some fragments were found in holes in the cliff (see Figure A-2), including a propeller blade. Other smaller aircraft fragments were scattered over an area several meters in diameter on the mountain slope.

Figure A-2. *Wreckage on the mountain's vertical wall*

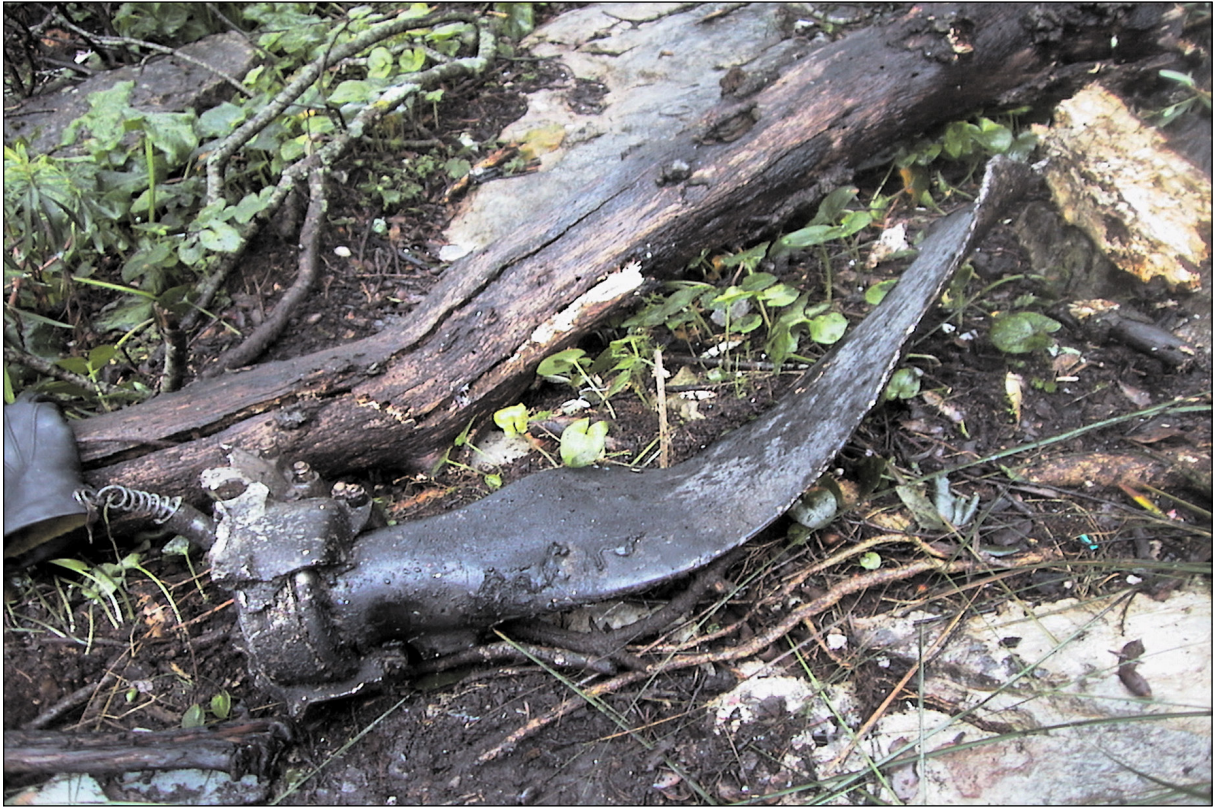
Figure A-3. *Wreckage of a propeller blade*

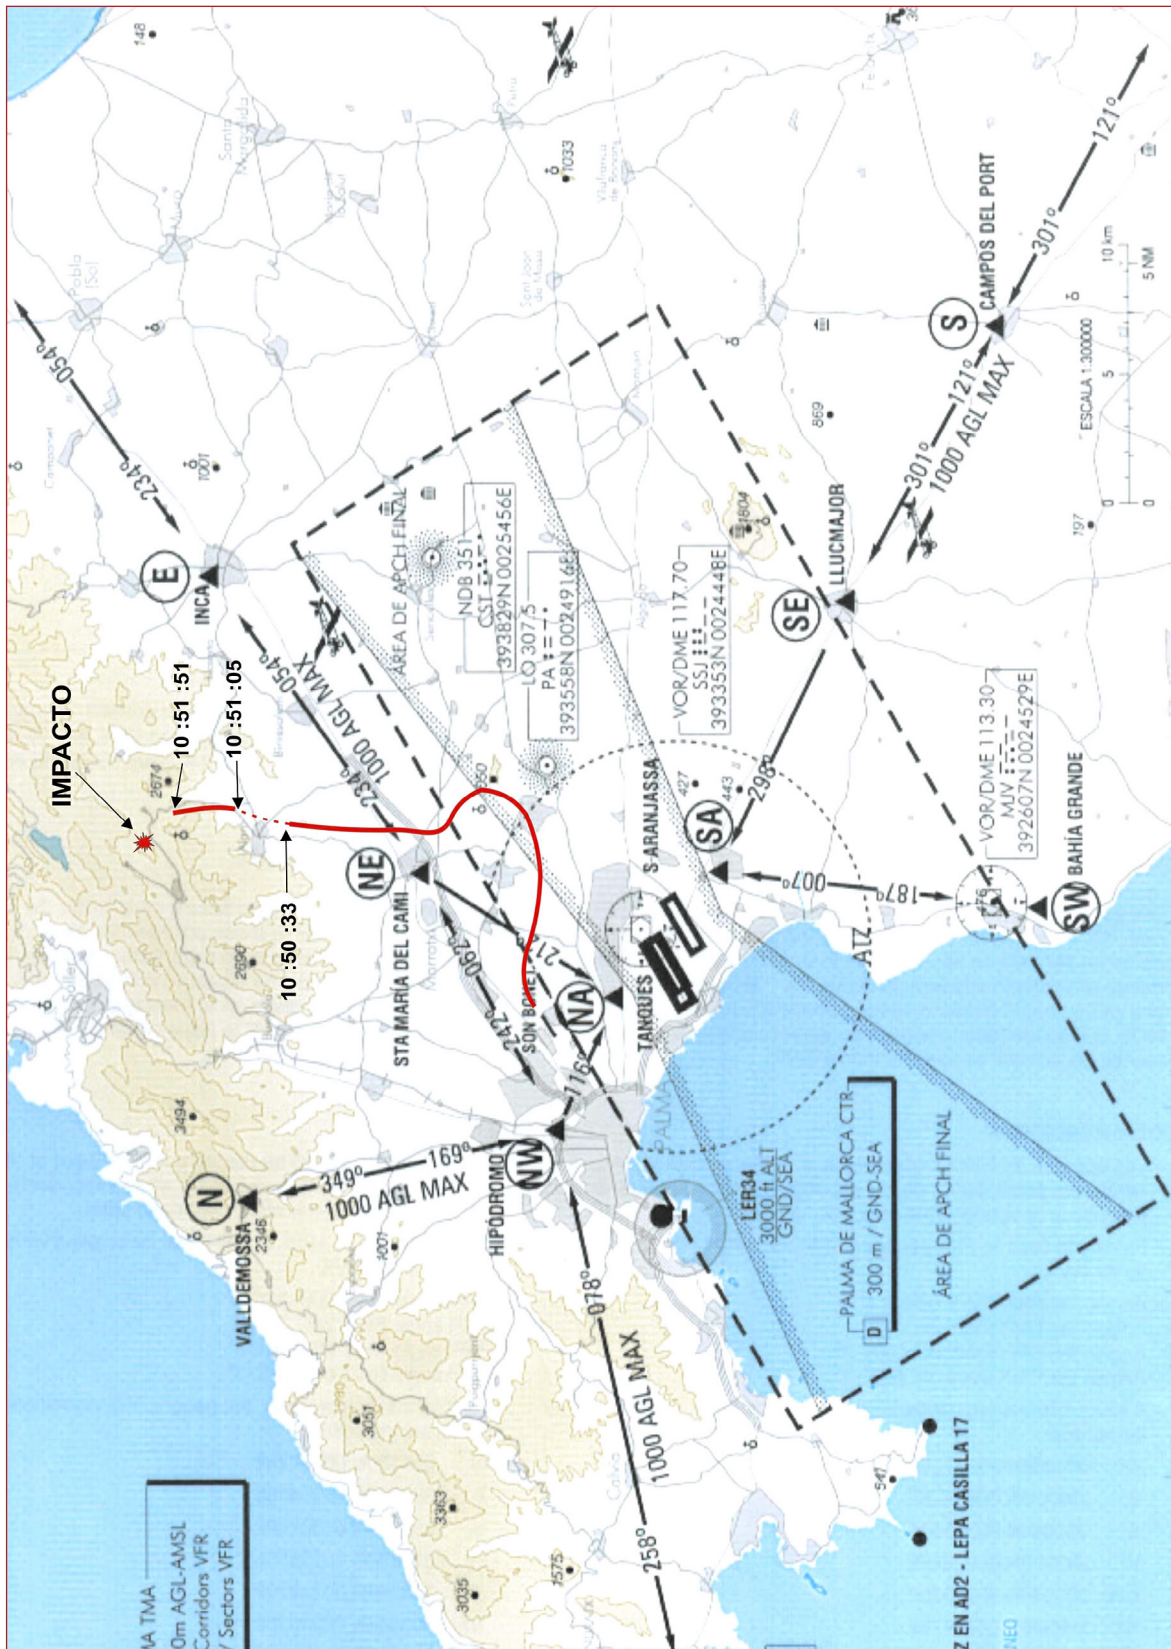
The ground path shown in Figure B-2 presents two discontinuous legs, showing that there was loss of radar signal coverage.

The first leg commenced with radar signal pickup at 11:46:35 h and continued until 11:50:33 h, the moment at which the radar signals were lost for the first time.

During this leg, the aircraft appeared on the control screens erroneously identified as flight AEA 8401 instead of GVN 051. At that moment the ATC-transponder's response code was 3260. The track confirms the aircraft's deviation to the right after takeoff, which penetrated 3 km inside the airport's control zone (CTR) and more than 1 km inside the final approach area. In the last part of this leg the aircraft adopted a northerly course.

The second leg of the path, now with reference GVN 051 and code 7071, started at 11:51:05 h and terminated at 11:51:51 h, when the radar signal was lost for the second time. At that moment, the indication in the control tower was a speed of 117 kt, flight level FL 20 and rising. As can be seen in Figure B-2, in this leg the aircraft, already in a mountainous area, flew following the valley through which the Alaro-Orient highway runs. In its run, the aircraft passed between Peñal d'es Coros, near the tip of which (822 m) are the ruins of Castillo de Alaro castle and the Soucadena (816 m) and Puig de San Miguel (663 m) mountains, finding itself at the end of the leg opposite the south-east face of mount Mola de Son Montserrat (628 m). The radar track ends one mile before the point of impact.

Figure B-2. Radar track of the accident flight

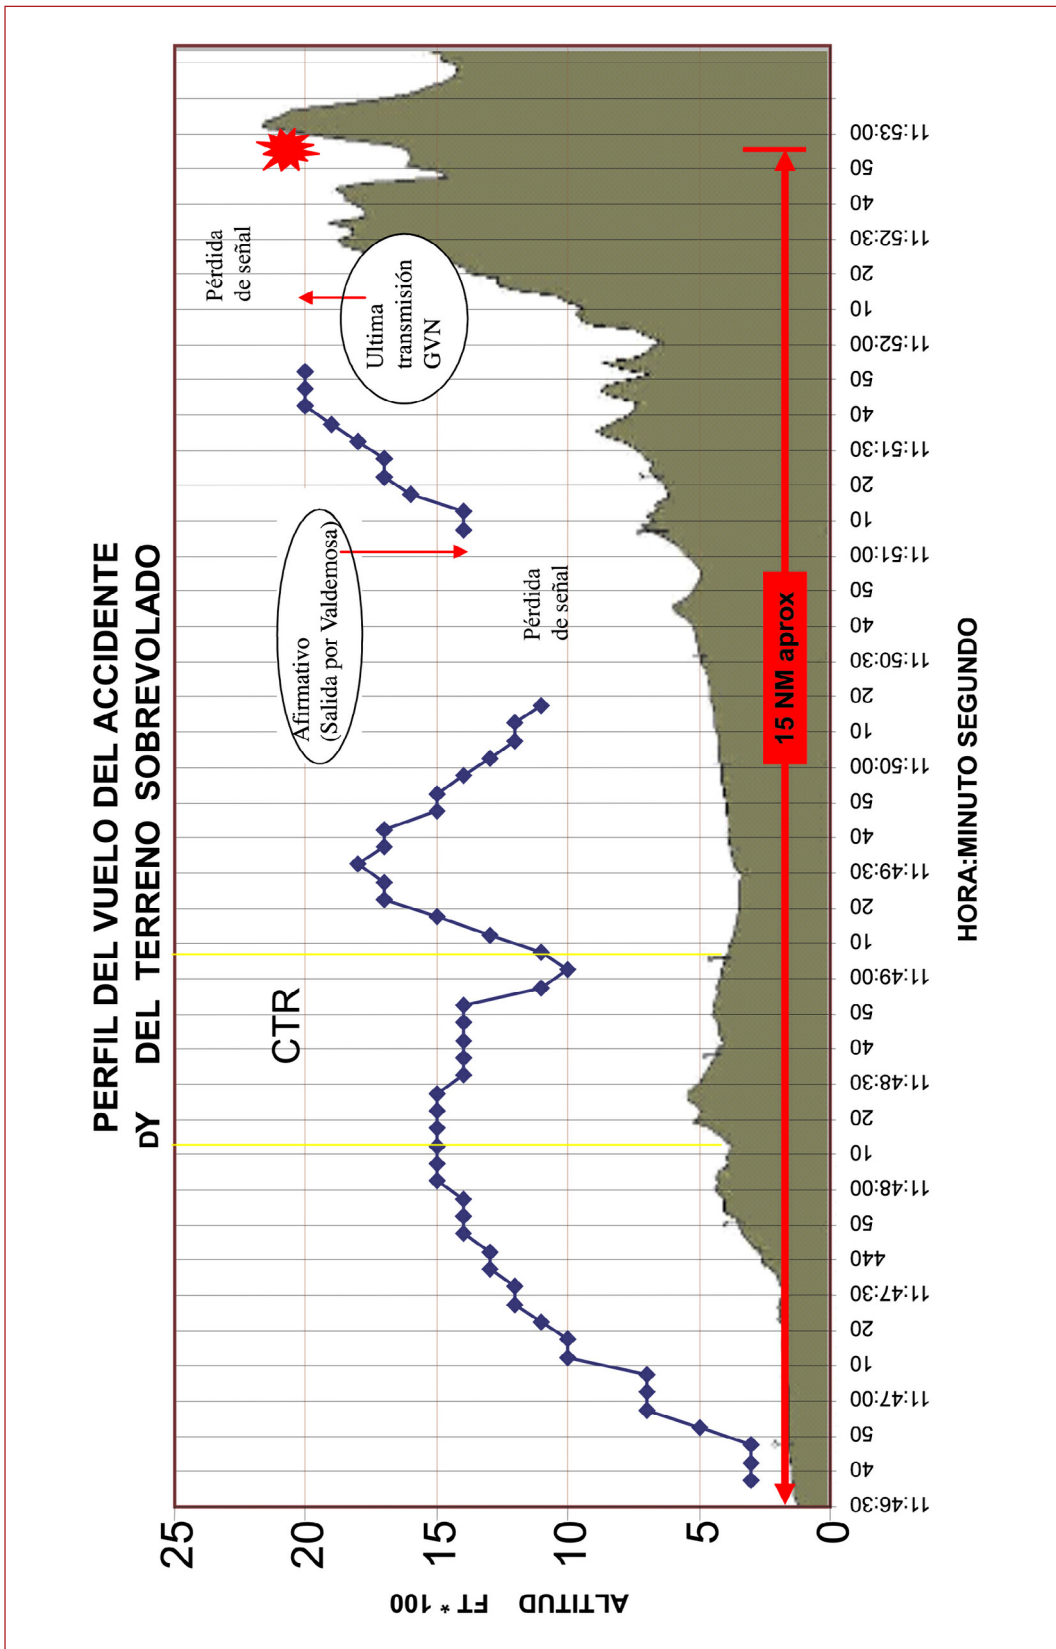
The flight profile is represented in Figure B-3 and shows the variation in altitude relayed by the aircraft via the ATC-transponder in the two legs defined above.

After takeoff, the aircraft climbed to an altitude of 1,500 ft at a rate of some 950 ft/min. At that moment the aircraft was entering CTR Palma and the takeoff area of runway 06L. Then, whilst turning to the north, the aircraft descended to an altitude of 1,000 ft and then climbed to 1,800 ft (some 1,200 ft above ground level at that moment).

Figure B-3. Profile of the accident flight
