## **TECHNICAL REPORT**

**A-002/2003**

Accident of aircraft  
FOKKER 50,  
registration PH-FZE,  
at Melilla Airport  
(Spain), on 17  
January 2003

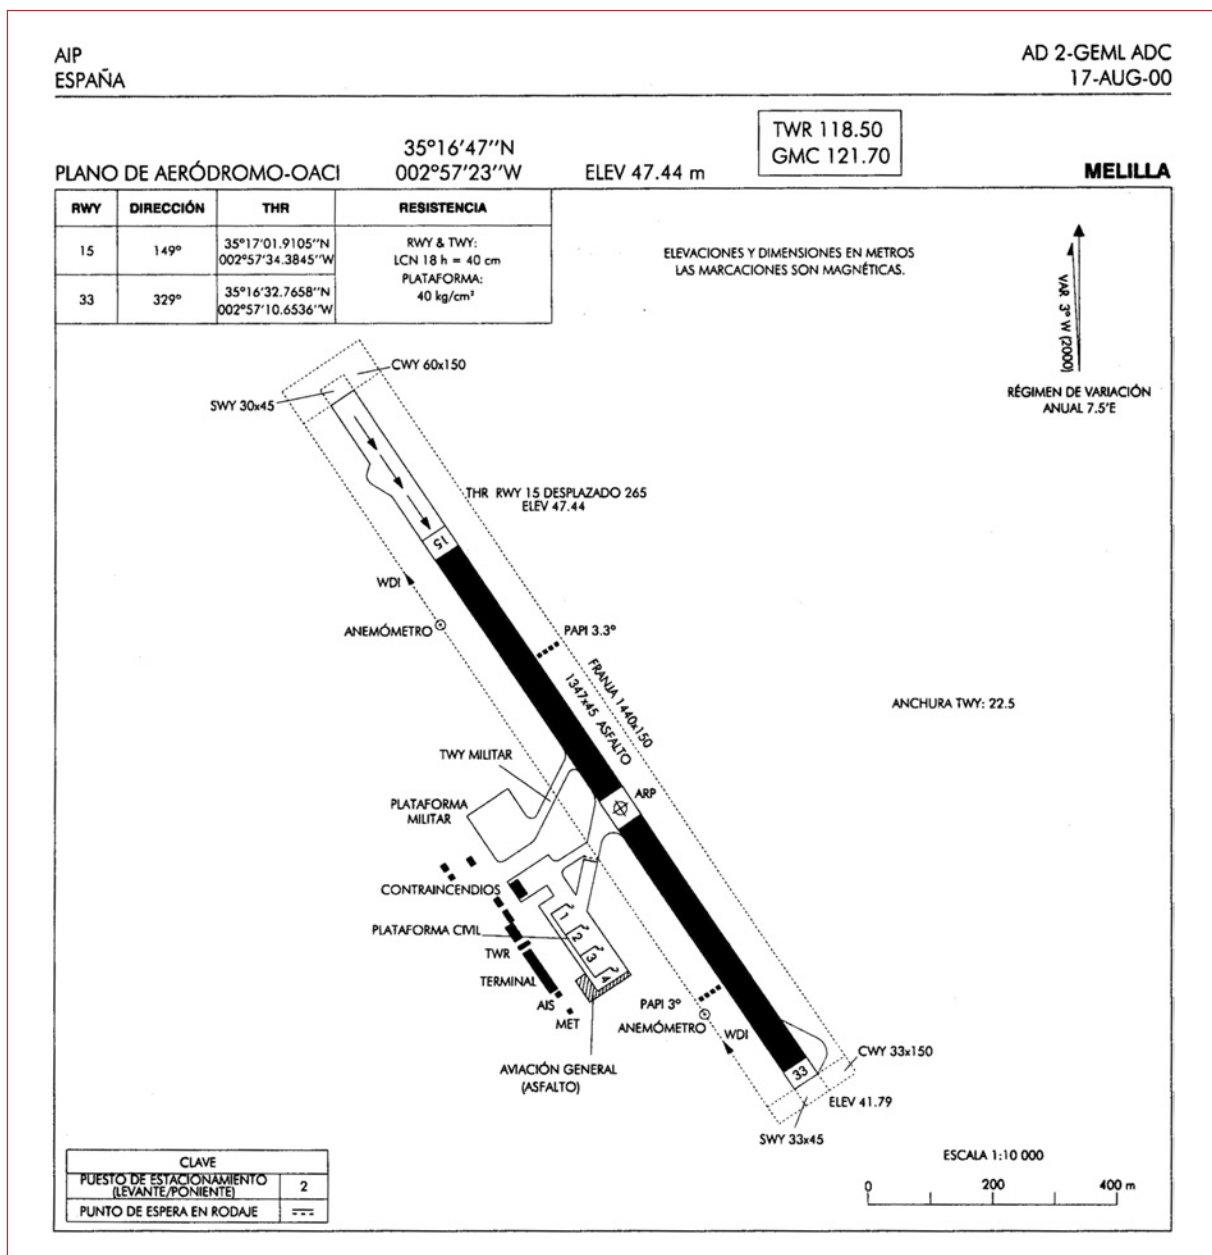
According to the AIP dated 17-8-00 (see Figure 1.10.1), since this runway had a stopway, it would mean that there was no strip available at the end of runway 15.

Figure 1.10.1. AIP revised in year 2000. At the end of Runway 15 there is a stopway of 33 m × 45 m

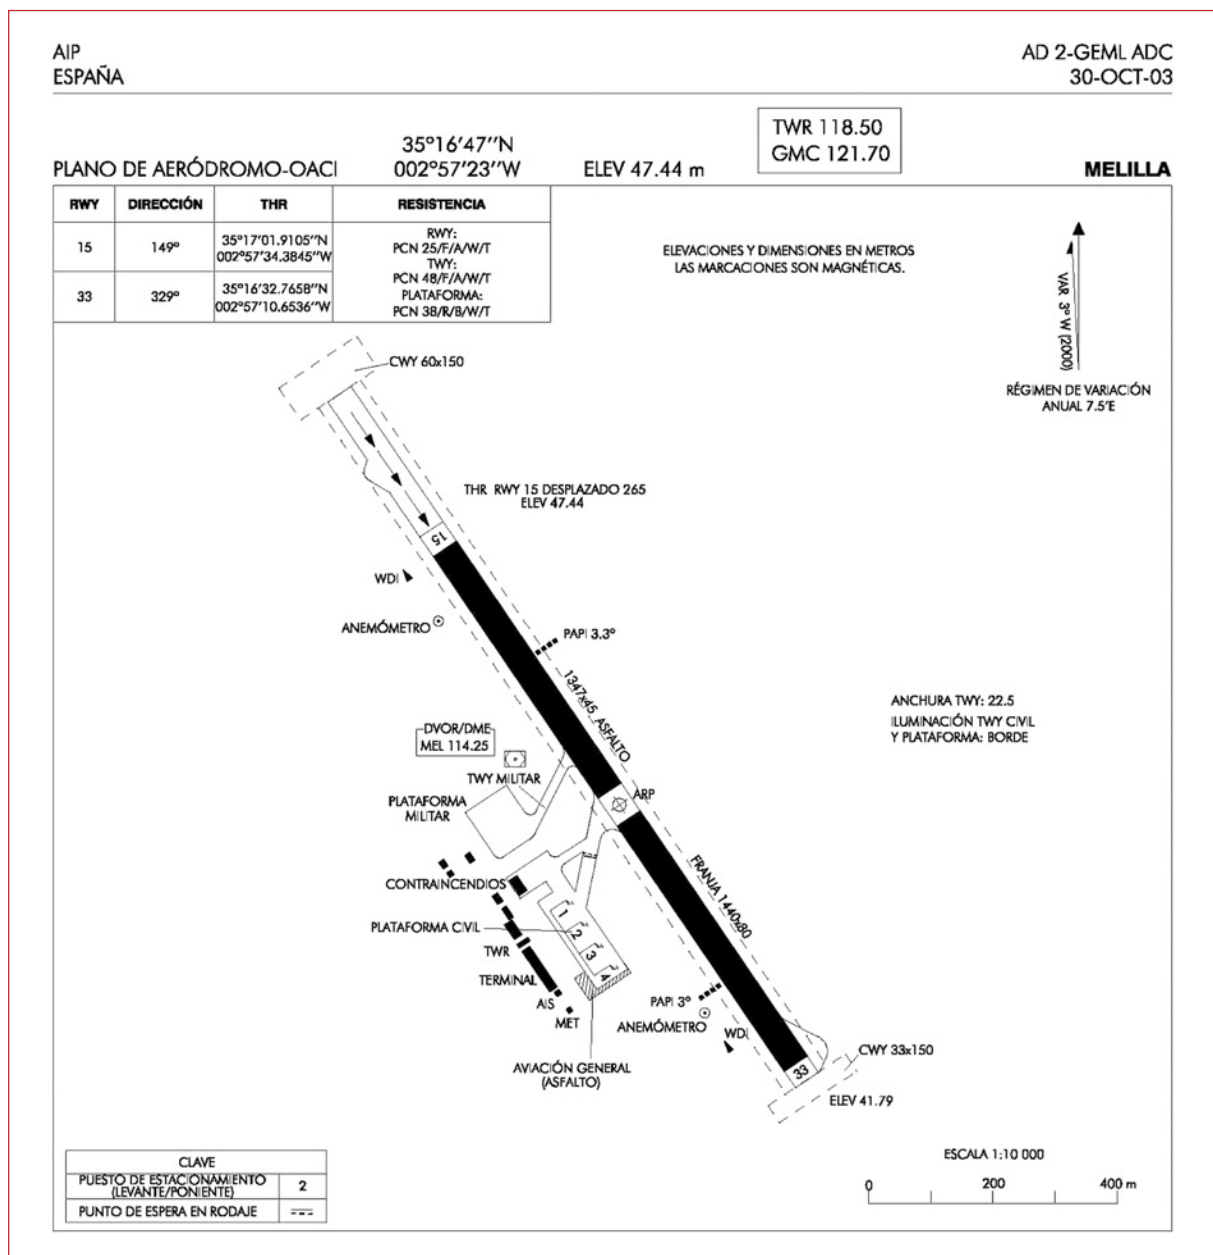
Some inquiries were made regarding the suitability of the strip at Melilla Airport and in October 2003, the AIP was amended and any reference to a stopway in runway 15 was deleted. It was stated that the runway strip extended 33 m × 80 m beyond the end of runway 15. However, this strip did not yet comply with the recommendations of Annex 14 of ICAO, which required a strip of 60 m of length and recommended 150 m of minimum width for such a strip (see attached Figure 1.10.2).

Figure 1.10.2. AIP revised in October 2003. At the end of Runway 15 there is no stopway

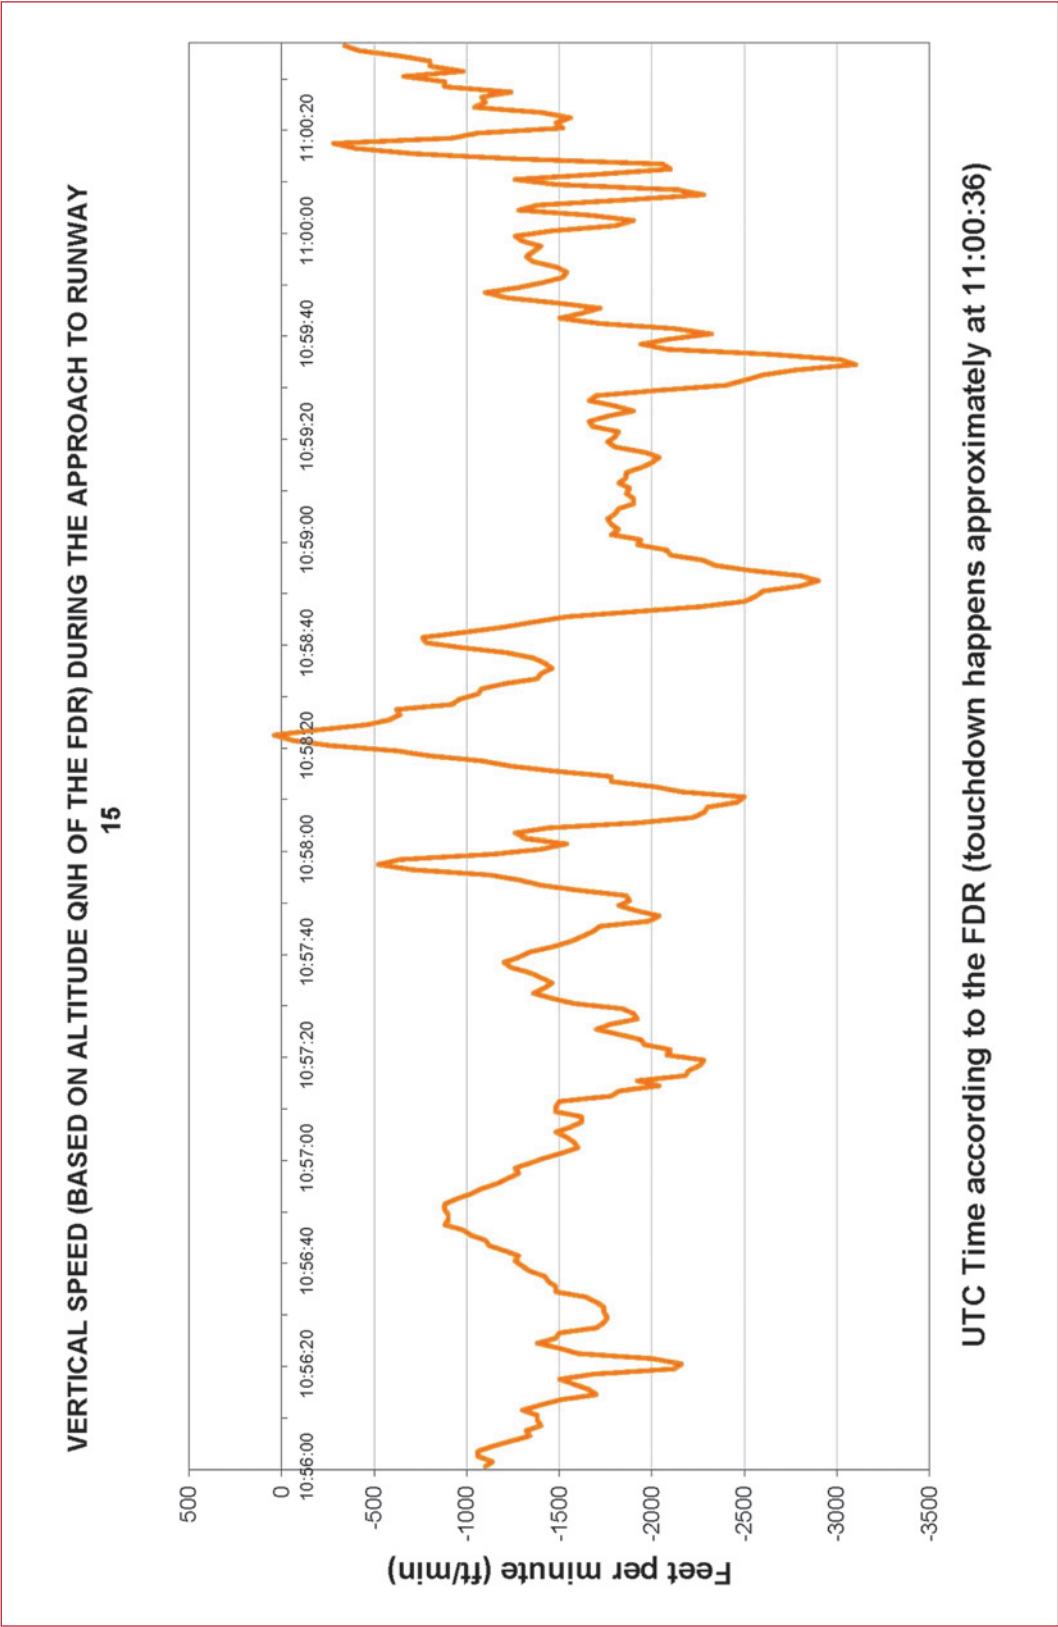
Figure 1.11.2.2.1. Vertical speed. Around 15 seconds before touchdown the vertical speed was between 1,500 and 1,000 fpm

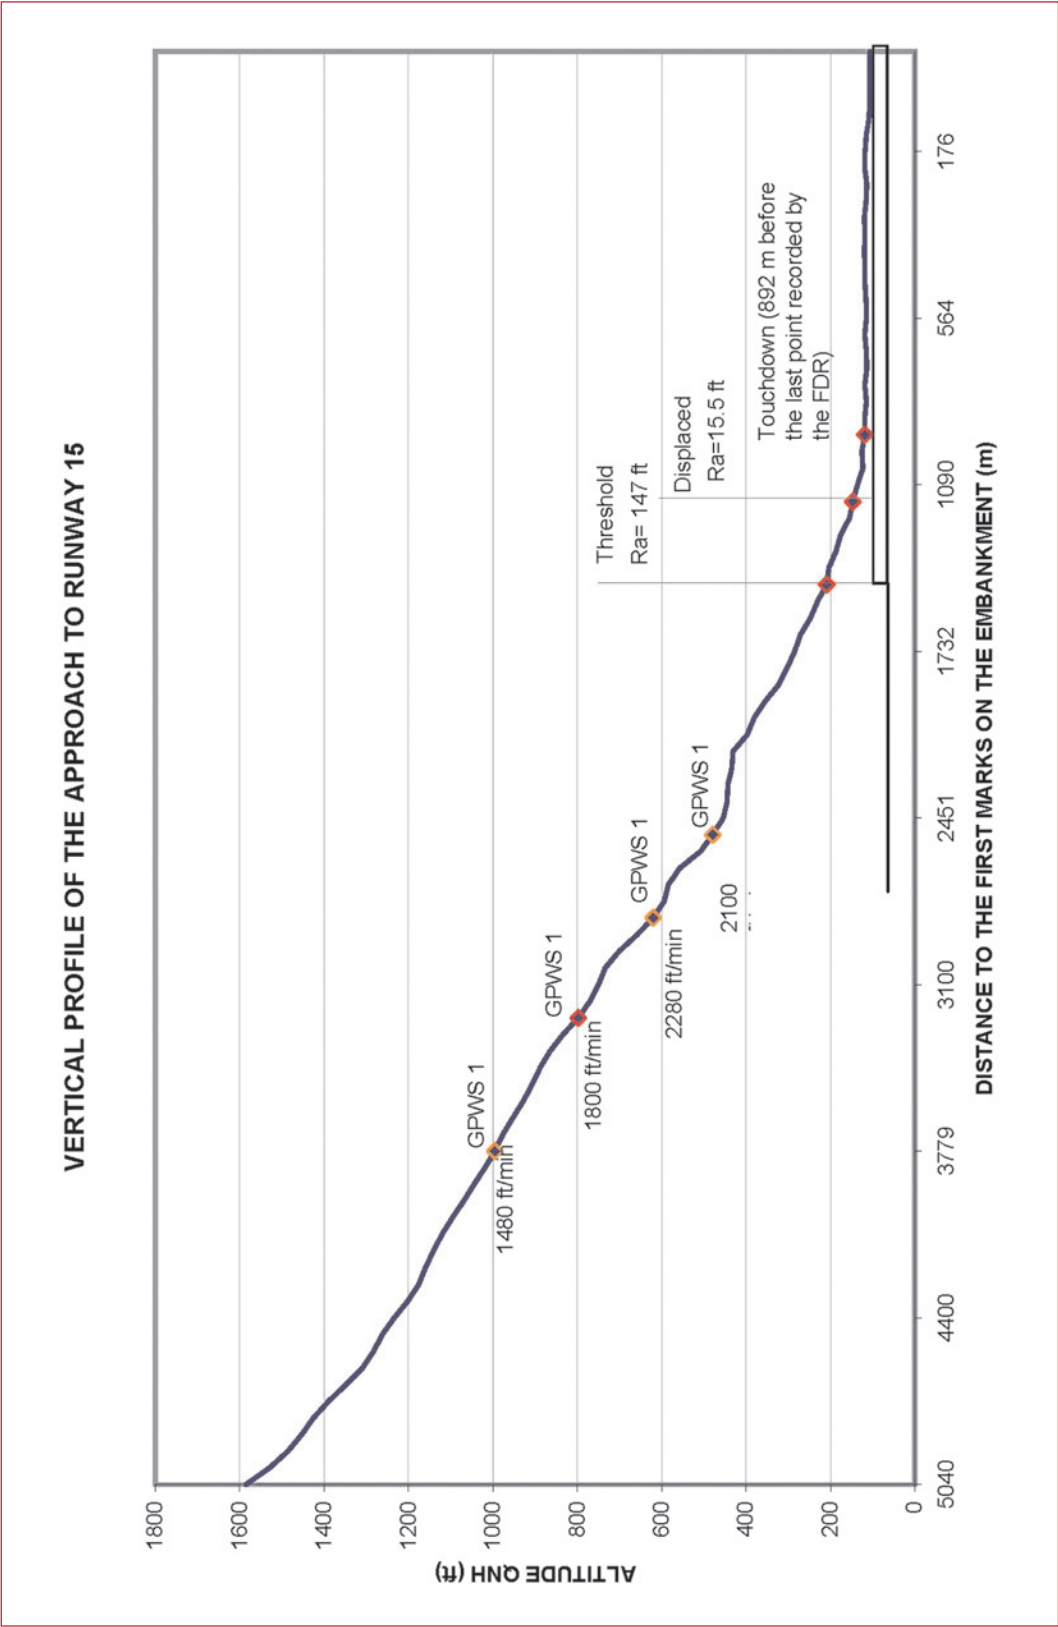
Figure 1.11.2.3.1. Vertical profile and landing rollout. The aircraft ran around 892 m from touchdown up to the end of the recording (impact with the terrain of the embankment)

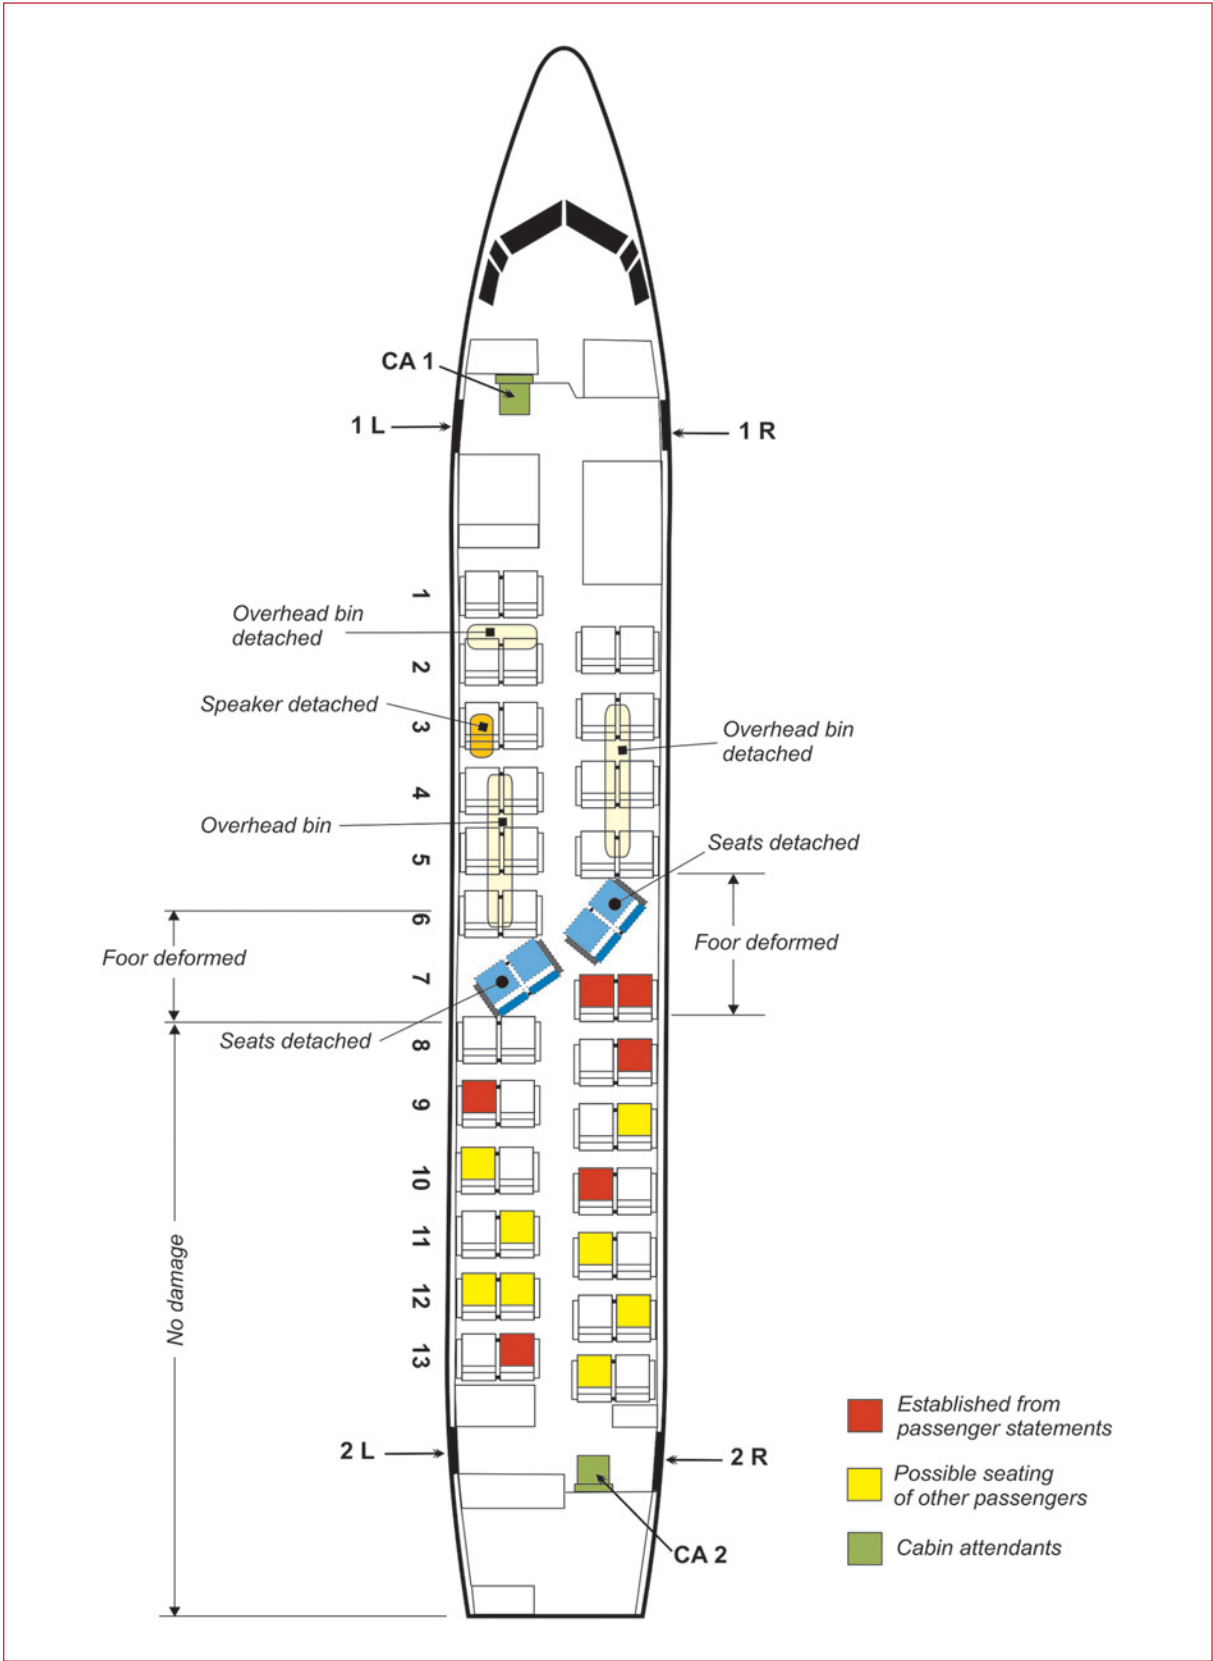
As a result of the impacts when the aircraft jumped through the slope (the highest and latest recorded value of vertical acceleration was 5 g), the passenger cabin suffered important damage in its central part, where the wing was detached from the fuselage. The four seats of row 7 were detached and 2 overhead bins detached and fell towards the seats (see Figure 1.15.1). However, there was no noticeable damage to the seats, overhead bins or floor from row 8 towards the tail of the aircraft.

Figure 1.15.1. Drawing of the passenger cabin damage

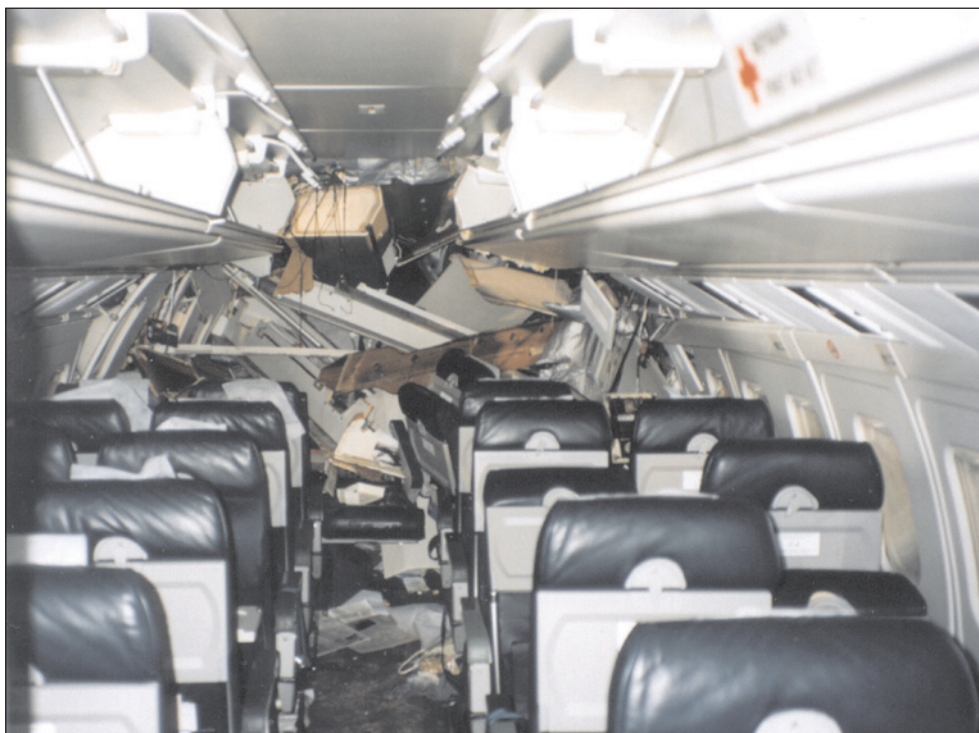
Figure 1.15.2. View of the damage from the rear part of the cabin

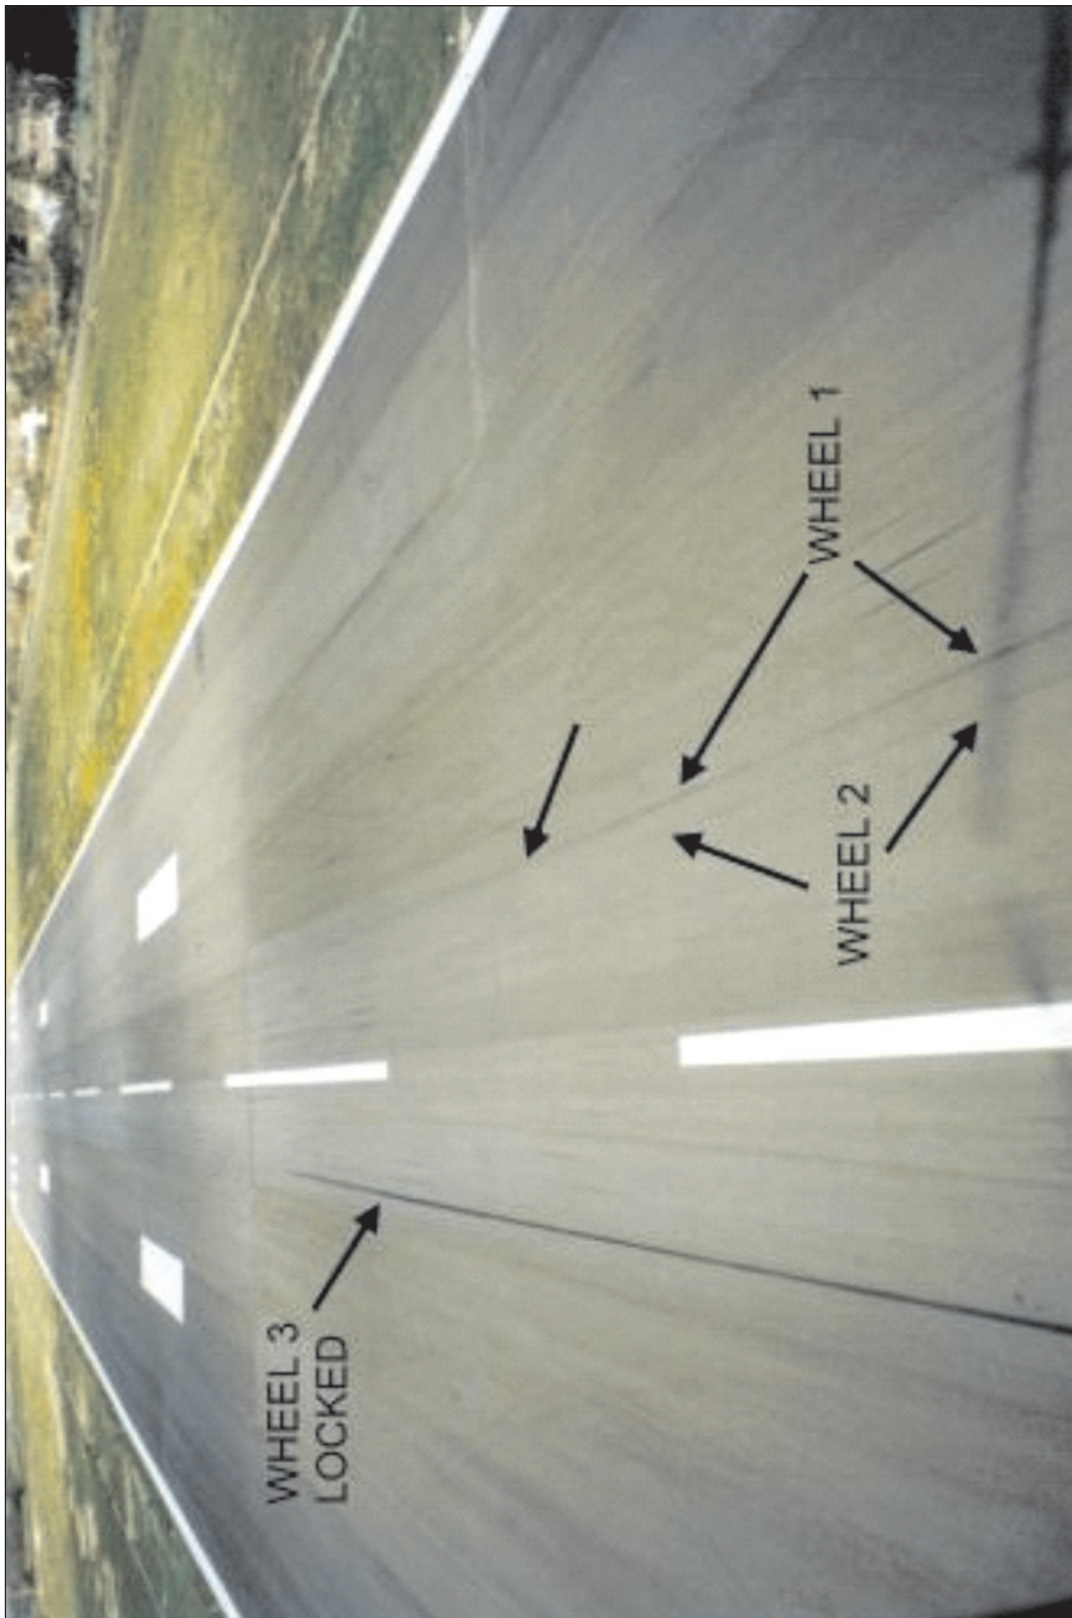
Photo 1. View towards runway 15 threshold (i.e., in the sense contrary to the landing roll). Track of wheel 3 clearly marked and showing signs of tire lock

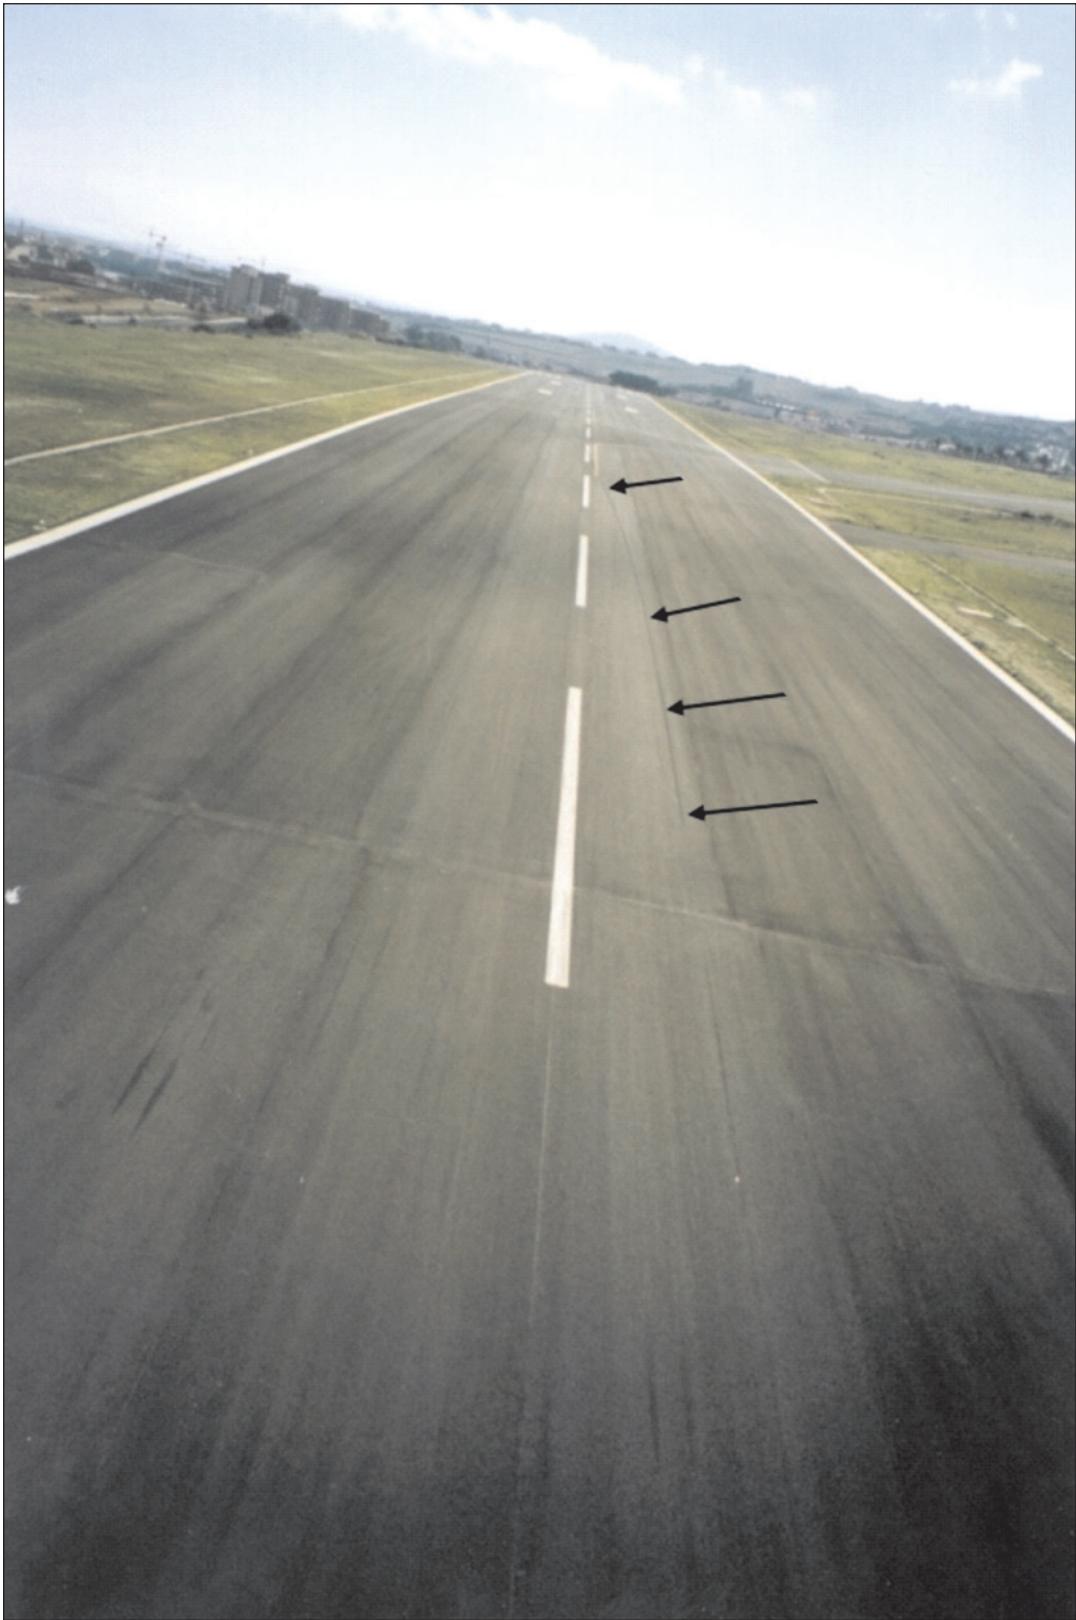
Photo 2. *View in the sense of the landing roll. Track of wheel 3 crosses the runway axis*

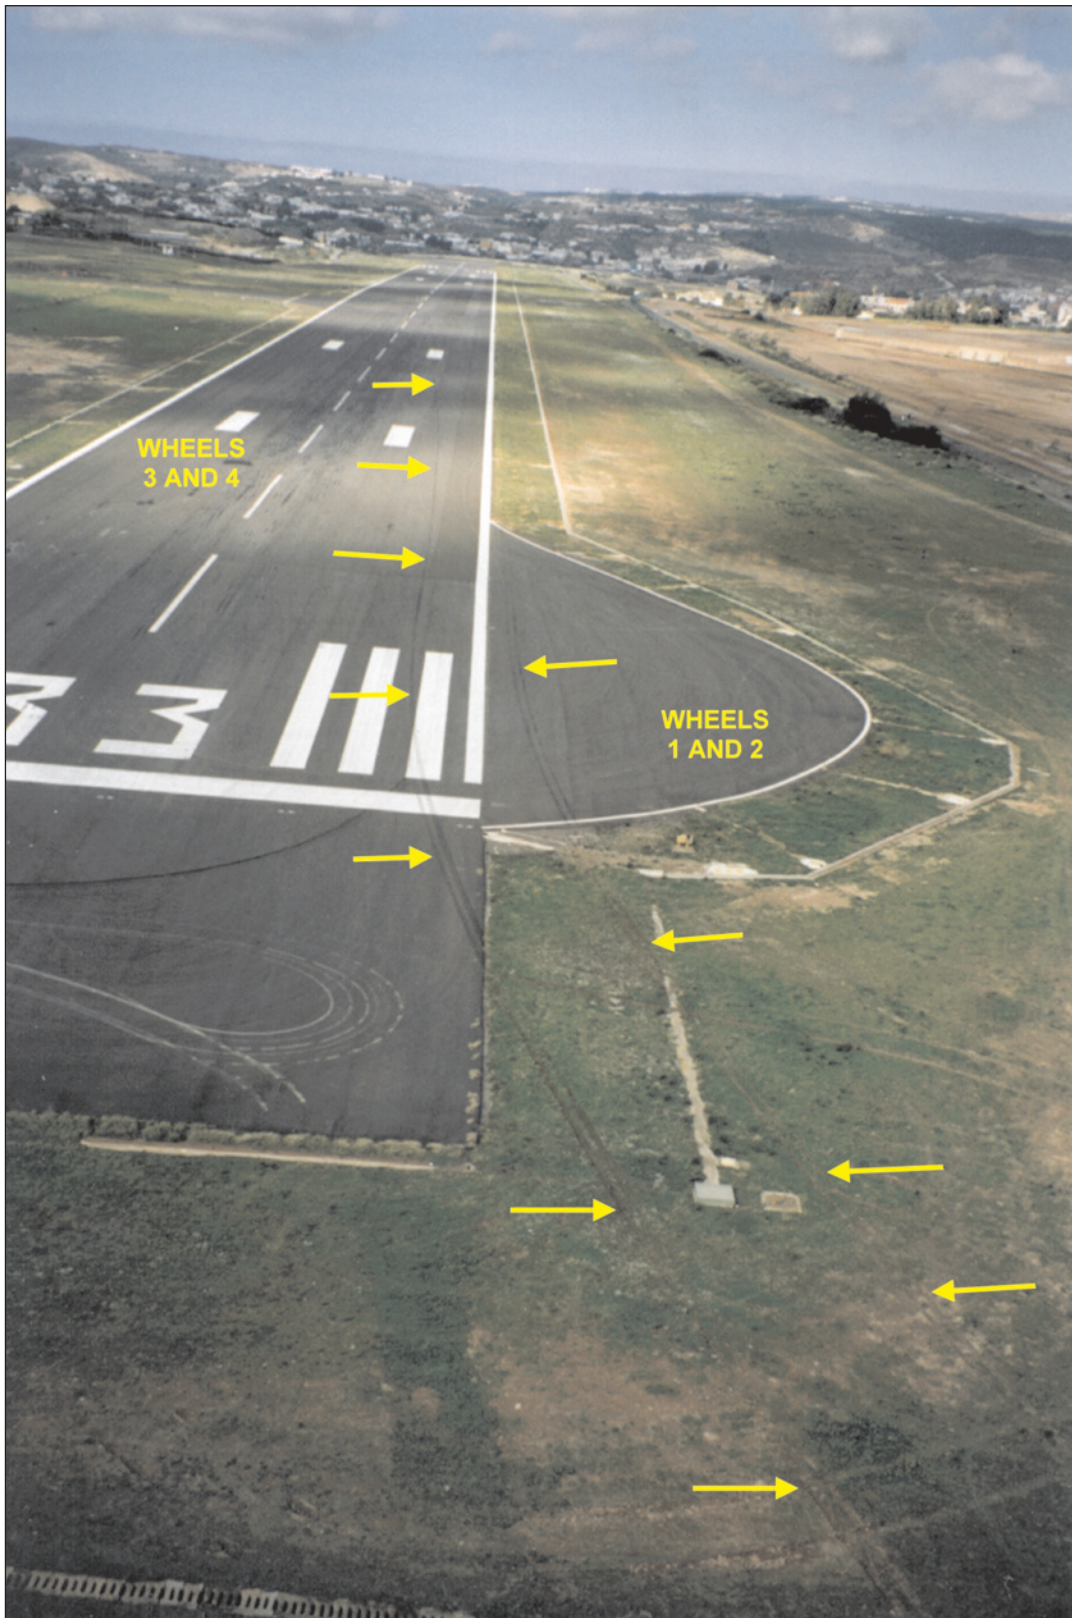
Photo 3. View in the sense contrary to the landing roll. Tracks of wheels 1 and 2 outside the runway

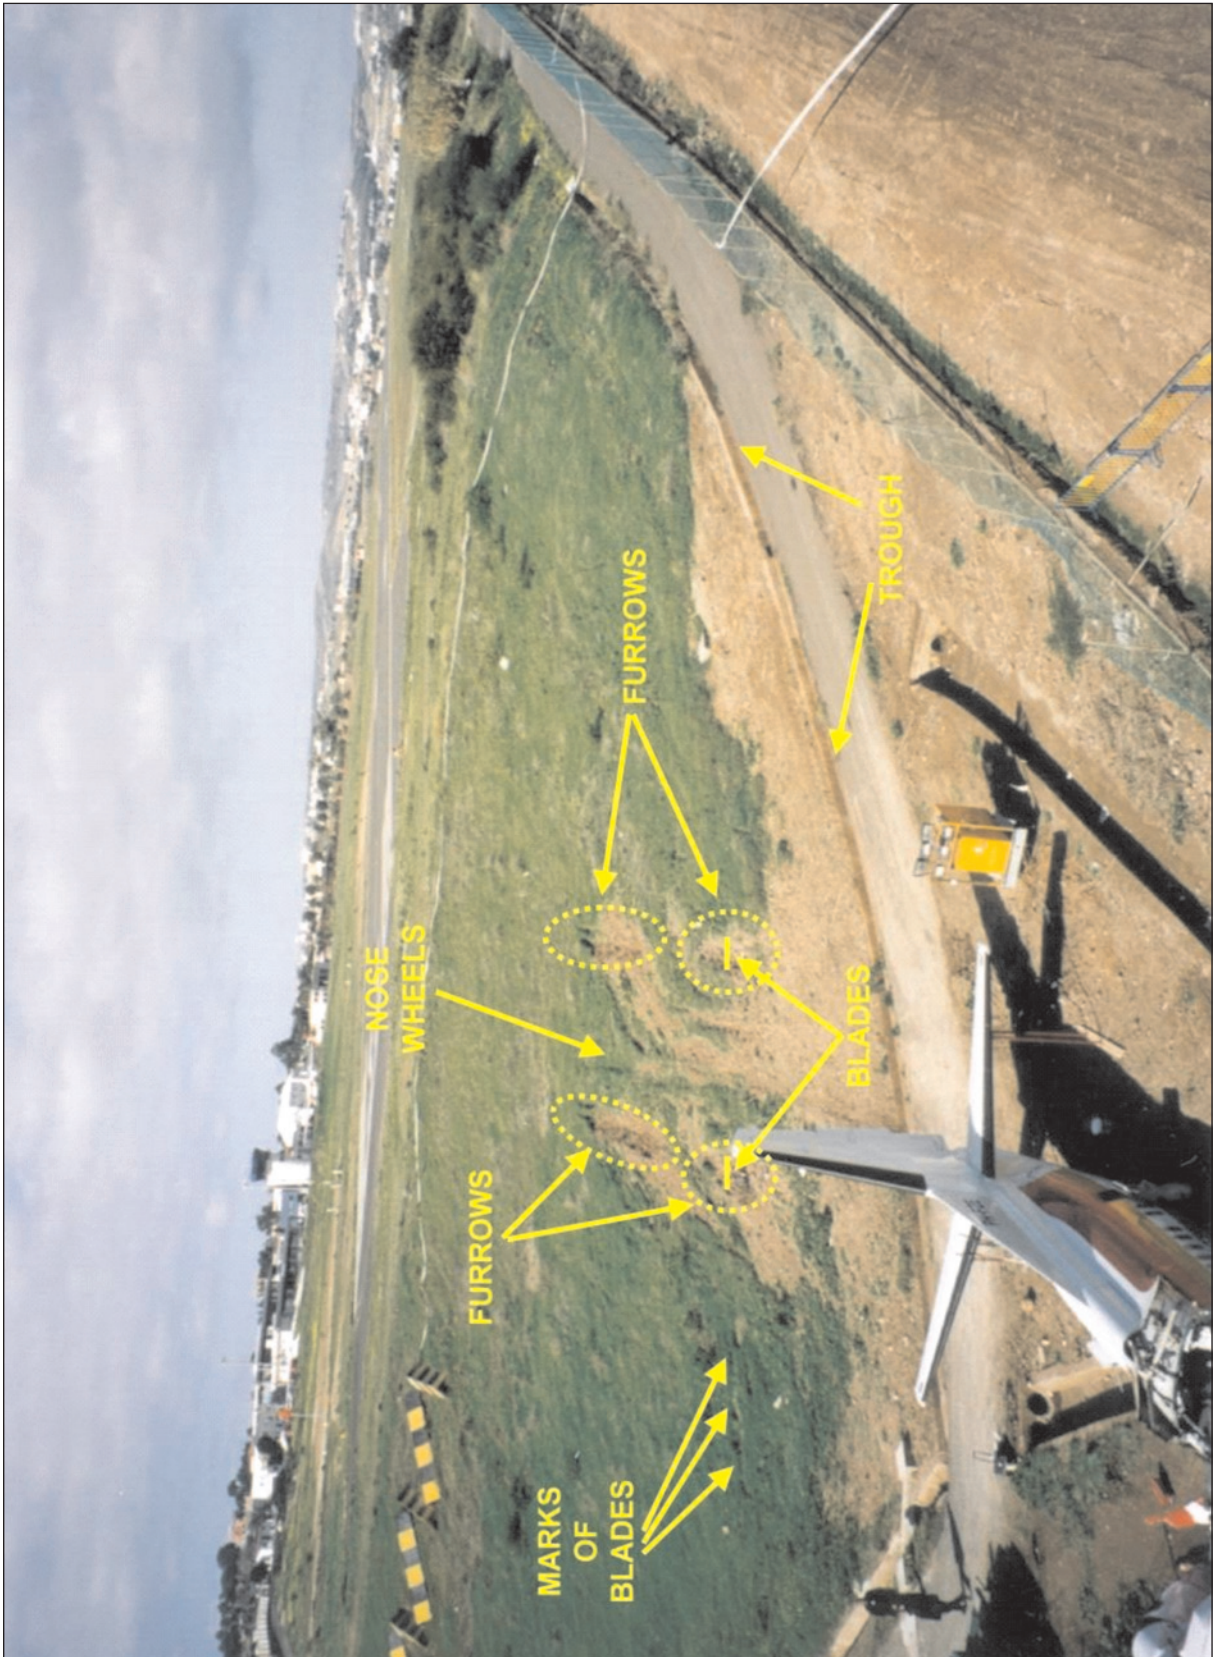
Photo 4. Final position of the aircraft and marks on the terrain of the embankment
