DATA SUMMARY
LOCATION

| Registration | EC-ICX |
| Type and model | BOMBARDIER DHC-8-315 |
| Operator | Air Nostrum |

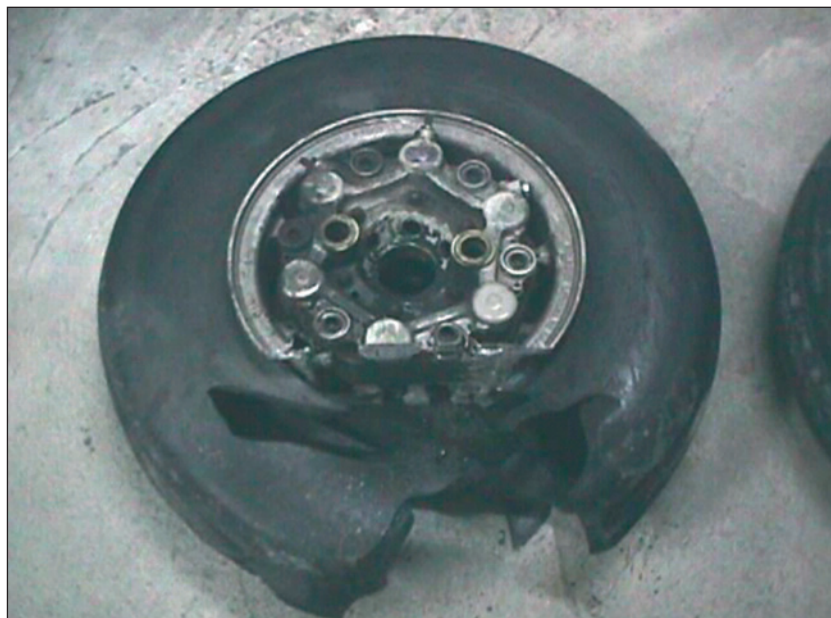
Inspection of the main landing gear after the incident showed that the four tires were blown out. Friction of the wheel rims with the ground abraded the aluminium and the steel in the brake assys to the piston housing.

It was disclosed that hydraulic fluid from No 2 HS was leaking.

When at last the airplane stopped, the friction of the wheel rims with the asphalt had abraded the piston housing of the brake assys and the hydraulic fluid leaked out. The low quantity of fluid made the pressure drop to less than 2,000 psi and the respective warning lights illuminated.

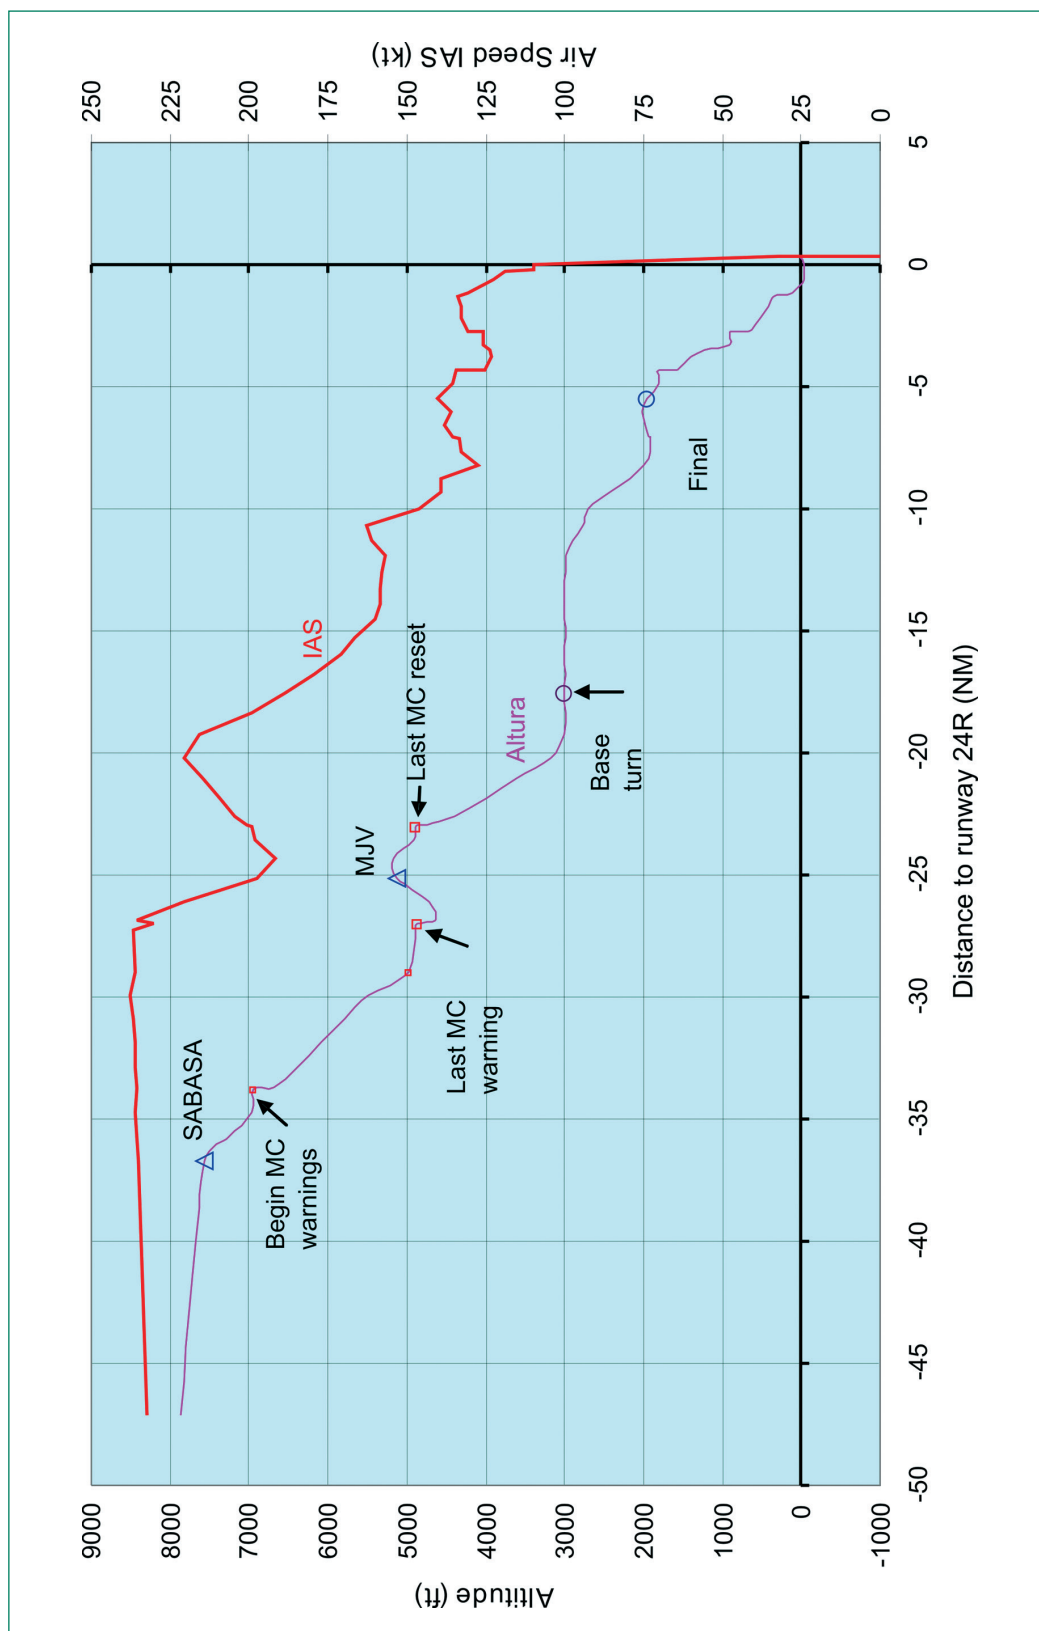
Figure B-1. DFDR events in relation to distance to touch down point estimated by speed integration

Graph B-1 shows MC warnings together with altitude and IAS speed evolution. From instant 0 onwards, when airplane touches down in Palma, it is observed on DFDR recordings a significant longitudinal acceleration increase taking values up to -0.391 g's , equivalent to 3.83 m/s^2 .
