DATA SUMMARY
LOCATION

| Registration | EC-DRS |
| Type and model | SOCATA RALLYE 235-C |

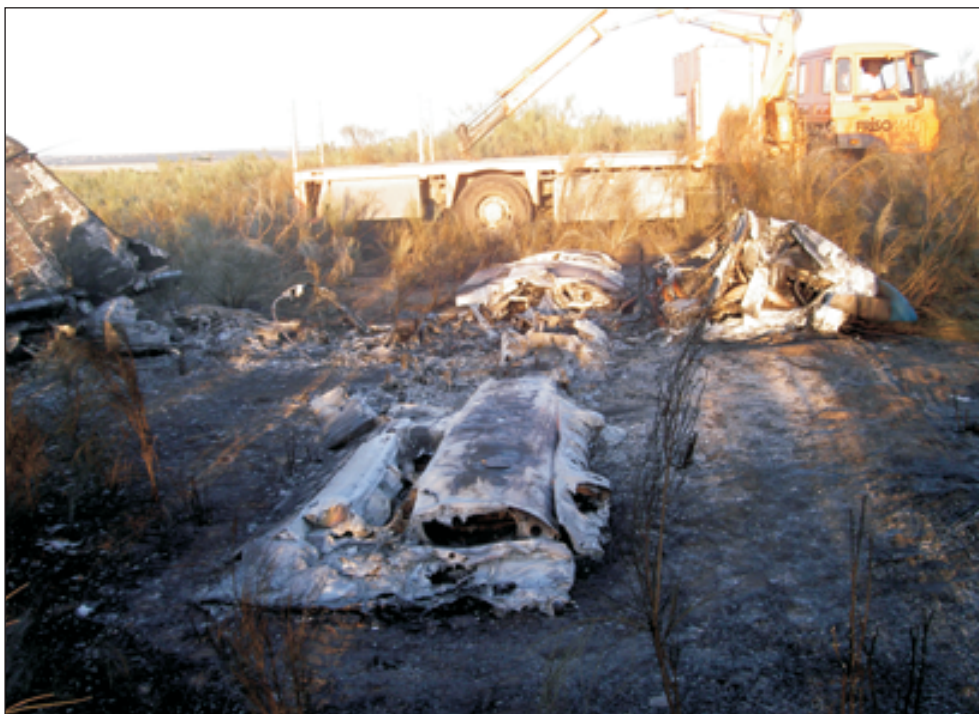
Photo 1. Aircraft damage

Meanwhile, the grass covering the ground where they landed, which was dry, had caught fire and quickly extended to the aircraft, resulting in it being almost completely destroyed.

The fire had burnt both wings and the whole fuselage, with the exception of the tail part.

The rest of the aircraft was completely destroyed.

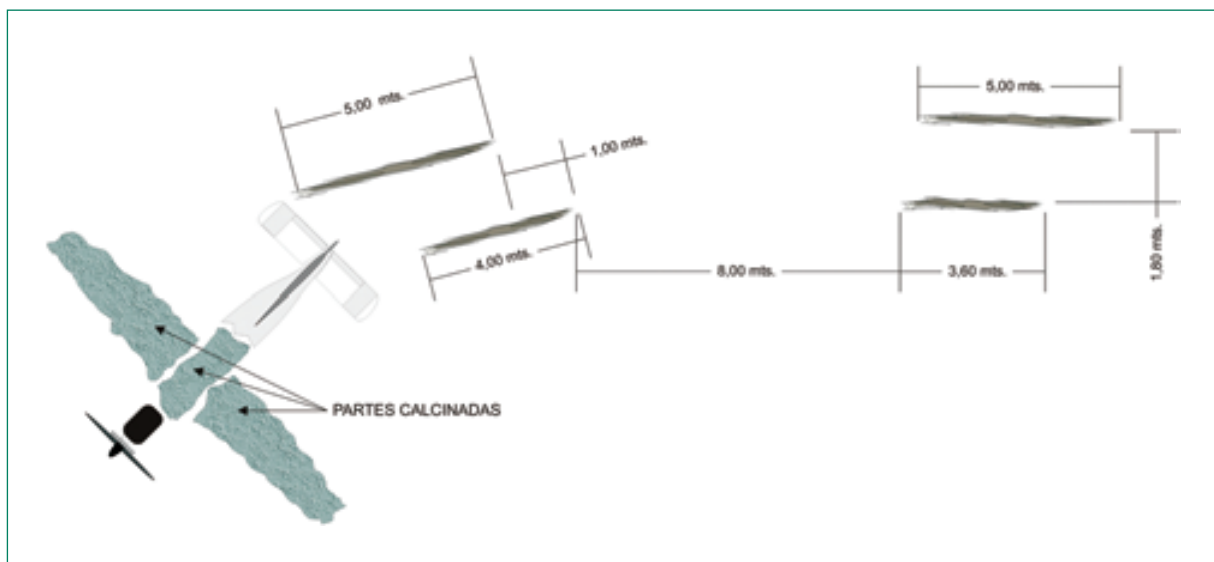
Figure 1. Diagram of ground marks and wreckage layout

The first mark found on the ground, some 5 metres long, was probably made by the right leg of the main landing gear.

Another mark, 3.60 metres long, was found parallel to the first one, starting some 1.80 metres after the first. There was a separation between both marks of 1.80 metres, which is the approximate width of the aircraft's main undercarriage.

Then there was a section of some 8 metres with no marks at all, and then two more marks, similar to those described above, but at an angle of 15° with respect to the first marks.

The aircraft was found at the end of these marks, turned at an angle of 45° with respect to the first marks.

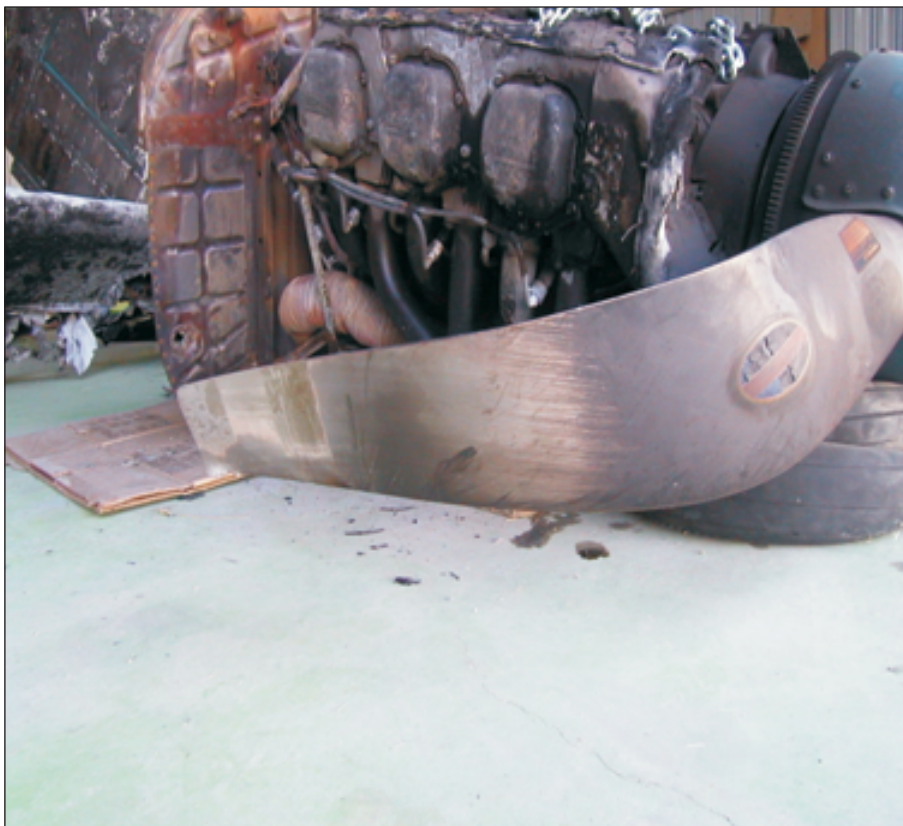
Both propeller blades were bent backwards, although this was more serious in one than the other. Neither of them showed signs of impacts on their leading and trailing edges,

Photo 2. Marks in one of the blades

only showing longitudinal marks, which must have occurred during their contact with the ground, indicating that, when this occurred, the propeller was not rotating.

The marks and bending on the propeller blades indicate that when they made contact with the ground the engine was hardly rotating.

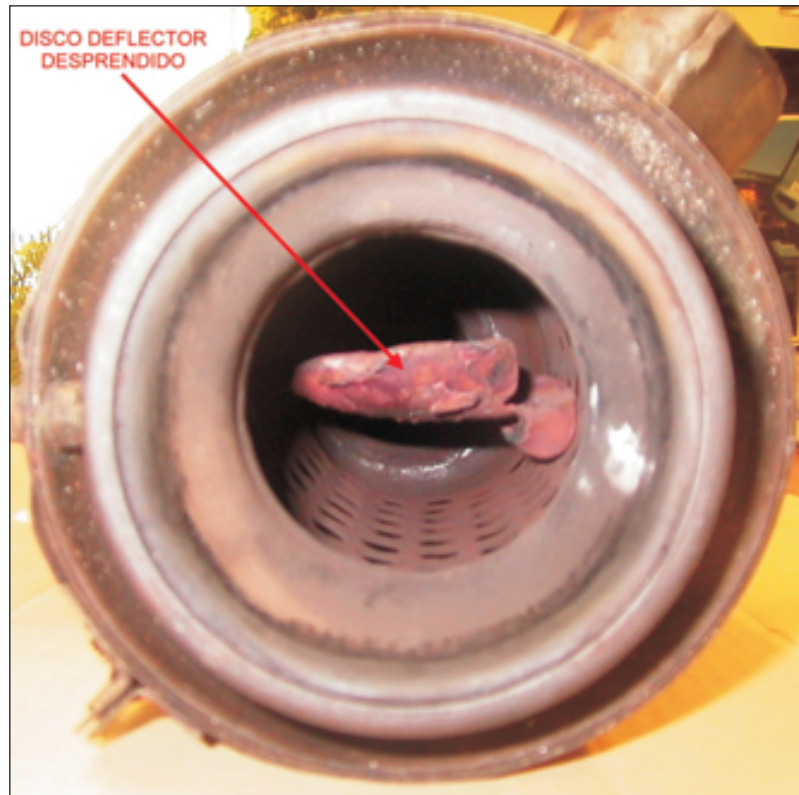
Photo 3. Loose baffler inside the muffler

The next step was to strip the two exhaust pipes mounted on this type of aircraft, which had previously been released from the engine. Both manifolds and exhausts were in good condition and without obstructions. However, the two mufflers were cracked and on moving them something sounded in their interior. In both cases the noise was caused by a baffler (an air deflector disc), which was loose. The bafflers condition indicated that they had worked loose prior to the accident.

No abnormalities were found in the engine and its systems to justify the loss of power, with the exception of the loosening of the deflectors of both mufflers.

The loose deflectors were caught inside the mufflers, where they were able to move freely. In this situation, it is possible that at a given moment they were positioned in such a way that they partially obstructed the exhaust gas outlet, which would result in a loss of power.

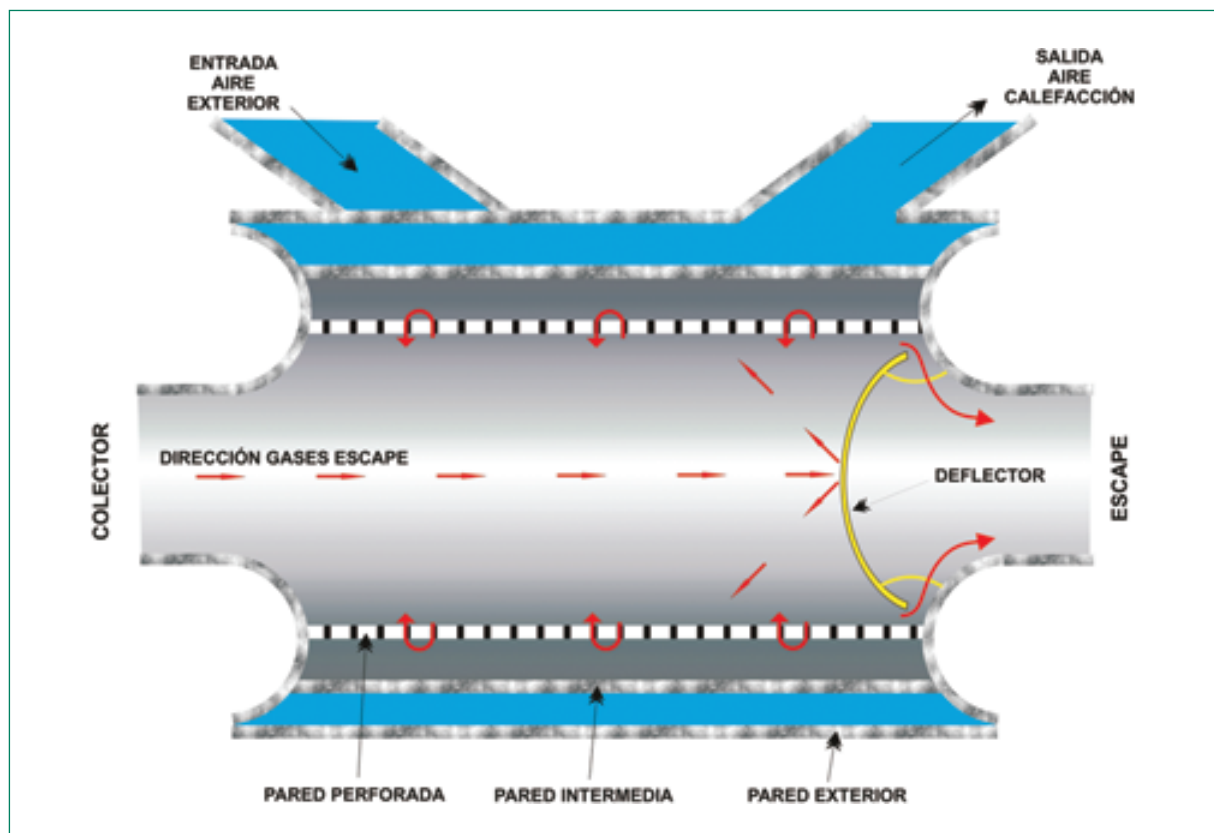
Figure 2. Schematics of the muffler

As can be seen from the longitudinal section in Figure 2, the muffler has two cavities separated by a wall (intermediate). The exhaust gases circulate through the inner cavity, which also has a perforated wall. In the base of this cavity there is a baffle or deflector

disc, secured by three pins, which are welded to the inner walls of the muffler. Outside air circulates through the most external of the cavities, is warmed up in contact with the intermediate wall, and then leaves the muffler and is carried to the cabin for heating purposes.

The exhaust gases enter the muffler and sink to the bottom, where they come up against the deflector disc, which directs them to the muffler's sides, so that they flow through the perforated wall, which reduces their noise. The gases then leave the muffler through the space that is left between its base and the deflector disc and enter the exhaust, which is a cylindrical pipe some 50 cm long, and are finally exhausted into the atmosphere through its end.

The aircraft's manufacturer informed that the aircraft's maintenance schedule establishes that a visual inspection of the exhaust system must be carried out every 100 hours, in order to detect the presence of cracks, burnt areas, etc., as well as to check the correct state of the joints of the various elements of which it is comprised. There are no indications in respect of the need to inspect the fastenings of the mufflers' internal deflectors.
