TECHNICAL REPORT

A-065/2003

**Accident to aircraft CIRRUS SR-22,
registration N-100BR, at southern slopes of the
Montes Alberes, 6 km to the North of Espolla
(Girona), on 12 October 2003**

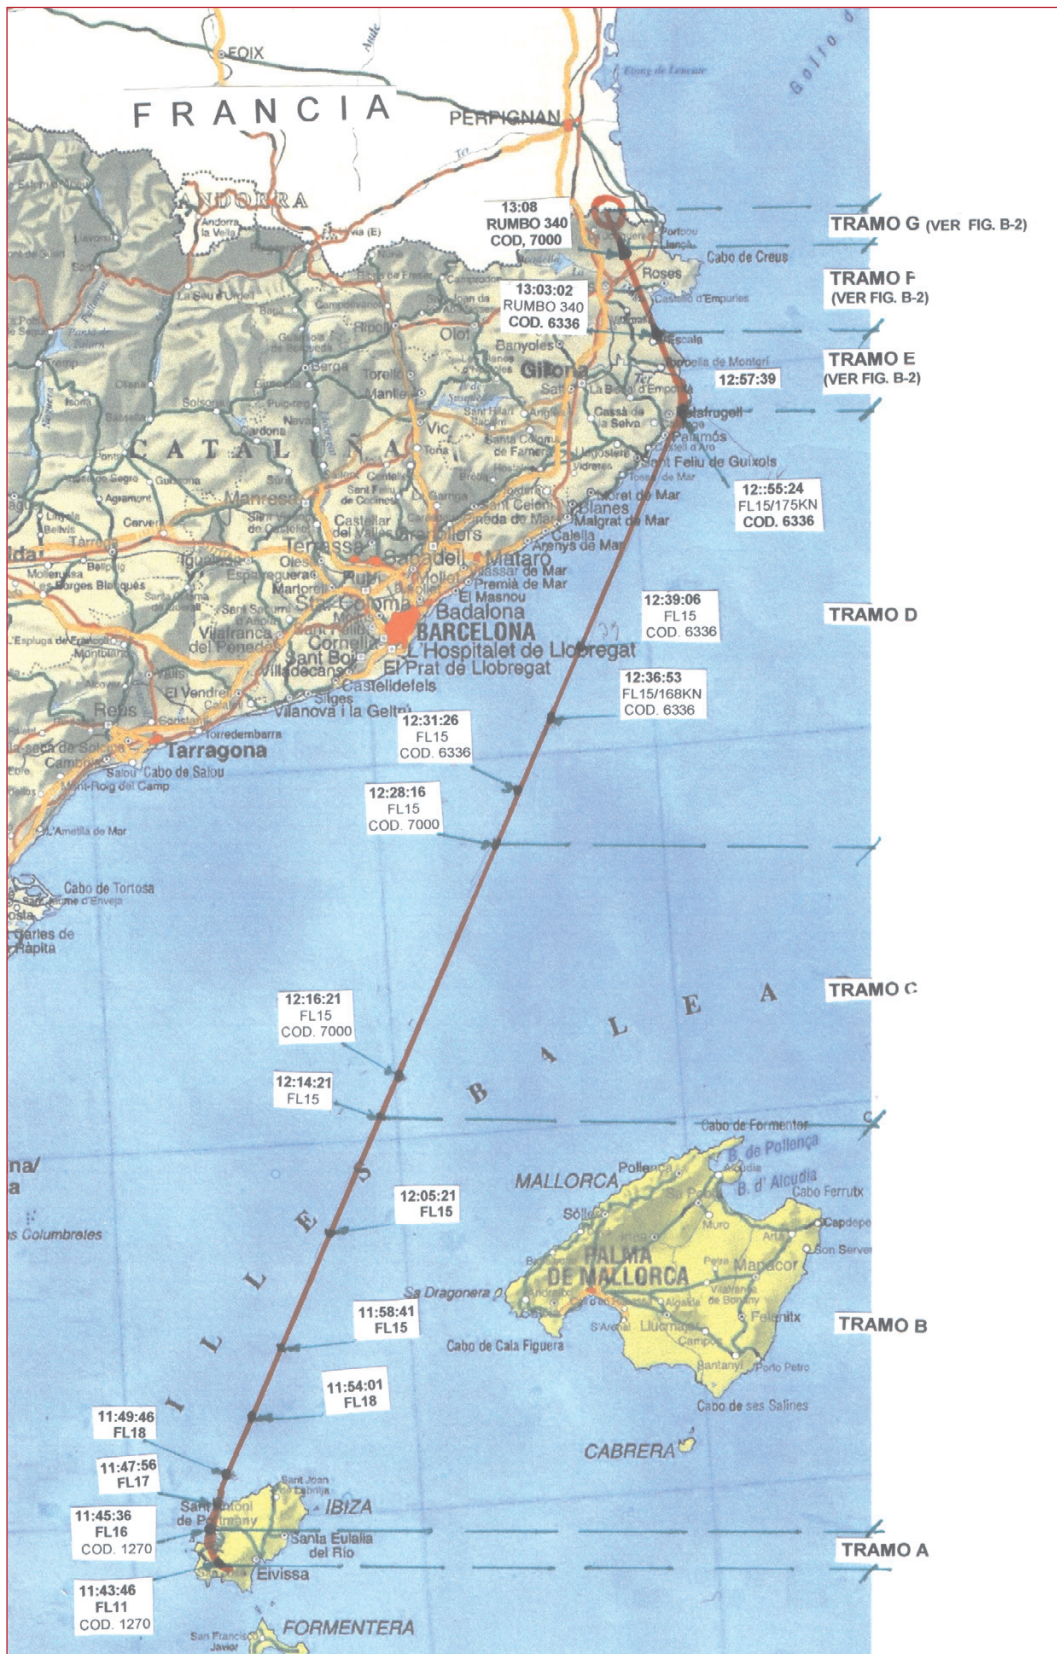
Figure B-1. Path according to radar data

Figure B-1 provides a reconstruction of the path followed by the aircraft, based on available Spanish radar data plus that acquired during the search subsequent to the event and supplied by the French services. These latter data are detailed in Figure B-2 (Appendix B).

The radar track starts at the initial ascent (leg A in the figure), being reflected in the two available on-screen displays, one at 11:43:46 h, height 1,100 ft, and the other at 11:45:36 h, height 1,600 ft. In both displays the aircraft was only identified with code 1270.

Then there is a leg (B in the figure), which lasts until 12:14:21 h, in which the aircraft's identification includes the flight identifier N100BR and the height. During this leg B, the height, after reaching a maximum of 1,800 ft, was stabilized at 1,500 ft and the course was also stabilized at approximately 30°, direct to Bagur VOR.

The successive available radar displays indicate that, whilst it maintained its level and course, the aircraft had code 7000 up to 12:28:16 h (leg C) and it changed to code 6336 from 12:31:26 h onwards. The aircraft remained with this code until the last available detection by the civil radar of Barcelona ACC (leg D) at 12:55:24 h. At that moment the aircraft's position was 5 NM (9.27 km) to the SW of Bagur VOR, in direct flight to it, (approximately course 30°), altitude 1,500 ft and speed 175 kt.

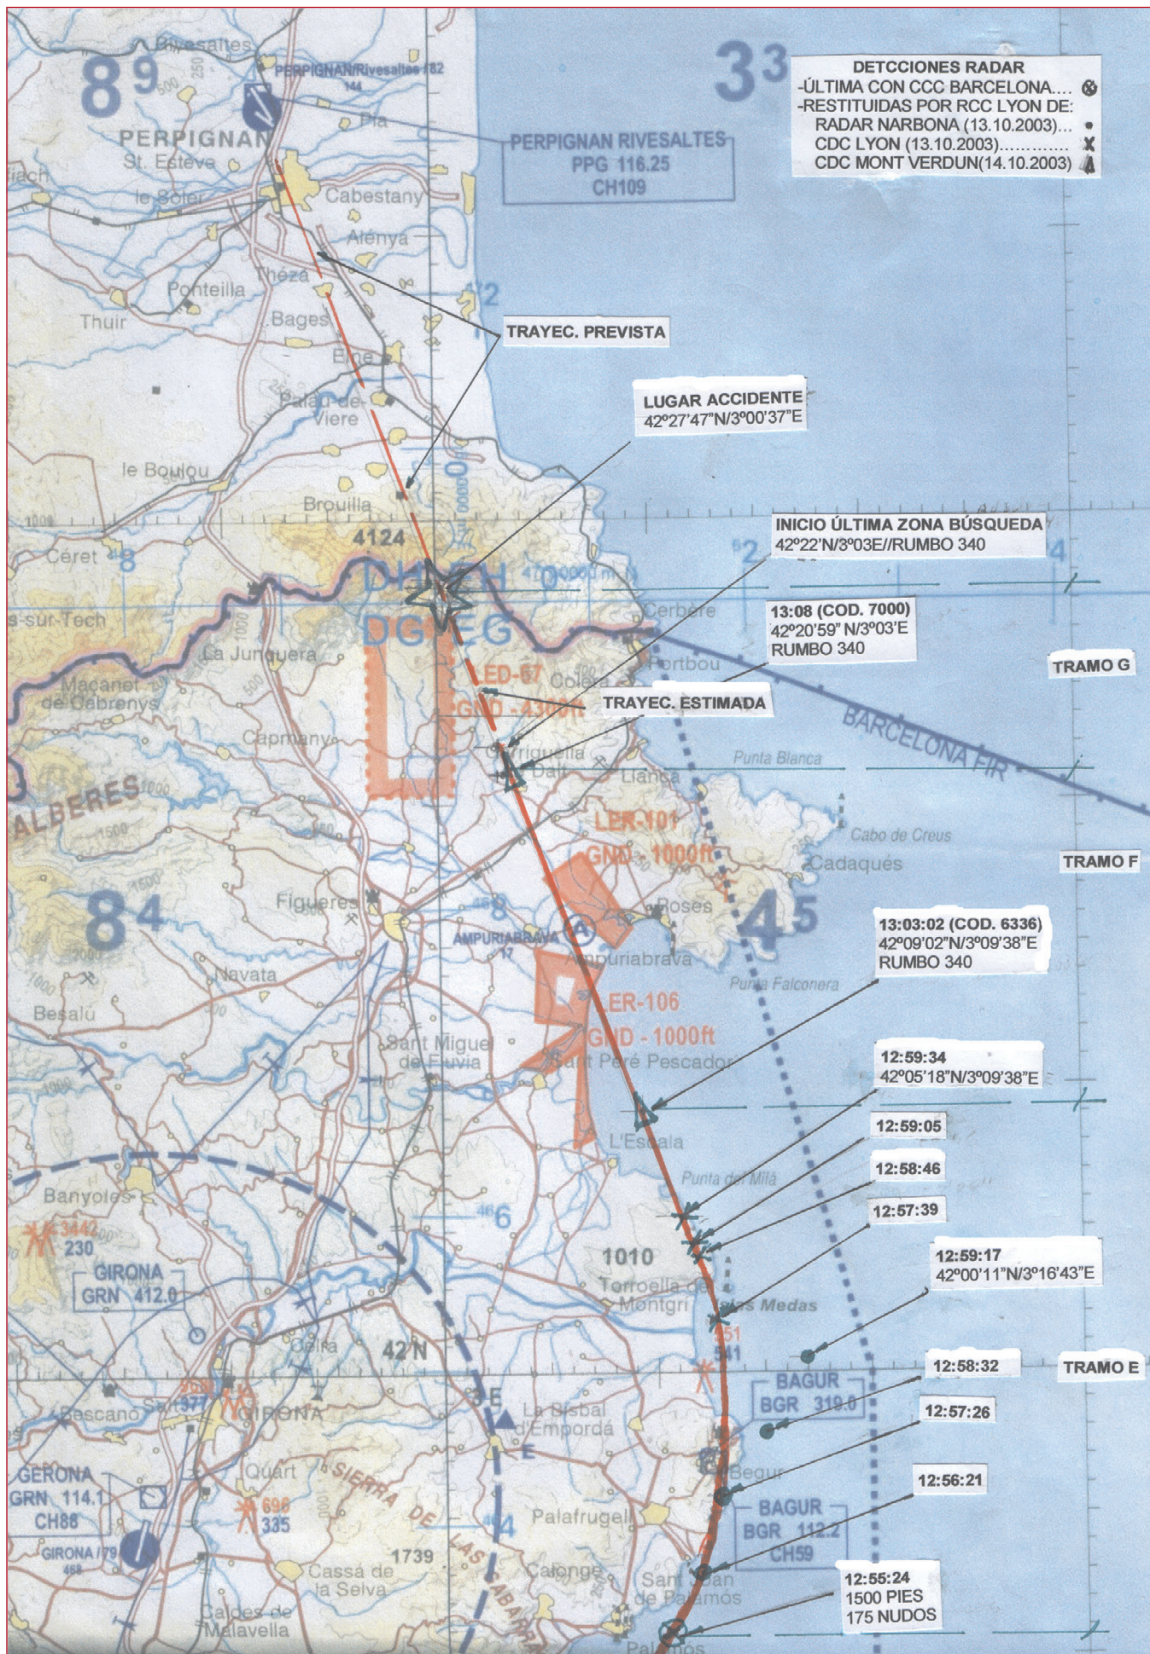
Figure B-2. Path amplified with rescue radar detections

search area starting point, as defined by the above CDC and detailed in Figure B-2 (Appendix B).

As can be seen in this figure, the information supplied by the Lyon RCC for leg E includes only an indication of time and position, with discrepancies in some detections relating to both time and position, possibly due to the fact that these data were taken from different radars, Narbonne and Lyon. In leg F there is an indication of time, course, ATC transponder code and geographical coordinates. In both legs the course is 340°, virtually heading to Perpignan in France. In the beginning of leg F the ATC code continues to be 6336 as allocated and ends up being 7000, a generic uncontrolled flight identifier (this VFR flight was uncontrolled) possibly awaiting for code allocation by the ATC services on entering a different region, Marseilles FIR.

Subsequent to the accident, it was found that the aircraft was detected by French radars up to 13:08 h (Appendix B, Figures B-1 and B-2, legs E and F). In these detections, it is noted that the aircraft changed its code from 6336, which it had maintained during the flight, to 7000, probably in preparation for the change of traffic control region and, also, it changed its course to 340°, heading for Perpignan, as it had previously requested. There is no record of any radio contact with French control centres. The information exchanged during the search for the aircraft led to the understanding that there had been no radio contact.

what can be observed in Figures B-1 and B-2 (Appendix B), at all times the aircraft followed the correct and most direct path to Perpignan. Knowing what has been said about the pilot, it is considered that most likely he was using the automatic pilot throughout the flight and this situation probably did not change until the accident, at least as regards to hold the course.

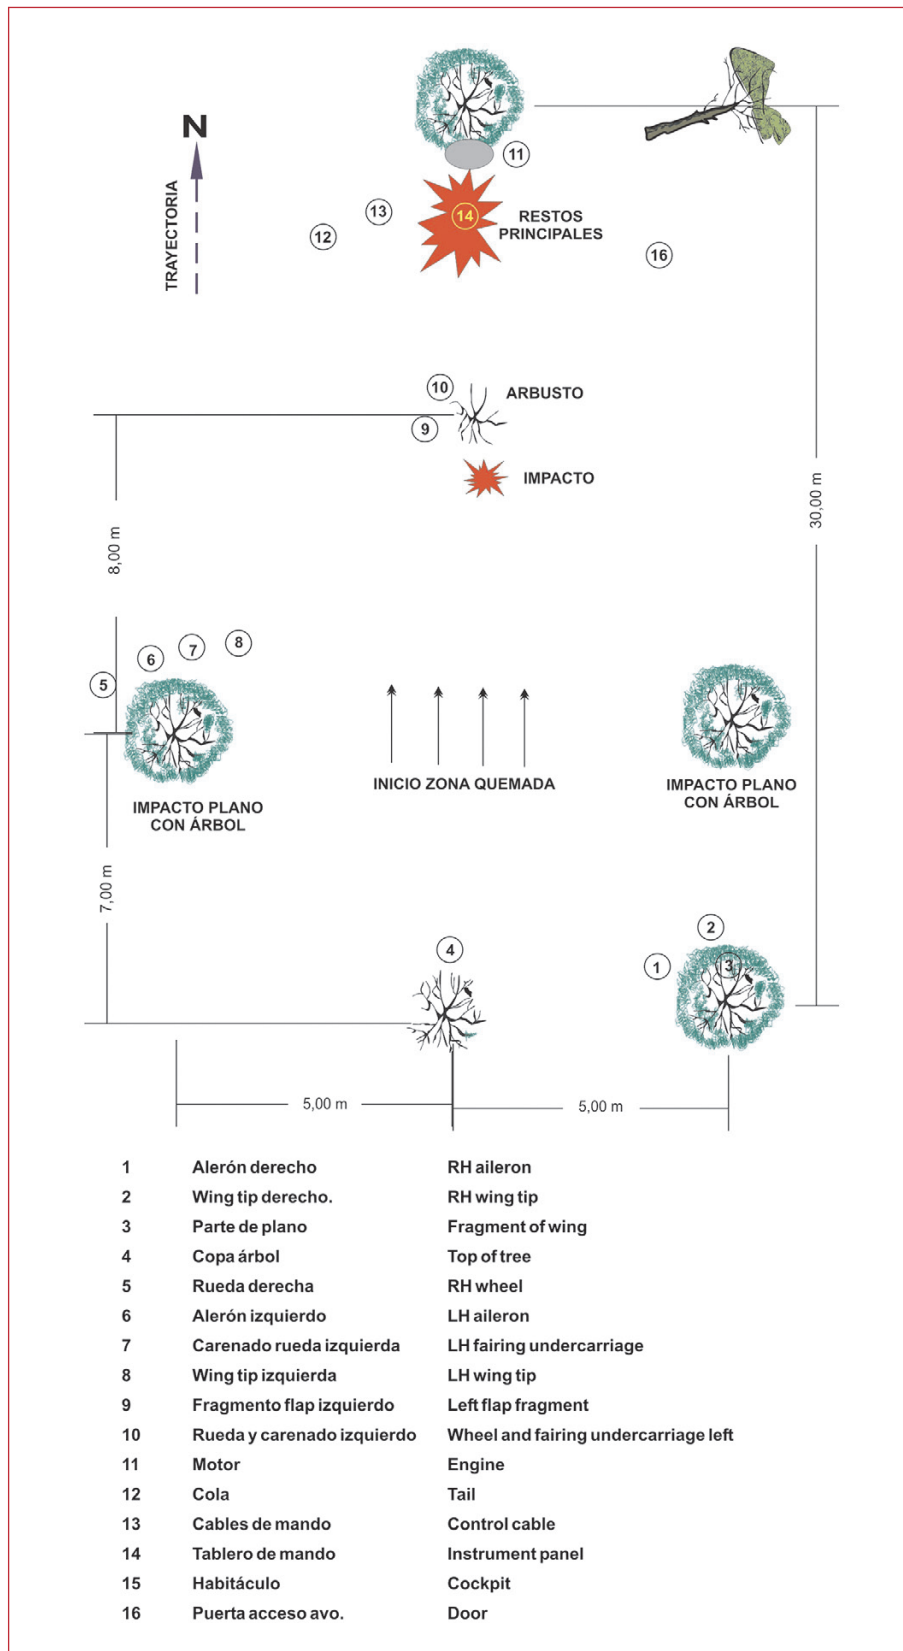
Figure C-1. *Distribution of wreckage (ground plan view)*

The wreckage was found in a wooded area with difficult access, at a height above sea level of 830 m (2,720 ft), in the situation and layout shown as ground plan and elevation in Figures C-1 and C-2 (Appendix C), respectively. These figures were prepared during the visual inspection of the site of the accident.

- The trace of the wreckage (Appendix C, Figure C-1) is orientated in a northerly direction.
- As can be seen in this figure, the aircraft first struck two trees situated almost perpendicular to the trace of the wreckage. The tree on the left, almost in the aircraft's path, appeared with the top cut off at a height of four metres and in the one on the right it left the aileron and tip of the wing on that side. Then the aircraft struck another two trees, also situated in a perpendicular plane to the trace. In this case, parts of the left wing and aileron and right wheel were found in the tree on the left whilst the tree on the right only suffered minor damage. Then the fuselage's impact against the ground can be seen, causing a not very deep hole and pulling a tree out by the roots.

- The main part of the wreckage, very burned, was located almost 15 m further ahead. In this area, first to the left, it was found the aircraft's tail, of which the vertical fin was not completely burned, followed by the main wreckage, including instrument panels, seats and cabin structure, all completely burned. Further ahead was the engine, which struck and came to rest in a tree in a vertical position. The propeller hub was broken, very close to the tree where the engine was found, with a blade cut off almost at the base, another wrapped around the tree and the third almost melted by the fire which broke out after the accident.

- The aircraft was virtually disintegrated. Given the damage to the aircraft, trees and adjoining areas, the conclusion can be drawn that the impact against the ground must have been at high speed. In spite of this, all the wreckage was found within an area of 30 × 10 m.

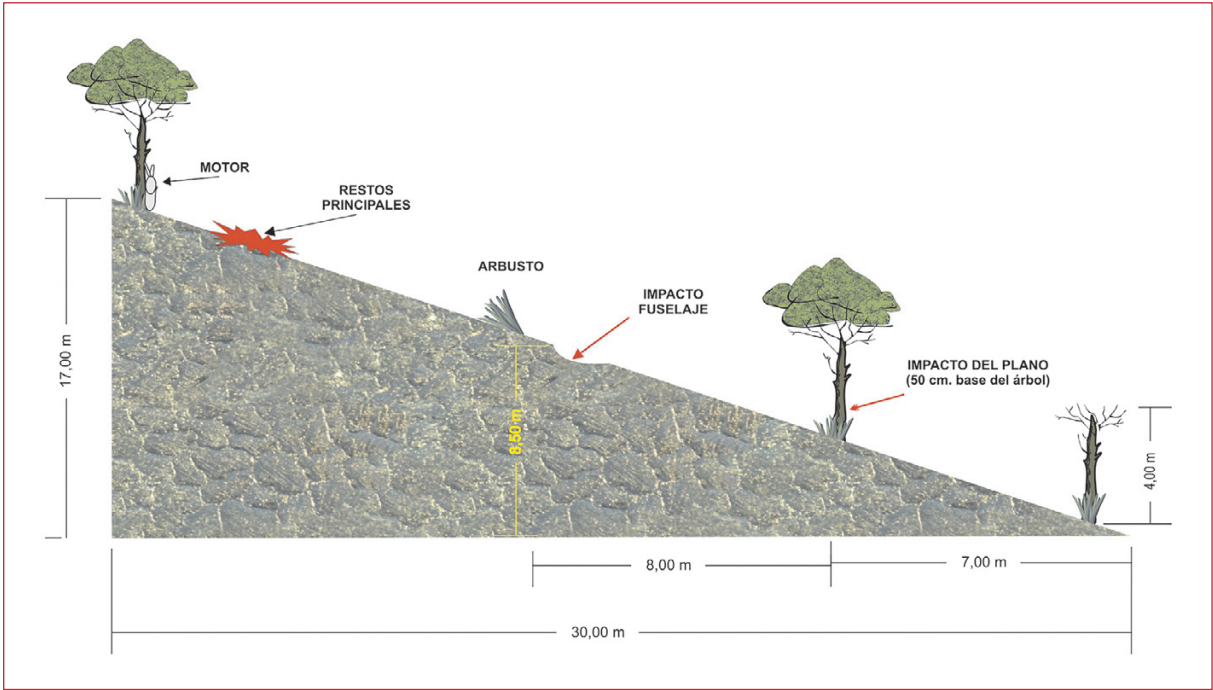
Figure C-2. Distribution of wreckage (elevation view)

- The elevation view (Appendix C, Figure C-2) shows that the path maintained height with a small curve upwards in the crash, which is the reason why the impact was not direct with the propeller and the hole caused by the fuselage was not deep.
