Report A-001/2004

Accident to glider Glaser Dirks
DG-600, registration EC-FIZ,
in Otero de Herreros (Segovia)
on January 2, 2004

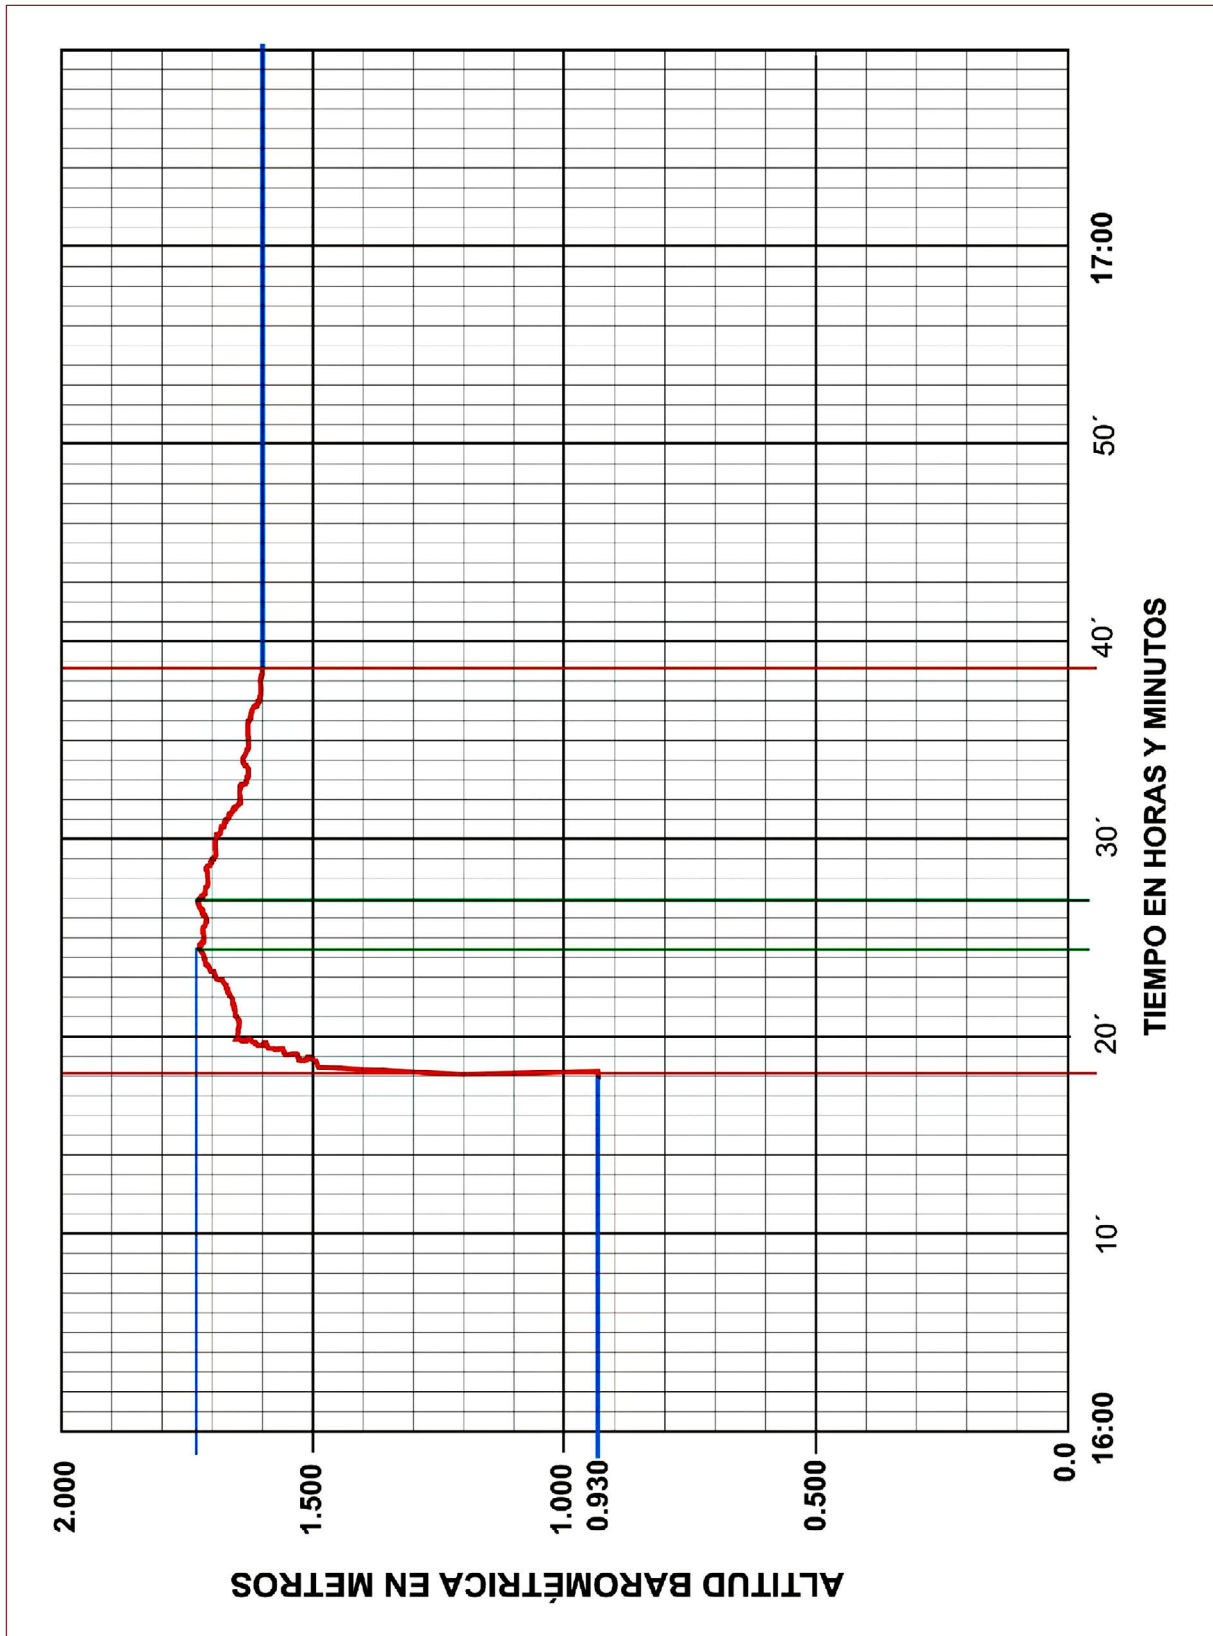
Vertical profile of the flight obtained from the GPS on board

The maximum altitude reached by the glider exceeded slightly 1,700 meters (1,730 meters) and was maintained for approximately 3 minutes. From 16:27 h UTC the glider was descending very smoothly until almost 16:39 h UTC when the data recording was interrupted. It is believed that the impact against the ground took place 20 seconds later. The glider then had an altitude of 1,600 meters, which was more than

It is observed in the indicated speed graph that this is quite stable, kept between 75 and 100 km /h. However, in the last two recorded data increasing values are registered with a trend towards 120 km/h, which indicates a significant increase in speed during the last minute of the flight.

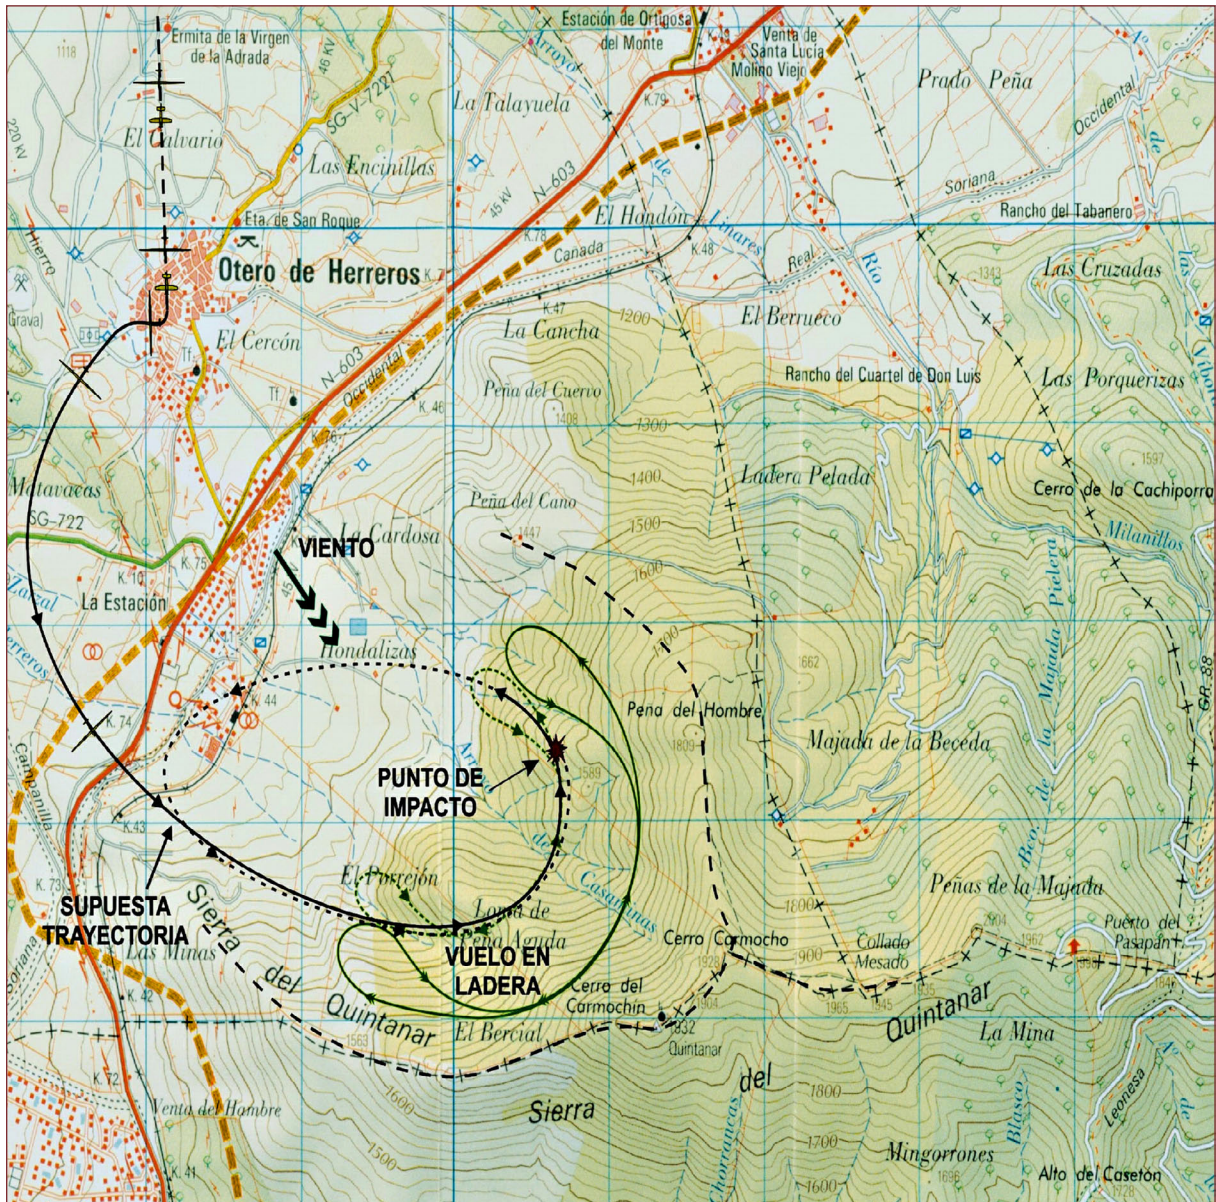
B2. Probable flight path and point of impact

In Appendix B the theoretical path of the slope flight in Hoya de Otero appears along with the likely one actually followed by the affected aircraft according to the witnesses' statements.

From 17:15 h, the time of the release, to 17:30 h, the time when the glider was seen for the last time, the glider could have covered between 20 and 25 km in a flight whose likely path has been sketched in Appendix B.

It can be deduced that the flight path of the glider, once this was released above Otero de Herreros, first headed Southeast, followed by a wide turn to the left and an immediate entrance to Hoya de Otero to begin the slope flight, flying along the hillside once, and continuing with a course towards the West, next making a wide curve towards the SW, followed by a 45° turn in order to come back to Hoya. The witness who was driving along the road saw this last part of the flight path for a few minutes until it disappeared between the clouds, and permanently disappeared from sight.

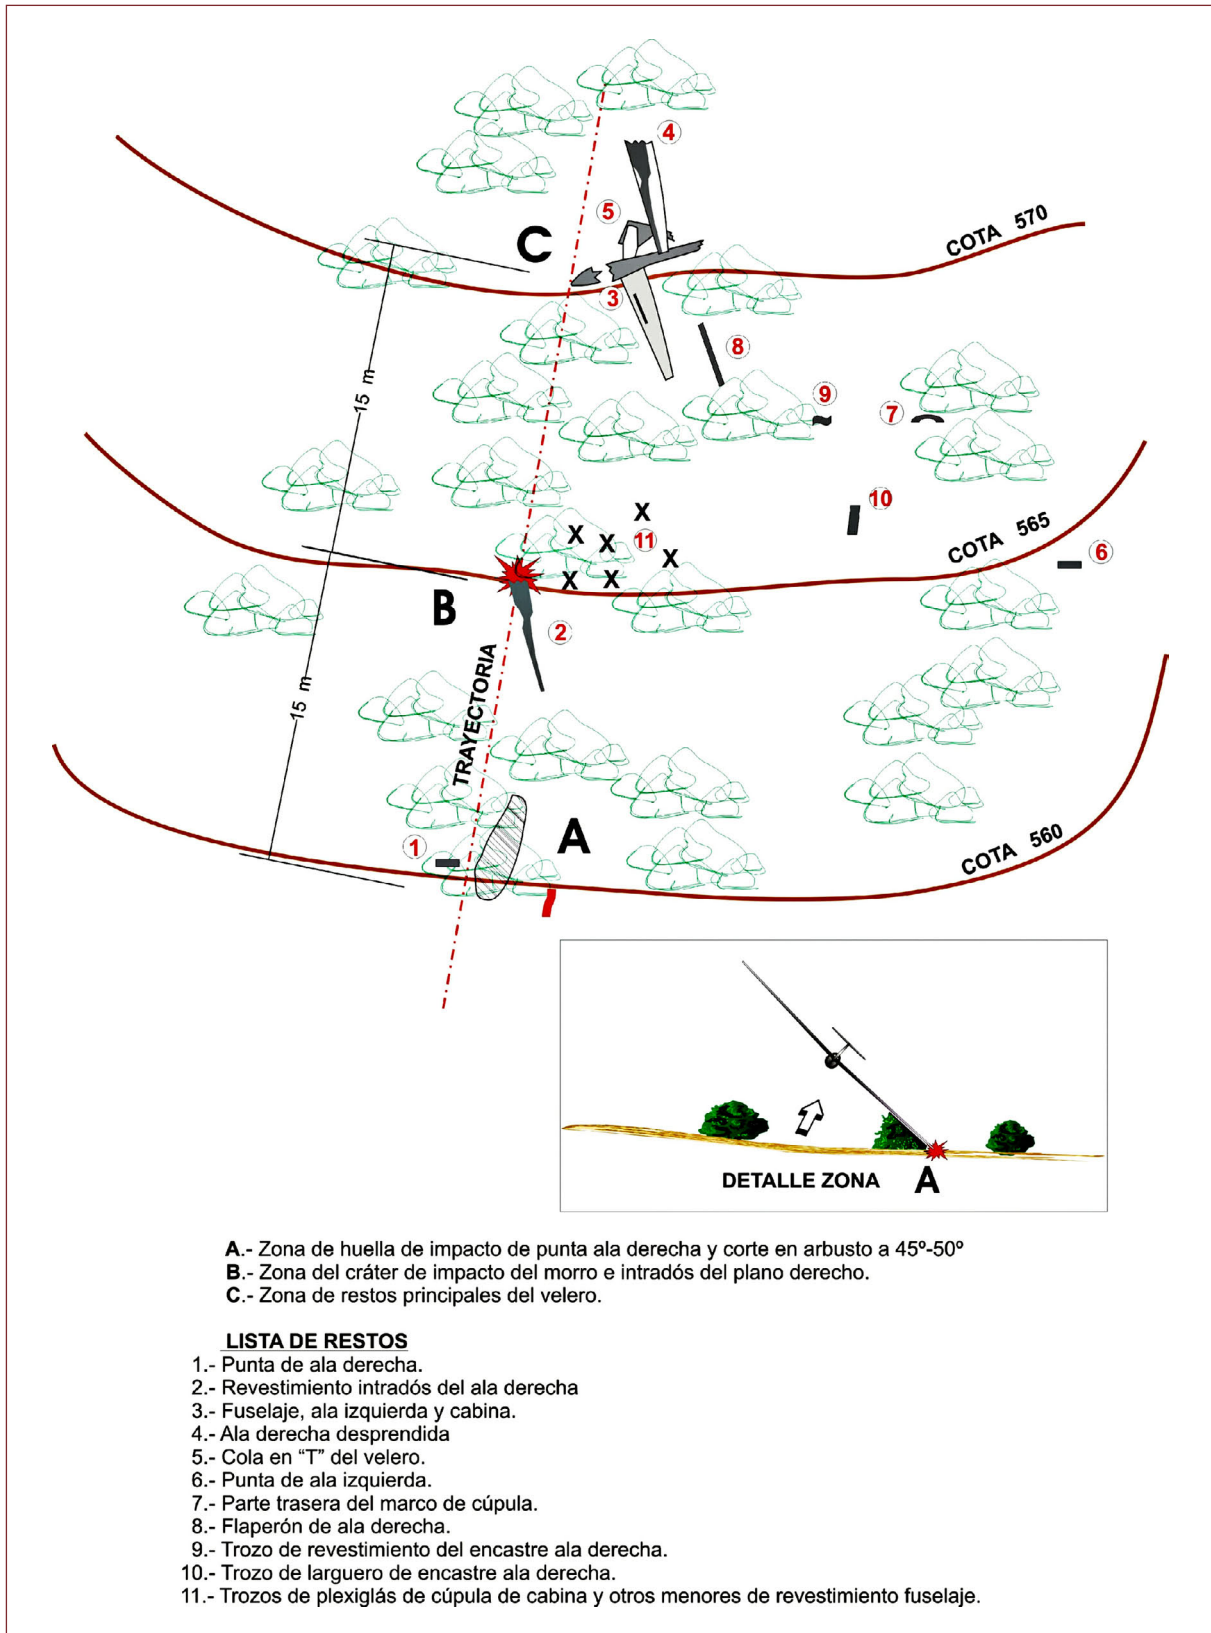
C1. Sketches of the aircraft wreckage and signs of impact

At the base of the hillside (zone A according to the sketch of Appendix C) the detachable wing tip of the right wing was found, the track left by its impact in the ground and the path cut in the bushes by the right wing was at an angle of about 45 to 50° relative to the horizon.

Moving uphill, 15 m away approximately (zone B according to the sketch of Appendix C) and in a crater about 50 cm deep, the lower surface skin of the entire right wing appeared, incrustated in the ground. This skin, made of carbon fibre and fibre glass, had joined together a part of the spar, made also of carbon fibre and fibre glass. A little to the right of this point pieces of the canopy of the cabin and some other small pieces of the fuselage's outer skin were found

Moving further uphill, approximately 15 m away (zone C according to the sketch in Appendix C) the main wreckage of the glider was found. The fuselage, with the left wing still attached, was located in a position almost opposite the crash line. The front part of the glider (nose and cabin) was separated from the rest and so was the T-tail, whose horizontal stabilizer was underneath it. The right wing was separated from the fuselage, in an upside down position and located to the right of the fuselage.

Based upon the observations at the accident site it can be deduced that initially the glider touched down with the tip of the right wing, then hit frontally about 15 meters further uphill, as most of the wreckage came to rest together an additional 15 meters beyond the primary point of impact.

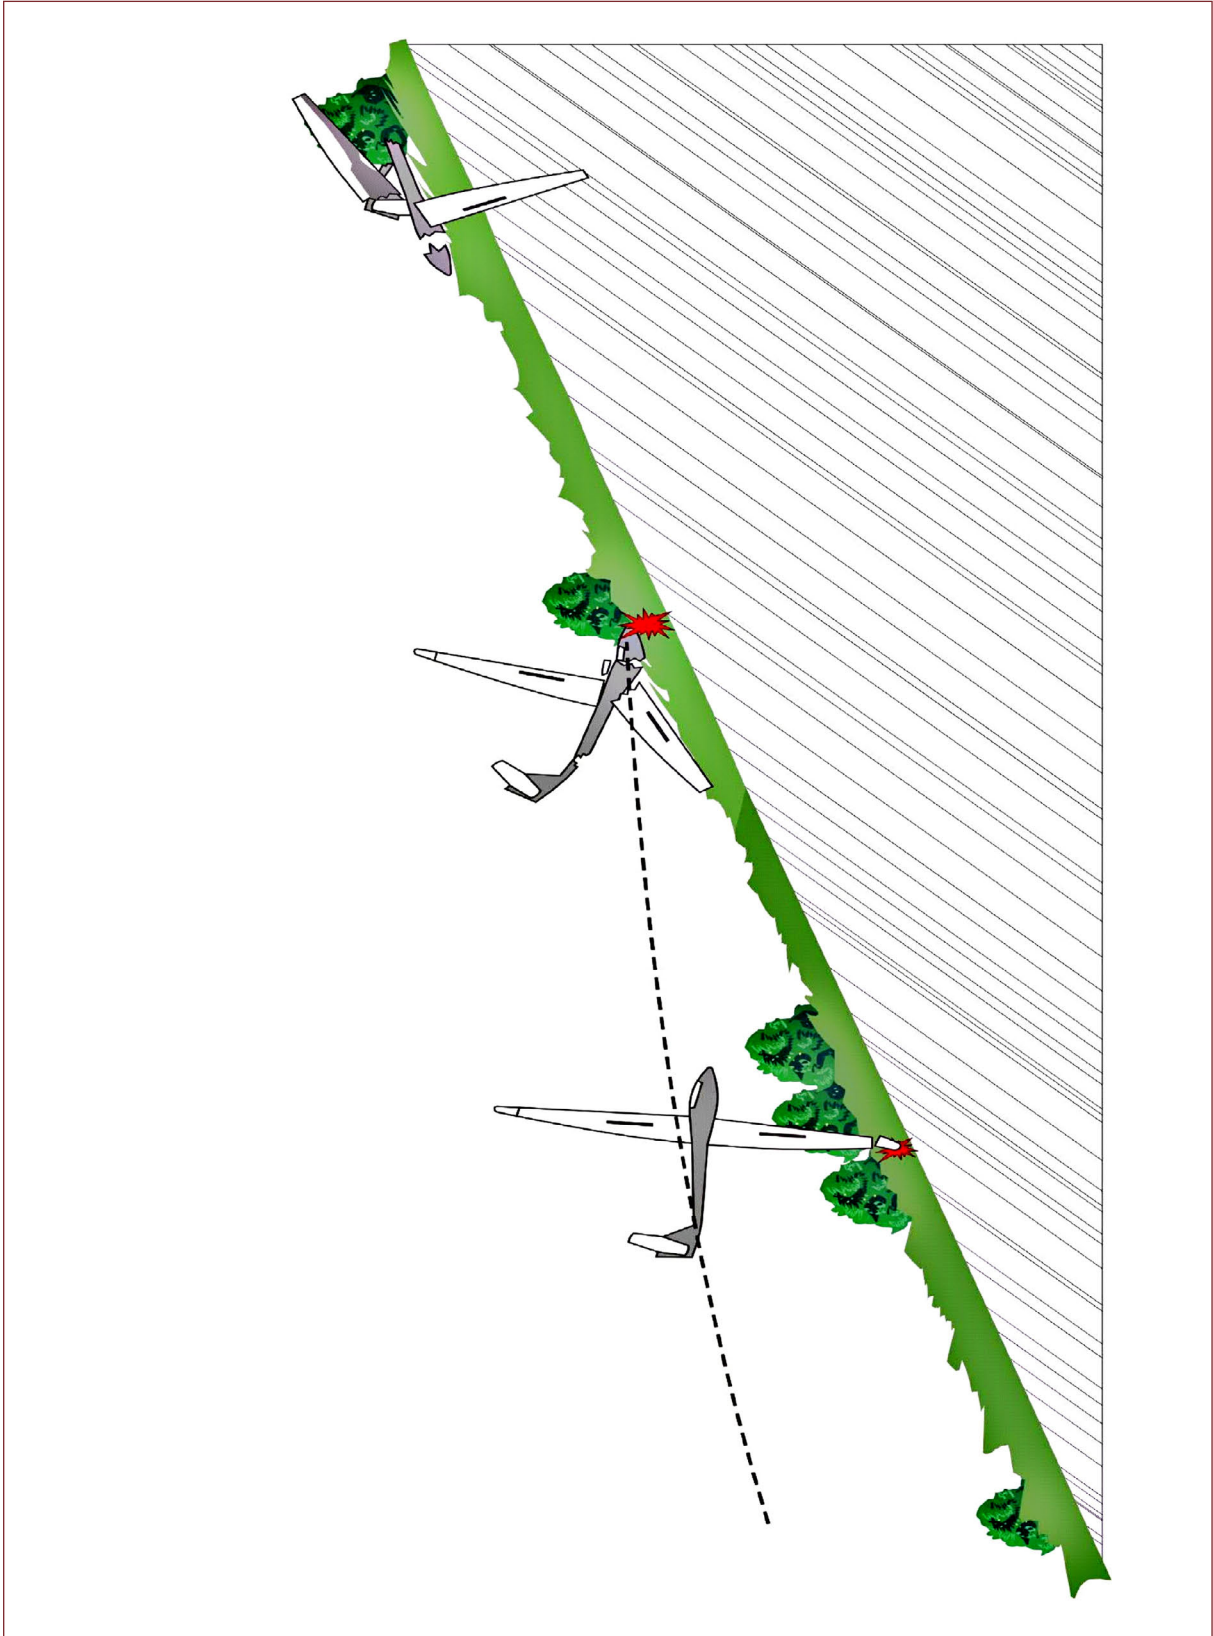
C2. Sketches of the glider's attitude when impacted into the ground

The orography of the area, the signs of impact and the distribution of the wreckage indicate that the aircraft was flying at the moment of impact under the following conditions:

- Flight path apparently straight, horizontal or slightly climbing and directed towards the hillside.
- The glider was in a steep roll to the right, of about 45 to 50°, and the distribution of the wreckage indicates that it was not carrying out a turn to the right.
