CIAIAC

TECHNICAL REPORT

A-016/2004

Accident of aircraft
Eurocopter SA-365-N1,
registration EC-GJE,
in San Bartolomé de
Tirajana (Las Palmas),
on 30 March 2004

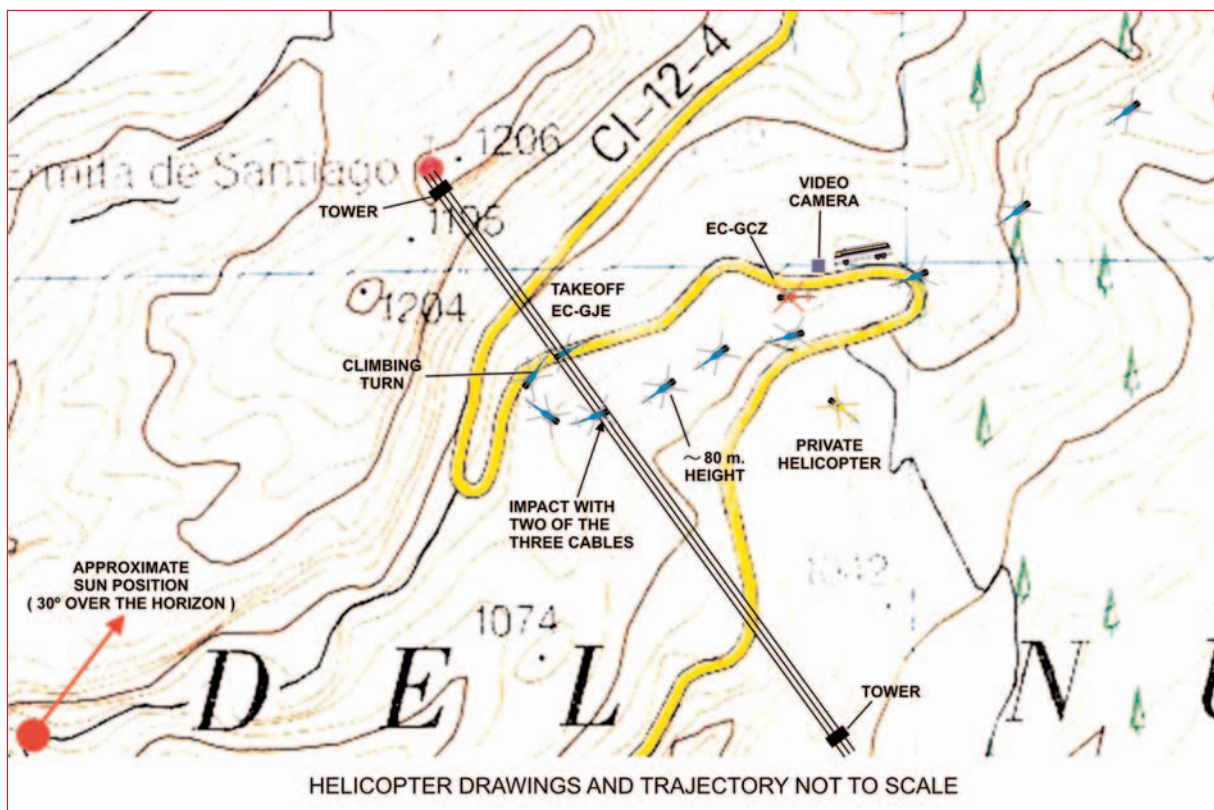
Figure 1.1.2. Initial trajectory of EC-GJE. The Bell 412 EC-GSK had already departed to the hospital. It had previously landed in the same site besides the road that was now being used by EC-GCZ

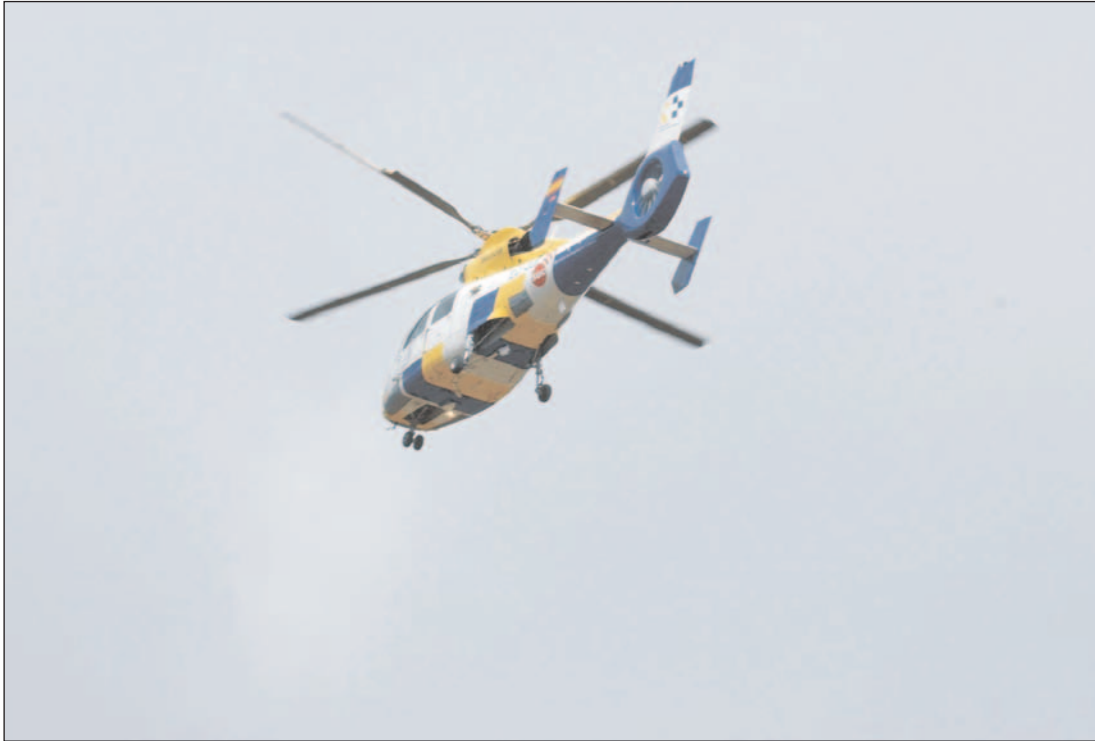
Figure 1.1.3. The helicopter flying shortly after the impact with the wires. Most of the chord of a blade is missing approximately in half of the span (photo «La provincia»)

Additionally, the red blade suffered major damage in a great portion of its span. The leading edge beam remained in place but the skin broke and detached in a chord wise sense towards the trailing edge after the impact.

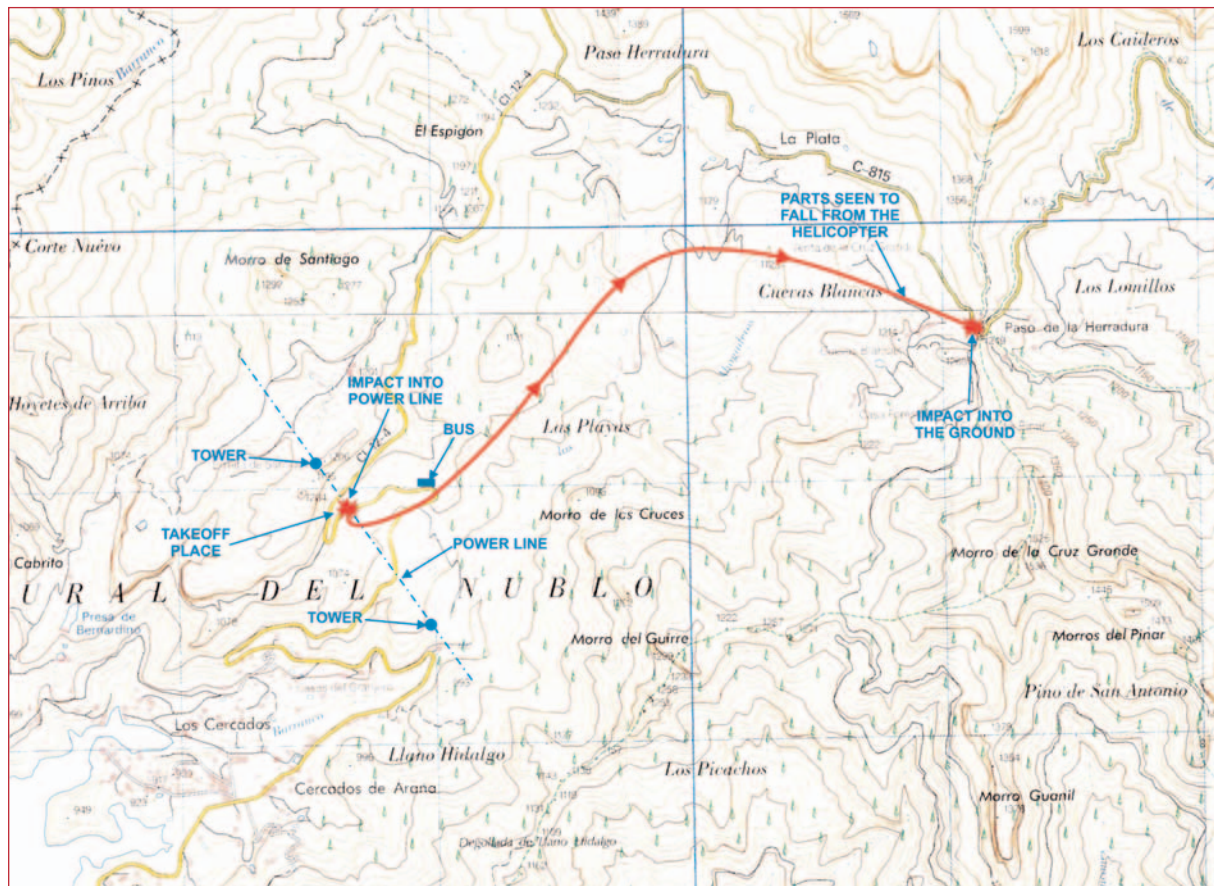
Figure 1.1.5. Possible trajectory of EC-GJE prepared after witnesses statements and wreckage trail

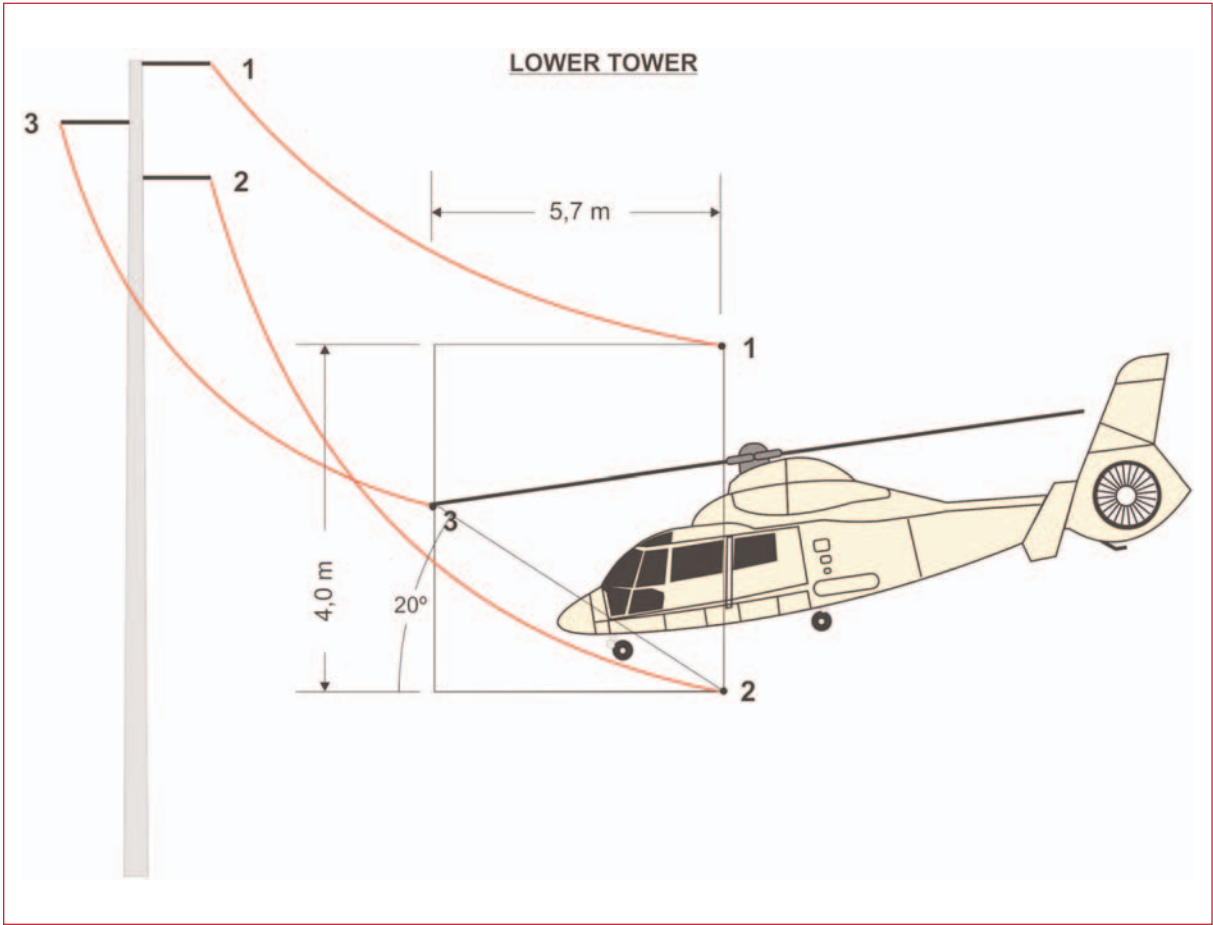
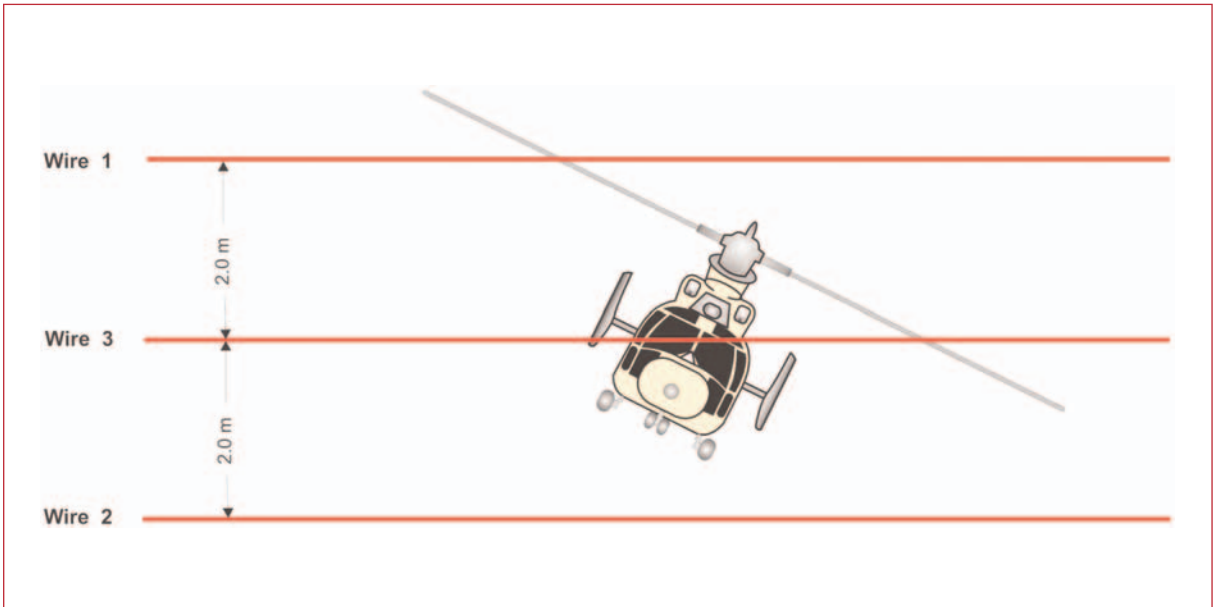
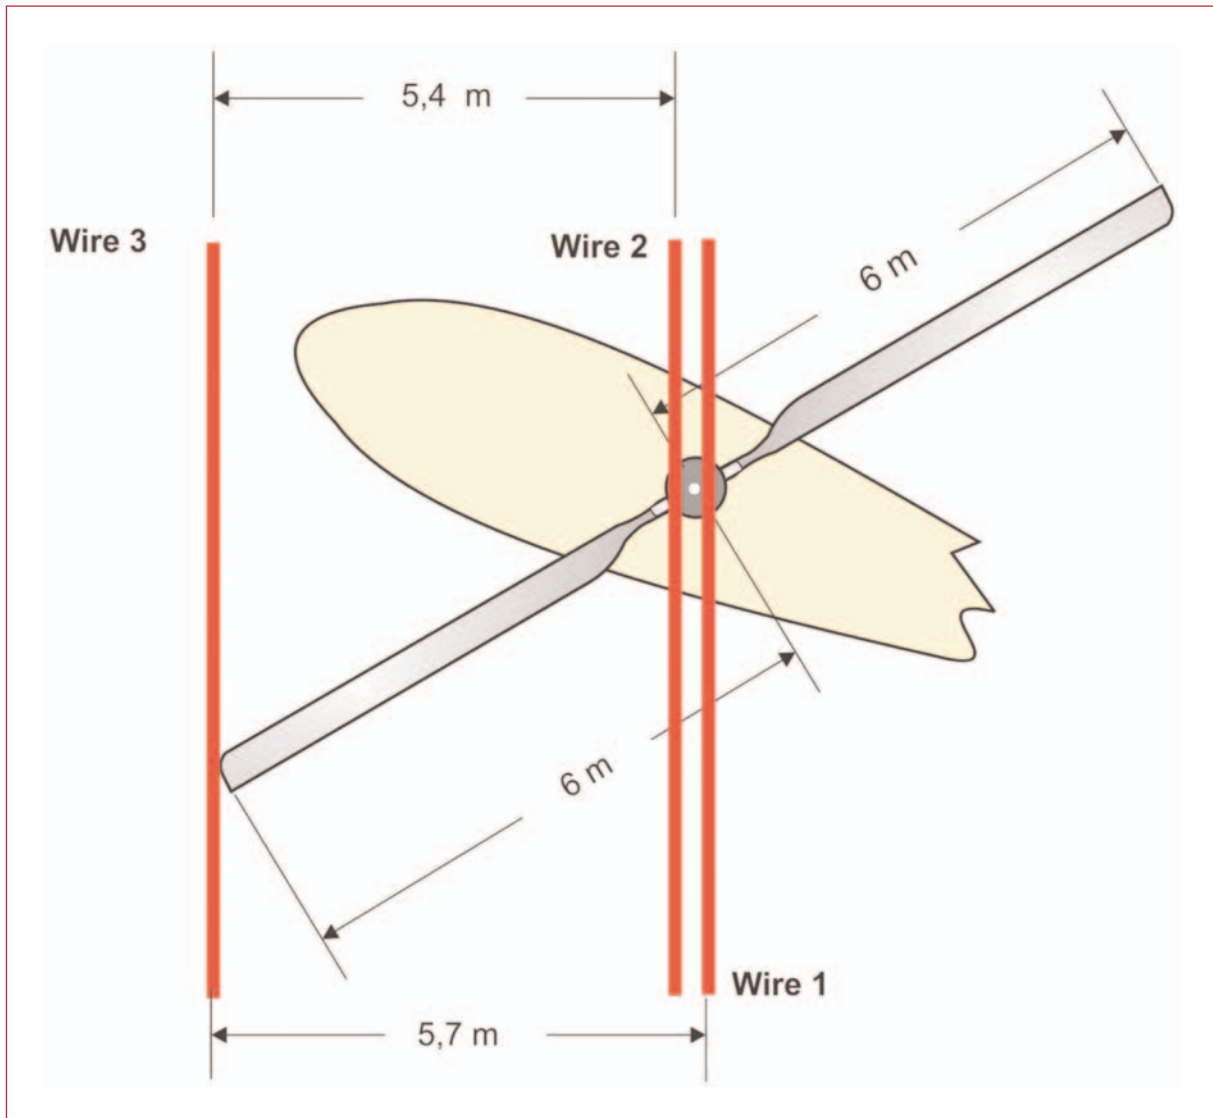
However, the helicopter cut the two upper wires (one to the right and the other to the left of the tower), while the lowest cable was not damaged. The fourbladed main rotor of the helicopter rotates in a clockwise sense when viewed from above.

All those facts led to the conclusion that the impact happened when the complete airframe of the helicopter was above the lowest cable (n° 2) and climbing with an angle lower than 20°, and the first cable that broke was the n° 1 (uppermost) when it was hit by the leading edge of the red blade (see Figures 1.16.1 to 1.16.4).

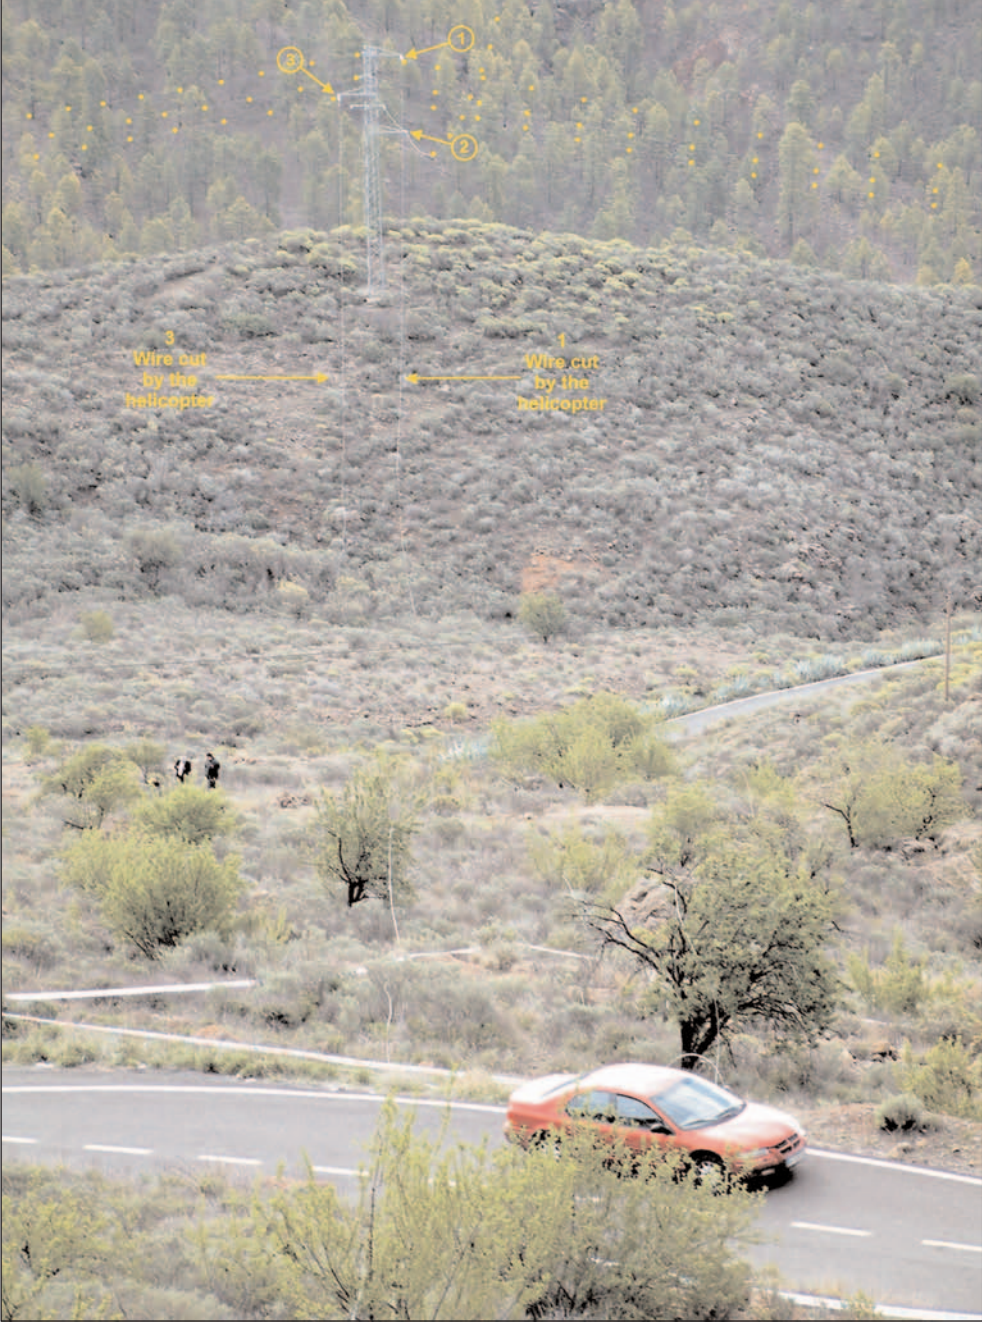
Figure 1.16.4. Lower tower. Wire 2, highlighted with yellow dots, remained undamaged. Lateral wires are also highlighted with yellow dots.

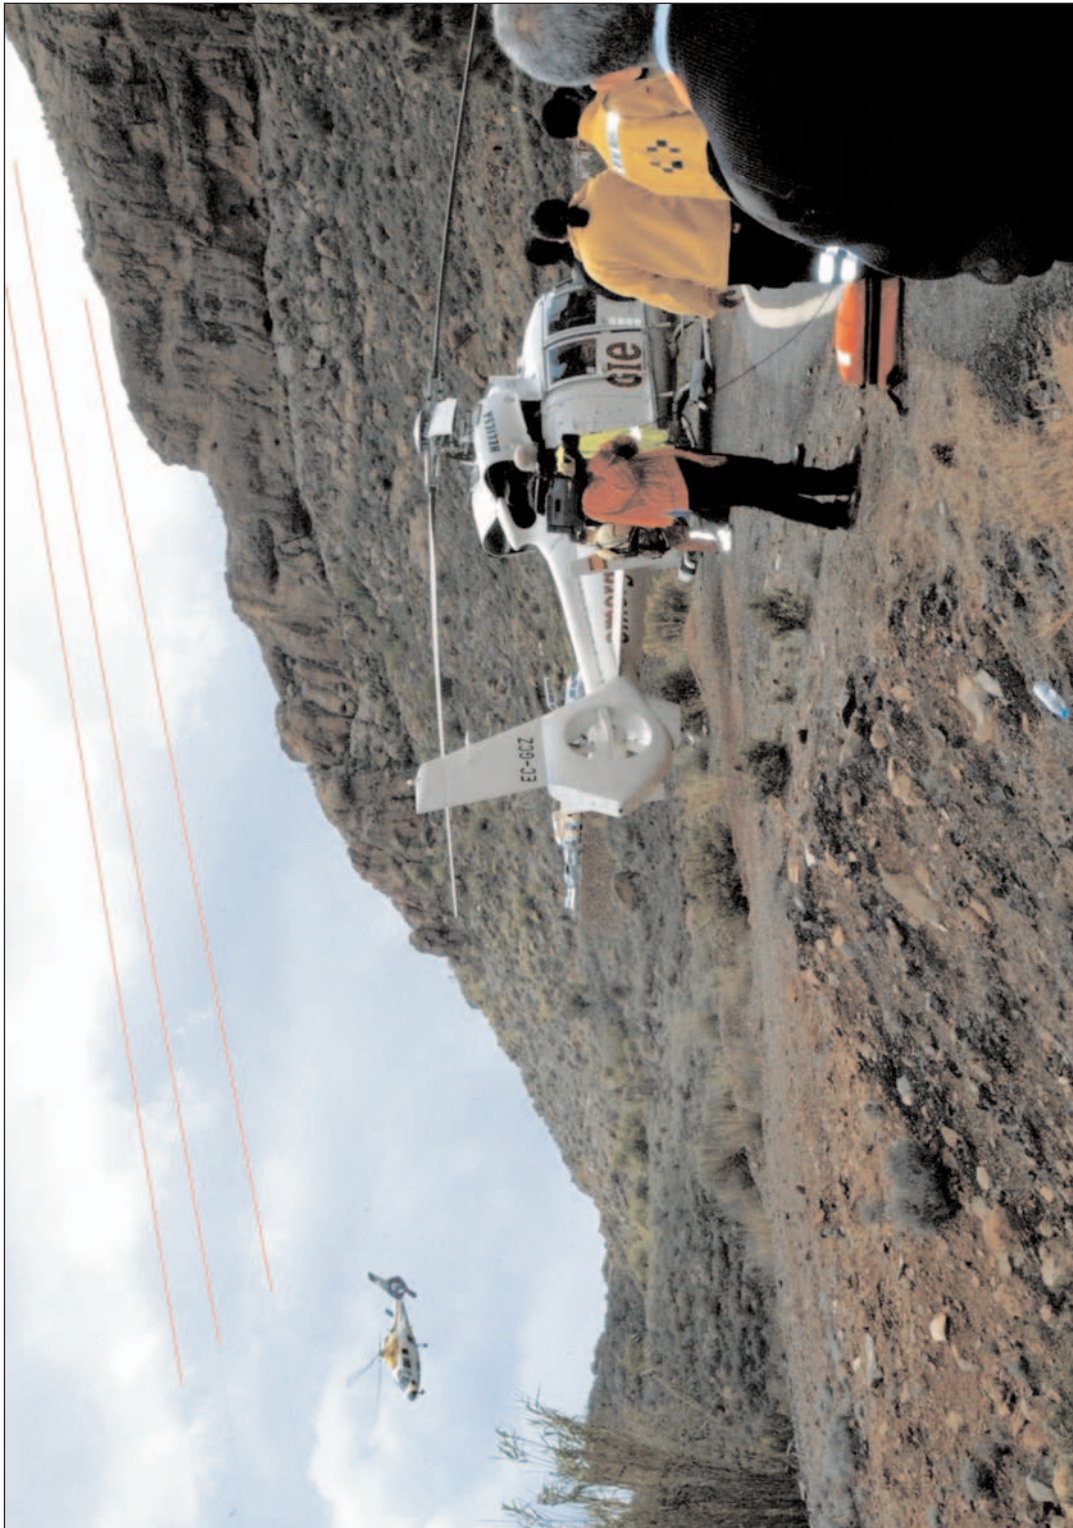
According to witness statements and to some photos reviewed (see Appendix A) the takeoff involved an almost immediate left hand climbing turn after liftoff. No specific explanation for this maneuver was found during the analysis of the accident. The operations manual did not allow this maneuver (200 ft of height required before initiating a turn), and the characteristics of the area and even the wind favoured a takeoff with a west heading while climbing in a normal angle. Even in absence of the wires, this manoeuvre would have imposed certain hazard to the helicopter because a tight turn was initiated towards an area that was outside the normal field of view of the pilot.

Photo 1. Helicopter EC-GJE is turning left shortly after takeoff, before impacting against the cables (photo: City Hall of San Bartolomé). The other Dauphin, EC-GCZ, is waiting and prepared to start the engines. The power cables have been highlighted in red for clarity

- REC 01/05.** It is recommended to the operator that more training is provided to flight crews involved in emergency medical services regarding the selection of landing areas and the actions to be taken on the ground by the pilot in command, including the need to conveniently prepare the subsequent take off.

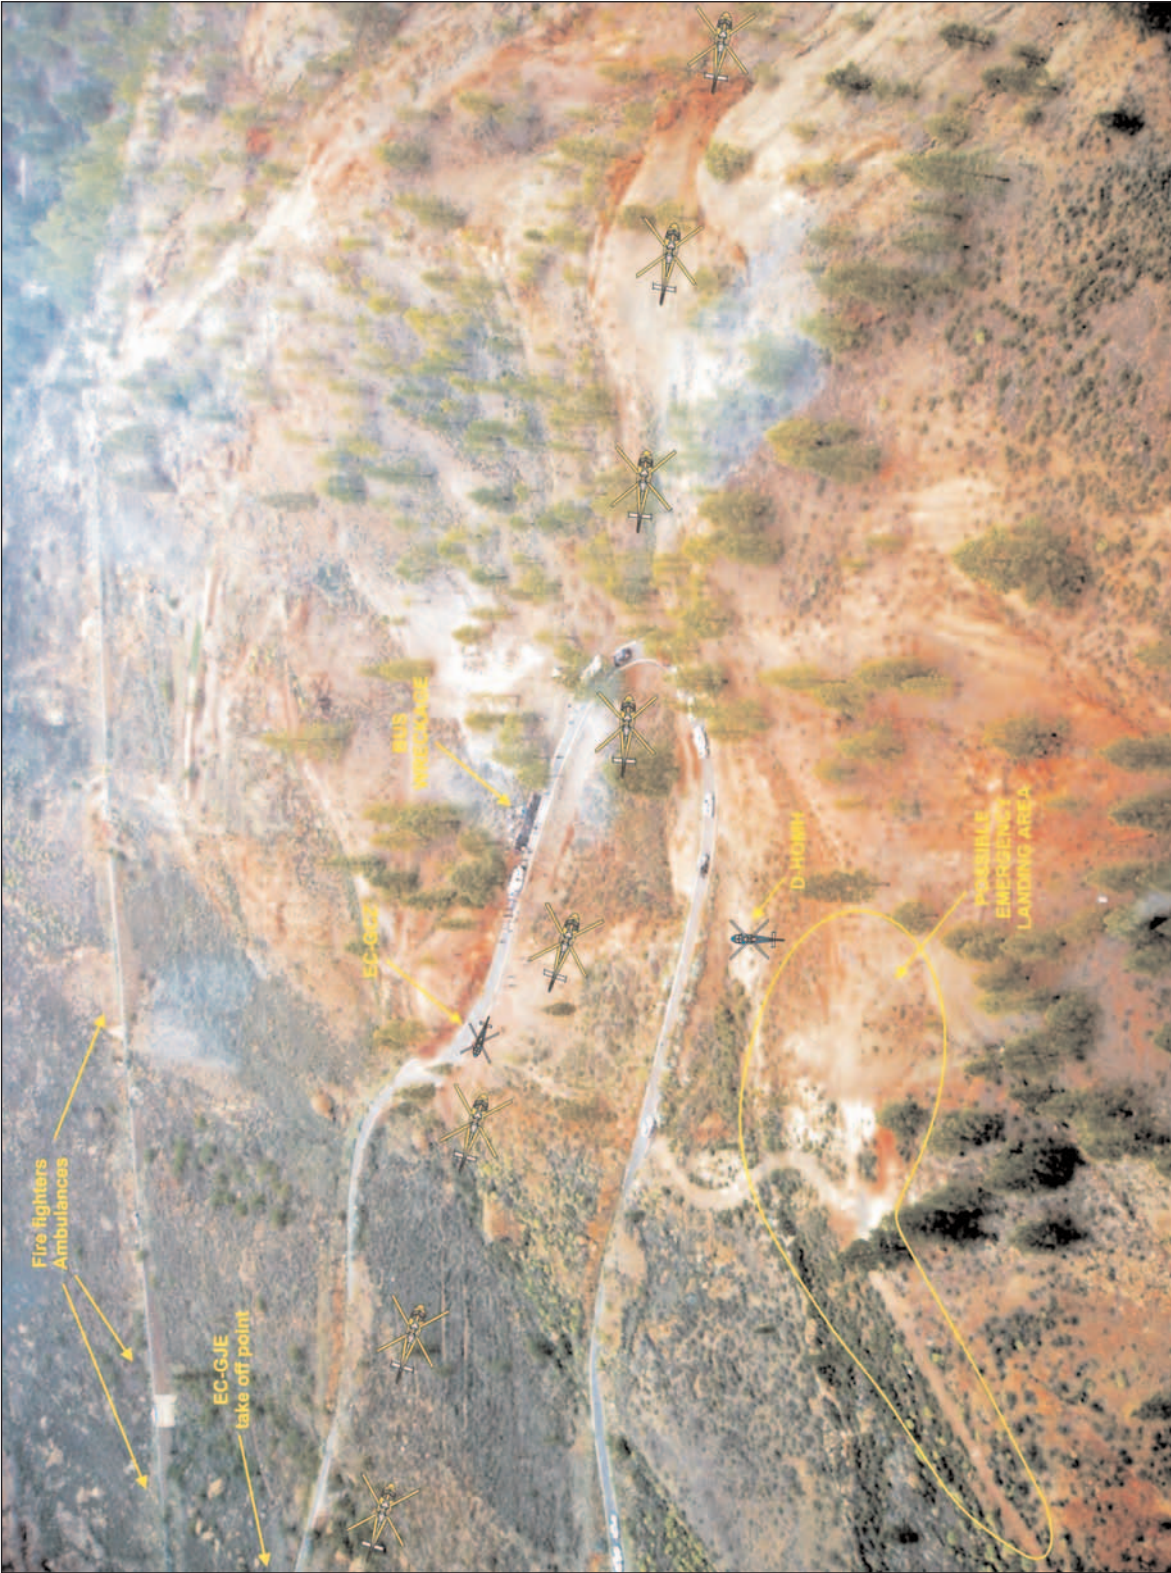
Photo 2. General view of the bus wreckage area and possible landing areas. Trajectory of EC-GJE after the impact represented in accordance with video tape recording (photo: City Hall of San Bartolomé)
