**DATA SUMMARY**

Date and time	<b>Wednesday, 12 May 2004; 19:30 h</b>
Site	<b>Cuatro Vientos Airport (Madrid)</b>

Registration	<b>EC-CTO</b>
Type and model	<b>ROCKWELL COMMANDER 680-F</b>
Operator	<b>ARE Aviación</b>

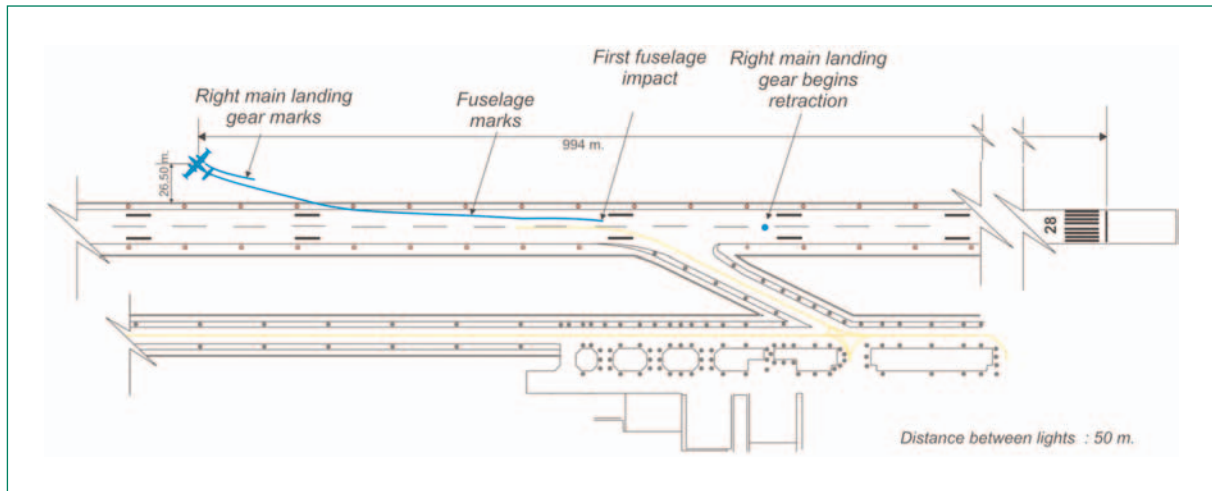
Figure 1. Aircraft path

The aircraft touched down on the runway and a few seconds later the right main landing gear started to retract. The first marks caused by the fuselage appear 650 meters from the threshold. The marks indicating that the aircraft came off the runway appear at approximately 900 meters from the threshold and the aircraft finally stopped 994 meters from the threshold and 26.50 meters from the edge of the runway. The trajectory followed by the aircraft can be seen in Figure 1. The final position is shown in Figure 2.

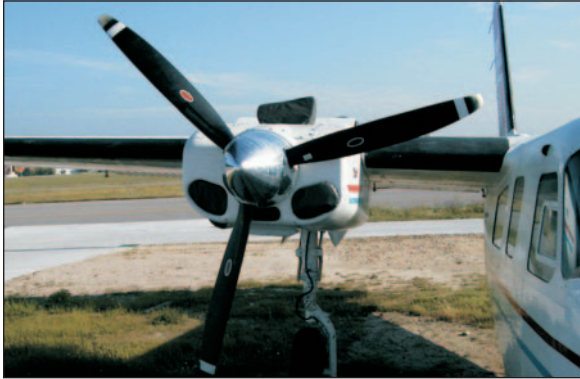
Figure 3. Propeller damages

The aircraft's right propeller was damaged. It was noted that the tips of the three blades were bent and worn due to friction with the runway and the grass verge (see Figure 3). When the right main landing gear retracted, the lower right-hand part of the fuselage touched the runway and then the earth and grass verge, with that whole area of the fuselage suffering deterioration due to friction (see Figure 4). The right-hand edge showed a slight crack probably due to the final contact of this wing with the ground when the aircraft came to a halt.

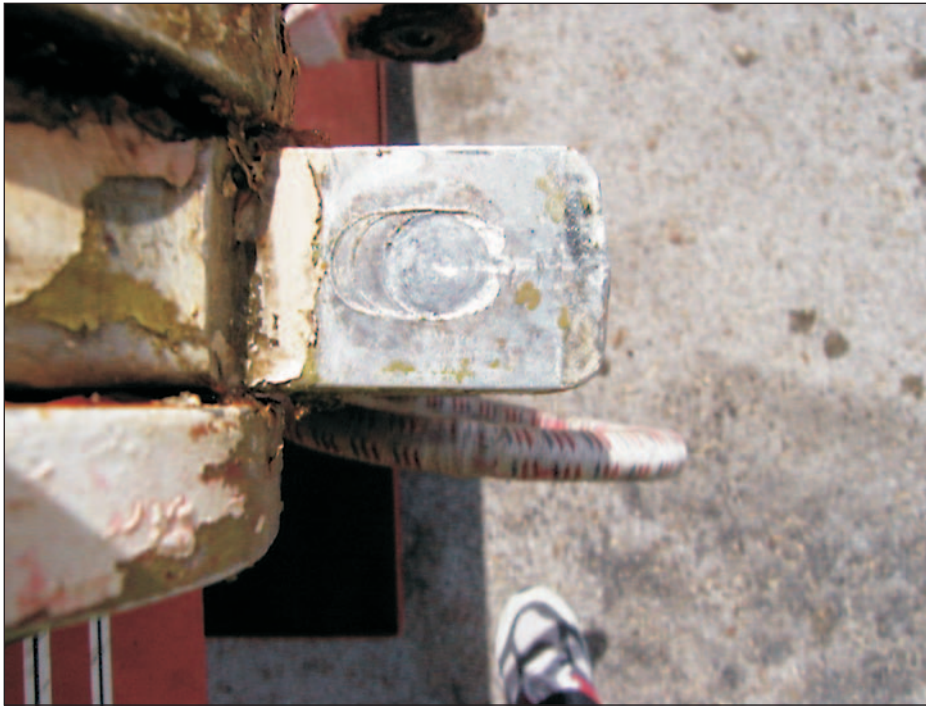
Figure 5.

During disassembly of the right main landing gear, the drag brace assembly was stripped to check the length of the braces. Once stripped, marks were noted on the lower drag brace produced by pin head P/N ED12439. These marks indicated that it had been mounted incorrectly (see Figure 5).

After checking the mounting of pin P/N ED12439 in the left main landing gear it was also found to be incorrectly mounted.

The investigation carried out demonstrated that pin with P/N ED12439 was incorrectly mounted and was preventing the right main landing gear from reaching the overcenter and, therefore, being locked. This would explain the three no commanded landing gear retractions that have occurred in the last three years.

The final conclusion is that the probable cause of the right main landing gear's retraction in the landing roll was that it was not locked due to the incorrect mounting of the pin P/N ED12439 that exerts pressure on the gear down and locked indicator switch, which prevented the overcenter from being reached.

However, because of the result of the investigation, it would be necessary to assure that the pin P/N ED12439 is mounted correctly and it is considered convenient to issue a new safety recommendation in this regard.

**REC 48/2004.** It is recommended to the aircraft's manufacturer that either the design of pin P/N ED12439 or the associated maintenance documentation is modified in order to preclude the possibility of it being incorrectly mounted.

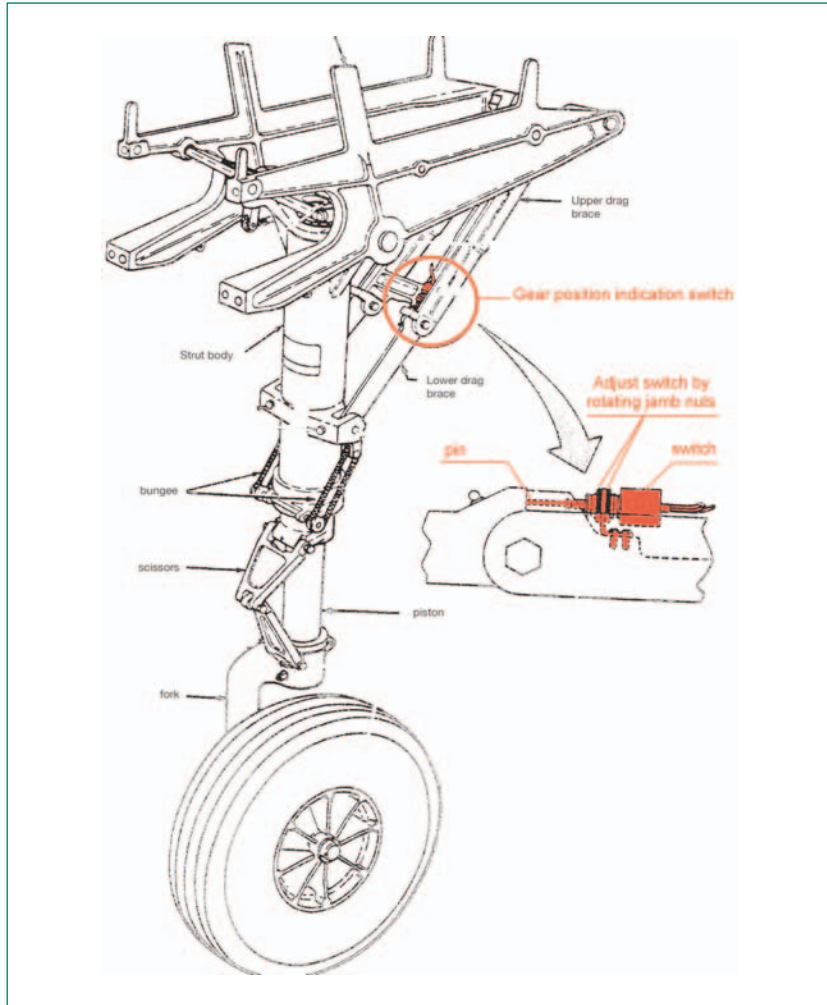
Figure 6. Main landing gear indication switch

- Each green light has a down and locked switch associated with it (see Figure 6) situated in the connection area between the gear's upper and lower drag braces.

- According to information made available by an authorized Aerocommander maintenance centre, there is no specific maintenance for pin P/N ED12439. The aircraft's maintenance manual does not specify the correct position of the pin. Only one figure appears which shows the switch-pin assembly in detail, as can be seen in Figure 6.

The lack of information in the maintenance manual relative to the pin's position would have contributed to this error and would have prevented maintenance staff in subsequent inspections from noticing that the pin was not correctly mounted.

A contributing factor to this incident is the lack of information in the aircraft's maintenance manual relative to the detailed mounting of pin P/N ED12439.

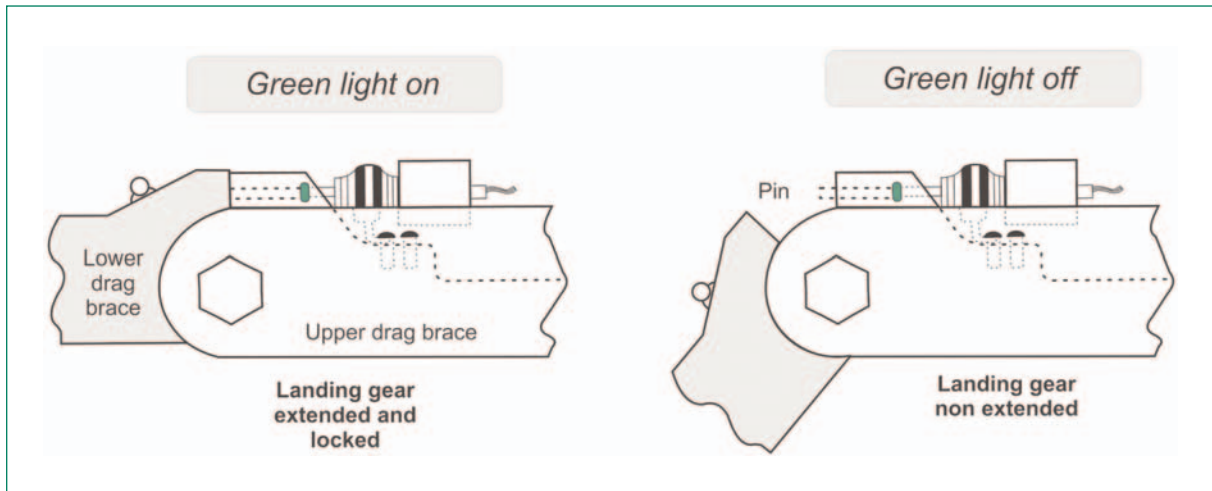
Figure 8. Right rigging of pin P/N ED12439

- The correct position of the pin is with the head upwards exerting pressure on the switch.
- In order to be able to change the pin's position from the correct one, with the head upwards, to the wrong one, with the head downwards, the gear down and blocked indicator switch has to be disassembled (see Figures 8 and 9).
