DATA SUMMARY

Date and time	Friday, 21 May 2004; 04:52 UTC¹
Site	Palma de Mallorca Airport

Registration	EC-ITP
Type and model	FAIRCHILD SA227-BC, SWEARINGEN METRO III
Operator	Top Fly

REPORT

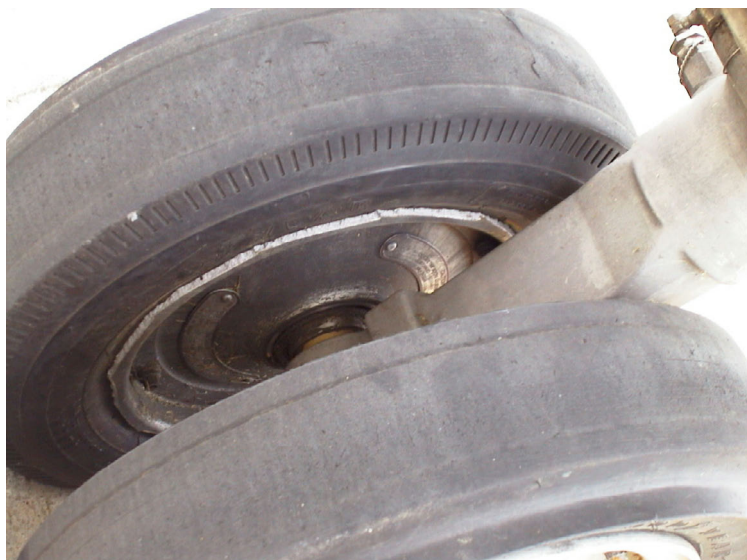
Figure 2. Nose gear wheels

The NLG tires were oriented to the right. The inboard rim of the NLG left wheel was chipped and cracked radially along its perimeter (Figure 2).

departure. The damage to the left nose wheel rim is consistent with a skid and an improperly facing wheel.

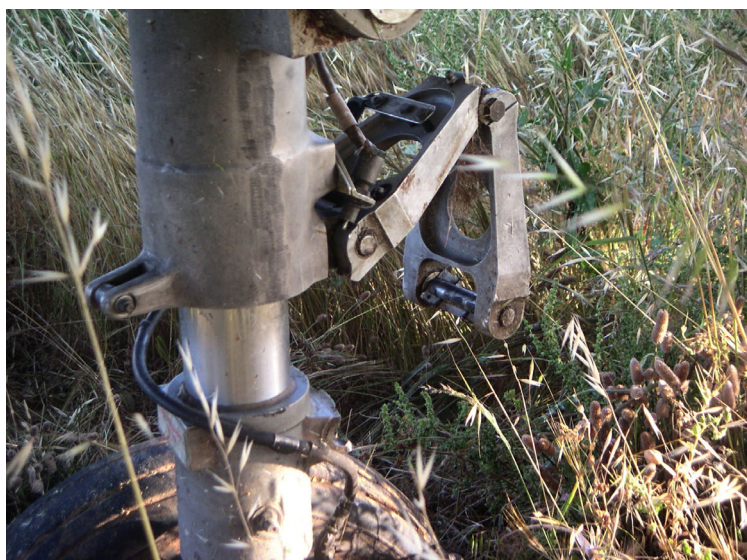
Figure 3. RH main leg. Breakage of the torsion link

After the incident it was noted that the RH MLG leg torsion link lower lug, in the sliding member of the strut, was torn off (Figure 3). The fracture surface showed evidence of brittle fracture.

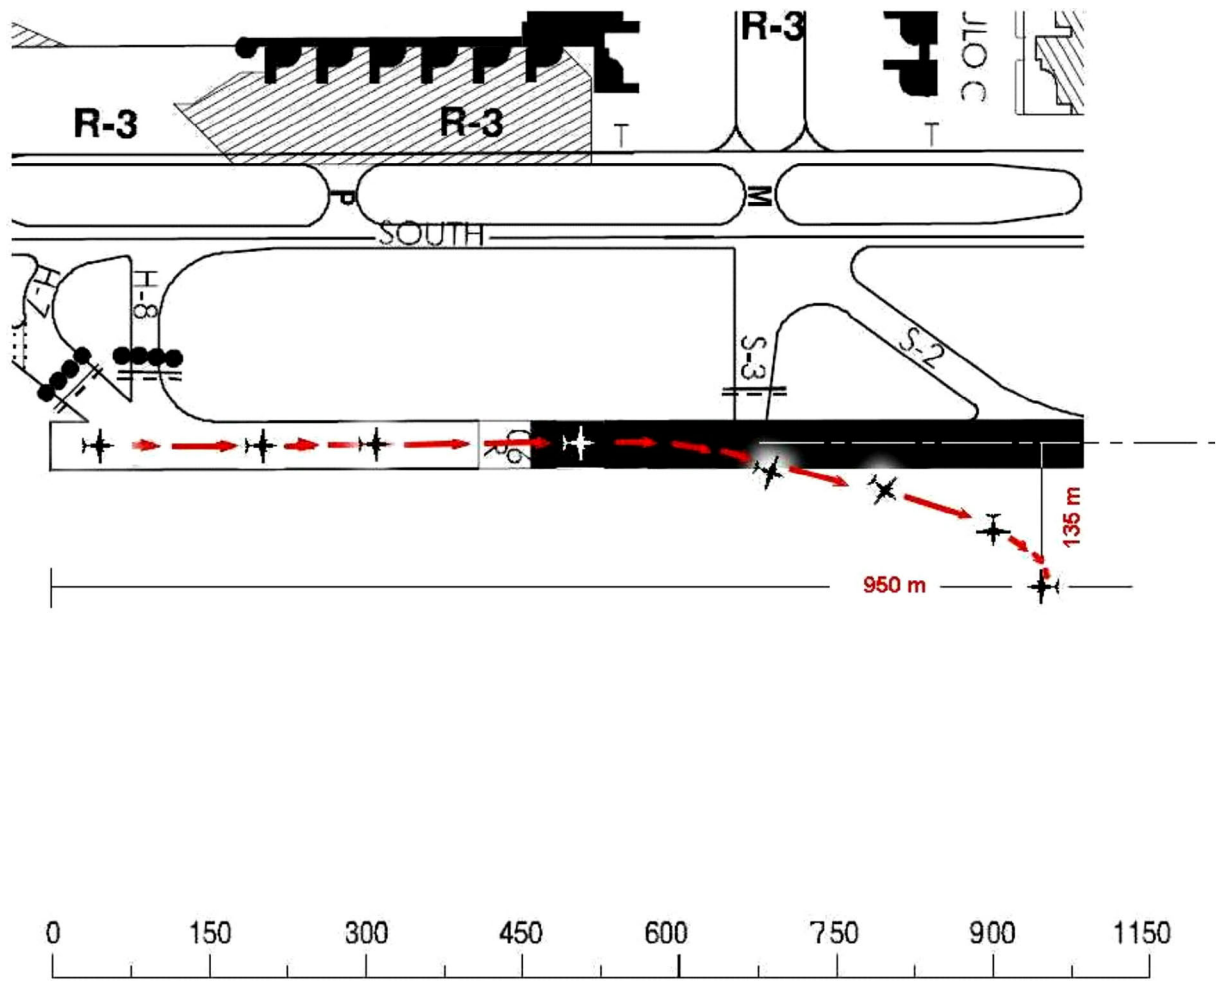
A-2. Partial view of runway 06R and trajectory of the acceleration-stop

The ground on the runway strip was covered with grass almost a meter tall, which resulted in the wheels tracing out the aircraft's trajectory as it skidded for 260 m beyond the runway before coming to a stop.

The aircraft stopped 135 m away from the runway 06R centerline and 950 m away from its threshold (see trajectory in Appendix A-2).

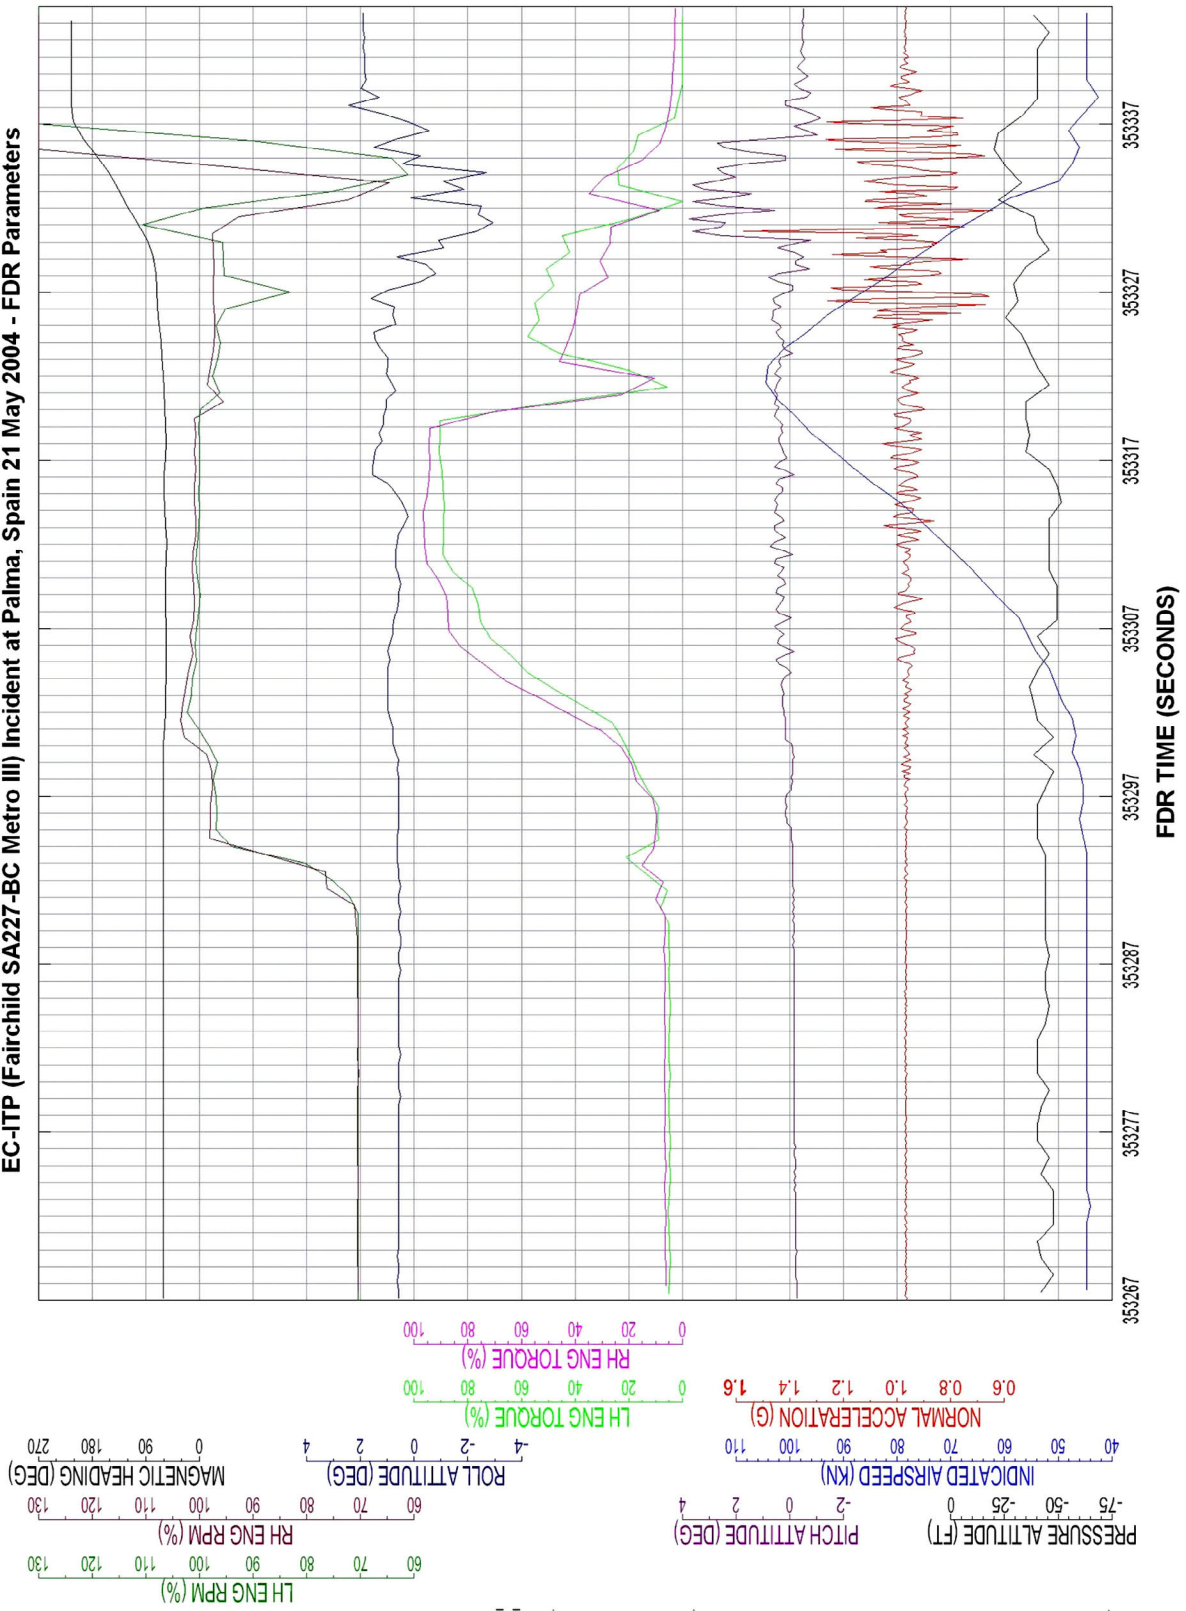
C-1. FDR parameter graphs

The data recorded revealed that both engines were at 100% RPM before the brakes were released, and that torque increased to 90% in the LH engine and 95% in the RH engine.

The aircraft accelerated normally to a speed of 107 kt in about 18 seconds. The decision to abort the takeoff was made some three seconds before the maximum speed was reached, as evidenced by engine thrust being reduced to ground-idle.

Reverse thrust was obtained two seconds later, the torque reaching 55% in the LH engine and 40% in the RH engine for a period of seven seconds.

The sharp fluctuations in vertical acceleration some 22 s after brake release mark the instant the aircraft left the paved surface.

The increase in the pitch and roll angles some 28 s after brake release mark the skidding and turning motion of the aircraft on the ground.

The aircraft came to a stop some 38 s after brake release. The aircraft's heading increased from the moment it left the runway, eventually settling on 220° some 4 s before coming to a stop.
