DATA SUMMARY

Registration	EC-GXE
Type and model	FAIRCHILD SA227-AC, Swearingen METRO III
Operator	Swiftair

Operation	Commercial air transport – Non-scheduled domestic cargo
Phase of flight	Take-off run, before V1

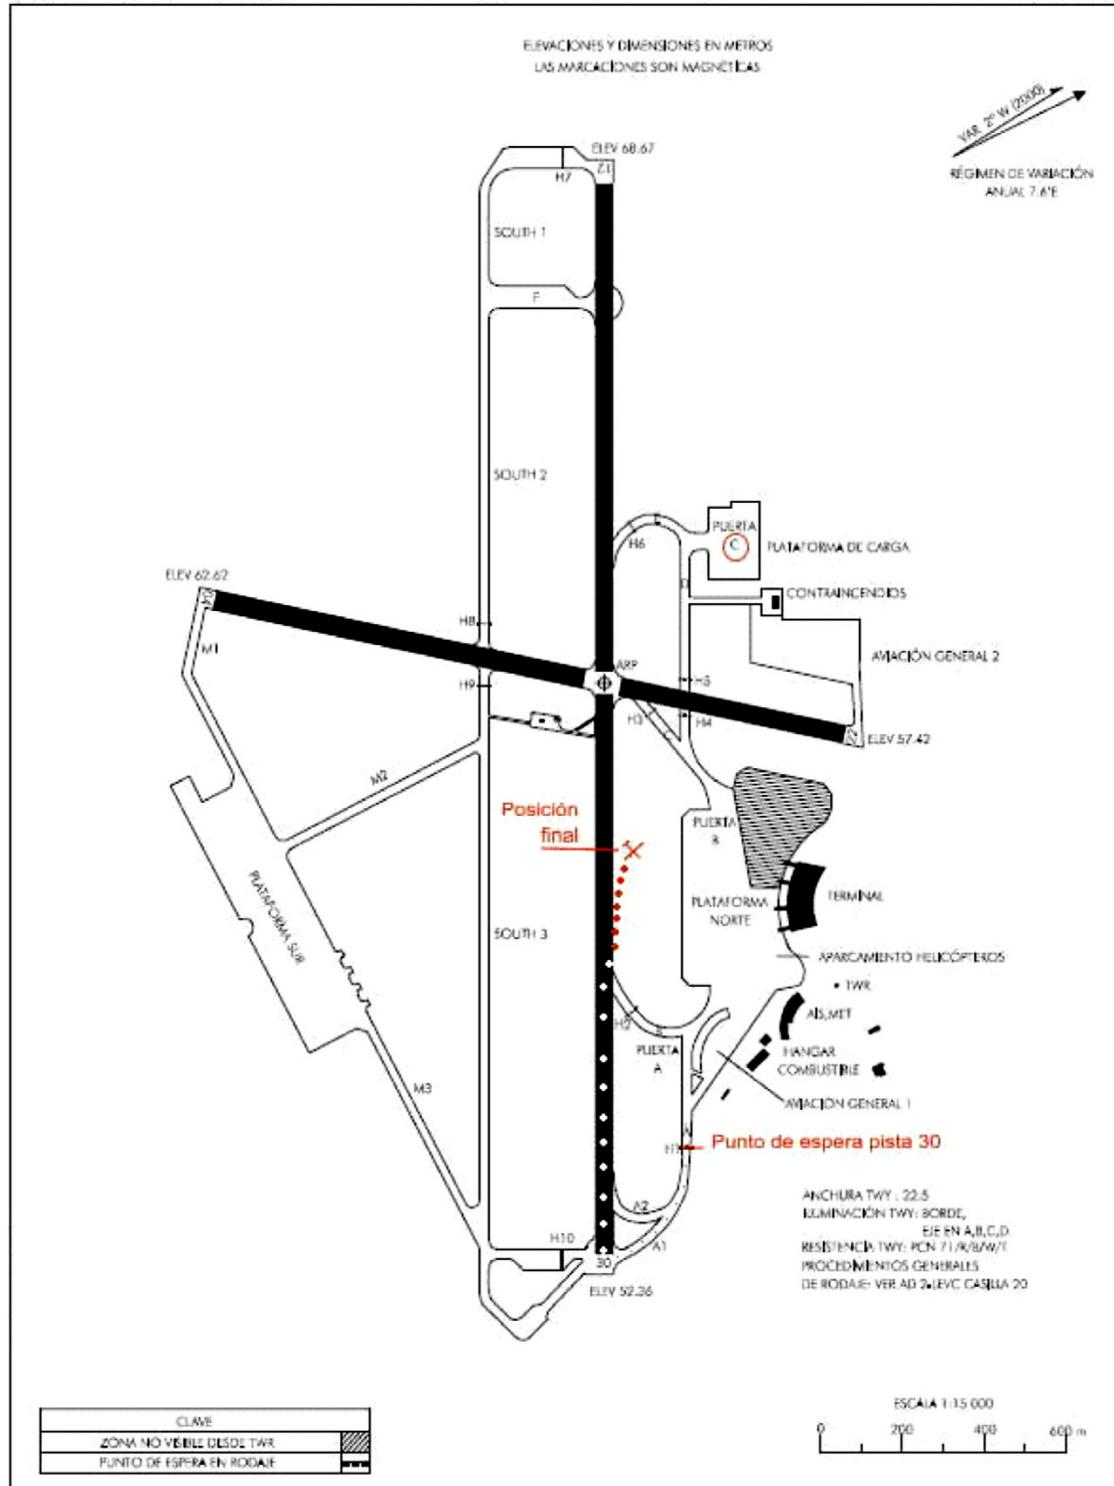
A-1. Airport chart and rejected take-off path

In APENDIX A, an airport chart for ground movements is shown. In this chart the cargo apron, holding point H1 for runway 30 and the supposed trajectory of the airplane are depicted.

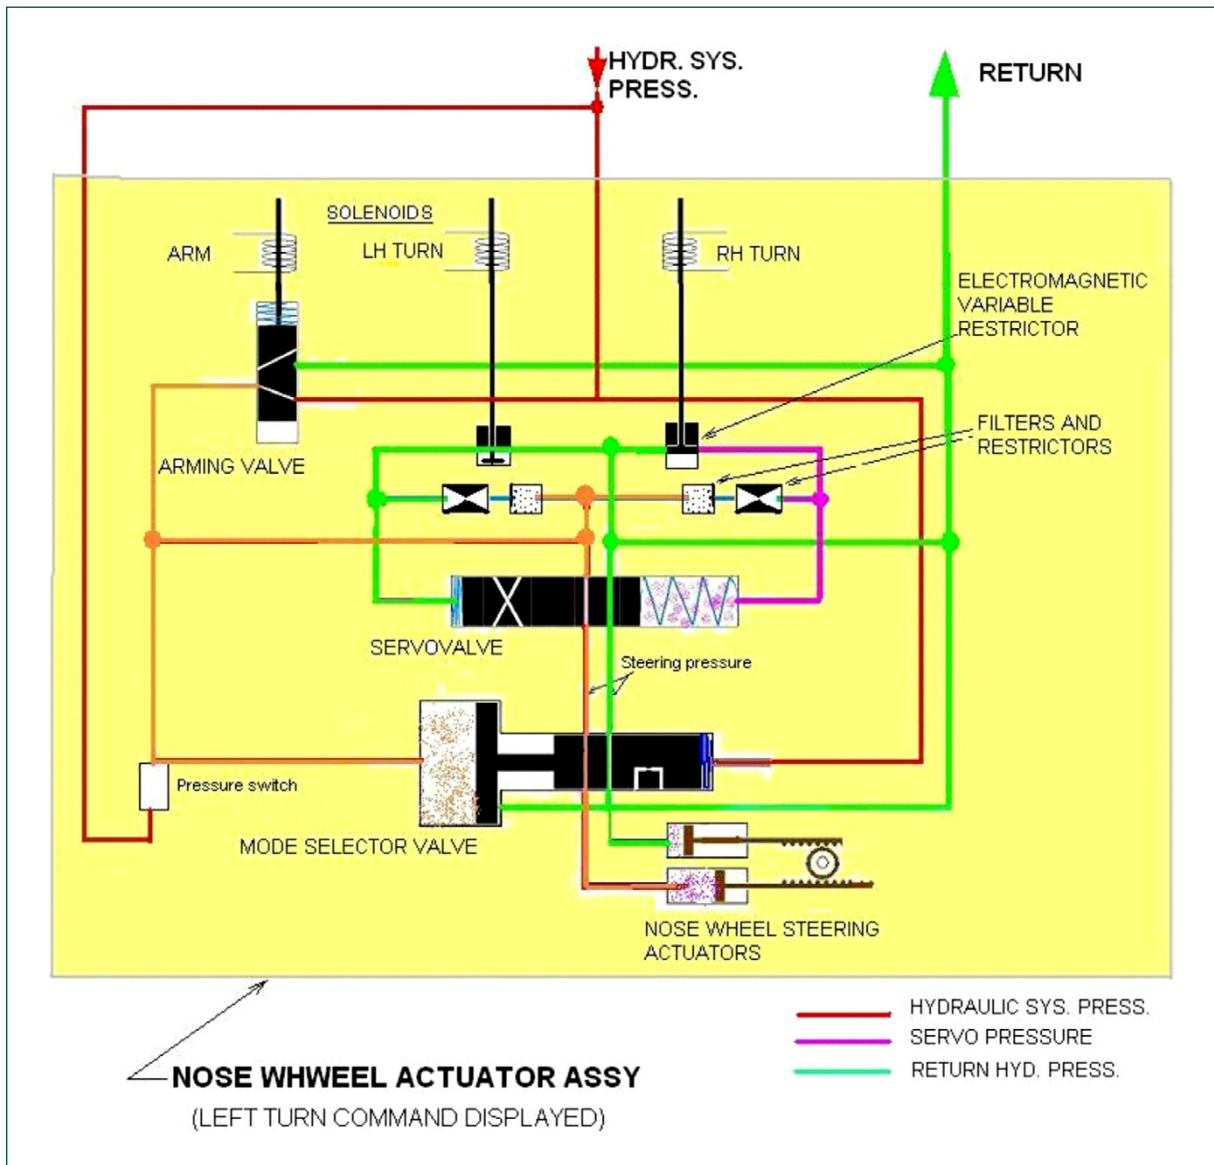
B-1. Hydraulic schematic diagram

Components of the NWS system hydraulic assembly (see diagram Appendix B-1)

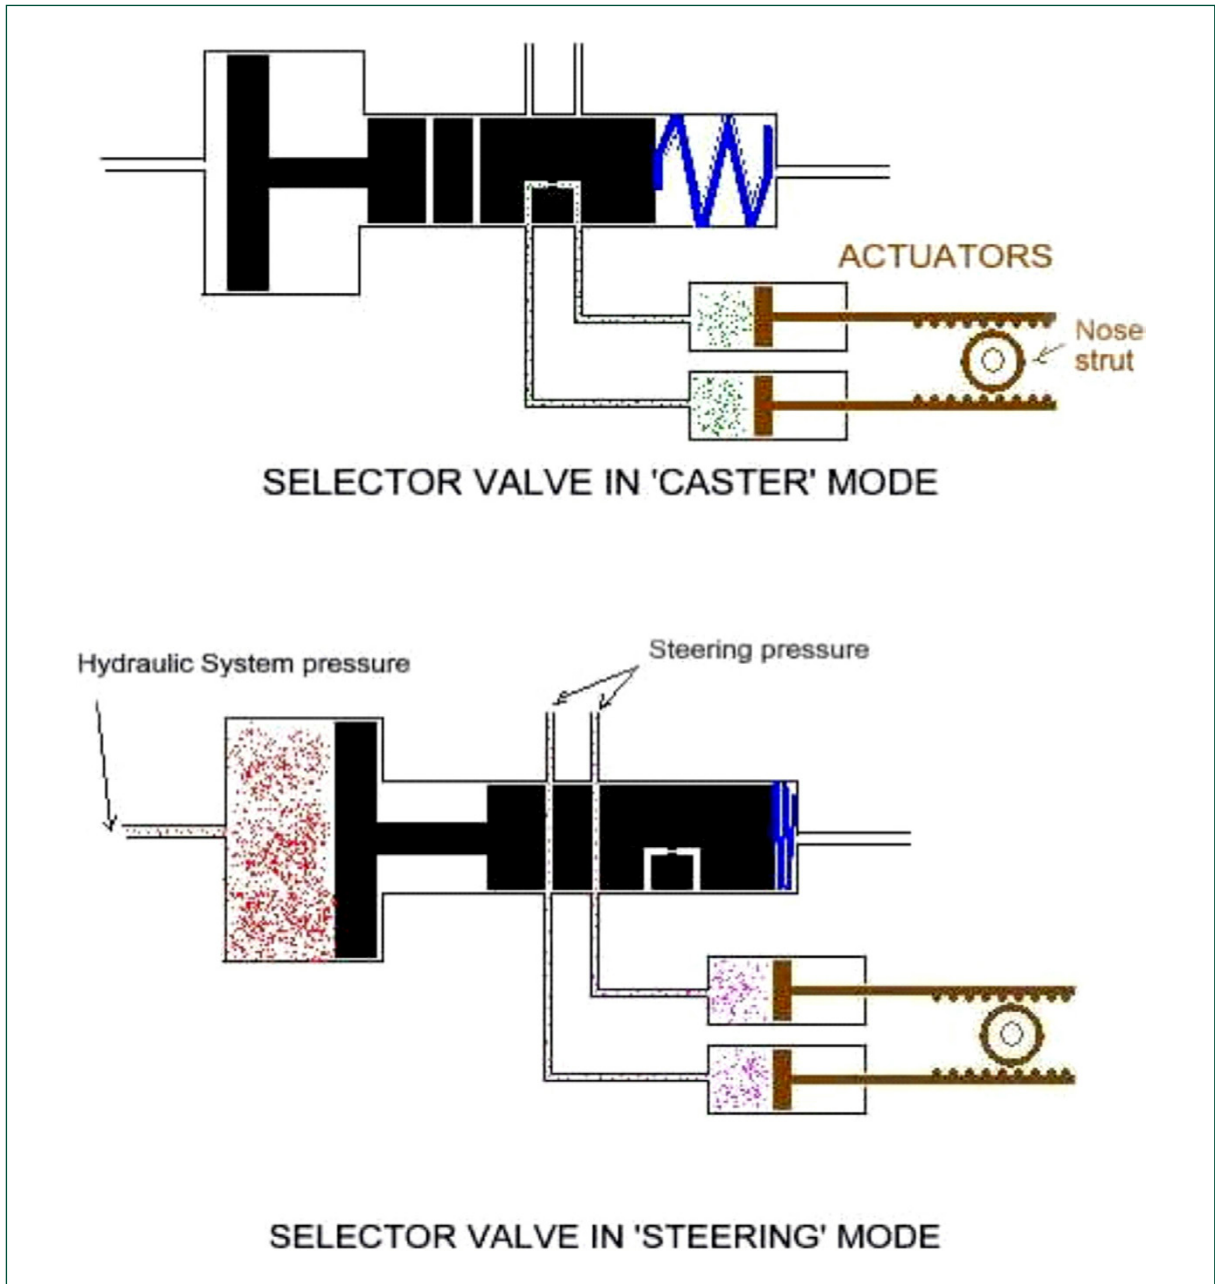
B-2. Mode selector valve

- A mode selector valve with two positions: steering mode, in which hydraulic system pressure is directed to the actuators controlling the nose wheel; and caster mode, in which the hydraulic liquid is isolated from the hydraulic system but allowed to flow between actuators, which serves to dampen shimmy. In caster mode, the NWS system is deactivated and the nose wheel is self-aligning, and thus not controlled from the cockpit (see detail in Appendix B-2).

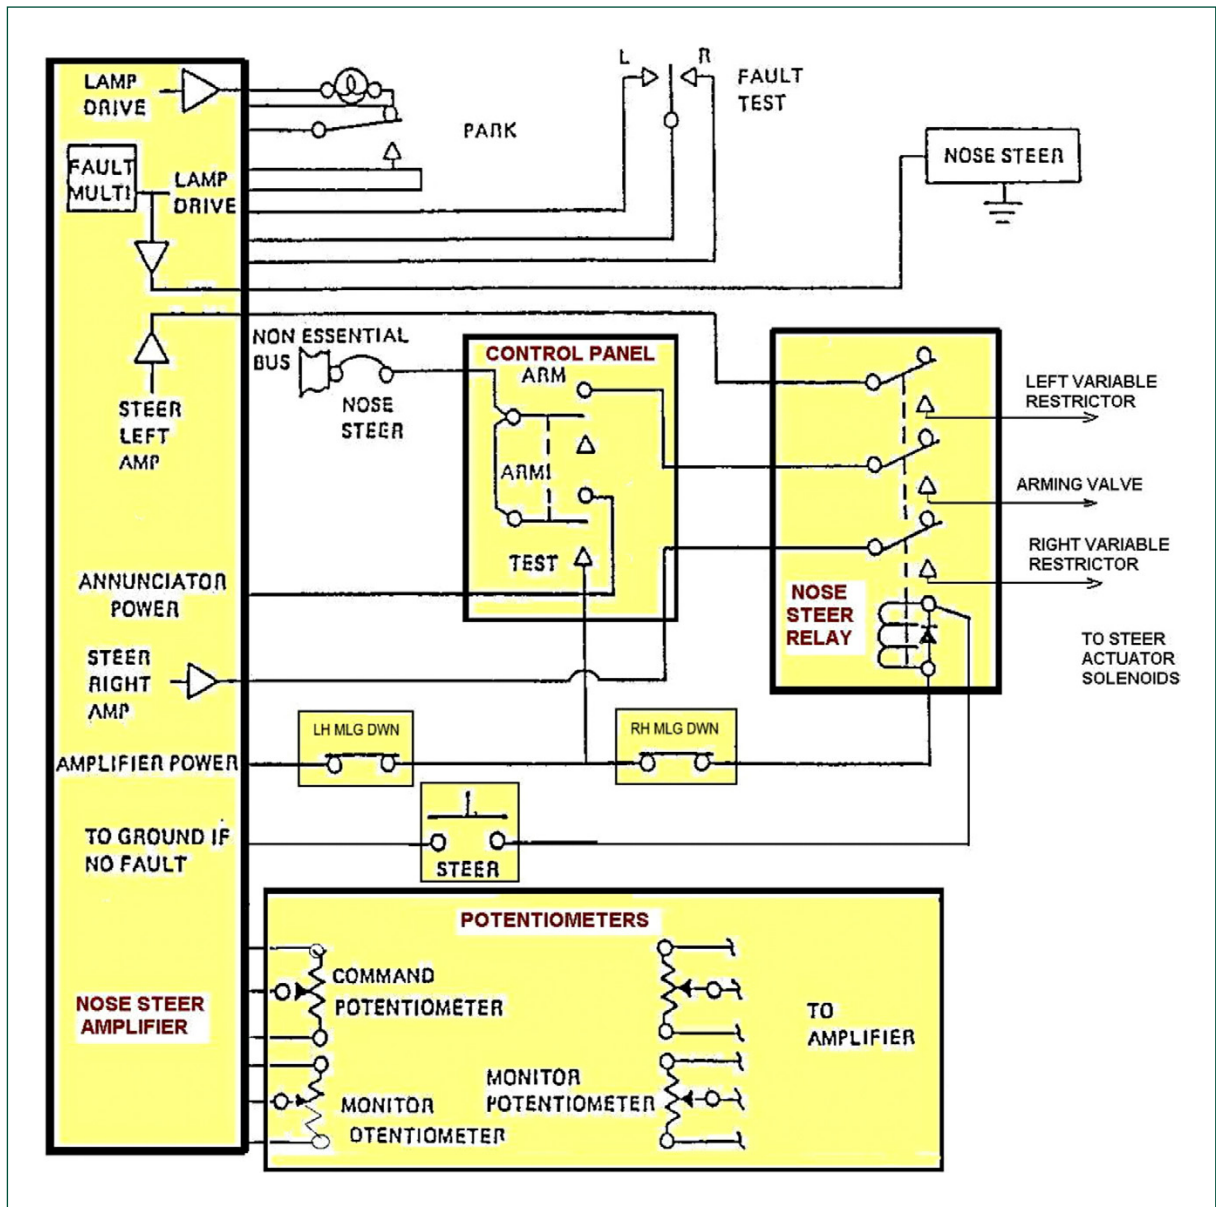
B-4. Electrical schematic diagram

- 1.° The system is armed,
- 2.° Either the power lever pushbutton or the speed lever microswitch is actuated, and
- 3.° The landing gear is deployed. (See the NWS electrical diagram in Appendix B-4).
