DATA SUMMARY

Registration	EC-GPA
Type and model	BELL 412, s/n 36071
Operator	Helisureste

1. FACTUAL INFORMATION

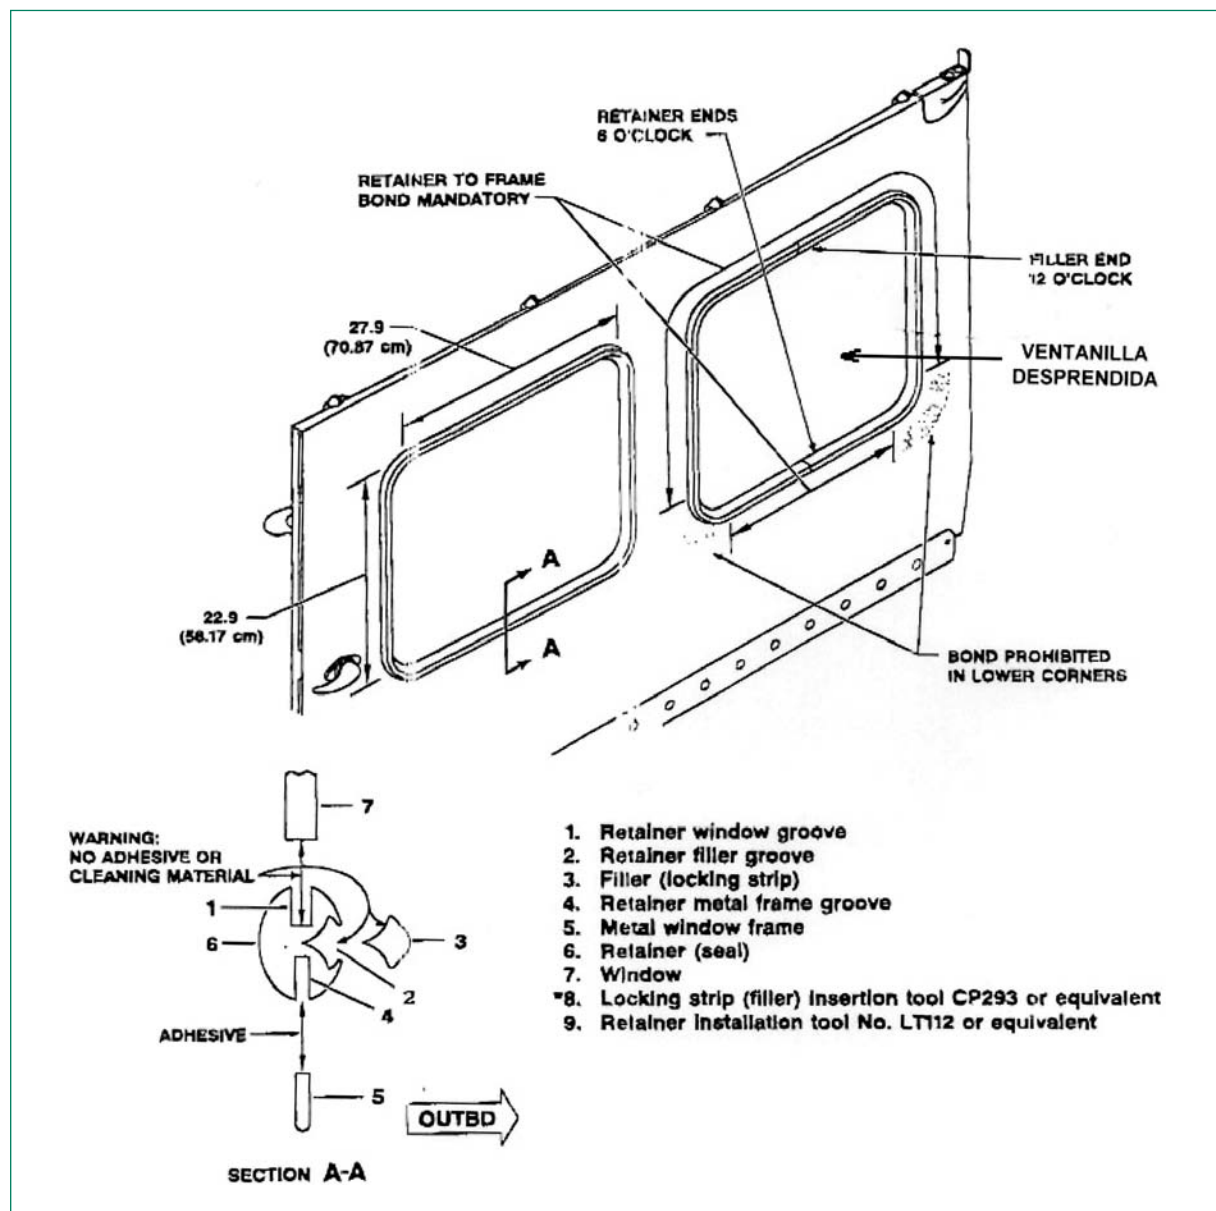
Figure 1. Drawing of the two windows of the left hand rear passenger door

provided for inspection, removal and installation. Every time the window is removed from the retainer, the «retainer» (part 6 of Figure 1) and the «filler» (part 3 of Figure 1) shall be replaced. No repairs are allowed on both components. The retainer is bonded to both sides of the window frame all along its contour except in the curved area of the lower corners, to allow its opening by pushing those areas.

On 03-06-2004, when the first repair was carried out after a corner of the window was found open, the filler (see item 3 in Figure 1) was still in place, and there were no signs that the retainer or seal (see item 6 in Figure 1) had started to detach in that corner. The rests of silicone of the frame were removed and sandpaper was applied, according to the information provided by the technician that carried out the repair. The retainer was replaced using the corresponding original repair kit (P/N 412-669-100), provided by the official Bell supplier in Amsterdam. After the repair, the decals of «EMERGENCY PUSH HERE» continued installed.
