Report A-070/2004

Accident to BOEING B-737,
registration PH-BTC, at
Barcelona Airport (Spain),
on 28 November 2004

(Issue 2)

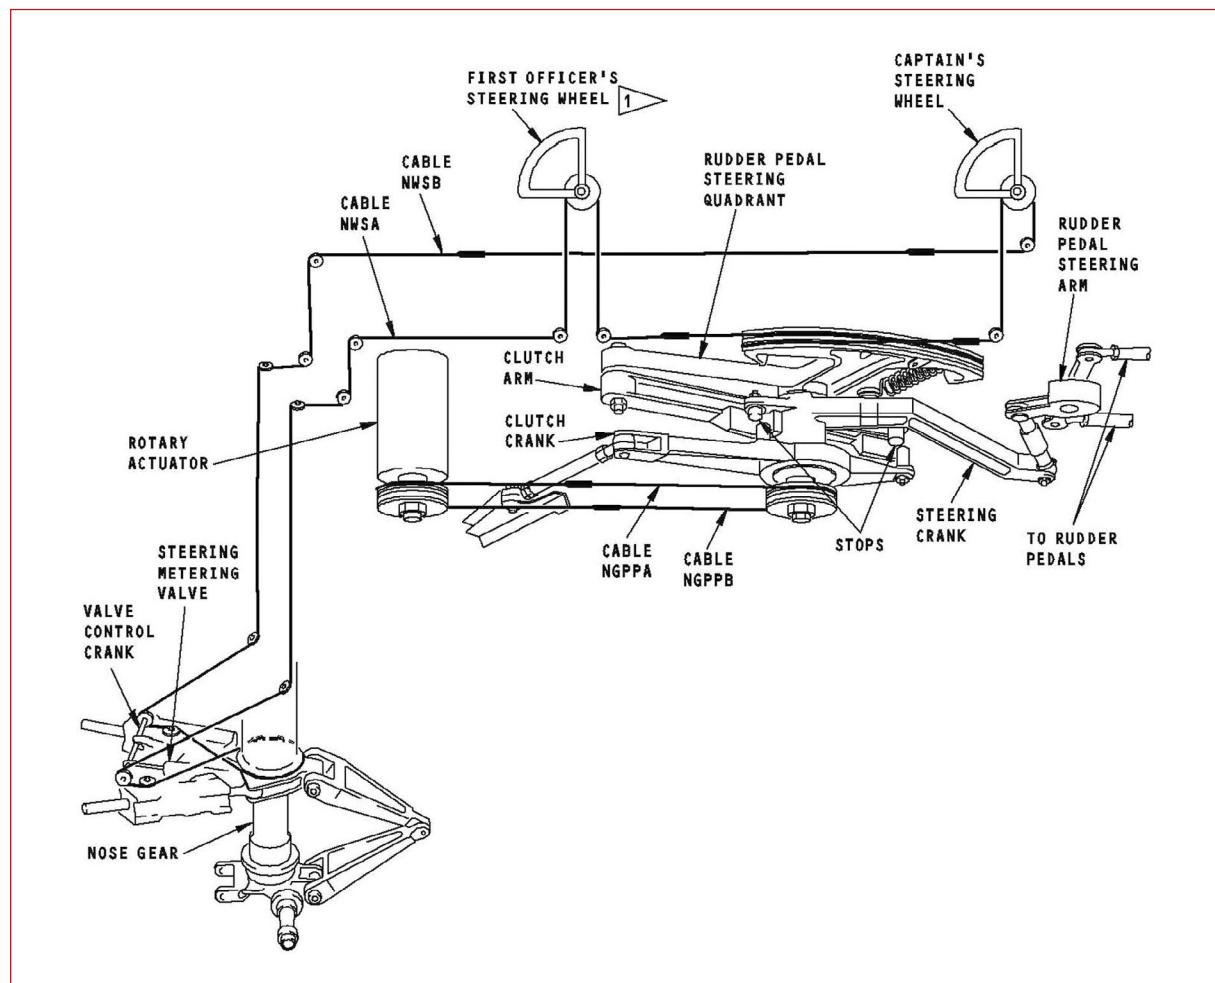
Figure 1.6.1. NWS mechanism from the AMM. Cable NWSB (on the right side of the NLG when looking in the direction of the flight) was found broken after the accident

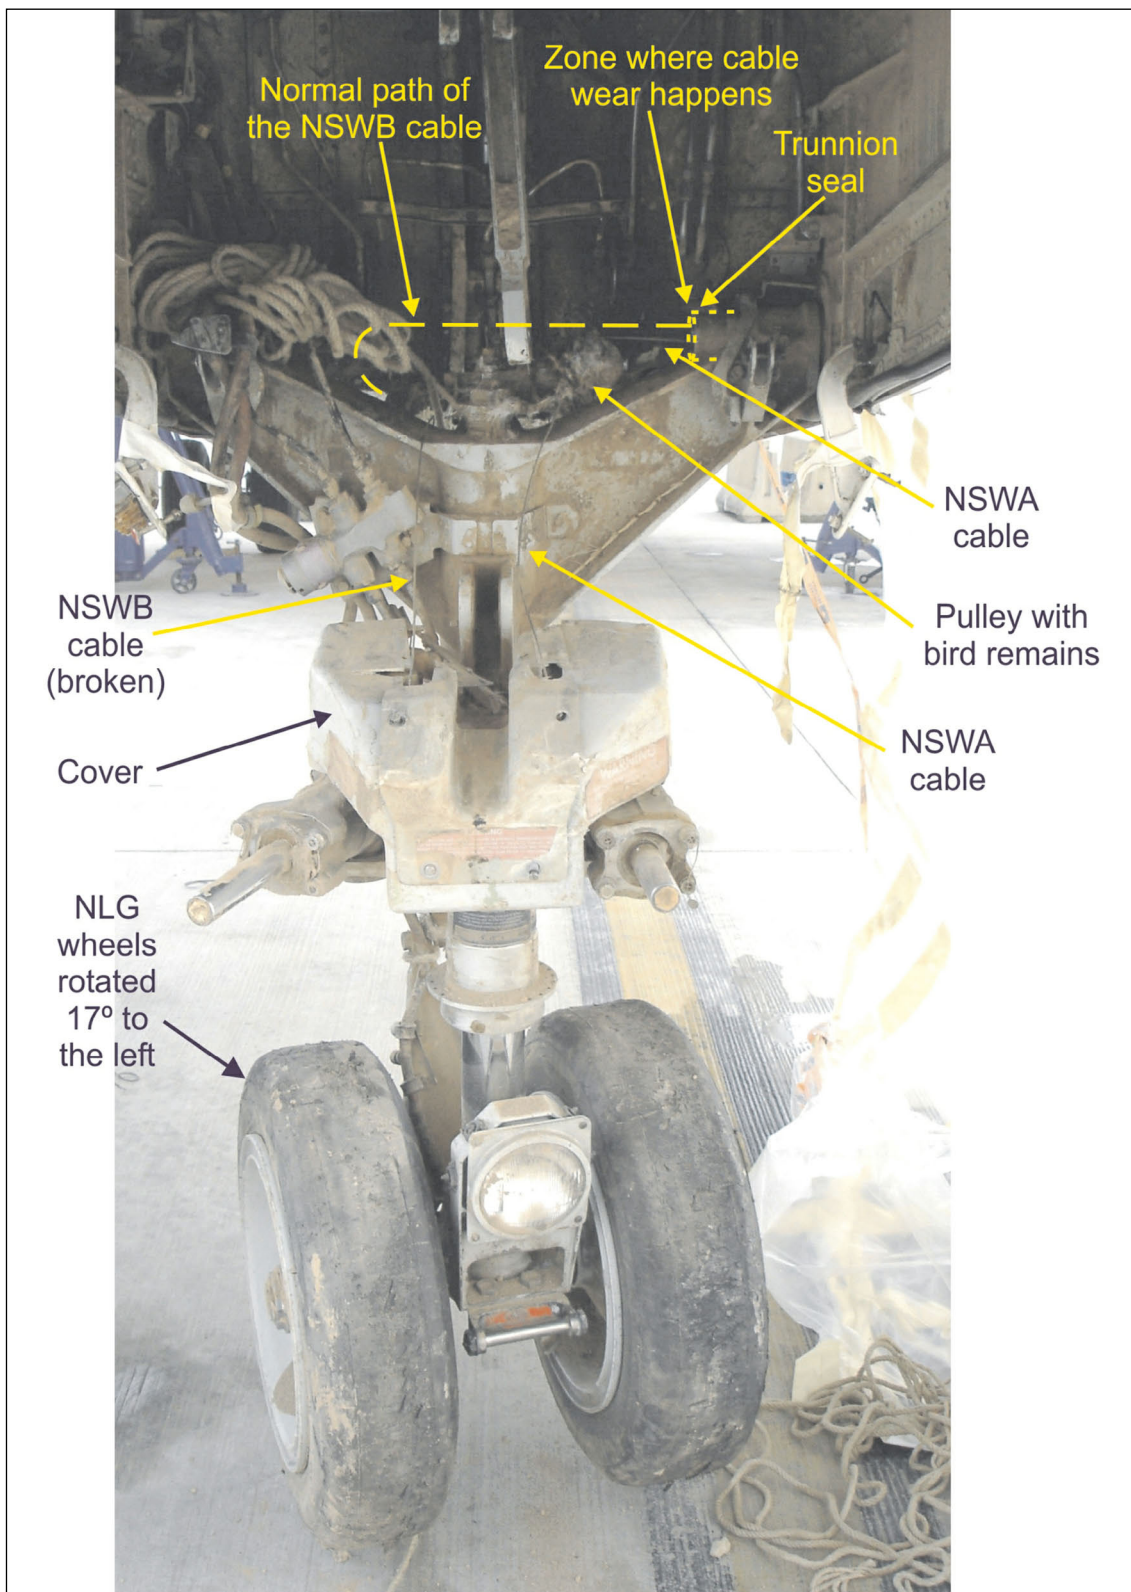
Figure 1.6.2. View of the front part of the NLG after aircraft recovery. The NSWB cable was found broken. The NSWA cable did not break, although it was also worn in the zone of the trunnion seal and its pulley had bird remains

In the nose wheel steering system, the bearings in both upper shock strut pulleys were pushed out such that the pulleys were wedged against the pulley bracket and did not rotate. The NWSB cable was fractured at a point 56 cm from the turnbuckle (see Figure 1.6.2). It appeared to be at the approximate point where it entered into the trunnion pin pressure seal. Examination of the cable under a magnifying glass showed signs of worn cable strands and wires. The upper pulley bracket for NWSB cable was fractured. Both cables and pulleys had bird remains on them. The steering valve cover was smashed in several places and attach brackets were fractured. Several other steering mechanism components were also fractured. The steering valve was intact. All components were heavily contaminated with dirt. First officer's tiller felt normal when operated left or right. Captain's tiller was very stiff in left direction and bound up prior to full turn inputs. Right turns had no resistance at all regardless of turn angle input. Rudder pedal operation felt normal.

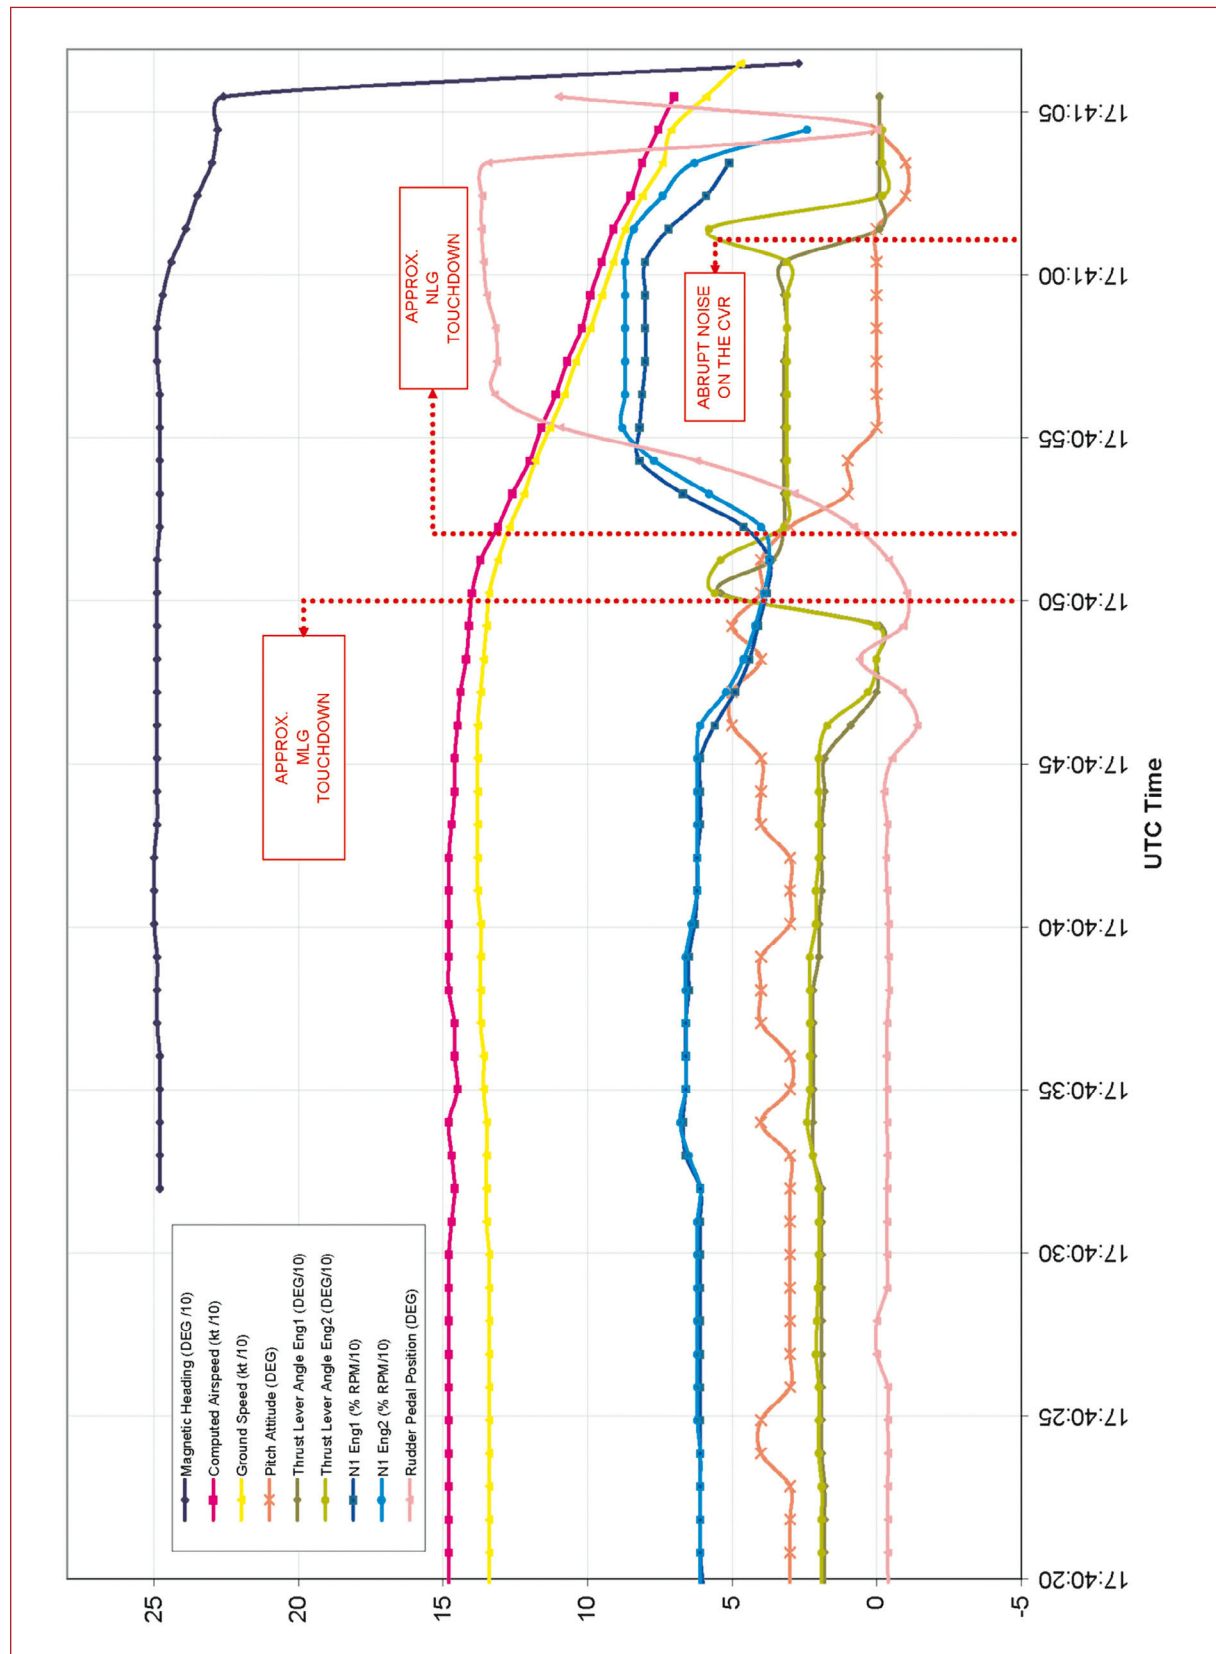
Figure 1.11.2.1. Several parameters during landing

The deflection of the pedal continued until it reached the maximum with airspeed of 111 kt at 17:40:56 h.

Between 17:41:01 and 17:41:03 h the aircraft exited the paved surface of the runway and noises were recorded on the CVR. At around 17:41:01 h the left and right thrust reversers were stowed. The DFDR showed that the LH thrust lever was moved to idle, and the value of LH N1 (rotational speed of the fan) also decreased. The RH thrust lever was advanced and then also retarded to idle. The maximum lateral acceleration (-0.29 g) was recorded at 17:41:01 h with 91 kt of airspeed (87 kt of groundspeed) while the maximum vertical acceleration (1.49 g) was recorded at 17:41:03 h with 81 kt of airspeed (74 kt of groundspeed).

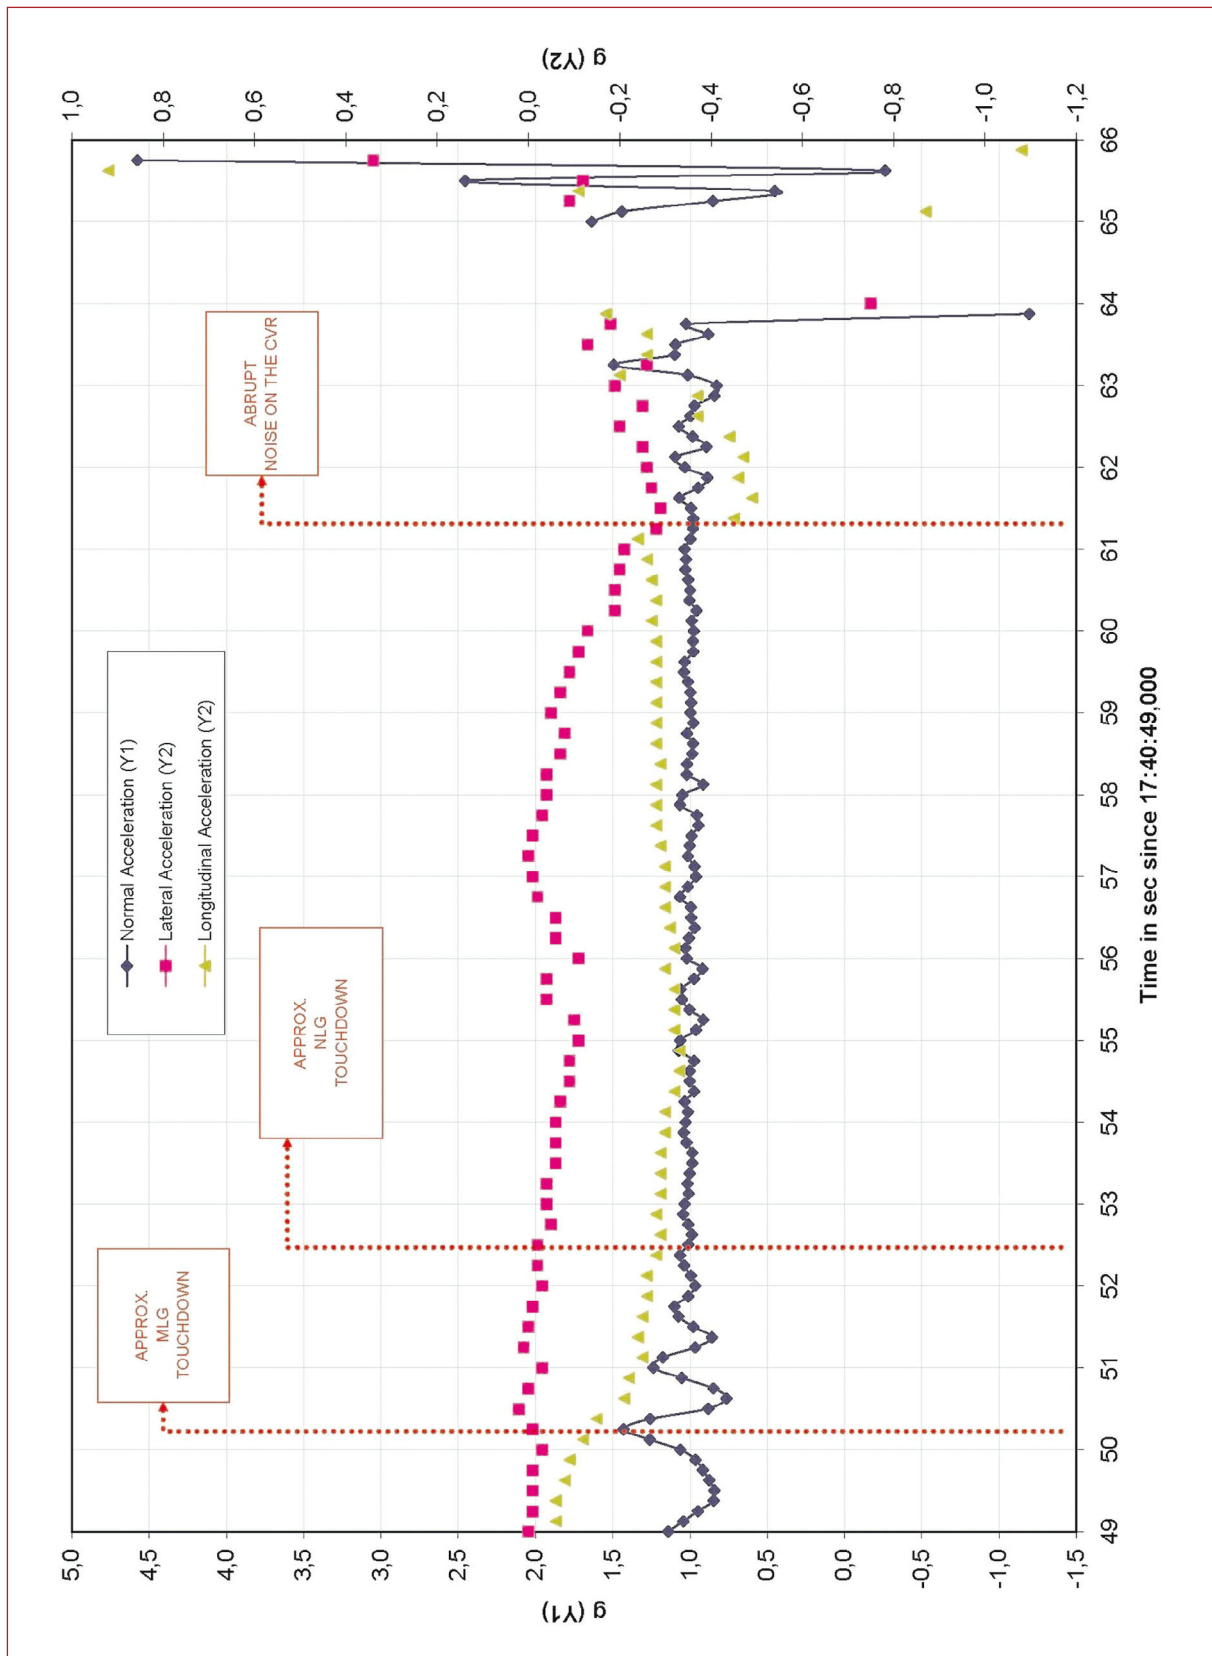
Figure 1.11.2.2. Accelerations during touchdown and landing roll

Since that moment (17:41:03 h), the parameters recorded on the DFDR are no longer reliable, according to the conclusion of the manufacturer specialists. The aircraft suffered heavy deceleration in the unprepared area beside the runway until it came to a stop. Therefore, it was not possible to ascertain the position of the levers or the values of the accelerations during the final part of the off-runway run.

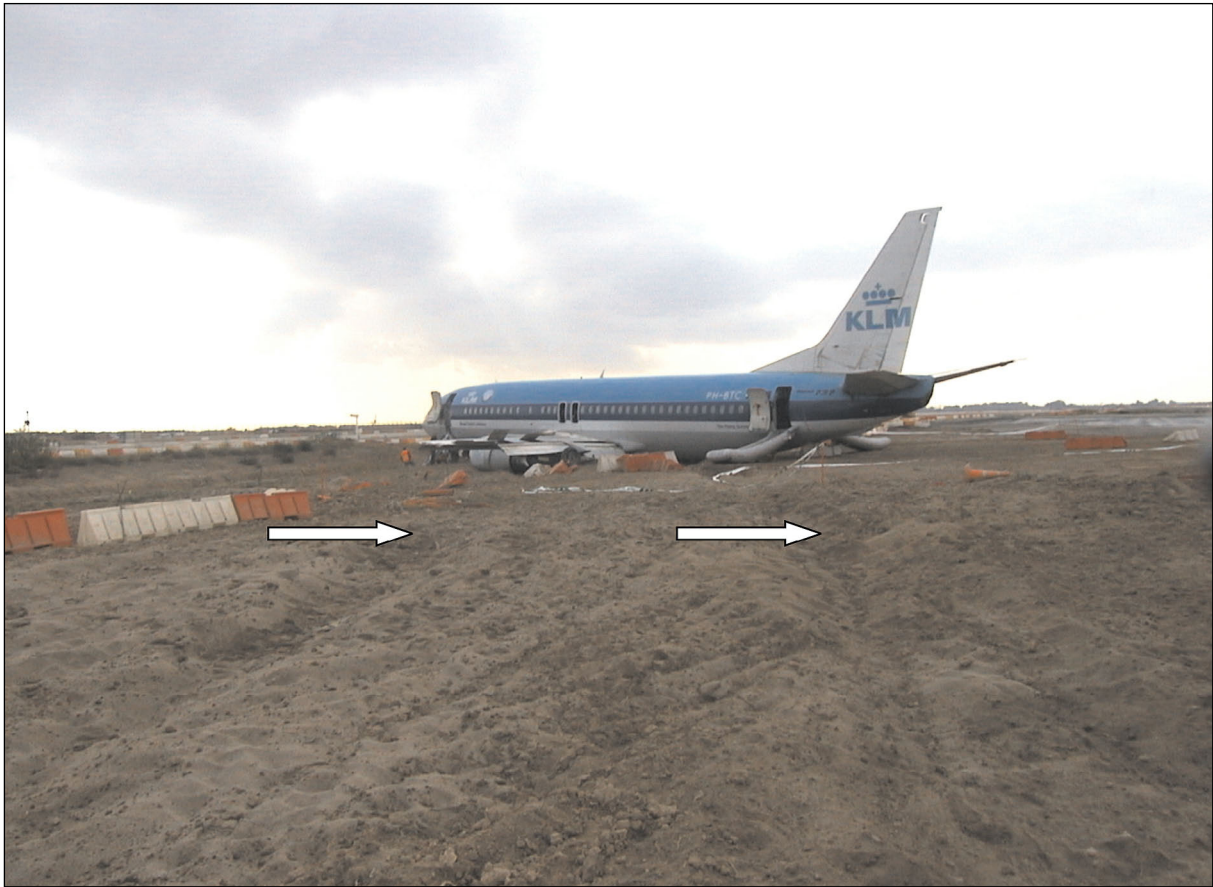
The aircraft exited the surface of runway 25R and went through another paved area under construction of some 10 m in width after jumping a step of approximately 10 cm of height. After passing over a trench around 20 cm deep, it then entered an unprepared zone covered mostly by sand and the landing gear dragged through the unprepared surface. The aircraft crossed a plastic fence line and suffered some damage from iron bars that were supporting construction signaling nets. The NLG and the LH MLG hit a buried pipeline that probably made them collapse and detach, respectively (see white arrows in the attached Photo 1.12.1.1).

Photo 1.12.1.1. Buried pipe noted in the tracks of the LH MLG and NLG

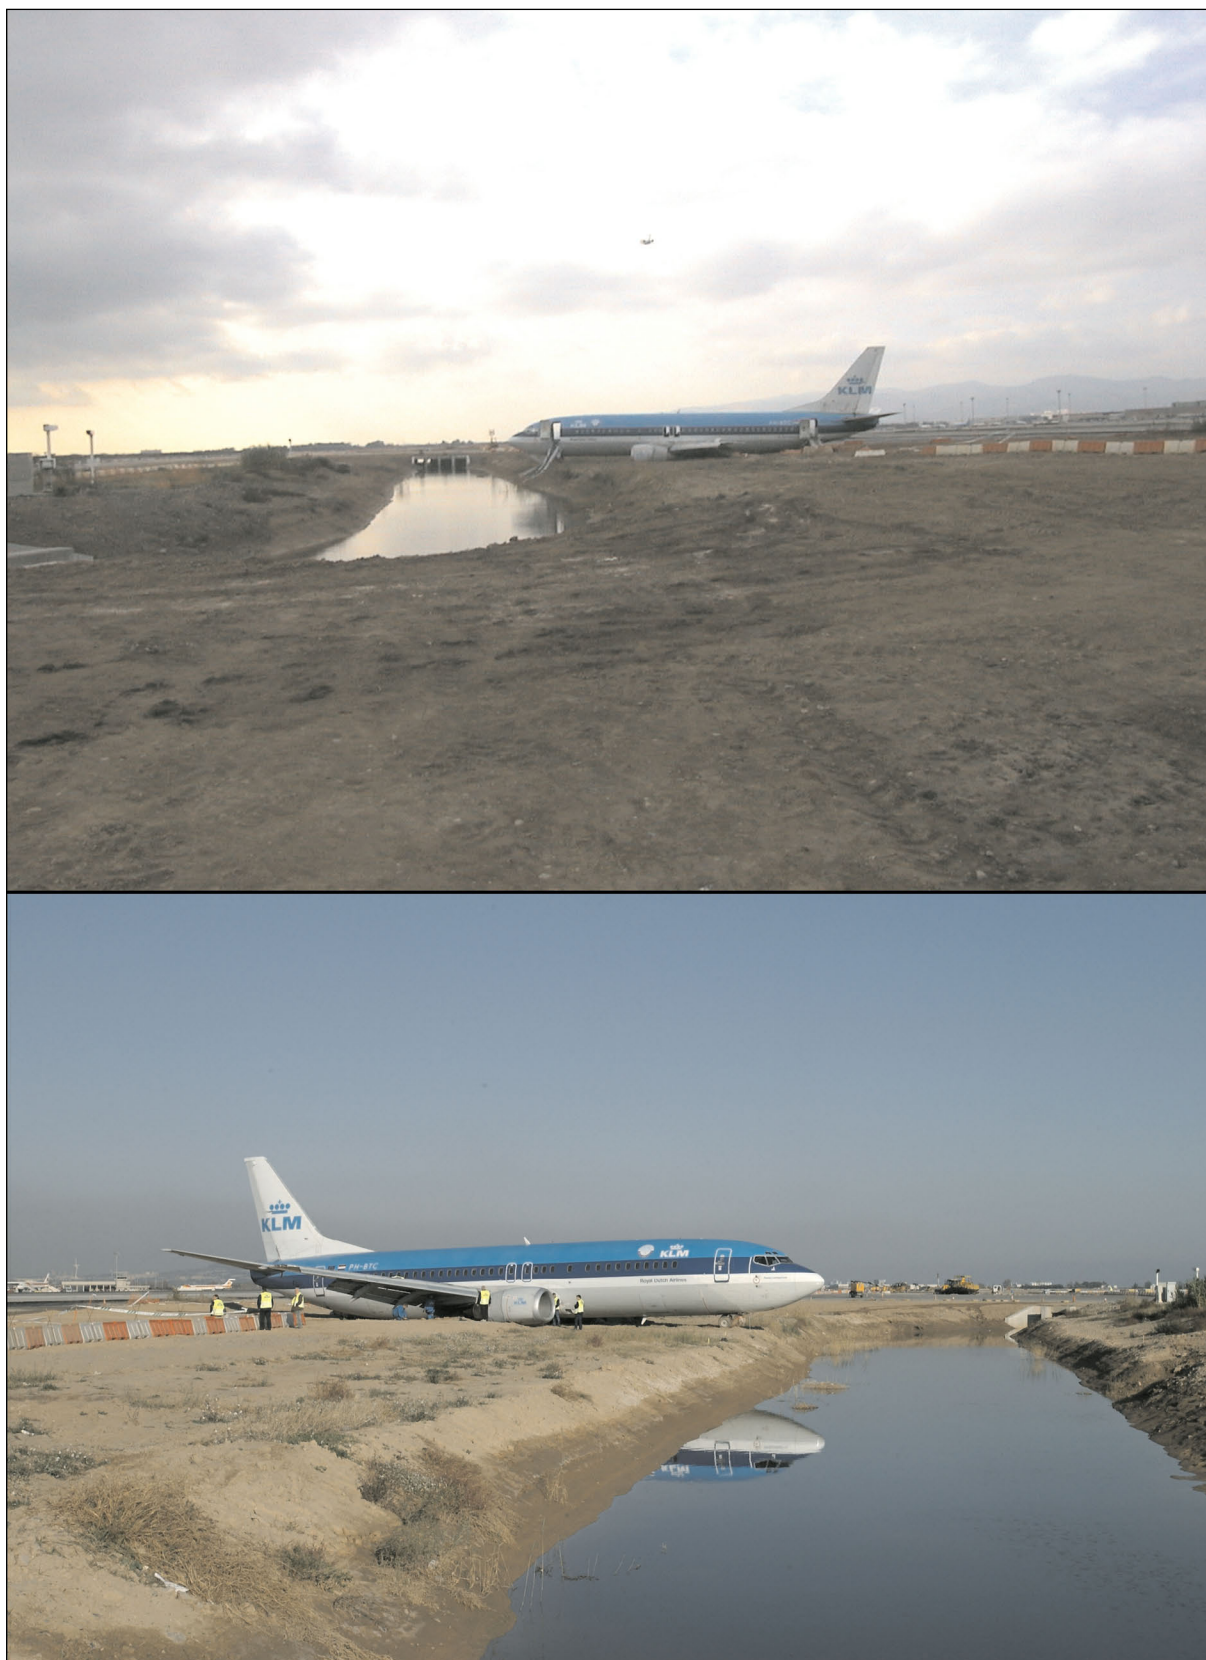
The aircraft came to a stop close to the edge of a rain drainage canal that ran approximately parallel to runway 25R. The canal was approximately 15 m wide, and 2.5 m high from the surface of the water. The water depth was approximately 1.5 m.

Photo 1.12.1.2. Final position of the aircraft close to the edge of the canal

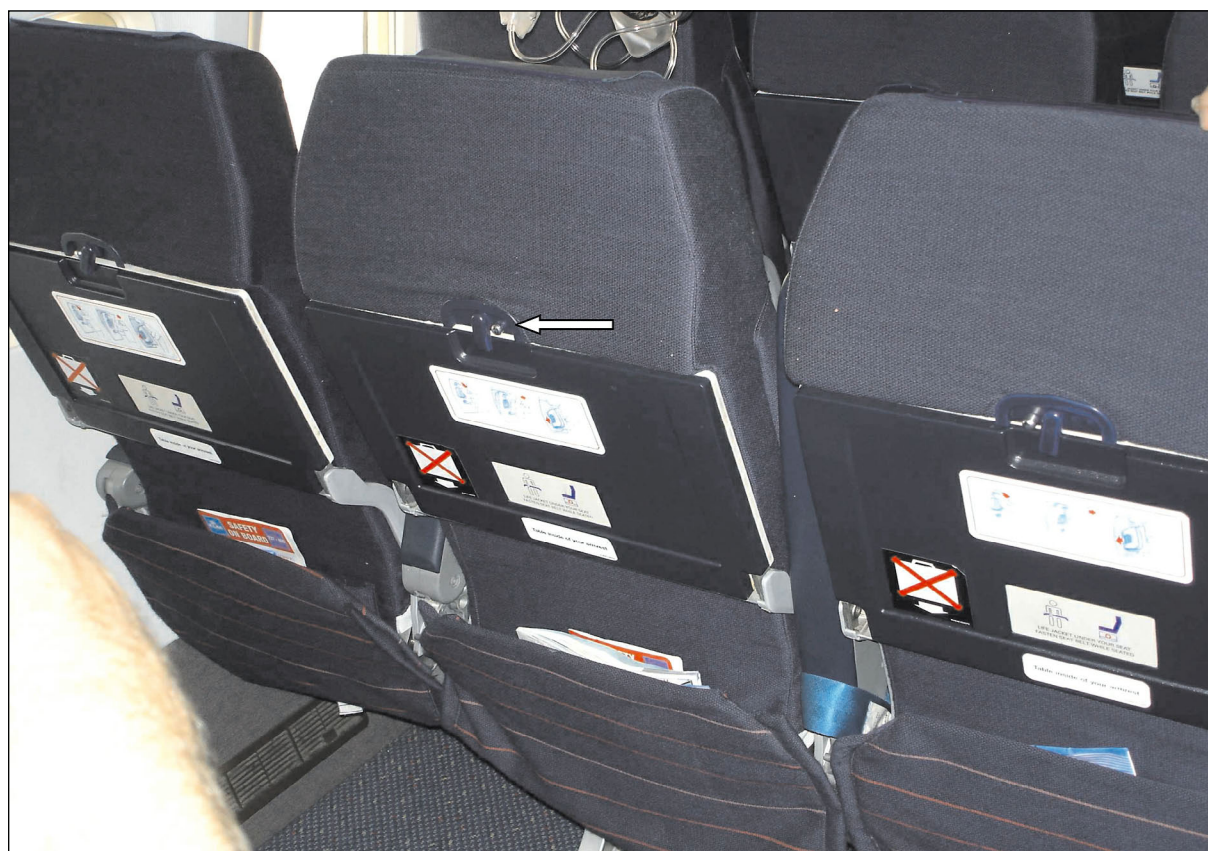
The meal tray table of the back of seat 10B (in front of seat 11B), which was located in the forward left hand emergency exit passageway, was found to have the restrain pin on its right hand side (i.e. towards the aisle). Therefore, the normal escape path of the passengers towards the type III emergency exit could easily release the tray (see Photo 1.15.1.1, white arrow in central seat back).

Figure 1.15.1.1. The latch of the meal table of the centre seat may rotate towards the sense of the Type III emergency exit escape path (to the left of the photo) and therefore it could be released during the emergency evacuation

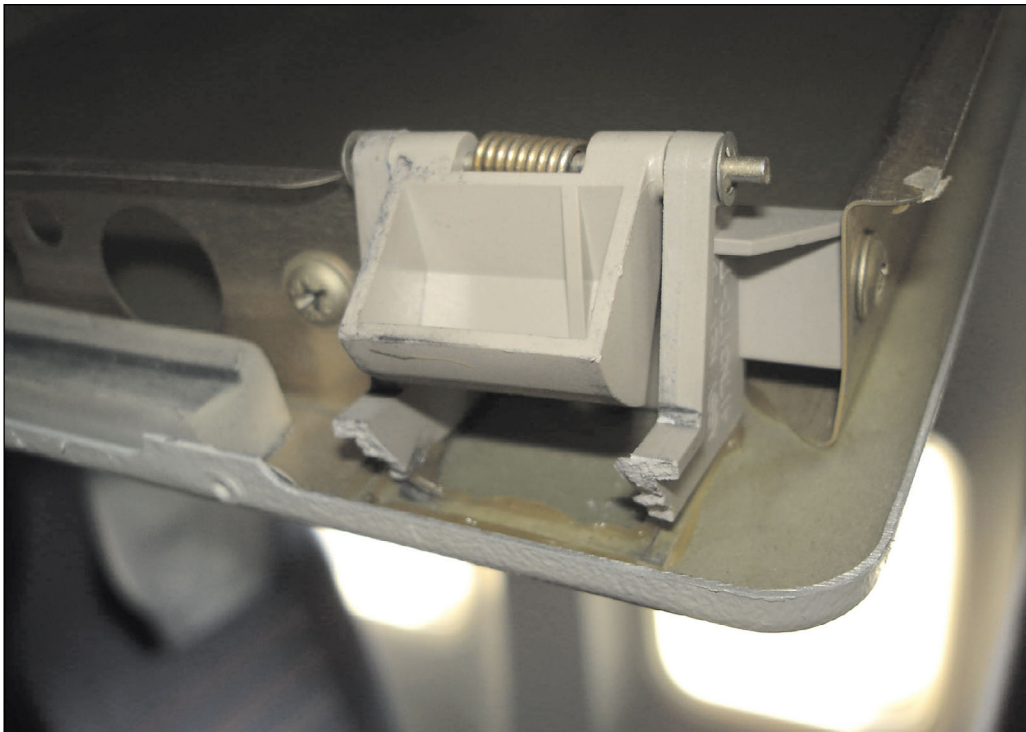
It was found that a lot of latches of the PSU panels were broken apparently due to lateral inertia loads towards the left of the aircraft or by the bending and torsion of the fuselage (see Photo 1.15.1.2).

Figure 1.15.1.2. Detail of a PSU panel latch broken on the left side of the aircraft

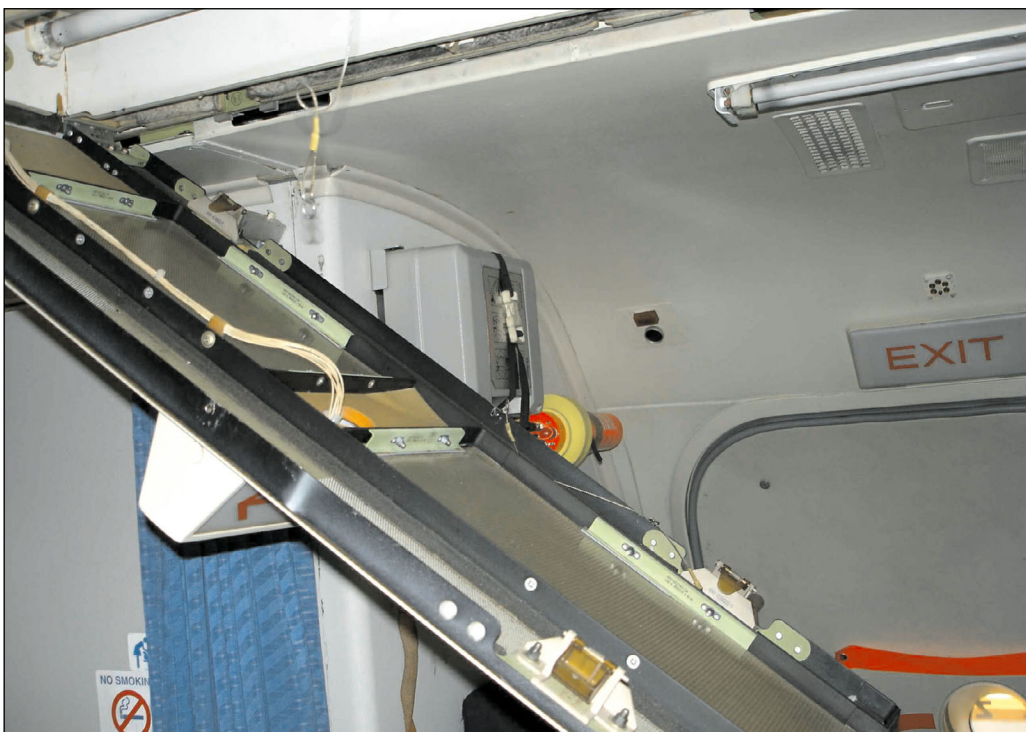
Figure 1.15.1.3. Ceiling panel in the rear cabin attendant compartment. During the inspection after the accident it was found closed, but witnesses stated that it opened after the aircraft came to a stop, therefore obstructing the path towards emergency exits L2 and R2. The lanyard released. The hook is at the end of the lanyard assembly

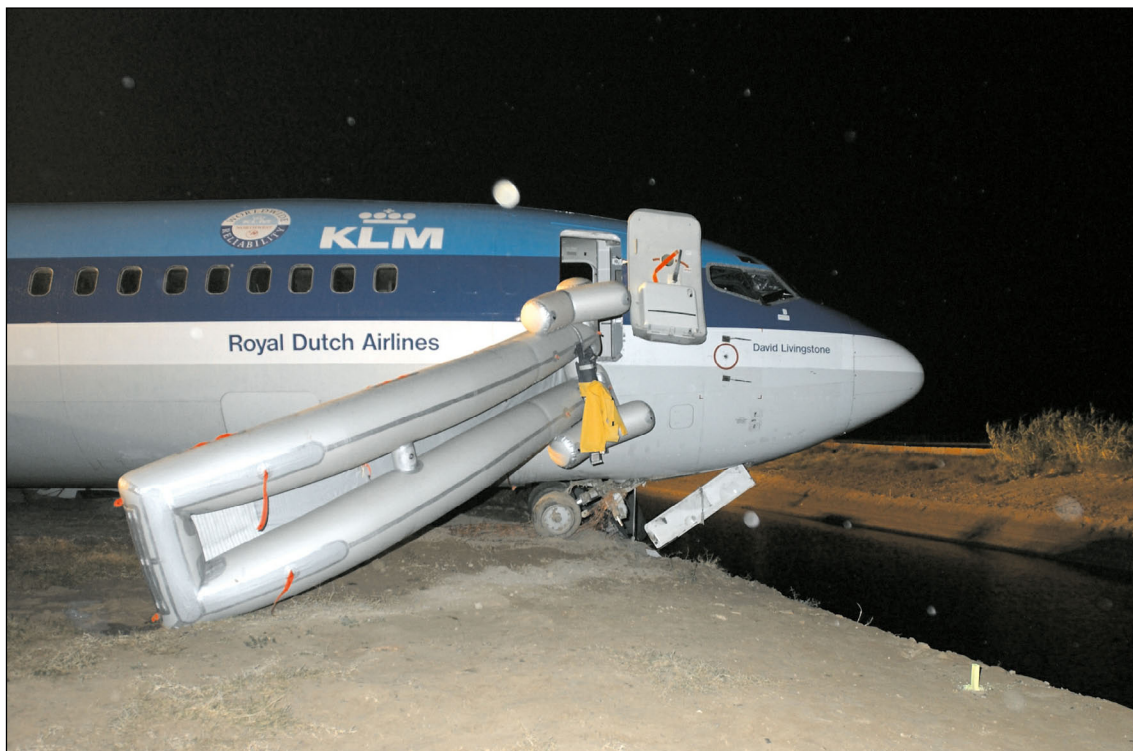
All the escape slides were found inflated, but the 1R slide was found twisted rearwards (i.e. front edge up and rear edge down) in a way that would have prevented its use for evacuation (see Photo 1.15.2).

Figure 1.15.2. Escape slide of door 1R was twisted

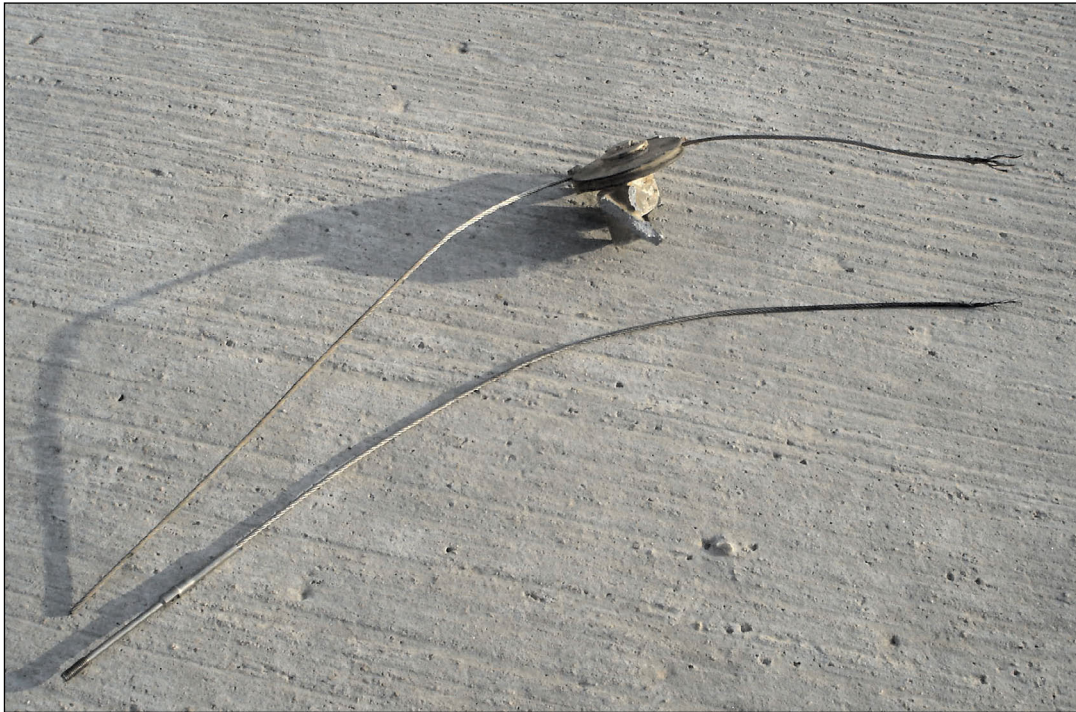
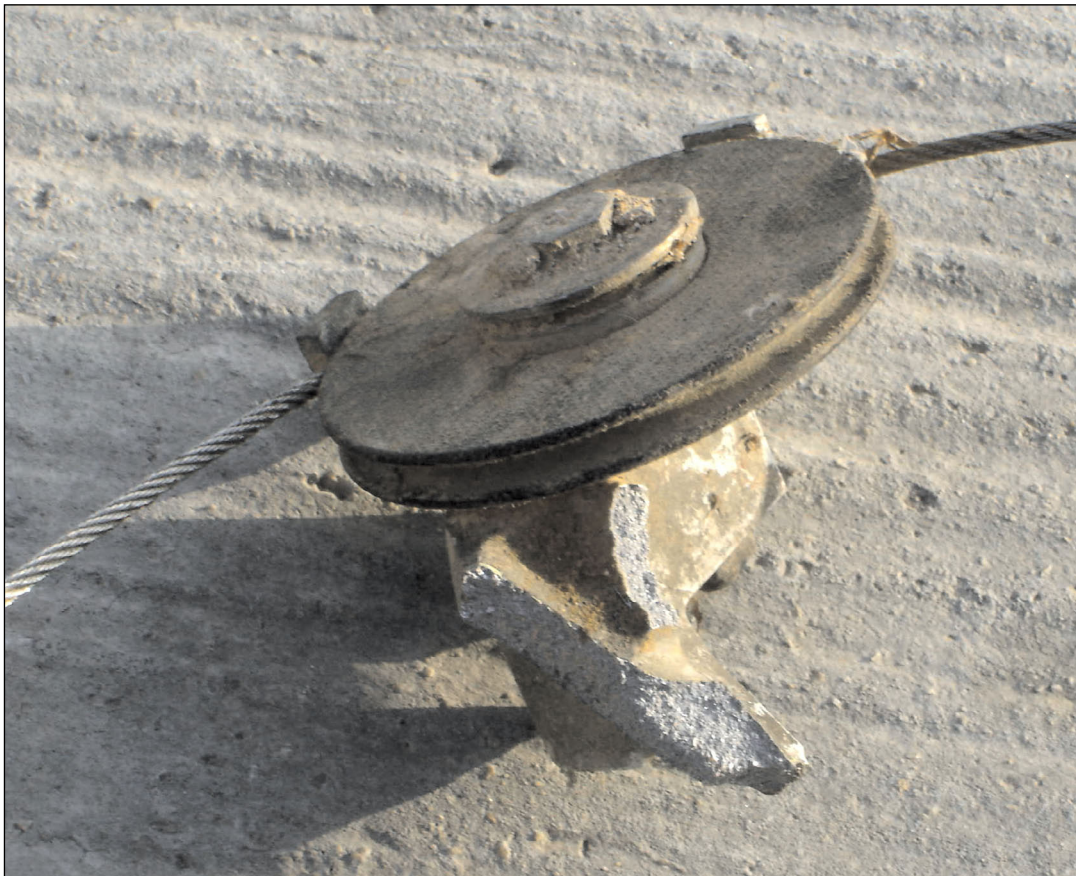
Photos 1.6.2.1 and 1.6.2.2. Each part of the broken cable was sent to a laboratory

A part of the broken NWSB cable P/N BCRE7631 (of approximately 560 mm of length including the cable terminal) was sent to a laboratory for fracture analysis. The diameter of the cable was 3/32 in (2.4 mm), with 7 strands of each 7 wires. The wire diameter was 0.29 mm, and it was made of 304 stainless steel. The laboratory concluded that the seven wires from the core strand failed by ductile overload. The six outer strands showed severe wear. Approximately 5 wires from each outer strand were worn-through completely; the other wires were thinned severely. Wear damage was observed over a length of approximately 80 mm. No corrosion was observed. Their conclusion was that «It is obvious that severe wear preceded the failure of the cable. The wear of the outer strands was so severe that nearly all load had to be carried by the core strand. A relatively low load was sufficient to cause cable failure».

The other part of the broken NWSB cable, together with the broken pulley bracket, was sent to another laboratory. The cable was still stuck against the pulley wheel due to bird remains.
