DATA SUMMARY

Registration	EI-DAC
Type and model	BOEING 737-800
Operator	Ryanair

REPORT

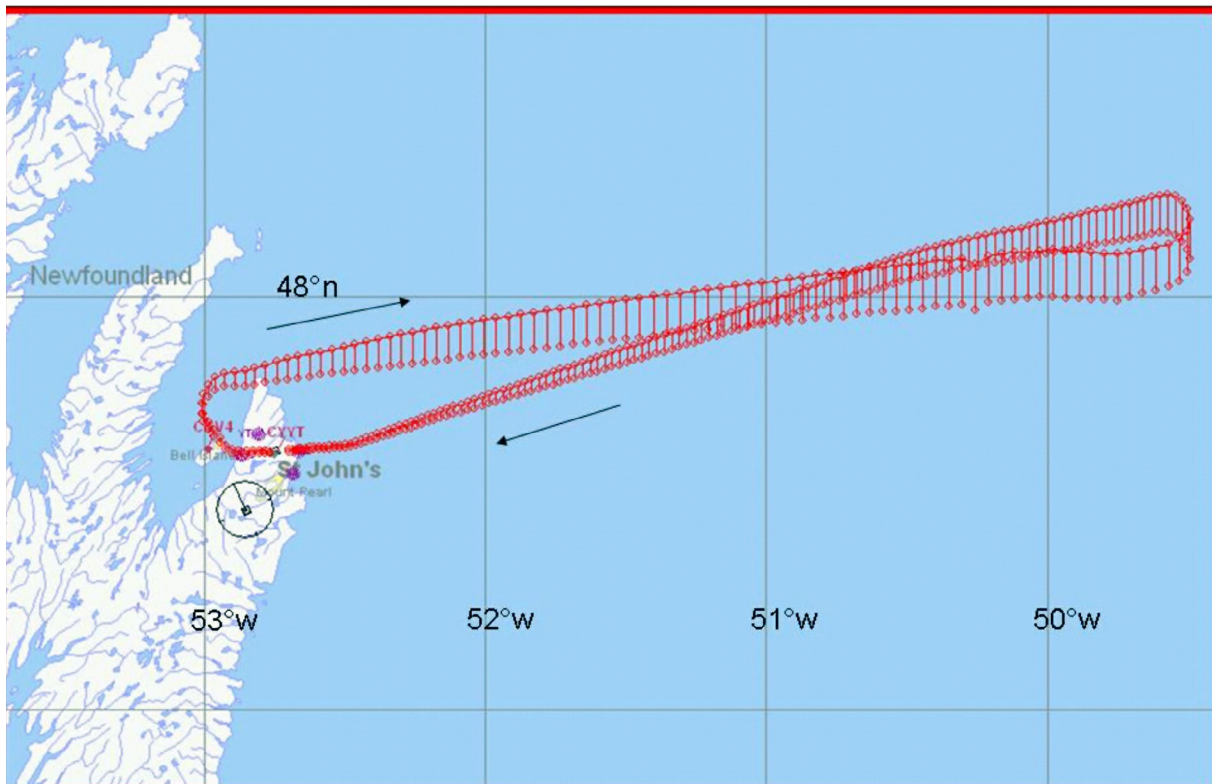
Figure 1. Flight path of the aircraft prepared by Canadian authorities using radar data

Canadian authorities provided the radar track data of the flight, together with a graph of the trajectory followed by the aircraft compiled from these data (see Figure 1).

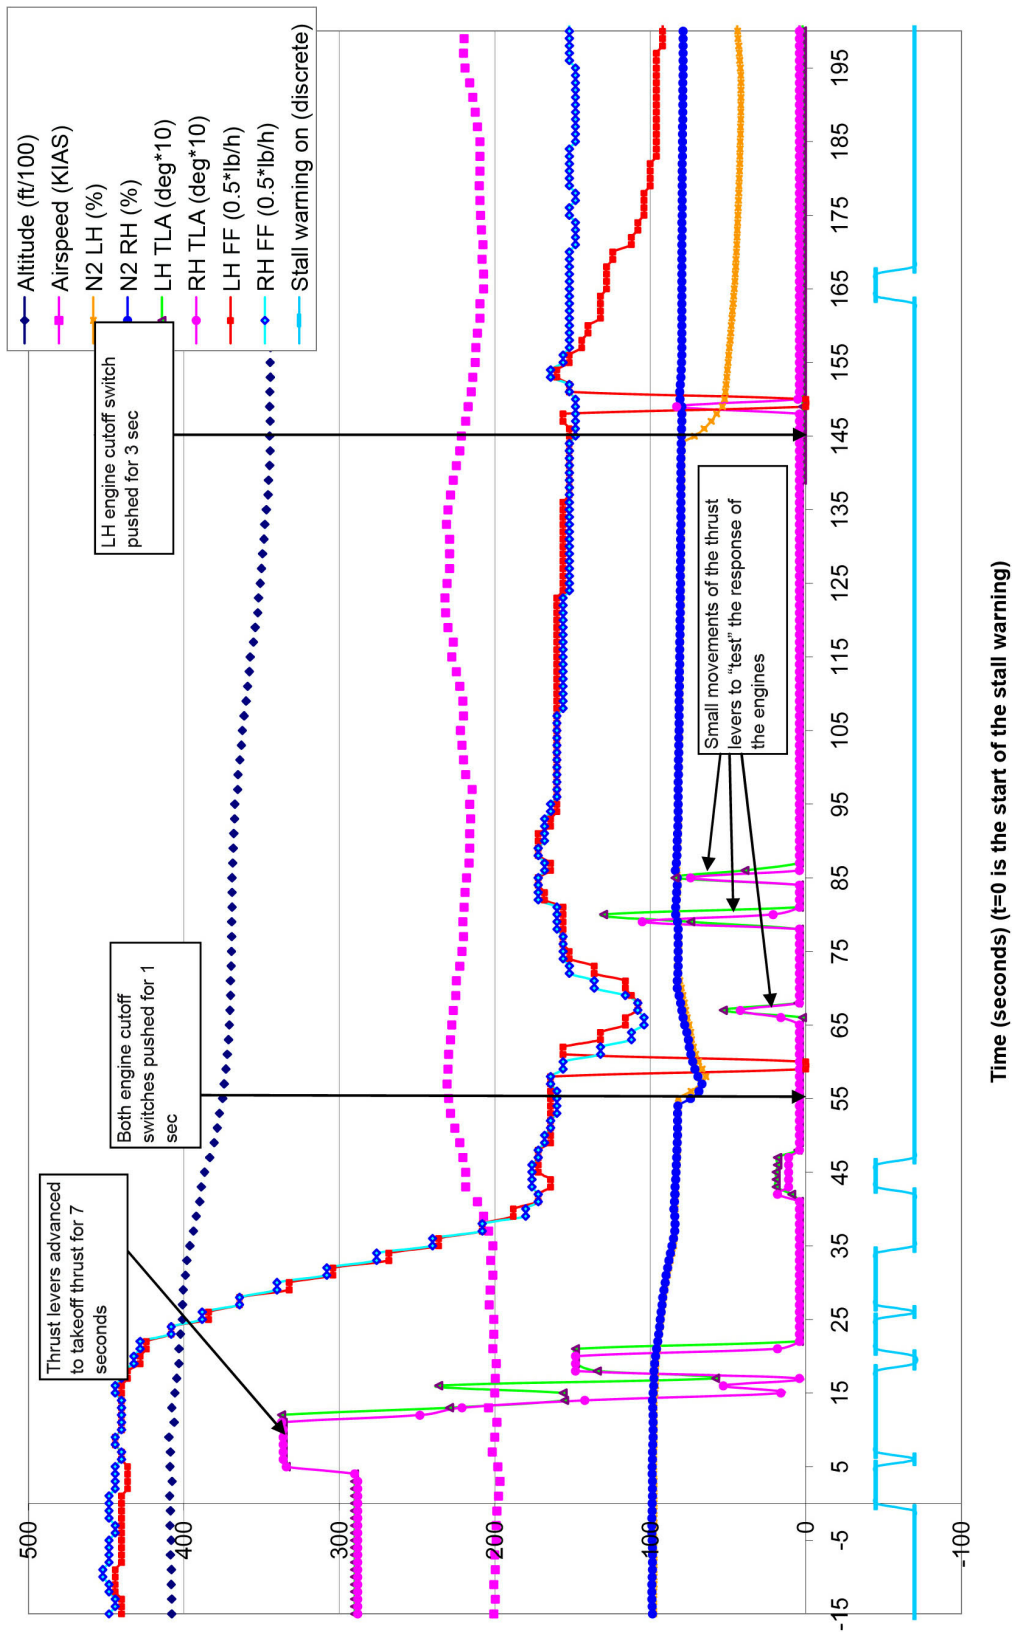
Figure 2. Qualitative variation of various DFDR parameters after the start of the stall warning. The scale of the curves has been adjusted to have all the data on the same graph

At second 56 the engine cut-off switches for both engines were pushed for 1 s. This caused the LH engine fuel flow to go to zero and the RH engine fuel flow to decrease noticeably also. Both N2 also fell. The manufacturer interpreted those values as meaning both engines were shut-down.

After a few seconds the engines recovered fuel flow and N2 and afterwards there were three movements of the thrust levers forward and backwards in what seemed to be a check of the status of the engines.

At second 145, with both thrust levers still at idle, the LH engine cut-off switch was pressed for 3 s, which caused the LH fuel flow to go to zero and the LH N2 to drop down to 41.7% in what was considered a complete shut-down of the engine. After several seconds, the fuel flow and N2 recovered and the engine re-started again.

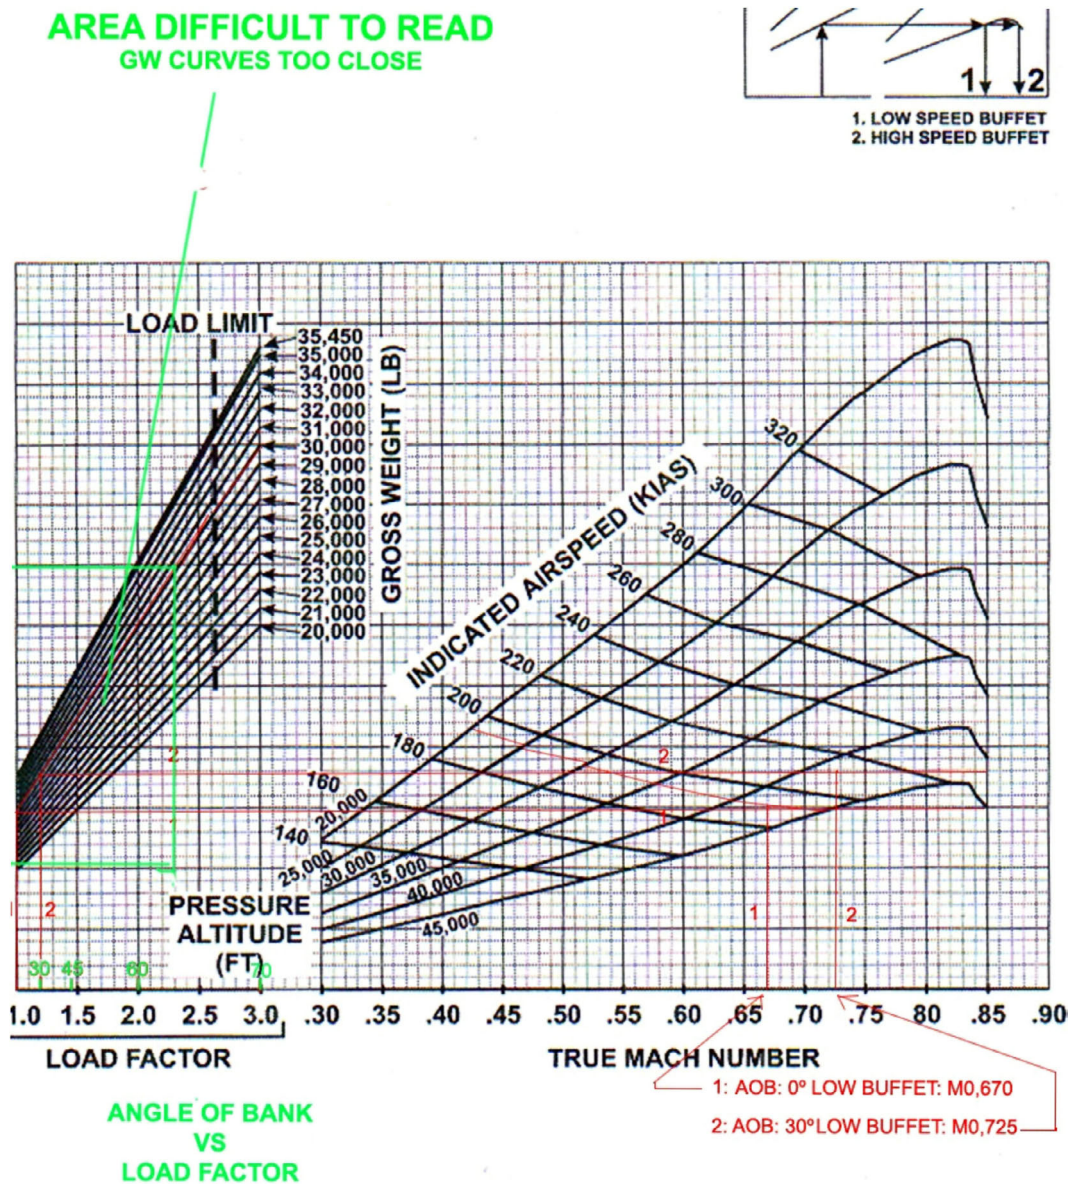
Figure 3. Modified composition of the buffet onset graph from the G-200 AFM

The performance information of the G-200 provided by the manufacturer was reviewed. The buffet boundaries are provided in Figure 7-19 of the AFM. However, the curves on this graph are closely spaced and are very difficult to read. The graph does not show bank angle (only load factor, which is less intuitive to the flight crews) (see Figure 3). Additionally, it would be useful for operational purposes if this graph were also included in the Quick Reference Handbook. A recommendation is issued in this regard.

- REC 40/07.** It is recommended that Gulfstream revise the buffet boundaries graph provided in Figure 7-19 of the AFM in order to improve readability of the gross weight curves and to include the bank angle in addition to load factor. Additionally, it is recommended that this graph also be included in the Quick Reference Handbook.
