DATA SUMMARY

Date and time	5 July 2005; 16:30 local time
Site	Near Castellbisbal (Barcelona)

Registration	EC-GUF
Type and model	AIR TRACTOR AT-802
Operator	Avialsa

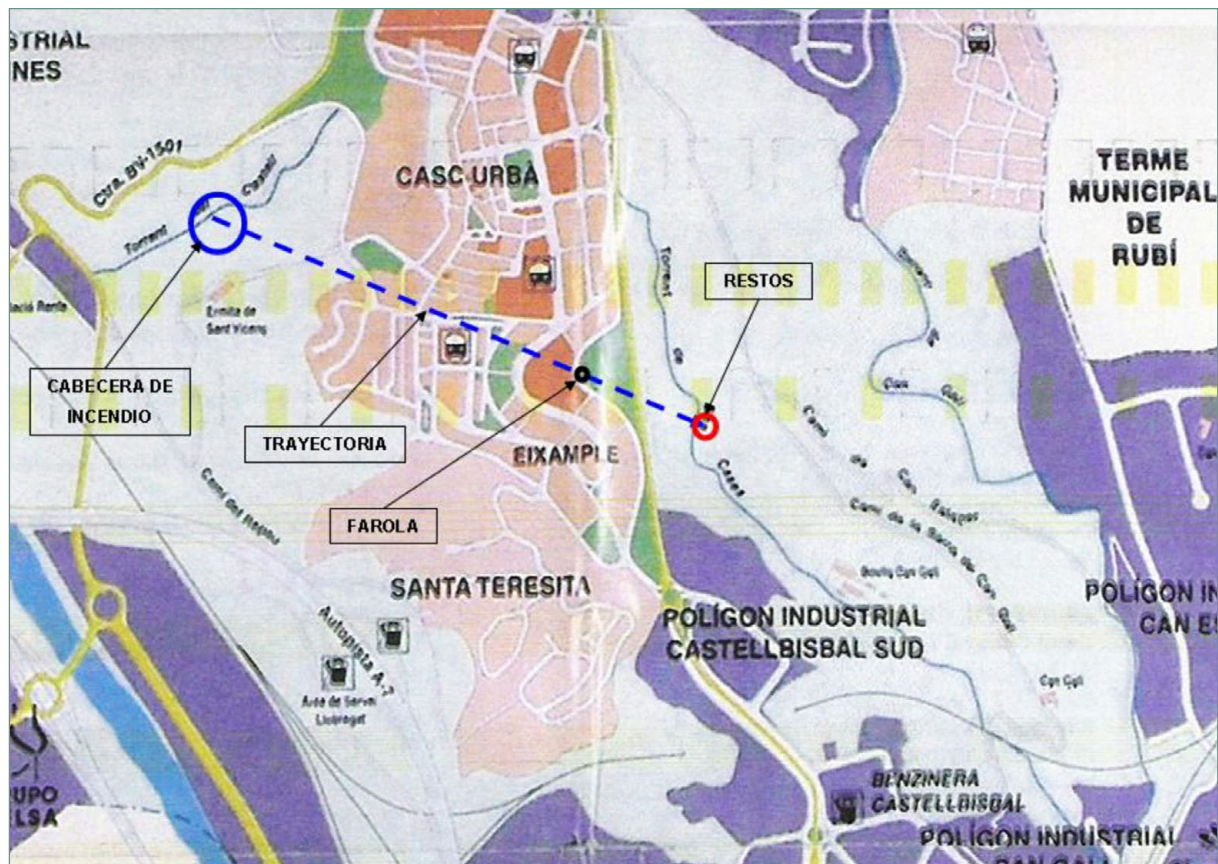
Figure 1. Final flight path superimposed on a map of Castellbisbal

A visual inspection carried out at the crash site has allowed for a reconstruction of the flight path up until the time of the accident. This was made possible by noting the condition of the street lamp with which the aircraft collided, the trail of damage caused by the aircraft to trees, shrubs and orchards located beyond the roadway and, finally, by the position of the wreckage at the bottom of the streambed in which it fell after sliding down an embankment and where it caught on fire. Figure 1 shows a diagram of this path overlaid on a map of Castellbisbal.

The labeled points on the diagram indicate the position of the leading edge of the fire which the aircraft was attempting to extinguish during the accident flight and the aircraft's trajectory.

The street lamp against which the aircraft collided was 9 meters high and was bent at the base by the force of the impact with its top part. The lamp was located some 200 m away from wreckage site.

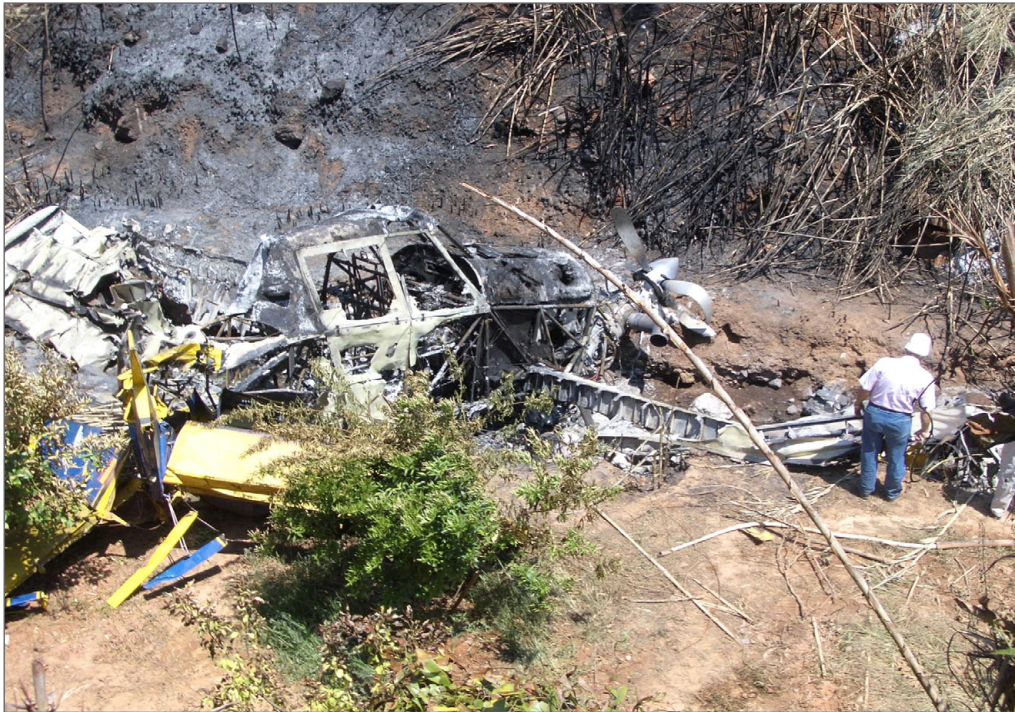
Figure 2. Main wreckage (front part)

The remains (Fig. 2) were confined to one area except for a few panels and pieces that detached as the aircraft moved along the ground. These were found within 50 m of the site. As shown in Fig. 2, the wreckage, particularly in the area of the engine and the forward and middle fuselage, was practically consumed by the fire which broke out following the accident. The fire was quickly put out by some of the aircraft which were taking part in extinguishing the forest fire that initiated the operation.

A visual inspection of the remains confirmed that all the engine controls, tubing and accessories, especially those for the fuel, were destroyed or severely damaged by the fire, along with the cockpit controls, especially those situated on the left side. No accurate determination could be made of the position of any of the flight control levers, located in the cockpit's left quadrant, although when the quadrant was recovered, the start control lever seemed to be slightly aft of the RUN position. The propeller was feathered.
