DATA SUMMARY

Date and time	Monday, August 8, 2005; 16:50 local time¹
Site	En route Ceuta-Malaga

Registration	EC-HFD
Type and model	BELL 412 EP
Operator	Helisureste

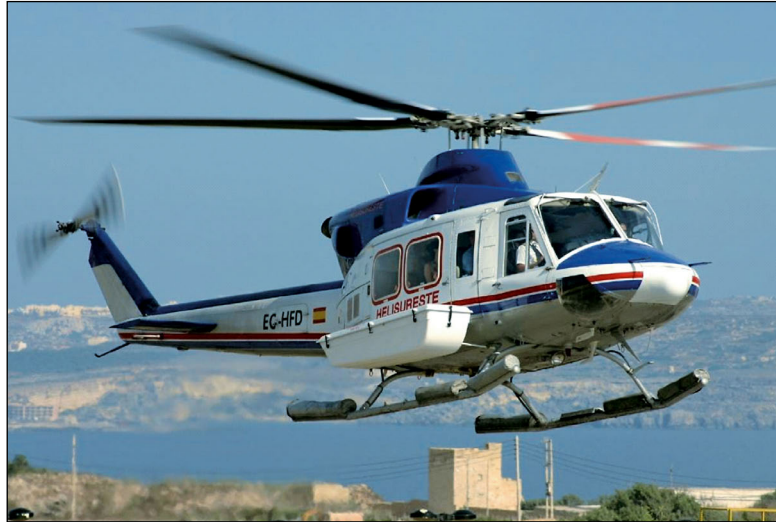
Foto 1. Helicopter general view

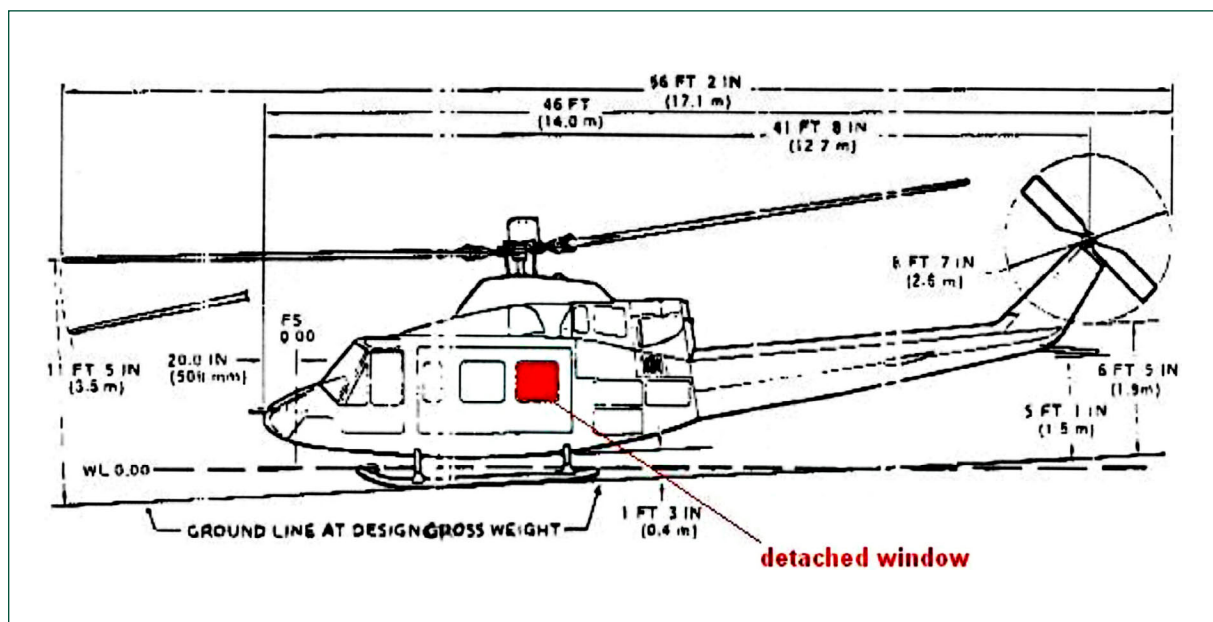
The helicopter was making a regularly scheduled flight between Ceuta and Malaga with 2 pilots and 7 passengers. At 16:50 (local time), at an altitude of 5,000 feet, the left rear emergency window became detached (see Figure 1) due to an inadvertent bump from one of the passengers, a minor who was traveling with his father. On noticing the situation and that the window had not impacted the helicopter's structure and had not caused any damage, the crew reduced altitude and velocity and calmed the passengers. The helicopter later landed without incident at Malaga Airport.

Figure 1. Position of the emergency window detached during flight

In conclusion, it has been determined that the in-flight window detachment was caused by the inadvertent blow from the child as he adjusted his seating position, there being a limited space between the passenger and the window. It has been verified that a passenger can lean on the window even with the seatbelt fastened. An additional closing feature should therefore be provided to prevent inadvertent opening of the window in flight, as well as mechanisms to avoid damage to the helicopter's aerodynamic surfaces or injury to the passengers should the window become detached. In addition, the passenger must be reasonably prevented from inadvertently hitting the window by informing him of and verifying that he has understood the danger this action implies for the safety of the helicopter.

REC 38/06. It is recommended that the manufacturer evaluate the possibility of including a modification to the design of the emergency window, adding a locking mechanism to prevent inadvertent in-flight opening to further reassure compliance with requirement *d*) of FAR 29.809 regulations and, in case of detachment, to prevent possible impacts with the helicopter's aerodynamic surfaces.

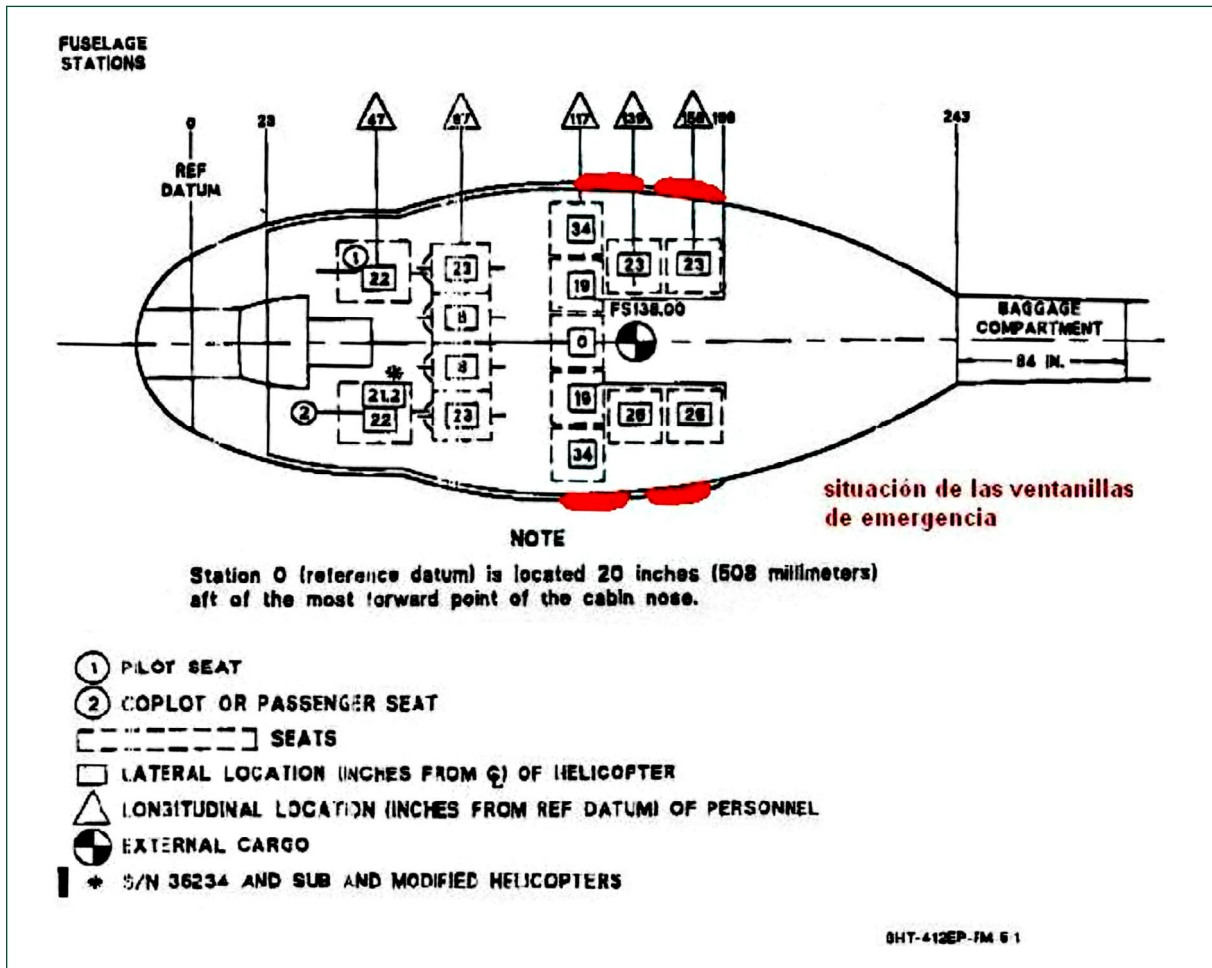
According to data from the manufacturer, the helicopter has a capacity for up to 13 passengers (see Figure 2) who access the interior by means of two sliding doors situated on either side of the fuselage. All the seats face forward, except for four in the rear which face sideways. Each access door has two emergency windows, approximately rectangular in shape and made of a clear acrylic material. The rear emergency window is unique in that the two seats previously described as facing sideways face the emergency window.

Figure 2. Seating arrangement and location of the emergency windows

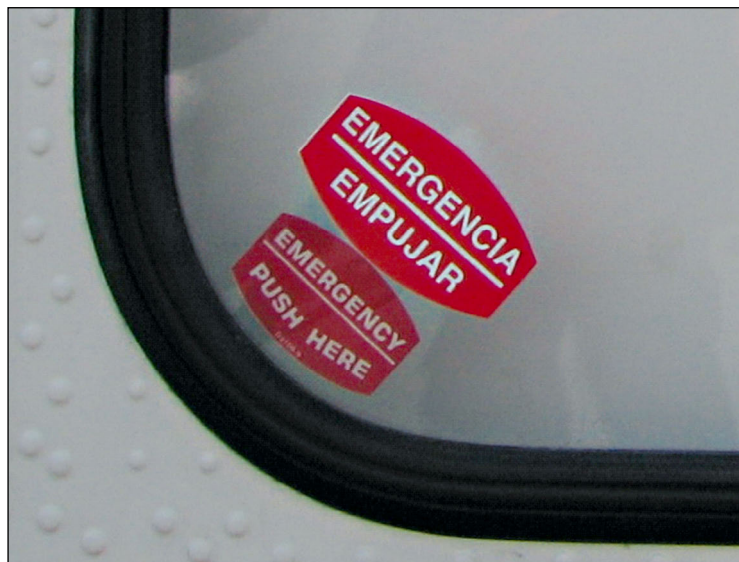
The purpose of the emergency windows is to facilitate the ground evacuation of the helicopter's occupants in case of an emergency. To this end the window's opening mechanism consists of pushing one of the window's lower corners, which then detaches automatically. To inform the passenger of this mechanism, there are two stickers situated on each window's lower corners which read: «EMERGENCIA, EMPUJAR» («EMERGENCY, PUSH HERE») (see Figure 3).

Figure 3. Stickers located on the lower corners of the emergency windows

- The passengers occupying the side-facing seats are warned by the maintenance technicians or by the crew of the danger of touching the emergency windows. This task is carried out with the sliding doors completely open. It has been noted that in this position, the passengers are unable to see either the windows or the warning stickers and that, should they not understand the language, the explanation would be of limited use.

REC 39/06. It is recommended that the operator adapt the safety cards and DVD to the type of operation involved (passenger transport) in English and in Spanish and to consider including French to take into account the typical passenger profile involved in its services, as well as ensuring that the oral explanation given to the passengers in the side facing seats as the doors are being closed have been fully understood.

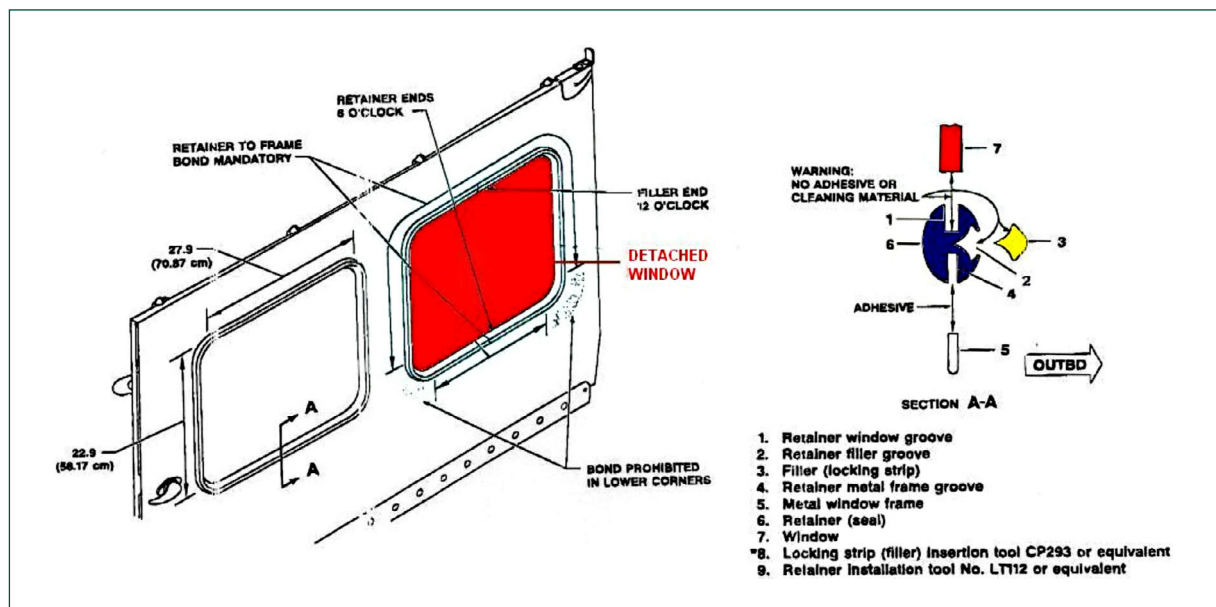
According to the aircraft’s maintenance manual, each window opening measures 708.7 × 581.7 mm. The minimum required thickness is 3.02 mm. On previously investigated events, the operator had recorded that the window measured 700 × 575 mm and weighed 1,360 gr. The windows are attached to the helicopter structure’s metallic frame by means of a retainer which is bonded at its perimeter to the metallic frame except at the two lower corners. The retainer keeps the window in place through the pressure exerted on it by the filler which is inserted into a groove machined into the retainer (see Figure 4).

The window can be opened by exerting pressure on one of the two lower corners (which are not bonded to the frame), which causes the lower edge to break free from the filler and the window to fall under its own weight. According to information provided by the manufacturer, a force of 50 lb (28 kg) on either lower corner is required to detach the window.

Figure 4. Diagram of the two emergency windows on the passenger door
