DATA SUMMARY

Date and time	Saturday, 29 October 2005; 10:13 UTC¹
Site	UW100 (FL 260) 50 NM of CJN VOR

Registration	D-AIRL	UR-GAL
Type and model	AIRBUS 321	BOEING 737-300
Operator	Lufthansa German Airlines	Ukraine Intern. Airlines

Date of approval	30 May 2007
------------------	--------------------

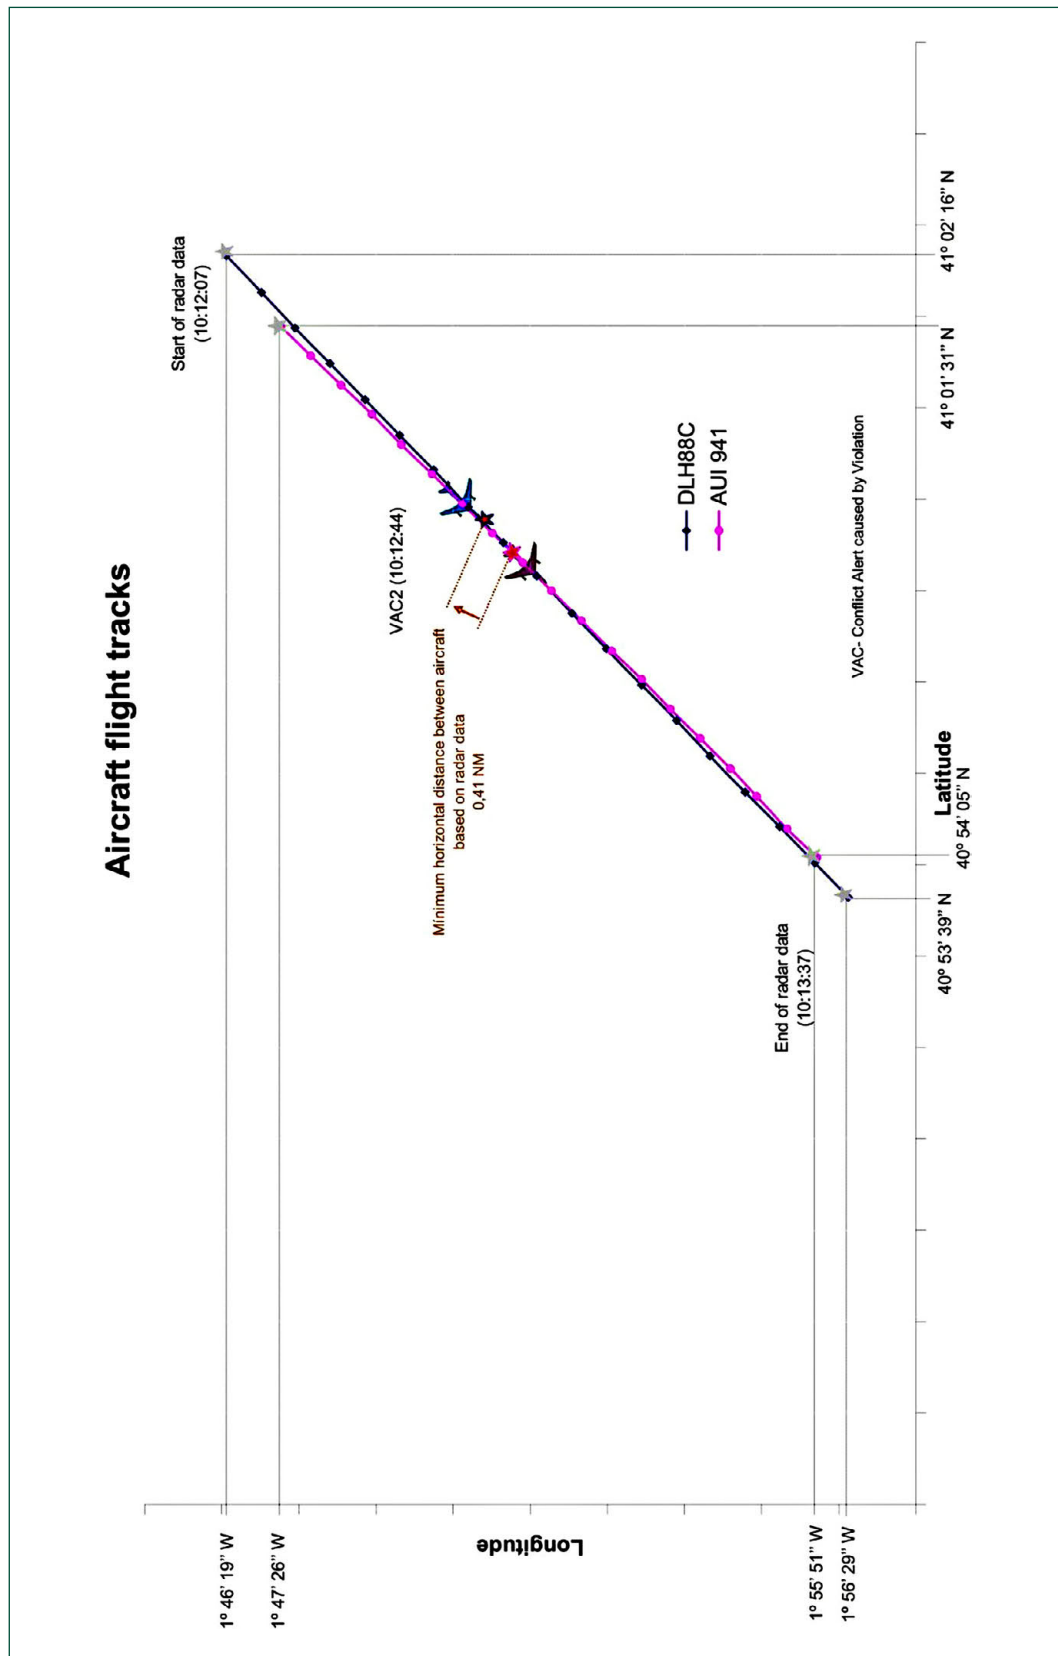
Figure 2. Aircraft flight tracks

Using FL250 as a reference, AUI-941 was reaching this level at 10:13:02 ("Radar data clock"). On the other hand, ATCO told somebody "OK. YOUR TRAFFIC IS NOW REACHING LEVEL TWO FIVE ZERO INCREASING RATE OF DESCENT"" at 10:12:58 ("ATC communication clock"). If this sentence can be assumed to be addressed to DLH-88C to inform them about the AUI-941 location, a delay of around 4 seconds appears between Radar data clock and ATC communication clock. Therefore, at the moment when the DLH-88C told the ATCO that they had the traffic below in sight they were at approximately FL264 and AUI-941 was at FL256 (800 ft of separation between both aircraft). Figure1 shows this moment, just before the TCAS RA warning was issued. It can be observed that the vertical distance between both aircraft decreases from 800 ft to 700 ft.

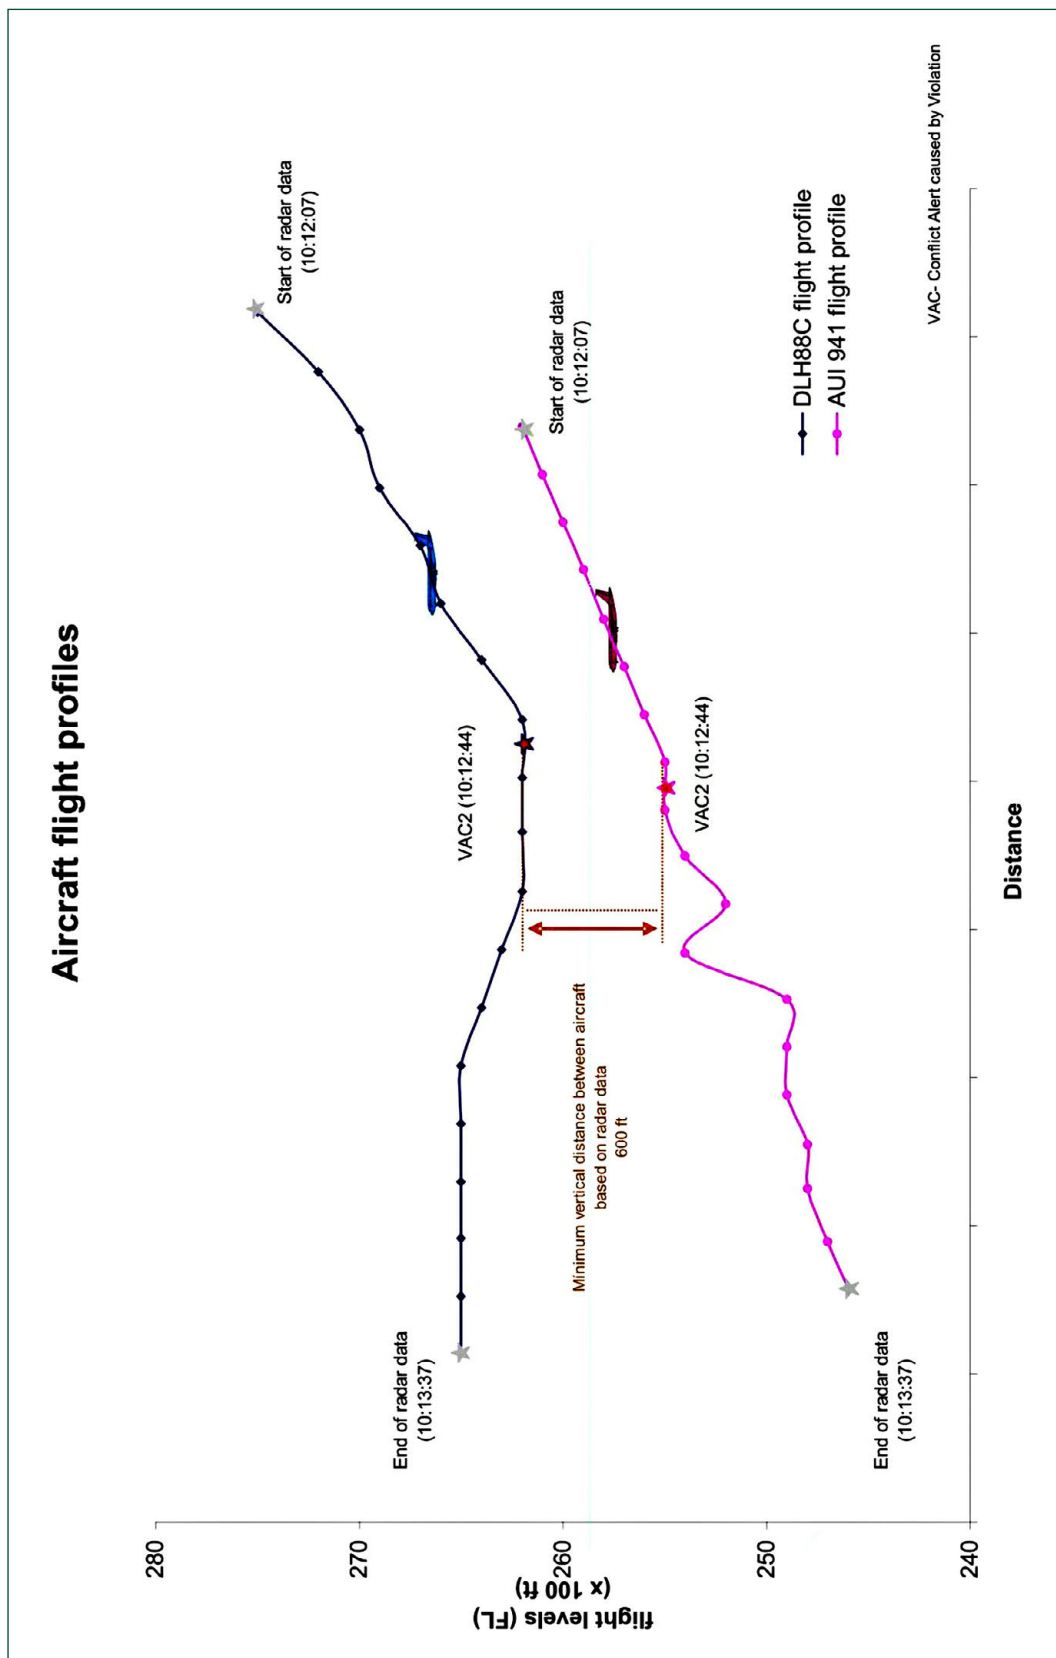
Figure 3. Aircraft flight profiles

Based on the radar data, the average rates of descent of both aircraft have been calculated from the 10:12:07 to the moment when the first alert of conflict traffic violation (defined as VAC on radar system) was issued on the ATC screen (10:12:37). The results of this calculation are the following:

Rate of descent of AUI-941	1,200 ft/min
Rate of descent of DLH-88C	2,200 ft/min

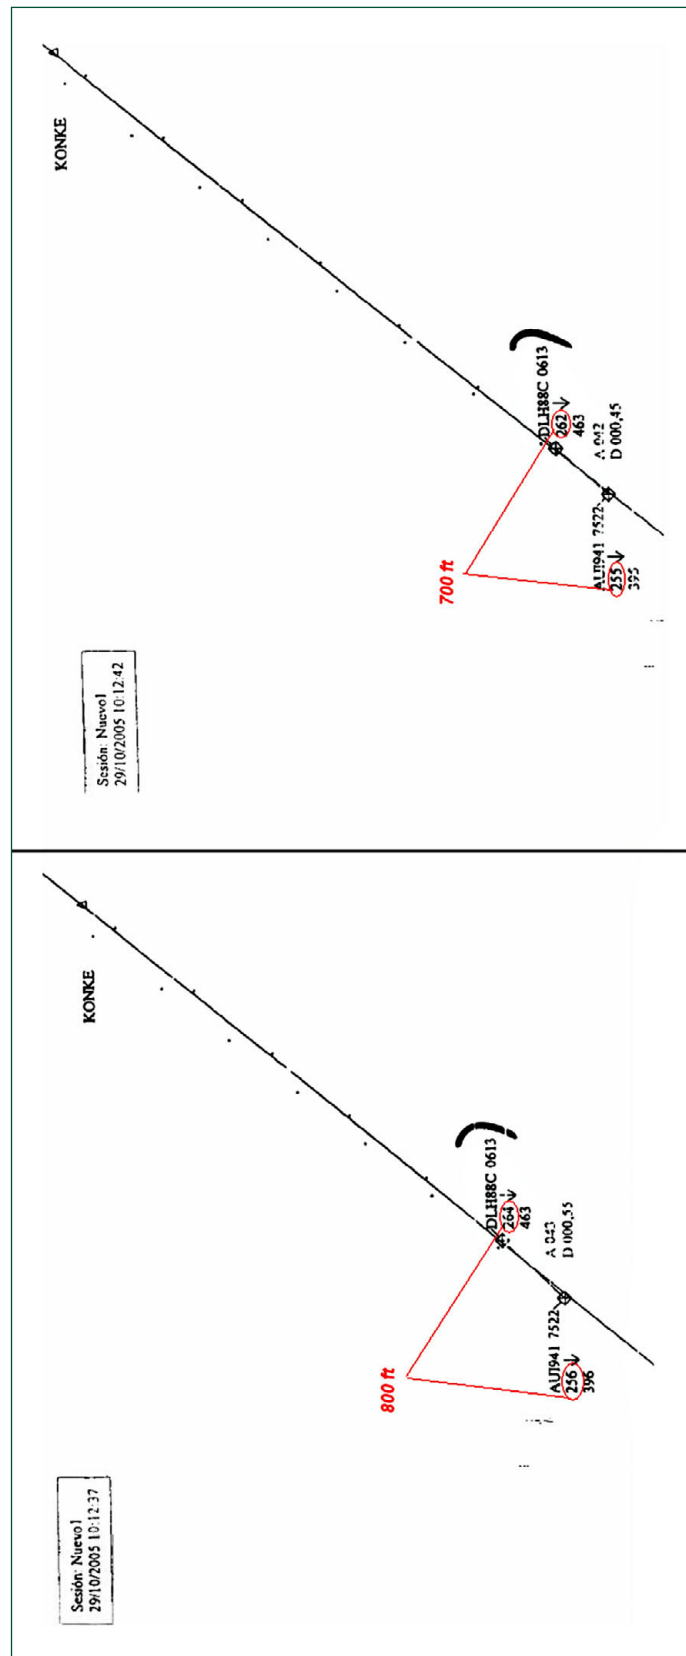
Figure 4. Two pictures of RADAR presentation

- According to radar data, the first CPA warning appeared at 10:12:05. According to the SACTA system configuration, the first CVA (conflict violation alert) would have appeared when the separation between the aircraft dropped below 800 ft. The minimum CPA alarm time prior to this alert would have been 55 seconds (under abnormal radar working conditions) and 110 seconds under normal conditions. The elapsed time between the initial alert is considered adequate for issuing separation instructions to both aircraft. The ATCO was also aware that the descent rate of DLH-88C was almost twice that of AUI-941.

REC 24/07. It is recommended that AENA establish measures intended to ensure control personnel act promptly in response to conflict alert warnings from the instant the first conflict prediction alert (CPA) (visual and audible) is received.

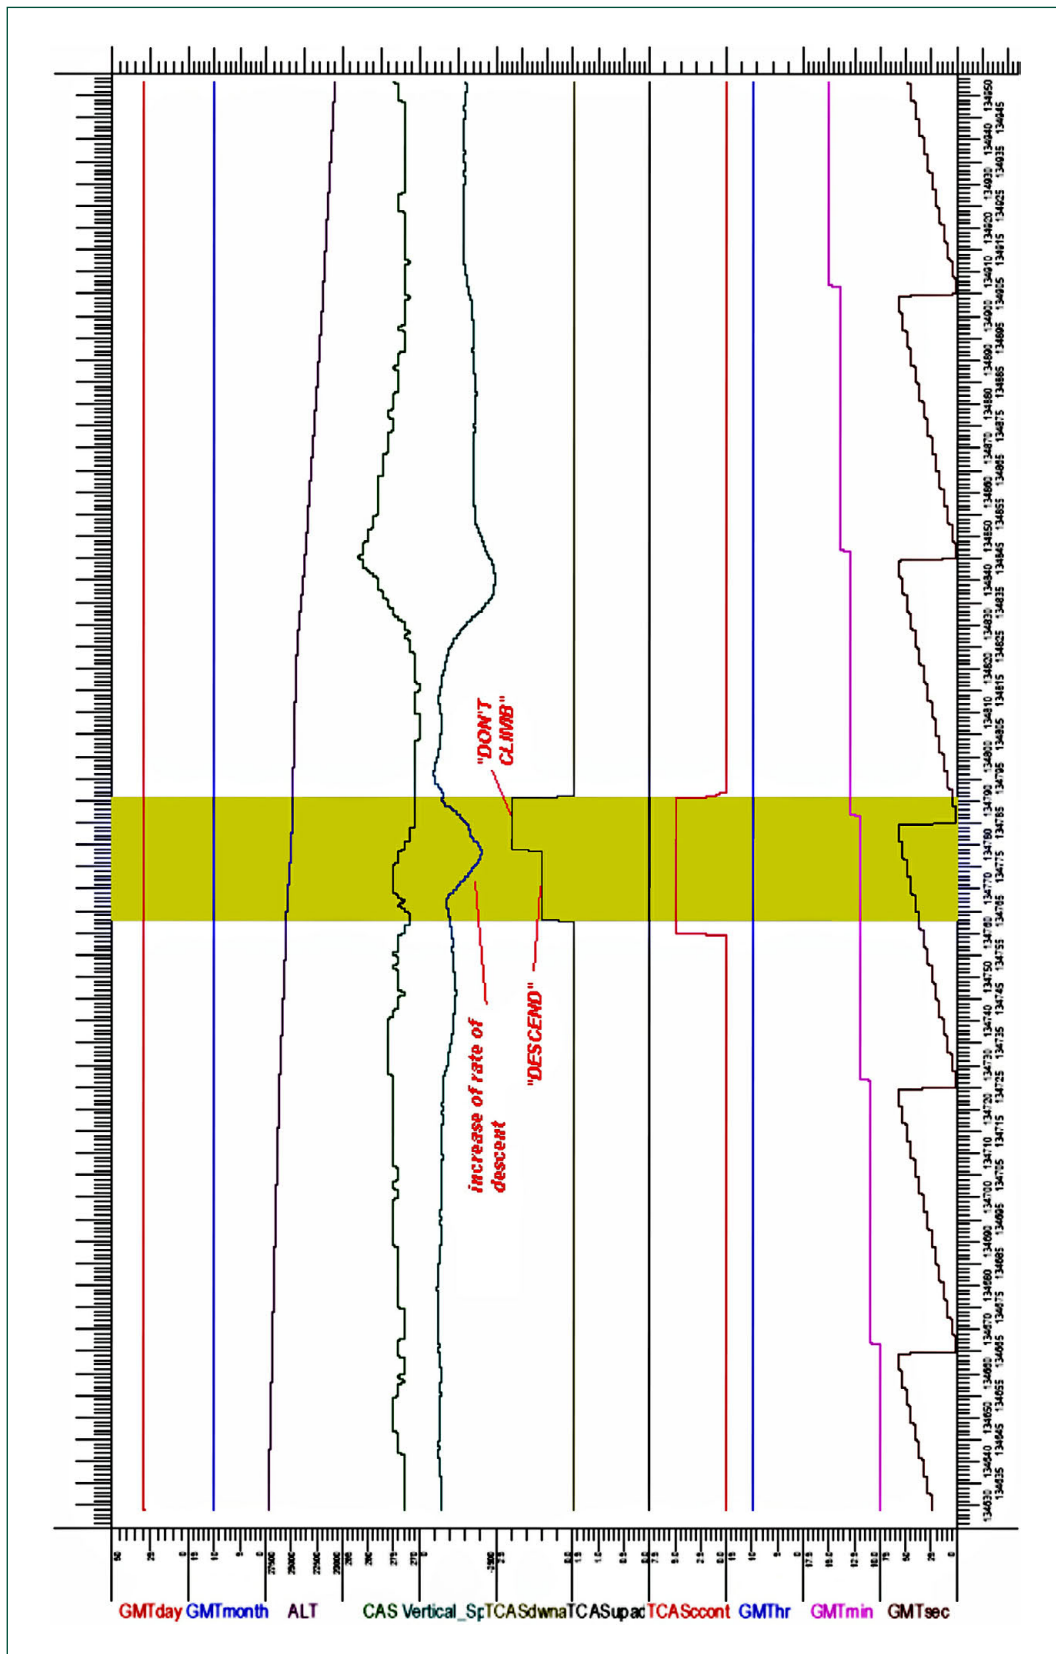
Graph 1. AUI 941 DFDR data I

The crew began to increase their rate of descent to 2000 ft/min from the moment the TCAS RA was issued (at approximately 10:12:44). ATCO had requested them to maintain a rate of 2000 ft/min or more at 10:12:40.

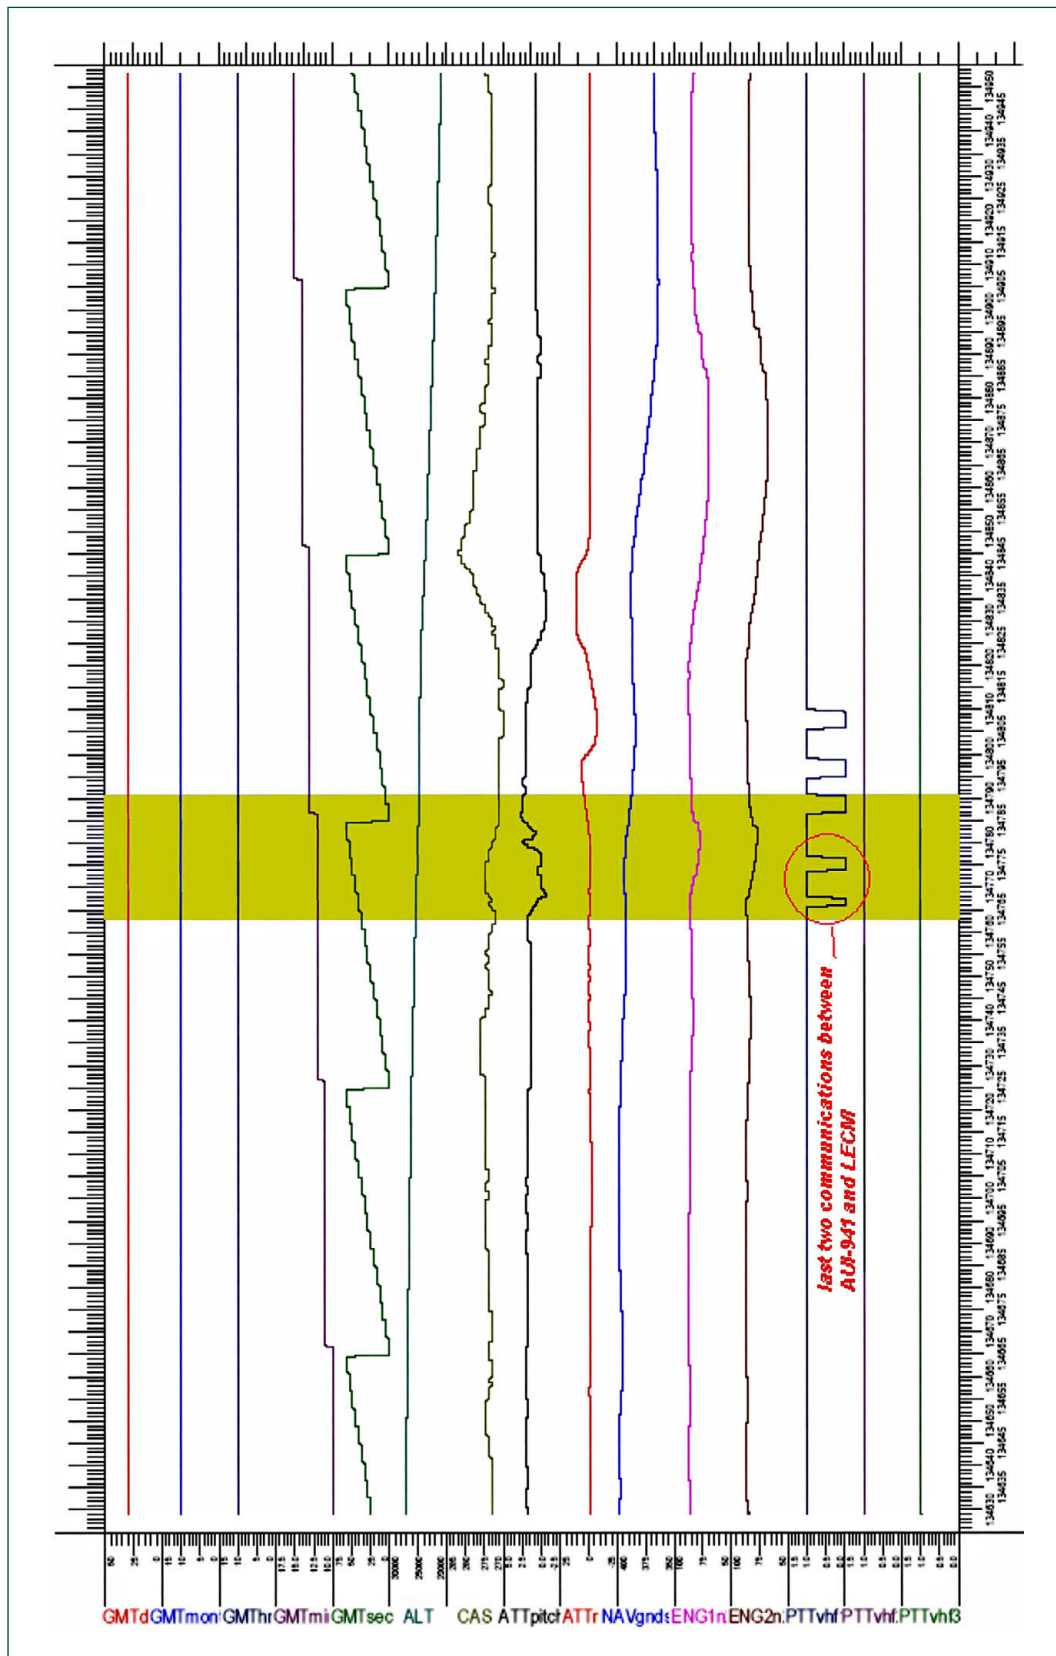
Graph 2. AUI 941 DFDR data II

The AUI-941 crew continued talking (see the PTTvhf1 of Graph 2 that shows the moment when the microphone key is pressed) around ten seconds after they had read back the Madrid Approach frequency (at 10:12:53).

- Reviewed their seasonal training programme to include occurrence reporting procedures.
- According to the DFDR data, the AUI-941 crew continued talking (see the PTTvhf1 of Graph 2 related to the moment when the microphone key is pressed) around ten seconds after they had read back the Madrid Approach frequency (at 10:12:53). Therefore, it can be assumed that they had already changed the frequency and that this could be the reason why they did not hear any TCAS report from the DLH-88C or ATCO. In summary, it is possible that, when the TCAS RA warning was issued and followed, the AUI-941 crew was switching the VHF radio frequency and contacting Madrid Approach.
