DATA SUMMARY

Date and time	Friday, 7 April 2006; 19:30 h local time
Site	Benabarre Aerodrome (Huesca)

Registration	EC-JAV
Type and model	TECNAM P92-JS
Operator	Ilerdair, S. L.

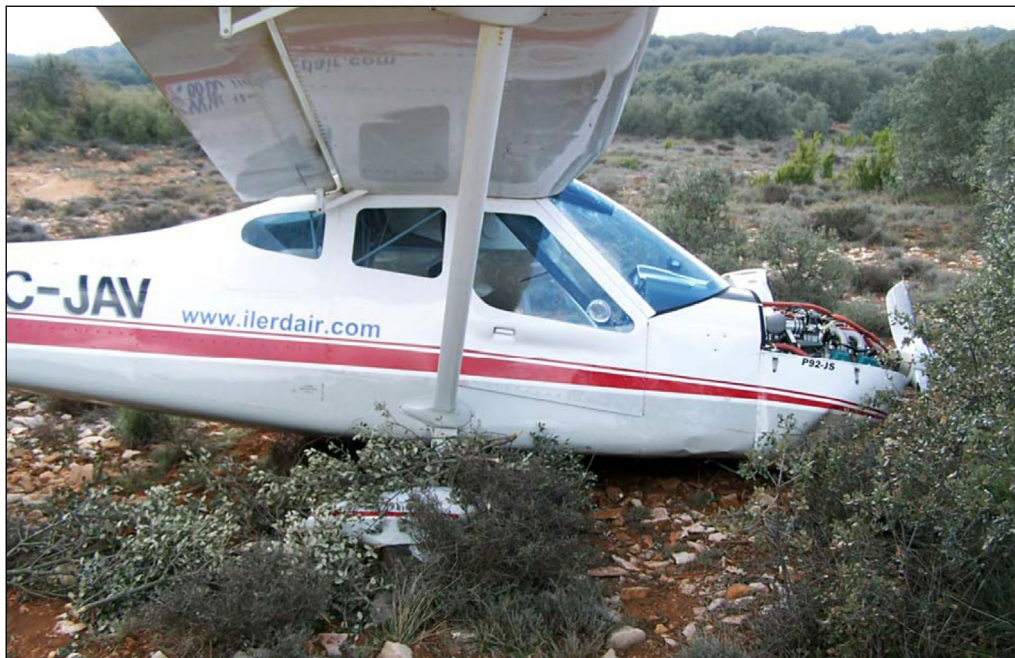
Figure 1. Photograph of the final position of the aircraft

- The engine mounting was buckled, as was the cowling that protects it. Also buckled was the oil cooler, the exhaust and the rest of the elements of which it is comprised had been struck.
- The main landing gear was broken off, and the nose undercarriage leg had also suffered damage.
- All of the lower part of the fuselage was dented
- The left wing showed several strikes at the ends and the leading edge, whereas the right wing did not have any apparent strikes.
- The stabiliser was damaged at its end, but the rudder was not affected
- The rear fuselage was also dented and the hook that is used for banner towing, installed on this airplane, was full of grass due to the impact.

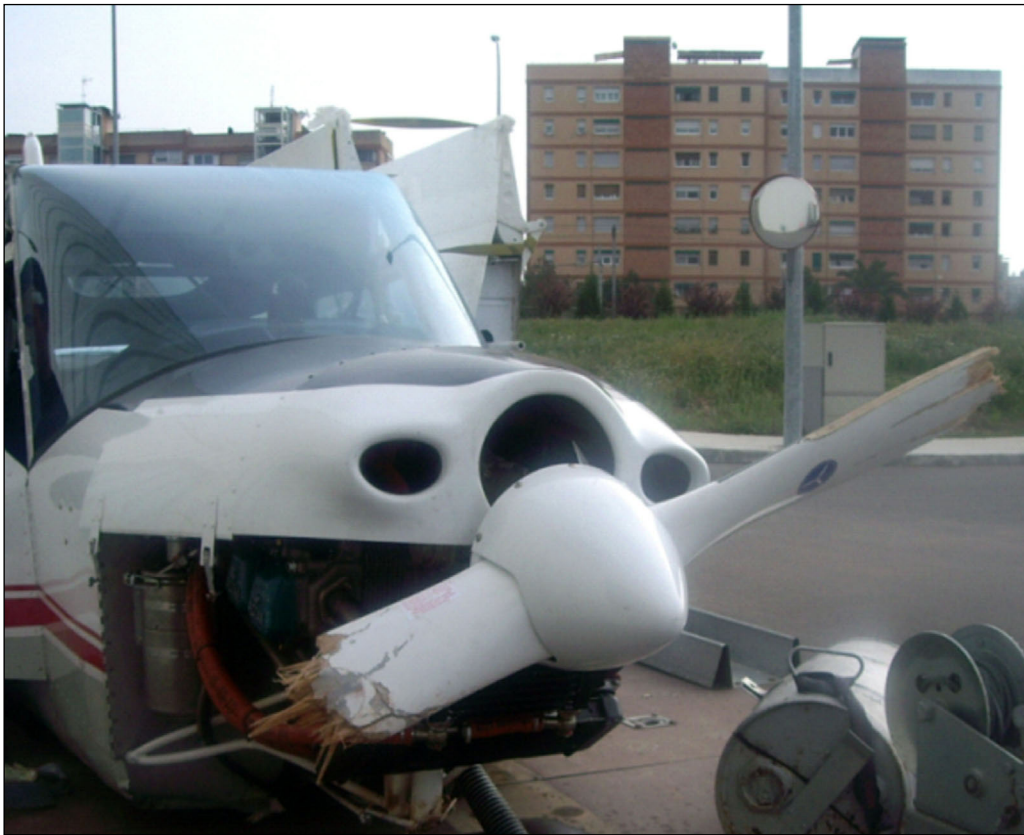
- The wooden propeller had broken off and one of the blades was chipped for more than half its length from the end, and the other was chipped and broken from the first third, the other two thirds of its length having been broken off.

Figure 2. Photograph of the status of the propeller

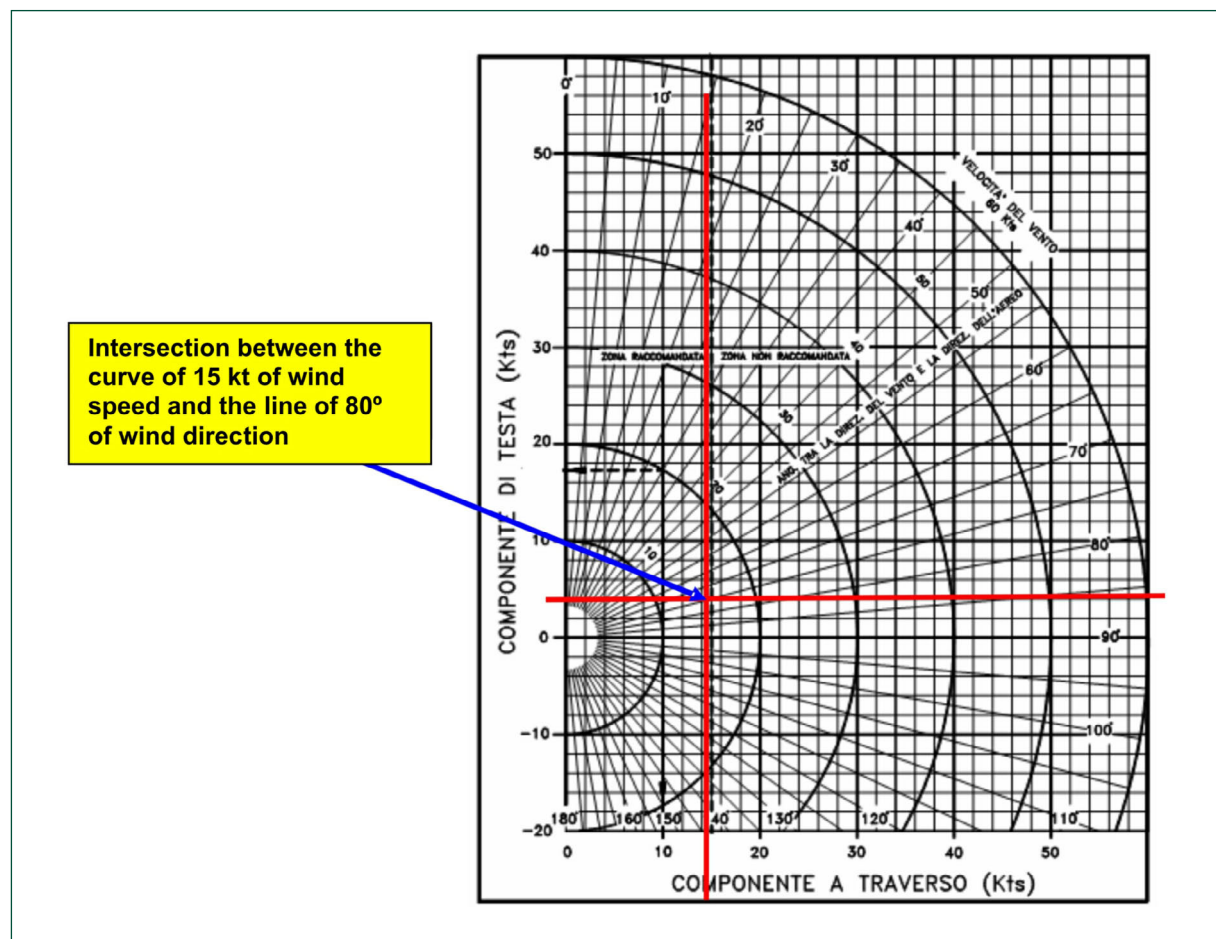
In this case the wind direction was between 200° and 230° , and the speed was between approximately 10 and 15 kt. Taking into consideration the worst-case scenario, which would be where the wind direction would be 200° (close to perpendicular to runway 28), this would incur a wind component that would form an angle of 80° with the flight direction, and a speed of 15 kt, which is greater than those under consideration.

Figure 4. Table for calculation of the cross-wind component

With this data, it is obtained from the table that the maximum cross-wind component would be 14 kt. This result would be near to 15 kt, which is the maximum component described in the manual.

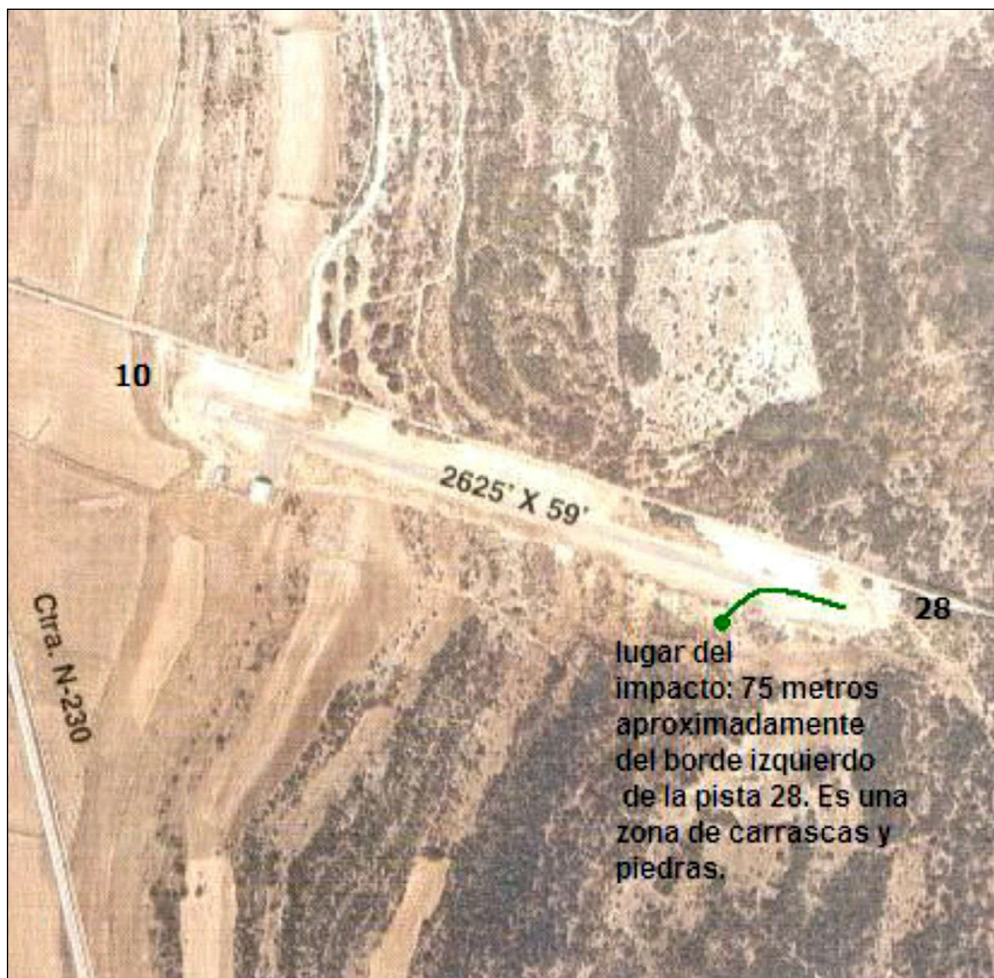
Figure 5. Trajectory of the aircraft

The runway has a steep incline and the contact was made some 30 m after the apron and it was reasonably hard, after which the aircraft quickly started to turn towards the left when it was approximately 70 m down the runway. The pilot applied right foot and did not achieve correction. As he saw that the direction of the aircraft was deviating from the runway he applied maximum power with the intention of becoming airborne again, but all he succeeded in doing was to make the aircraft go more to the left due to the effect of the torque of the engine. He also managed to lift the aircraft half a meter from the ground. By doing this he avoided the slope on the runway edge and planed over the scrub and baby oaks as the aircraft braked over them. He could see that the left leg of the main undercarriage was broken. The distance that the aircraft travelled from the runway was between 60 and 70 m approximately.

In this case the aircraft made the final approach with the nose at a 30° deviation to the left of the runway. It was not possible to confirm whether any of the previously described techniques was consciously used to carry out the landing. At some moment during the approach the left wing had to turn to windward because otherwise the wind would have turned the airplane towards the right. Simultaneously, the pilot was trying to correct with the right pedal but without aligning the nose at any time. The wind came from the left practically perpendicular (at 80°) to the runway axis and at 14 kt, which is almost the maximum component allowed. The aircraft's light weight contributed decisively to the weathercock effect (tendency of the airplane to orient its longitudinal axis towards the wind), in addition to the fact that the nose was already deviated from the runway at the beginning of the approach. For that reason, the action on the rudder was not enough to counter the roll control applied and it was not possible to align the aircraft.
