Report A-037/2006

Accident involving
a SIKORSKY S-61N
helicopter, registration
EC-FJJ, on 8 July 2006,
in Roque Bermejo
(Tenerife – Canary
Islands – Spain)

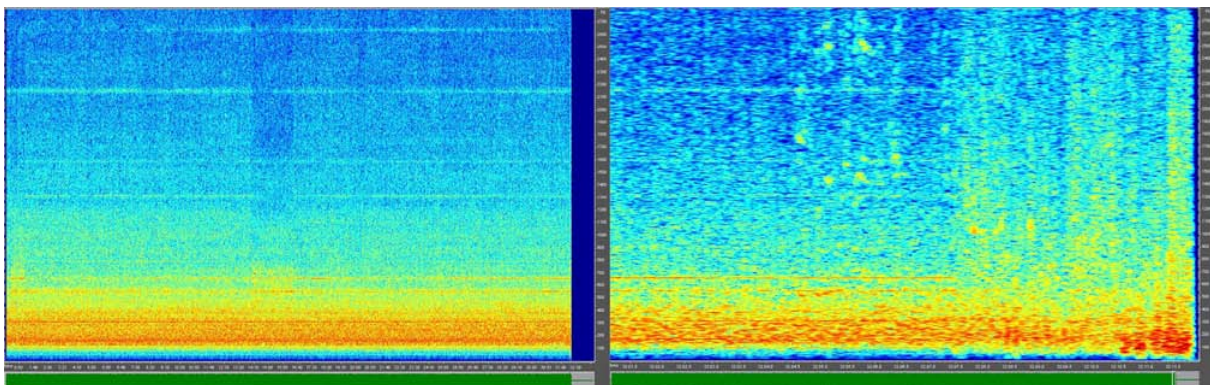
Figure 3. Spectrum of area channel, complete and last 11 seconds

On the channel associated with the area microphone, it was possible to identify the frequencies and harmonics corresponding to the aircraft's alternating current and those generated by the rotation under normal operating conditions of the following components:

- Tail rotor.
- Power turbine tachometer generators.
- High-speed transmission shaft
- Hydraulic pump.
- Meshing of main rotor mast with the planetary gear on the main transmission.

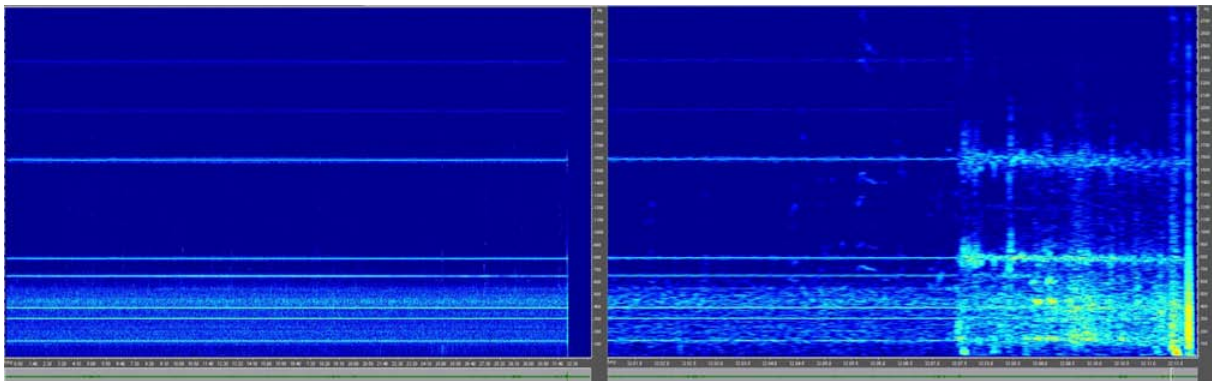
Figure 4. Spectrum of blank channel, complete and last 11 seconds

These signals remained constant throughout the flight until, as with the conversations and other sounds, they suddenly disappeared 4.5 seconds from the end of the recording as the background noise increased and persisted until the conclusion of the recording. Under these conditions, it was impossible to establish whether any of the helicopter's primary mechanical components failed.

The spectrum of the blank channel was also analyzed at the NTSB's laboratory to look for the frequencies associated with electrical noise. Practically the same frequencies and variations were found as were present in the area microphone. The fact that frequencies corresponding to acoustic signals, such as that produced by the turning of the gear on the main rotor mast, were found on a channel that was not designed to record them, though unusual, does occur with relative frequency and is explained as the result of electronic coupling or interference induced by the rotation of these components in those cables routed next to them.

The study of the last 4.5 seconds of this channel also yielded no valid information to establish the possibility of a failure in one of the helicopter's primary mechanical components.

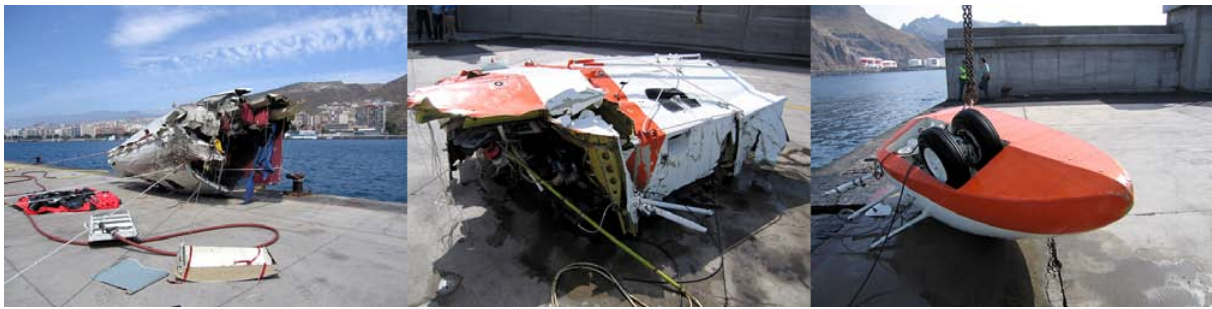
Figure 5. Wreckage recovered, at the port in Tenerife

As detailed in 1.15, floating debris was found on the same day of the accident and recovered. The debris included the aft section of the fuselage and structural components from the lower center section of the fuselage.

As a result of the search conducted between 1 and 8 September 2006, light components were found on the sea bottom from every area of the fuselage that had not been previously recovered (except the tail section), along with parts from four of the five main rotor blades and some of the helicopter's documentation.

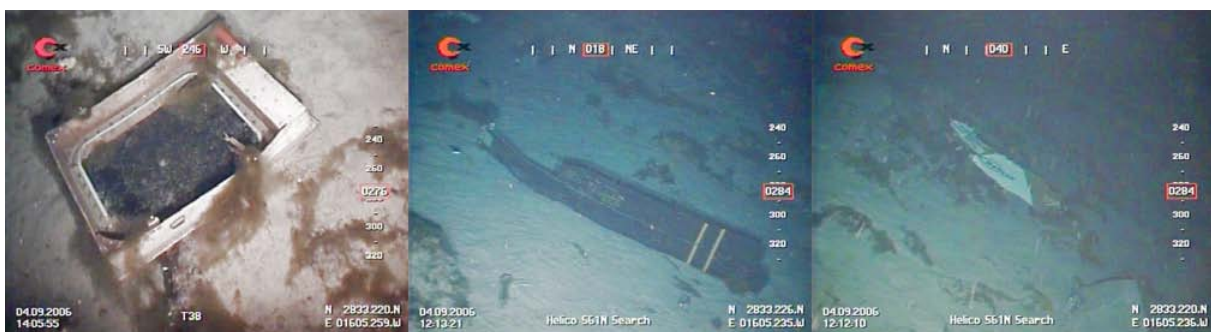
Figure 6. Debris found on ocean floor

In addition, light elements were found on the ocean floor from every one of the helicopter fuselage sections that was not previously recovered, except for the tail section.

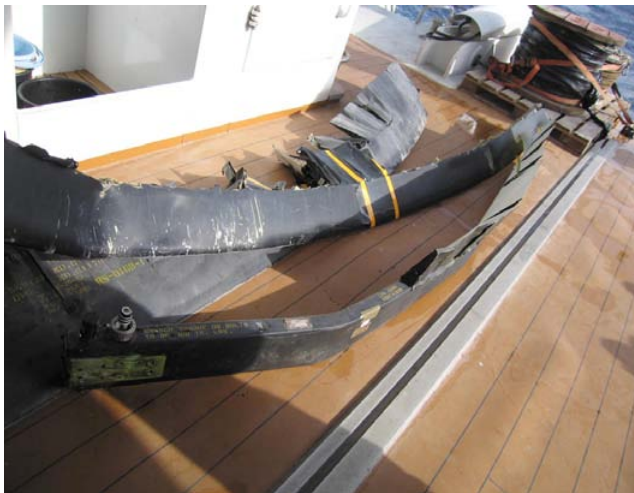
Figure 7. Recovered main rotor blades

All of the segments found for four of the five main rotor blades correspond to the part closest to the union of the respective blade with the rotor head.

With regard to the sections that exhibited the fractures, three of them showed breaks of similar characteristics at both ends, all of them having detached from the rotor head due to fractures in the blades in a section close to the union with the rotor head. The fourth had broken from its rotor head attachment due to the breaking

of the fastening bolts. Of the three aforementioned blades, the first two fragments were recovered and measured approximately 4.5 and 5.5 m. The third fragment was not recovered. The fourth, belonging to the fourth blade, measured some 3.8 m.

It was noted that the breaks in the first two spar segments were of a static nature. Due to their similar characteristics, judging by the images captured by the ROV (Remote Operated Vehicle), it is believed that

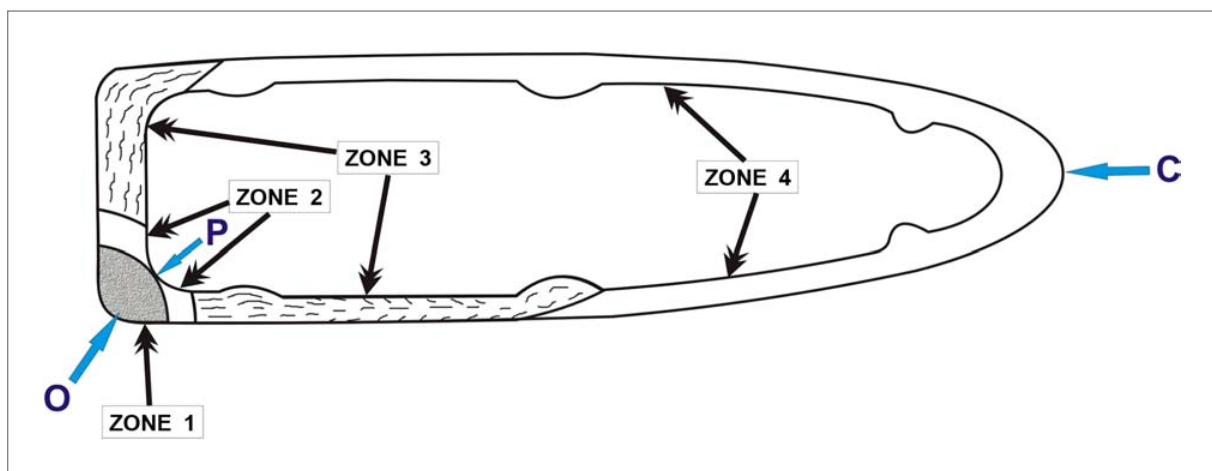
Figure 11. Fracture surface zones

In general, the entire surface of this segment was corroded as a result of having been submerged in sea water for some two months.

Referring to the diagram in Figure 11, four clearly separate areas were evident in the fracture surface:

As a result of this study, it was determined that the break in this section of blade initiated along the lower part of the rear spar wall (point O in the diagram of Figure 11), propagated via a fatigue mechanism and developed and failed due to a tensile static overload.

The zone exhibiting signs of a progressive failure caused by a fatigue mechanism extended over approximately 5% of the blade section's surface and affected practically the entirety of the spar wall thickness. On the edge that opened toward the inside of the blade there was a strip of material about 1 mm thick, corresponding to the fracture exit lip (point P in the diagram of Figure 11).

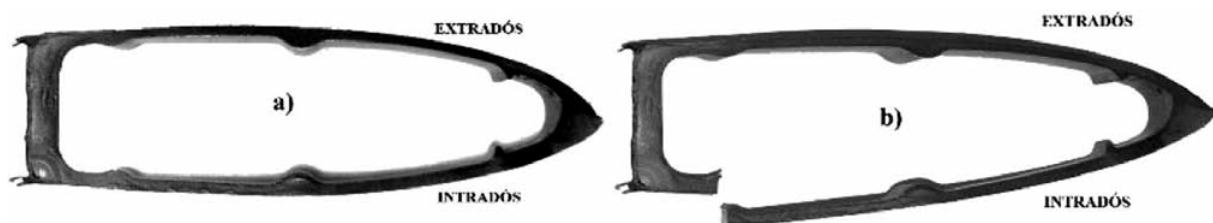
Figure 12. Fracture section before and after the cut

As for the initiation of the fatigue fracture, it took place in an area whose surface had flattened during the crack propagation and subsequently undergone an oxidation-corrosion process, over a limited area, which masked any information concerning the existence of a possible process prior to the corrosion. This process, very localized, could have contributed to the initiation of the fatigue process.

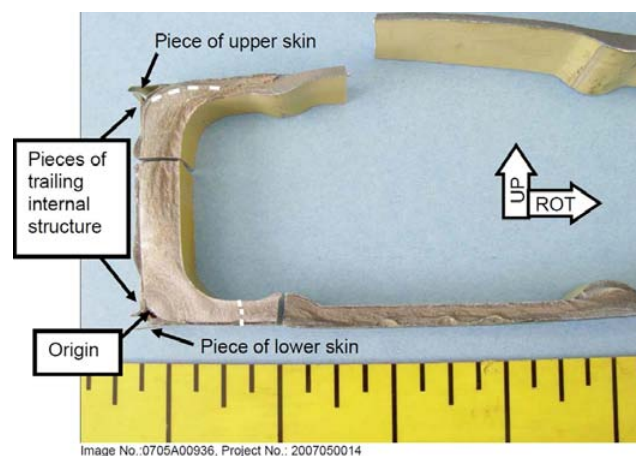
Figure 13. Extent of fatigue fracture limits

In this study, it was noted that a portion of the fracture surface on the spar's trailing edge exhibited relatively flat characteristics along a plane perpendicular to its longitudinal axis, characteristics which were consistent with a fatigue crack. There were lines along which the fracture stopped, also consistent with a fatigue crack, originating at the lower corner of the spar's trailing edge, as shown in Figure 13. These typical fatigue fracture features extended to the top and forward to the dashed lines shown in the figure.

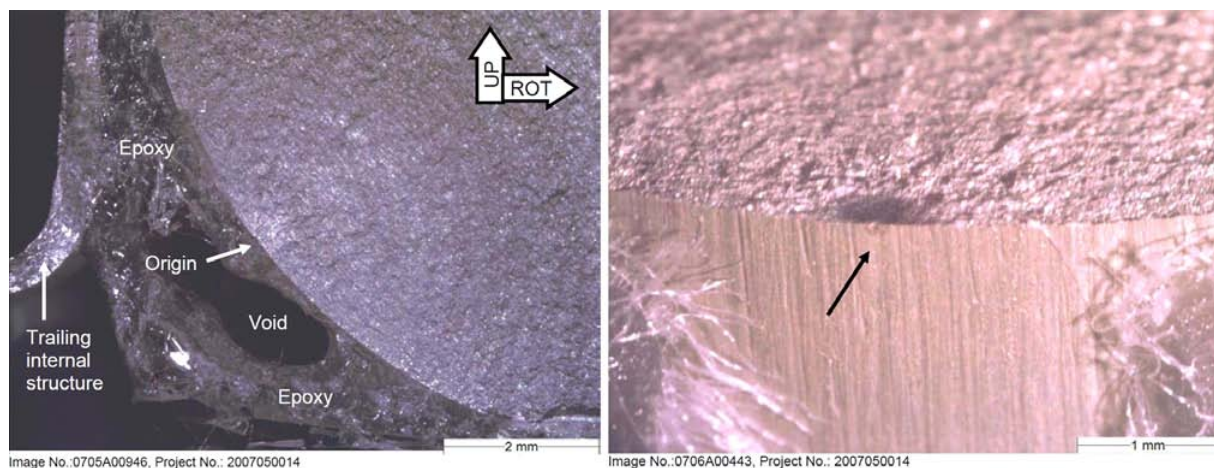
Figure 14. Fracture initiation point

The bellow image of Figure 14 shows the fracture initiation point in detail. The origin was situated at approximately the halfway point of the arc that joined the rear and lower spar surfaces. Epoxy was found on the spar surface and although there was a large void next to the origin, there was epoxy between the void and the spar surface. As can be seen in the right image of Figure 15, once the epoxy was removed from the area where the fracture initiated, a corrosion pit was found, surrounded by material that was of a darker color than the rest of the surface.

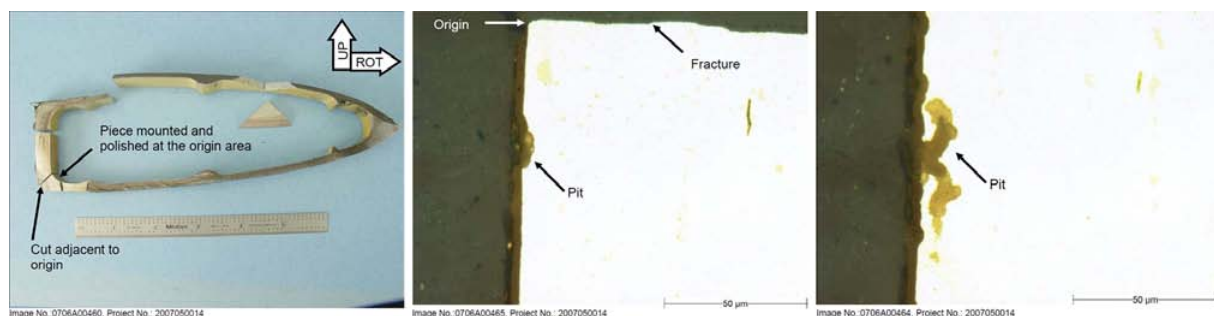
Figure 15. Analysis of fracture initiation point

To examine the microstructure of the area of origin, the piece was cut as shown in the left image of Figure 15 and prepared for analysis. As is evident in the center and right images in this figure, although no anomalies were found along the plane cut by the fracture surface, a small corrosion pit was found next to it, as well as another one further away.

The results of this study generally support the idea that the fatigue process started in a small corrosion pit that would not have been detectable under normal conditions, unless the crack propagated to the extent that it could have been detected via the BIM system. No manufacturing defects or marks produced by tools used during maintenance activities were detected in the material.

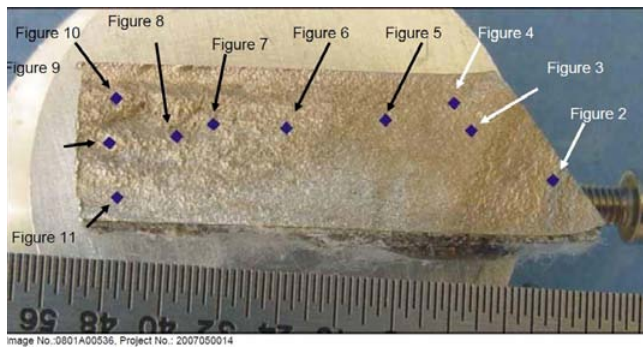
Figure 16. Fracture section on which additional study was conducted

INTA was consulted once again. It replied that, from a macrofractographic standpoint, a fracture along a plane perpendicular to the blade's longitudinal axis is not, in and of

itself, indicative of a fatigue fracture. Numerous references can be found in the literature in which a fracture that is initiated and propagated by a fatigue mechanism in a plane that is perpendicular to the forces that cause the fracture, at a given moment will quickly propagate from a static overload along the same fracture plane.

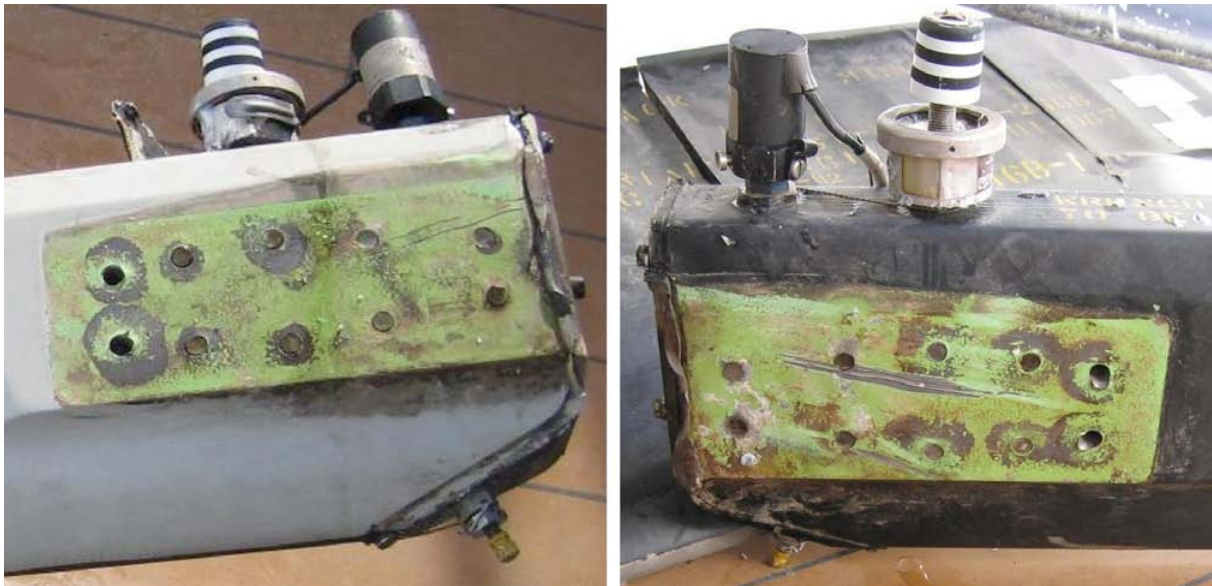
Figure 17. Top and bottom view of the "black" blade root

The photographs in Figure 17 show how parts of the bolts remained in eight of the bolt holes in the "black" blade.

The ends of the bolt segments, which were still in their housings, showed signs of shear fracture resulting from the relative displacement between the two components that held the blade to the cuff.
