DATA SUMMARY

Date and time	Saturday, 15 July 2006; 10:30 h UTC
Site	Madrid-Barajas Airport (Madrid)

Registration	HS-TGY	F-GOHC
Type and model	BOEING B747-400	EMBRAER EMB-135
Operator	Thai International Airlines	Régional

REPORT

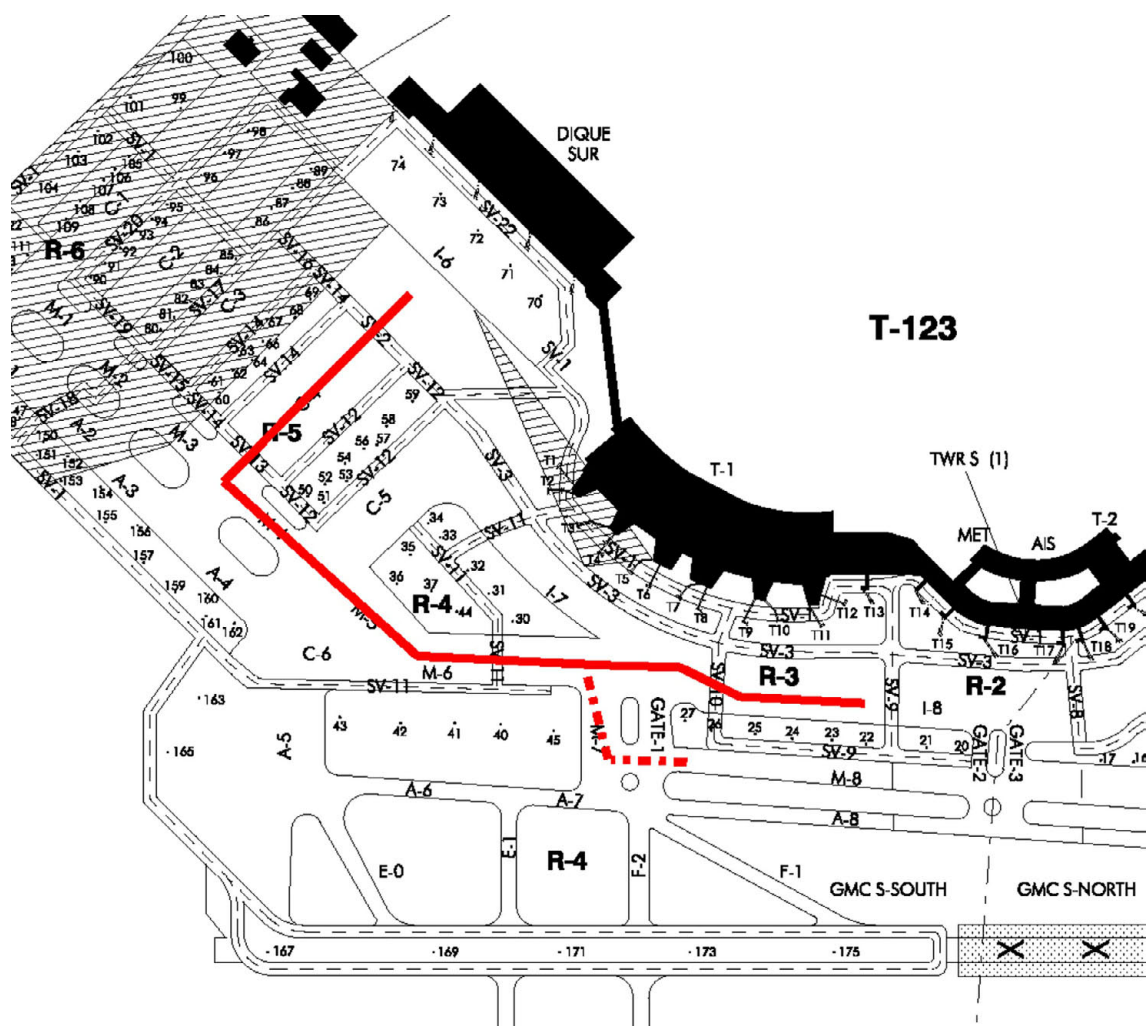
The general layout of the applicable part of Madrid-Barajas Airport is shown in figure 1. The aircraft had followed the approximate trajectory shown in Figure 1 by a solid line. To follow taxiway M, it should have turned to the right (as shown by a dotted line in Figure 1) upon reaching the sign on the ground (see Figure 2) but instead continued straight into taxiway I.

Figure 1. Approximate trajectory of the aircraft (solid line) versus intended trajectory according to the AIP taxiing instructions from Ramp 5 to runway 36R (dotted line). The ATC specifically offered the aircraft to taxi initially through C-4

- REC 47/07.** It is recommended that AENA revise the AIP taxi instructions for Madrid-Barajas Airport in order to provide an independent and separate set of instructions for taxiing from every terminal area to every runway threshold.

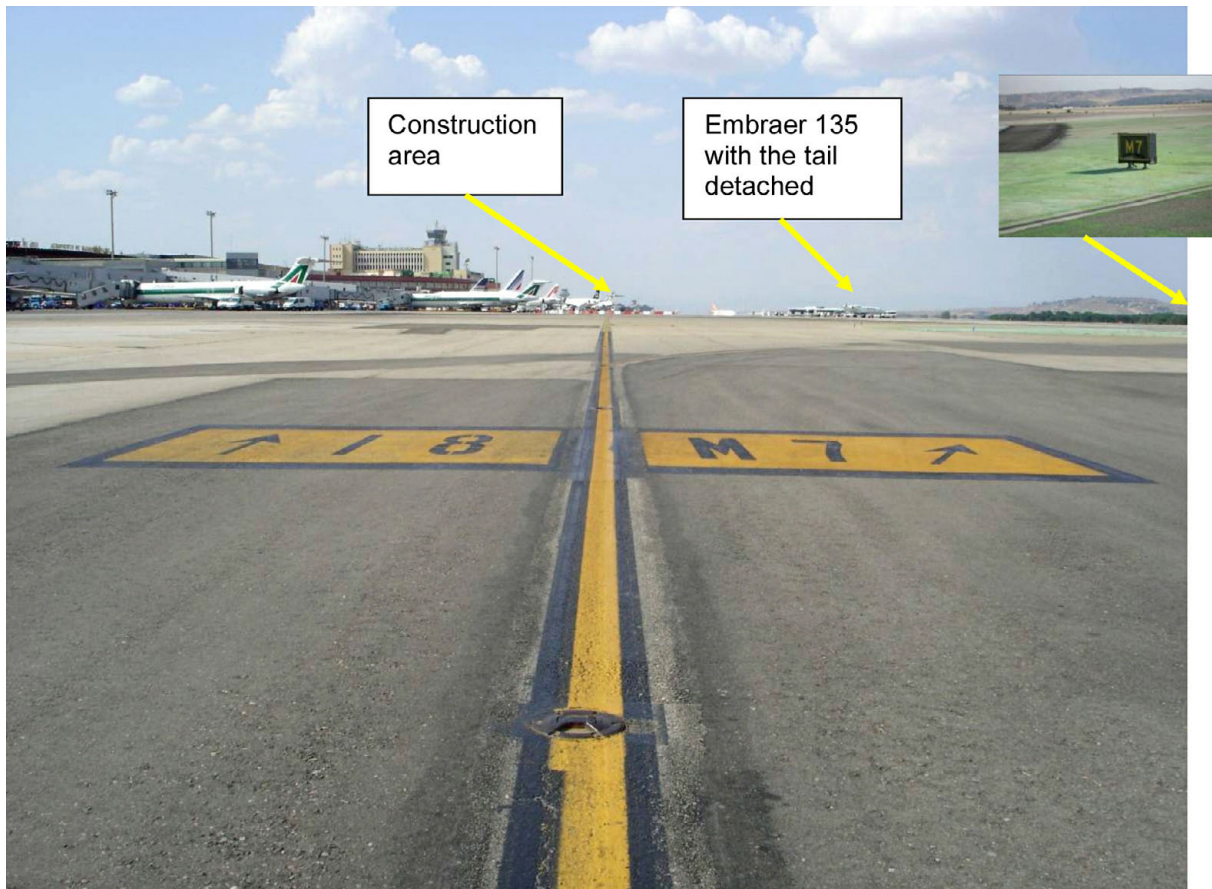
Figure 2. Horizontal mark on the taxiway at M6-M7 junction as viewed at surface level. On the left, the South Control tower can be seen. In the center background, the construction area and the damaged Embraer aircraft are visible. On the right, outside the picture, there was a vertical sign showing M-7

Taxiway M had both horizontal and vertical signs. Those signs had the appropriate size and color. Toward the end of M-6 there were horizontal signs with arrows to show the direction to M-7 or I-8 (see figure 2). The arrow on the M-7 sign was at 45° and therefore was not in compliance with the rule that requires an arrow at 90° for taxiways that are perpendicular.

There was also a vertical sign with the legend "M-7" to the right of the M-6/M-7 junction (see figures 2 and 3).

- REC 48/07.** It is recommended that AENA review the horizontal signs at Madrid-Barajas airport to ensure they comply with applicable norms.
- REC 49/07.** It is recommended that AENA establish procedures to ensure that construction zones within the airport's maneuvering area be provided with suitable provisional markings to clearly show the flight crews the aircraft restrictions affecting the zone.

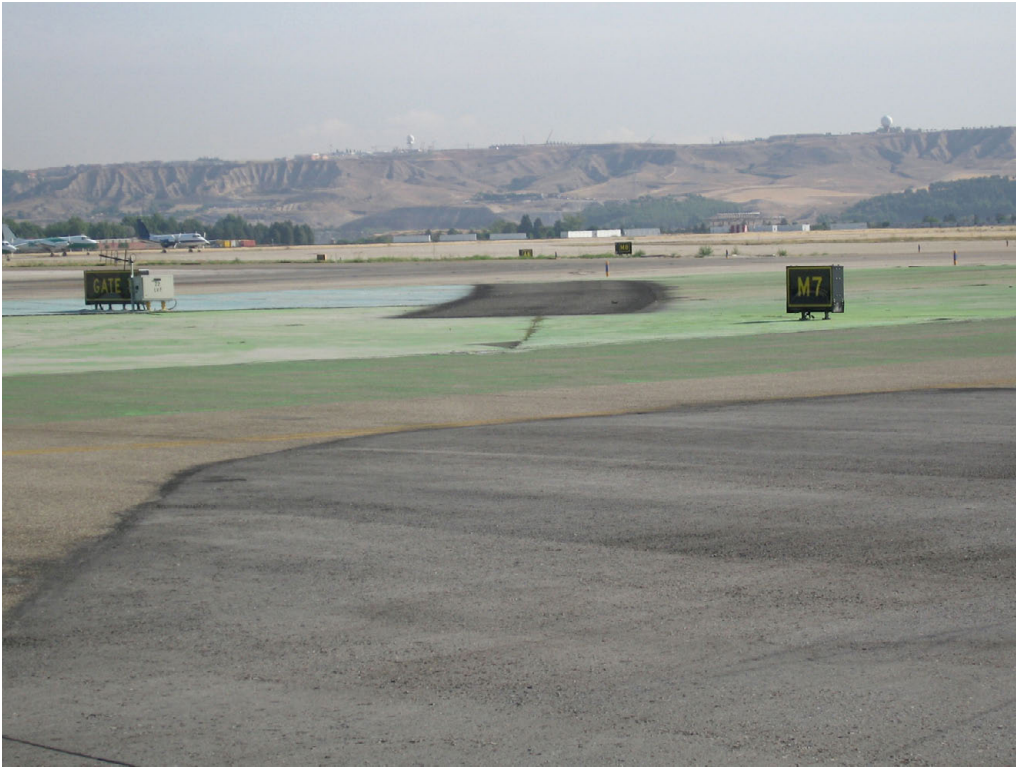
Figure 3. Vertical signs of M-7 and GATE 1 viewed from ground level from the M-6/M-7 junction

There was another vertical sign showing "GATE 1" in the next taxiway junction (see figure 3). The position of GATE 1 can be seen in the AIP chart in figure 1 and in the Jeppesen chart in figure 8.

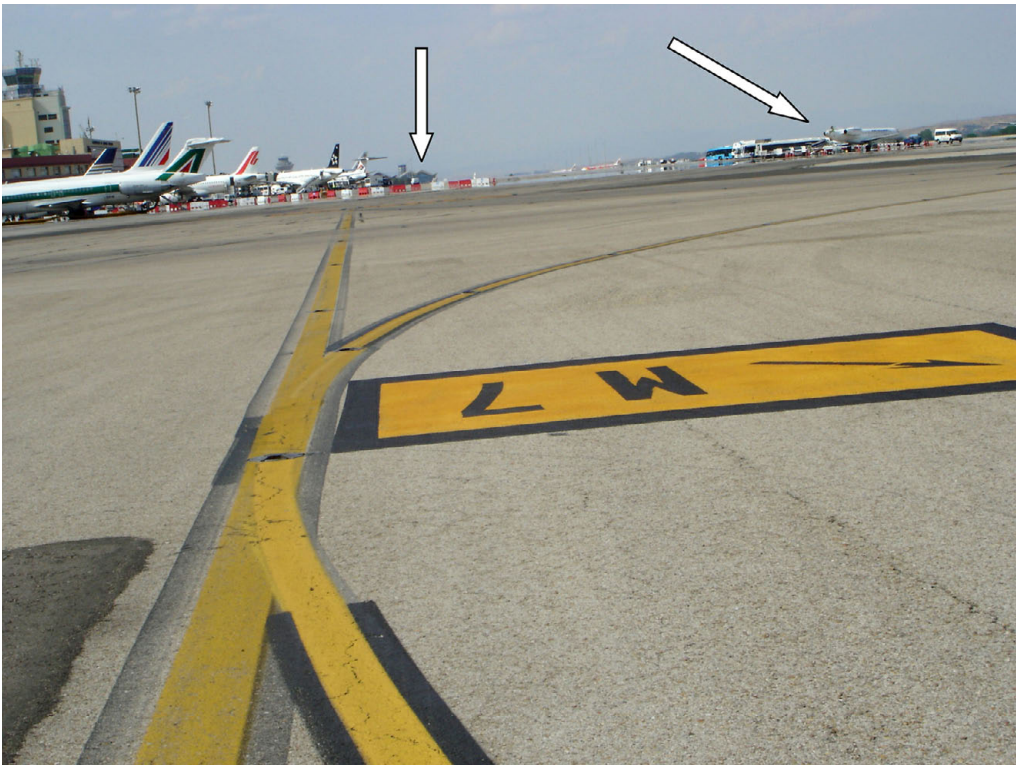
Figure 4. Horizontal sign showing M-7 turn directed at aircraft taxiing in the opposite direction from that followed by the B-747. The construction works area and the damaged EMB-135 are noted by white arrows.

After the M-7/I-8 horizontal sign, there was no other horizontal sign showing I-8 up to the construction work area. There were signs with arrows showing the direction of "I-7", "M-7" and "GATE 1" advising that turns were needed to enter those taxiways or gate but those were aimed at aircraft taxiing in the opposite direction, and therefore the crew of the B747 could only see those signs backwards as shown in figure 4.

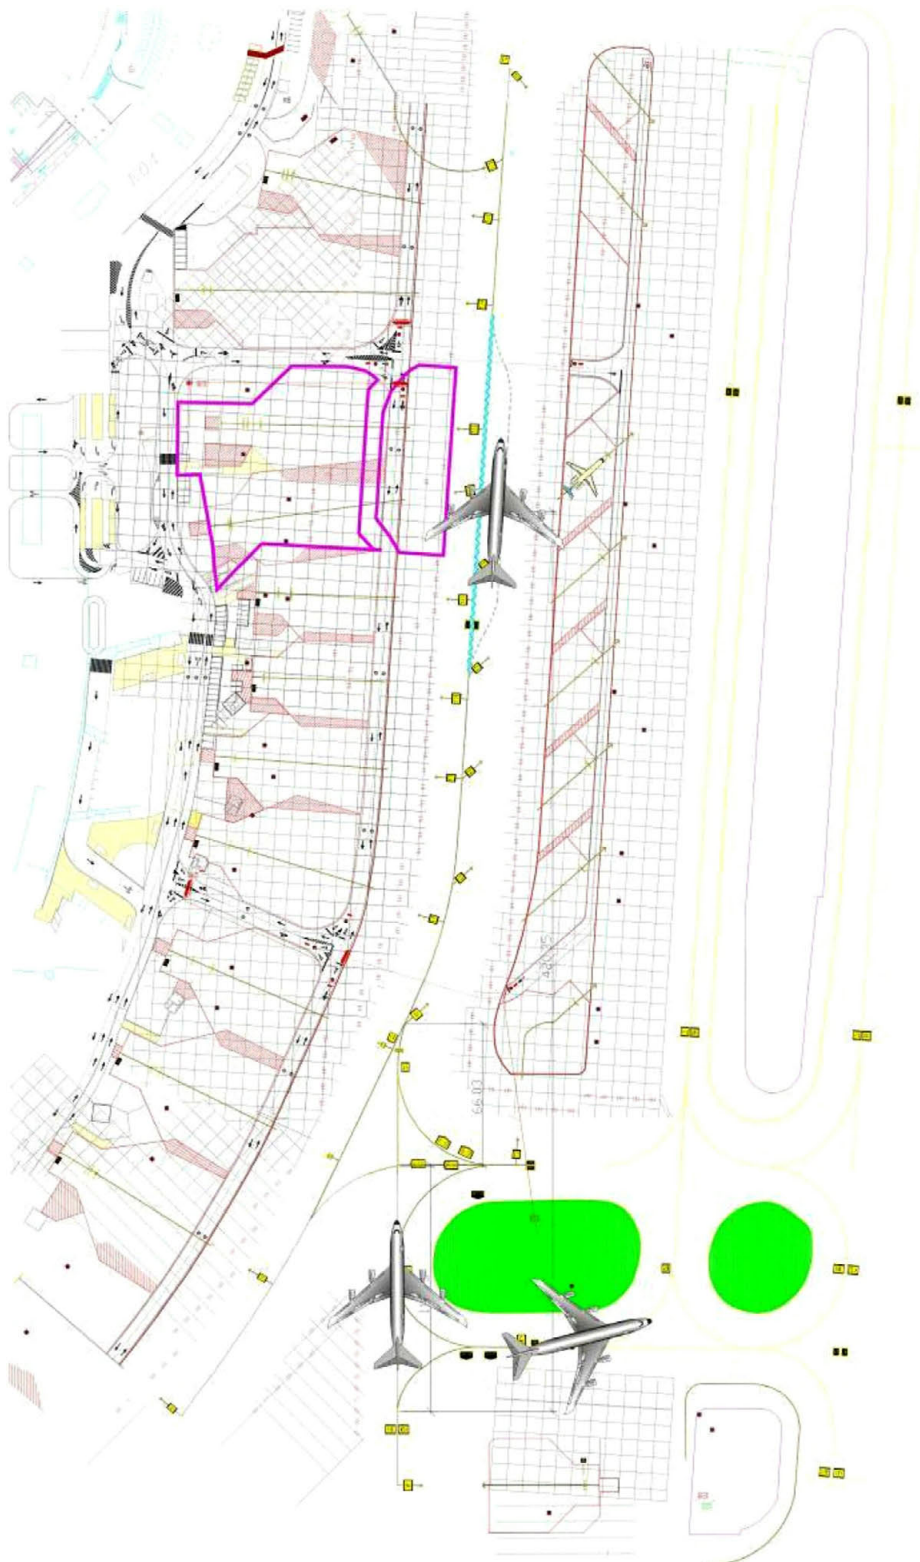
The construction in taxiway I had led to the deletion of the original taxiway centerline and the establishment of a new centerline that deviated to the right to avoid a spot of pavement being modified (see Figure 5).

Figure 5. The layout of the accident area in detail. The original I-8 taxiway centerline is shown in blue. It was displaced 11 m to the right (dotted line) due to the construction work in the area, enclosed by a purple line. According to the AIP taxiing instructions, the aircraft should have turned right to M-7 after the M-6/M-7 junction, as shown in the picture

There was construction work being carried out on taxiway I-8 on the day of the accident. This taxiway has a width of 76 m. The drawing of Figure 5 shows the layout of the construction work that had led to the modification of the taxiway centerline, which was displaced 11 m to the right leaving 27 m of available distance from the new centerline to the parking position of the EMB-135.

Therefore, I-8 had the limitation of A-321 as the biggest aircraft that could use the taxiway, because the actual width available on that taxiway was 54 m. ICAO Annex 14, paragraph 3.10.2, requires a taxiway strip width of 52 m for a C code-letter aircraft like the A-321 (the actual span of this aircraft is 34.1 m).

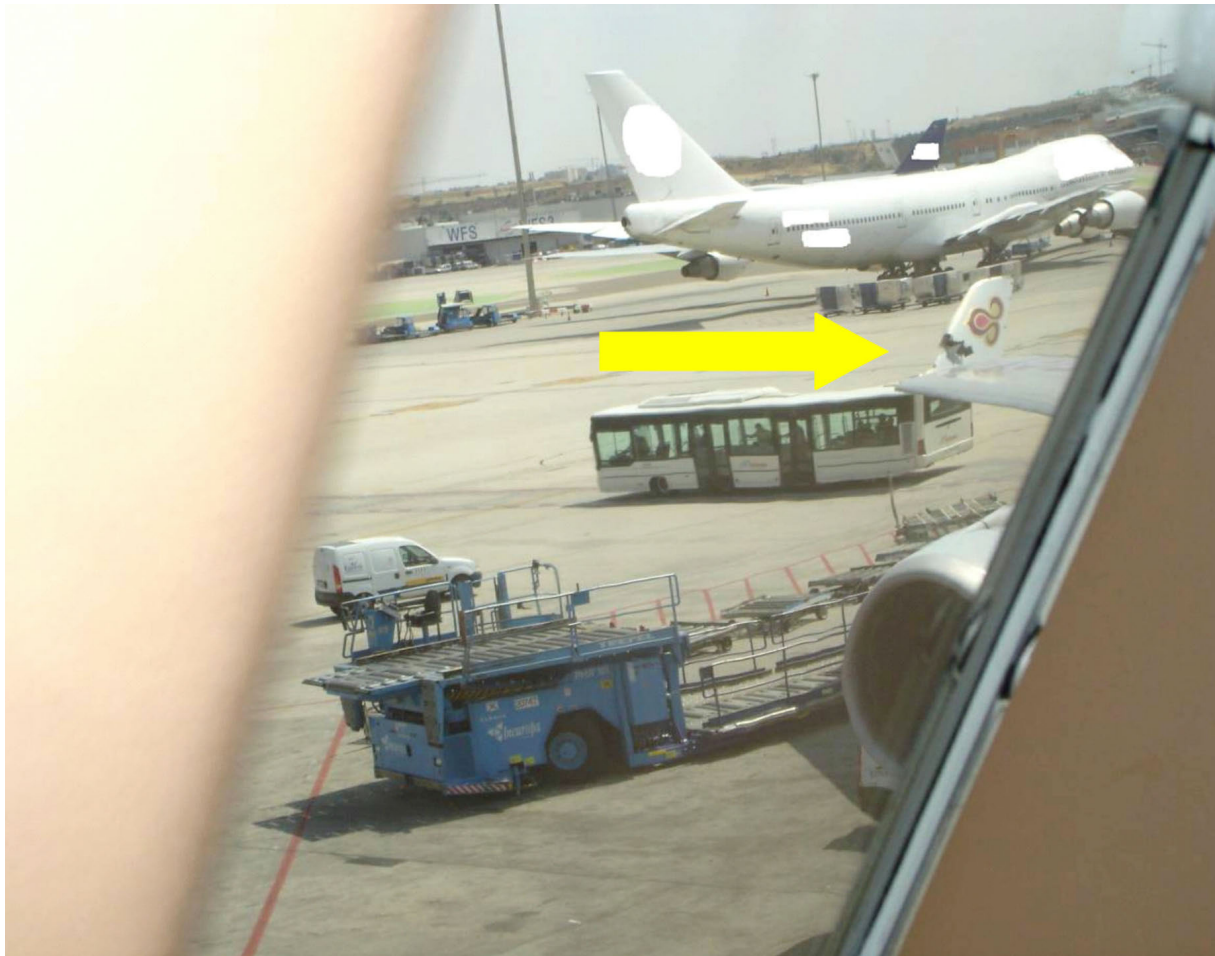
Figure 6. View from the copilot side of the wingtip of the accident aircraft

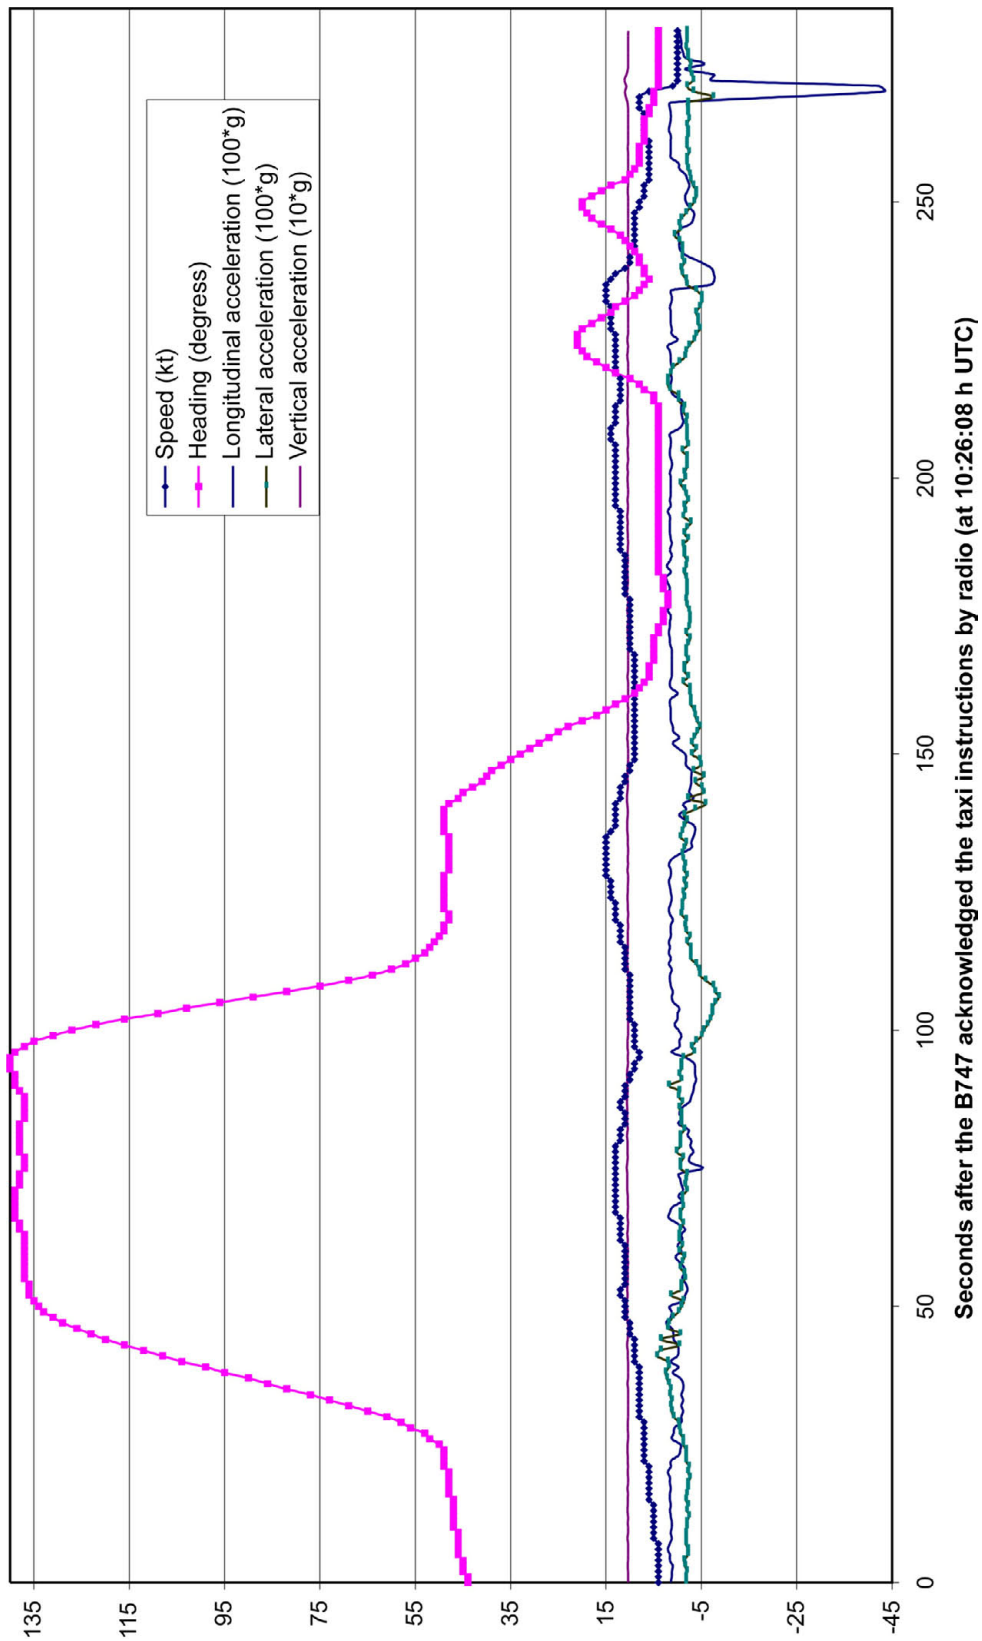
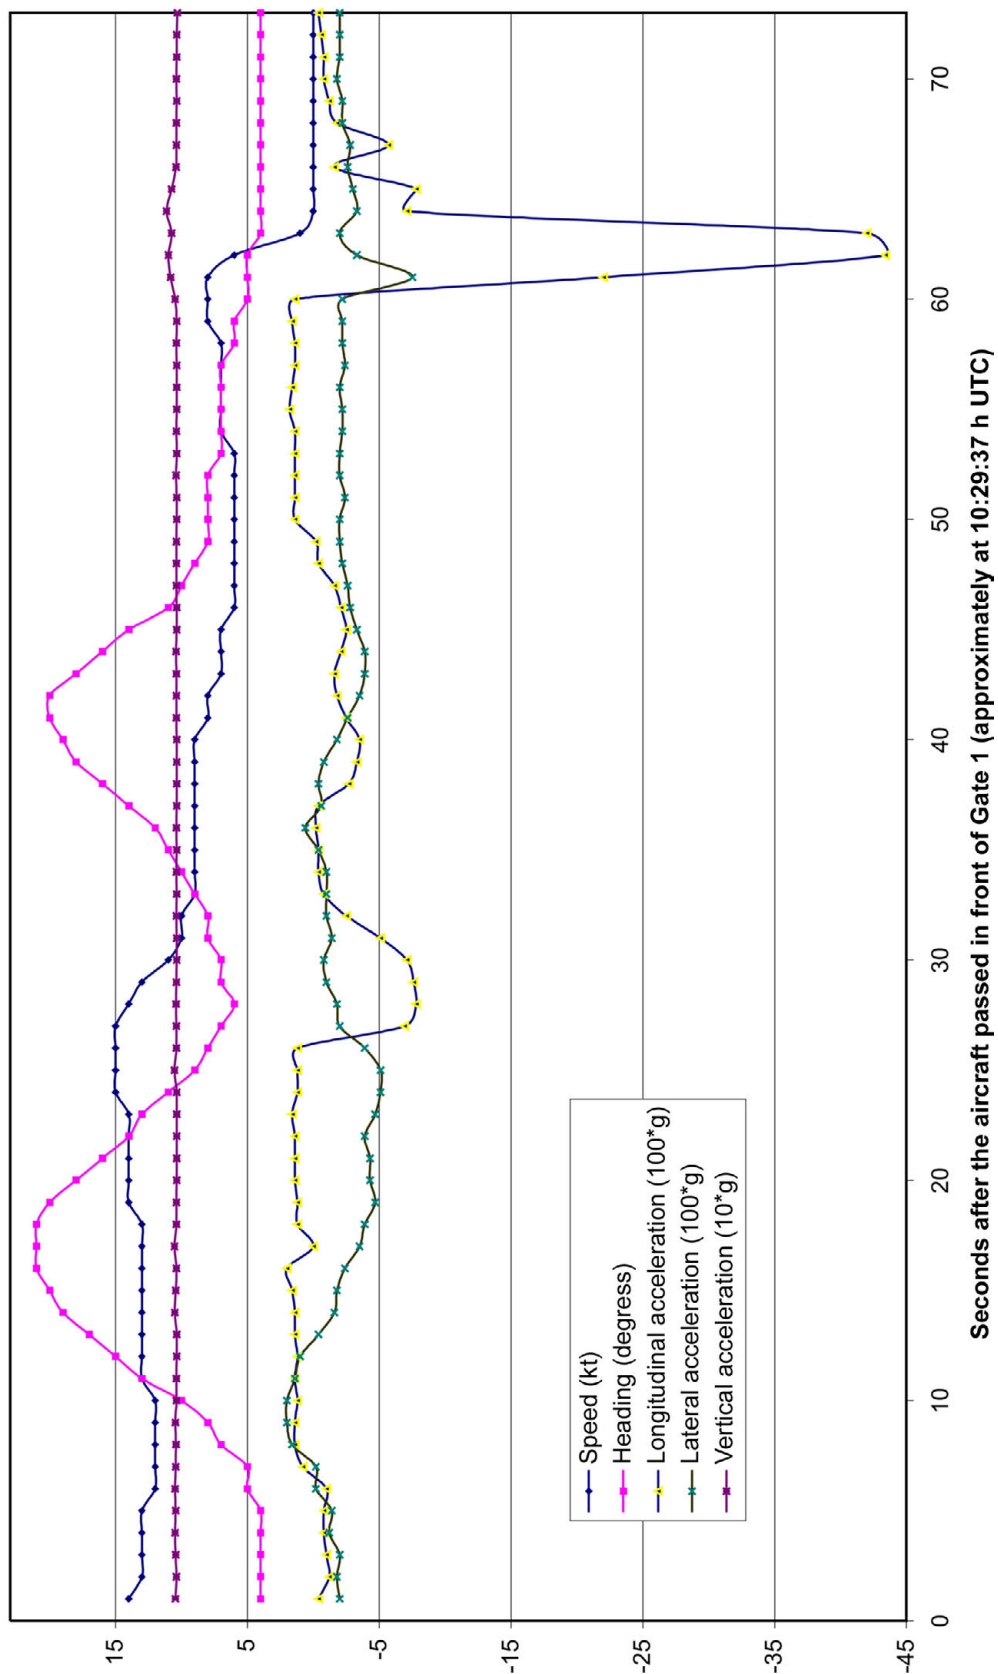
Figure 7. Two graphs prepared from FDR data. Heading shows the turns carried out by the aircraft. Negative longitudinal acceleration means that brakes were applied

Figure 7 shows two graphs with the most important parameters of the FDR. The first graph shows the movement of the aircraft after it started taxiing forward, after the flight crew said on the radio: "OK TAKE CHARLIE FOUR AND MIKE THAI NINE FOUR THREE". The other graph shows in detail the last minute prior to impact, after the approximate moment the aircraft passed in front of Gate 1.

The aircraft was in constant motion from the time it started taxiing, i.e. they never stopped at any intersection until they applied the brakes after the collision. The push back and taxi was normal. At 10:30:00 h the speed of the aircraft was 15 kt which is normal for the operation being conducted. As the aircraft approached the deviated centerline area of I-8, it reduced speed down to 6-8 kt while turning. At 10:30:41 h the speed was zero because the impact had already happened and the crew applied brakes. The rest of the taxi had been normal.

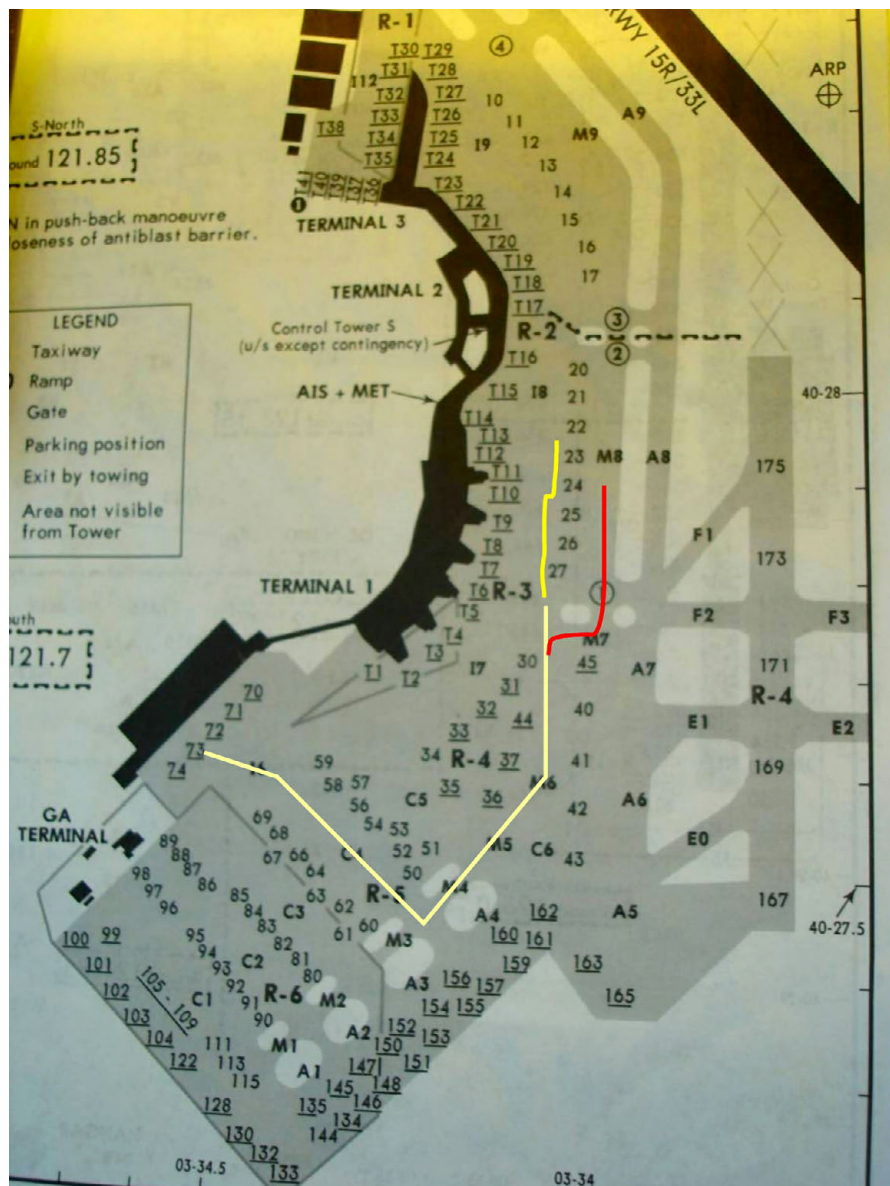
Figure 8. The Jeppesen chart that was on board. The actual path they followed is shown in yellow. The path the B747 aircraft should have followed is shown in red. The Jeppesen chart includes the number 1 inside a circle, meaning "Gate 1"

The flight crew had a Jeppesen chart on board of Madrid-Barajas Airport (see Figure 8). The chart's level of detail for the ground movement area was far less than that of the Spanish AIP (see Figure 1).

- The chart the crew had on board (see Figure 8). It has been determined that this chart was not detailed enough to provide an accurate position of the aircraft along the complex network of Madrid-Barajas airport, specifically within several conflicting platform zones, such as those near M-6, M-7 and M-8. The airport charts used by the crew should allow any given restricted or forbidden airport zone to be quickly and easily located so as to avoid it. A safety recommendation is issued to the operator in this regard.
- The horizontal sign painted on the ground (see Figure 2). It has been determined that, although the sign did not exactly comply with the norms of the AENA manual (i.e. the arrow pointing to M-7 was at a 45° angle with the taxiway axis instead of 90°)

- REC 44/07.** It is recommended that Thai Airways International ensure that the airport ground movement charts provided to its flight crews have adequate detail to facilitate accurate compliance with ATC instructions.

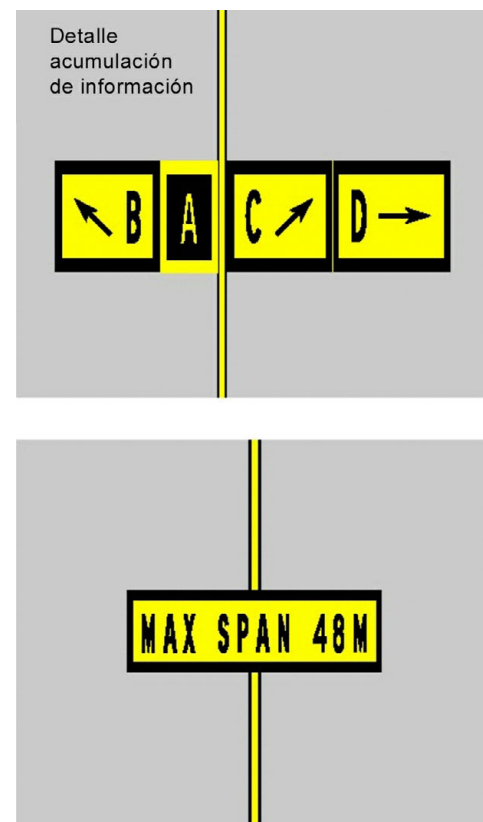
To avoid the condition described in bullet b) above, in addition to the use of NOTAMs to advise the flight crews involved, a useful safety measure could have been to provide provisional visual signs to advise of the maximum span allowed in that taxiway (in this case, the Airbus A-321 was the biggest aircraft allowed in I-8). AENA already has standardized signs for this purpose (see Figure 9) and therefore a safety recommendation is issued in this regard.

Figure 9. Signs from manual the AENA²
