DATA SUMMARY

Registration	EC-JCQ
Type and model	TECNAM P2002-JF
Operator	Private

REPORT

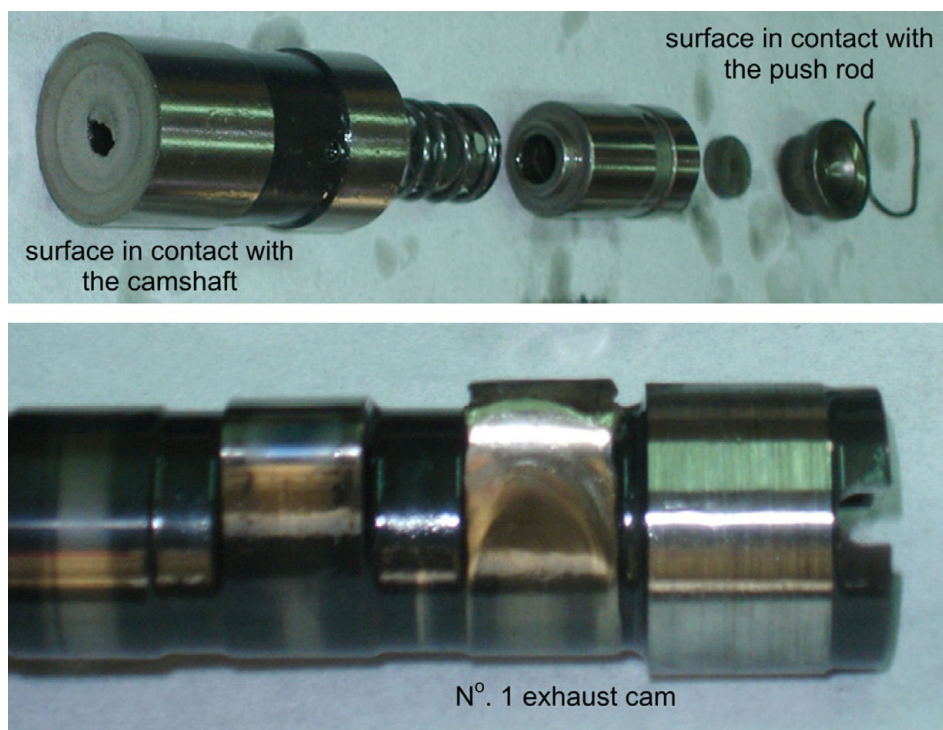
- The propeller did not rotate freely.
- Upon removing the gearbox, the magnetic plug was found to contain a large quantity of metallic particles.
- The oil pump's upper casing showed evidence of circular abrasion marks.
- The combustion chambers showed clear signs of oxidation. Metallic particles and abrasion marks were also found.
- The crankshaft did not rotate and showed abrasion marks on the crankpins.
- The hydraulic tappet on the exhaust valve of cylinder number 1 was jammed. Extracting it revealed that the contact area between the tappet and the cam was perforated (figure 1).
- The camshaft showed signs of wear, as did the cam associated with the exhaust valve number one cylinder, whose tappet was perforated (figure 1).
- The camshaft bearing in the crankcase showed abrasion marks.

Figure 1. Hydraulic tappet and exhaust cam for the n° 1 cylinder

Mechanical and metallographic analysis revealed that the hydraulic tappets met design hardness specifications, except the perforated tappet with an HRC value of 53-54 below the minimum required of 55 HRC. According to the manufacturer, that value is not conclusive due to the fact that the hardness of the perforated hydraulic tappet could not be measured at the required point (1.54 mm off the center) given the perforation on the surface.

A hardness analysis of the camshaft material showed that the cam (showing massive wear too) associated with the exhaust valve number 1 cylinder met design specifications, with a hardness of 724 HV10 with respect to the minimum value of 680 HV10.

After a total of 45 minutes of operation since being installed on aircraft EC-JCQ, the new certified Rotax 912S2 engine began to exhibit a loss of power, increased temperature, vibrations and a metallic sound. The inspection of the engine revealed that the hydraulic tappet from exhaust valve cylinder number 1 was perforated, did not meet design hardness specifications, and that the associated camshaft cam showed a massive loss of material.

According to the manufacturer, the cause of the perforation is an excessive roughness of the hydraulic tappet contact surface in combination with the engine oil used for lubrication. These conditions led to excessive friction and heat, which caused the loss of material and perforation of the tappet and camshaft cam. In this regard, the

- Polishing the surface that came in contact with the cams on the hydraulic tappets in order to reduce the friction between the two pieces.
- The improvement of the engine oil used on the serial test bench.
- The inclusion, in the quality control process for the pieces, of a tappet size control step and of a visual inspection of the roughness of the area in contact with the hydraulic tappet cam.

- A check of the tappet spring tension and visual inspection of the accurate assembly and the right colour of the spring.
- The installation in new engines of the new polished hydraulic tappets so as to prevent excessive friction.

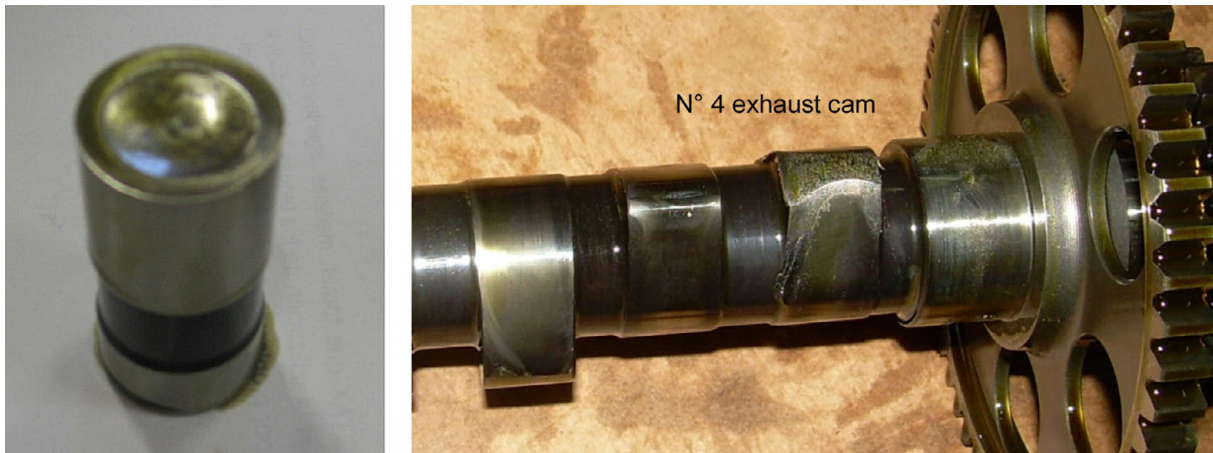
The inspection of the engine revealed a large quantity of metallic particles in the magnetic plug, the propeller did not turn freely and a stuck-open exhaust valve on the number 4 cylinder as a result of the associated hydraulic tappet being stuck in its housing in the crankcase. After disassembly, it was verified that the tappet surface in contact with the camshaft was no longer flat, and that a dimple had been created as a result of wear. In the associated camshaft cam, wear was also observed (figure 2).

Figure 2. Hydraulic tappet and camshaft cam from exhaust valve cylinder n° 4 on aircraft EC-IZC

Despite similar wear on tappets and camshafts of aircraft EC-JCQ and EC-JCQ, the manufacturer considers that the EC-IZC problem is different from that of the EC-JCQ and does not share the same cause.

That scenario explains problems which occurred on new engines or engines with new tappets installed. However, it does not explain problems which appeared on engines with more operating hours, like the EC-IZC aircraft, in which at just 152 hours of total operation, the engine showed similar wear and loss of material on tappets and the camshaft cam. Nevertheless, the manufacturer considers that the EC-IZC occurrence is a different case and does not share the same cause.

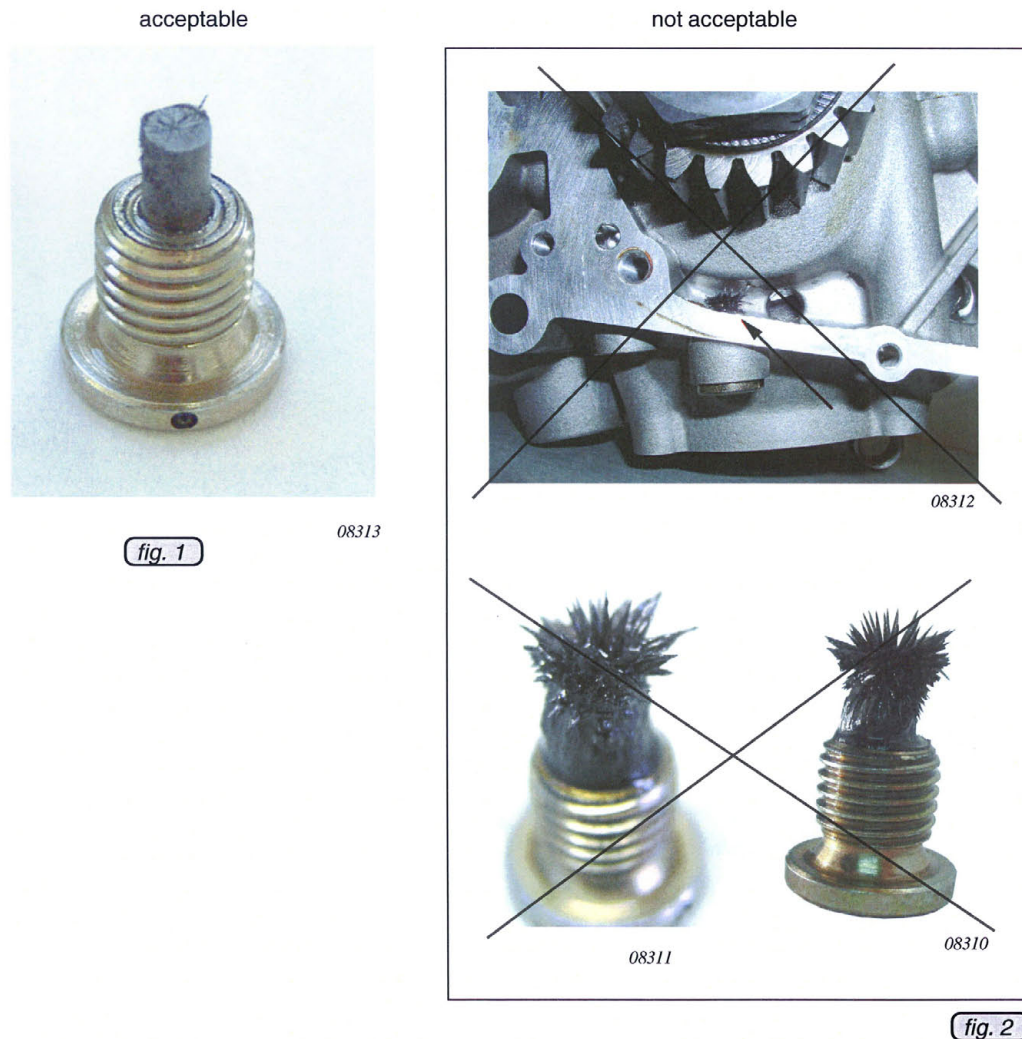
See fig. 1 and fig. 2

■ **CAUTION:** If a greater quantity of metal particles (more than 3 mm (1/8")) is detected, consultation of an authorized distributor regarding further action is necessary. The engine must not be taken into operation until the cause has been identified and eliminated.

- Remove the magnetic plug according to relevant Maintenance Manual.
- Inspect magnetic plug in accordance with procedure in relevant Maintenance Manual.
