## DATA SUMMARY

Date and time	Thursday, 27 July 2006; 22:15 local time
Site	29.8 NM east of Barcelona Airport, FL 235

Registration	EC-IJF
Type and model	BOMBARDIER CRJ200 CL-600-2B19
Operator	Air Nostrum LAM

Type and model	GENERAL ELECTRIC CF34-3B1
Number	2

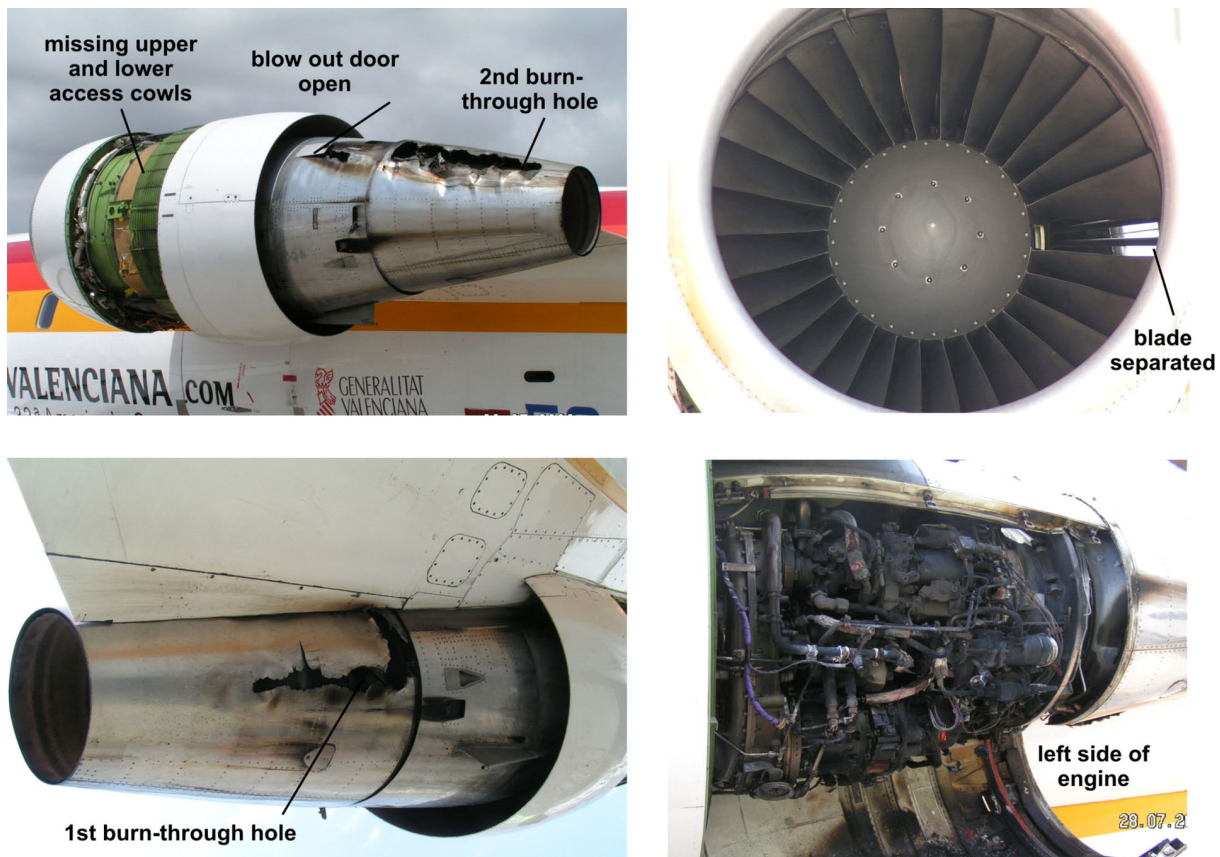
The damage to the aircraft was confined strictly to the left engine. A cursory glance revealed that a fan blade and the upper and lower access cowls had detached, as well

Figure 1. Left engine of aircraft EC-IJF after the incident

as areas where an intense fire had burned through. There was no damage to the rest of the aircraft.

After the incident it was noted that a fan blade had become detached. The separation was contained and the remains of the blade were found embedded in the fan containment ring. The upper and lower access cowls were lost in flight and not recovered.

There was extensive fire damage to the accessory compartment, especially to the left side in the vicinity of the fuel pump and main fuel control. The fuel, oil and electric lines were all damaged by the fire.

Lastly, there was a second 180° counter-clockwise rotation of the LPT module and of the exhaust nozzle fairing, which accounts for the position in which they were found after the incident. This second rotation, like the first, resulted as a reaction of the turn of the LPT rotor and probably happened when the engine increased their rpm once the autopilot was disengaged (N1 near 30% and a speed of 314 kt) with the aircraft in a nose down attitude some seven minutes after the failure. When this rotation took place the fire was still burning in the aft engine compartment. It was then that the fire burned through the exhaust nozzle fairing again, this time through the blow out door (Figure 1).

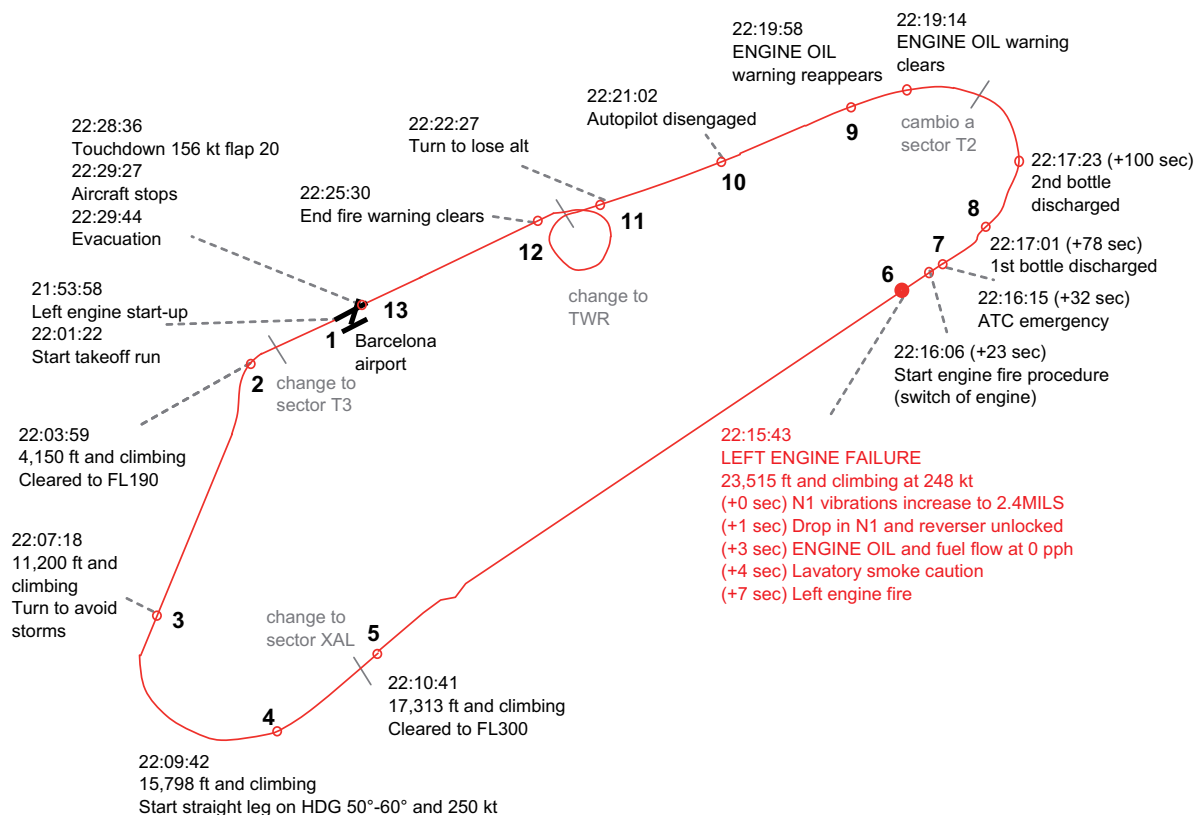
Figure 2. Complete flight path

The flight lasted a total of 36 minutes from the initial engine startup to shutdown. Figures 2 and 3 show the complete flight of aircraft EC-IJF. The first 22 minutes (points 1 to 5 in Figures 2 and 3) transpired without incident and with the engines working normally. The aircraft climbed, requested a turn to avoid an area of storms and continued climbing on a course of 50°-60° and an average GS of 250 kt (segment 5-6 in Figures 2 and 3).

At 22:15:43, with the aircraft at an altitude of 23515 ft, at 248 kt and climbing, the left engine failed (point 6 in Figures 2 to 5). At that instant the left engine N1 RPMs indicated 93.2% and the ITT temperature was 780 °C. On takeoff, at sea level and with takeoff thrust, the N1 RPMs were 87.6% and the ITT temperature was 790 °C. The recorders show the following after the failure:

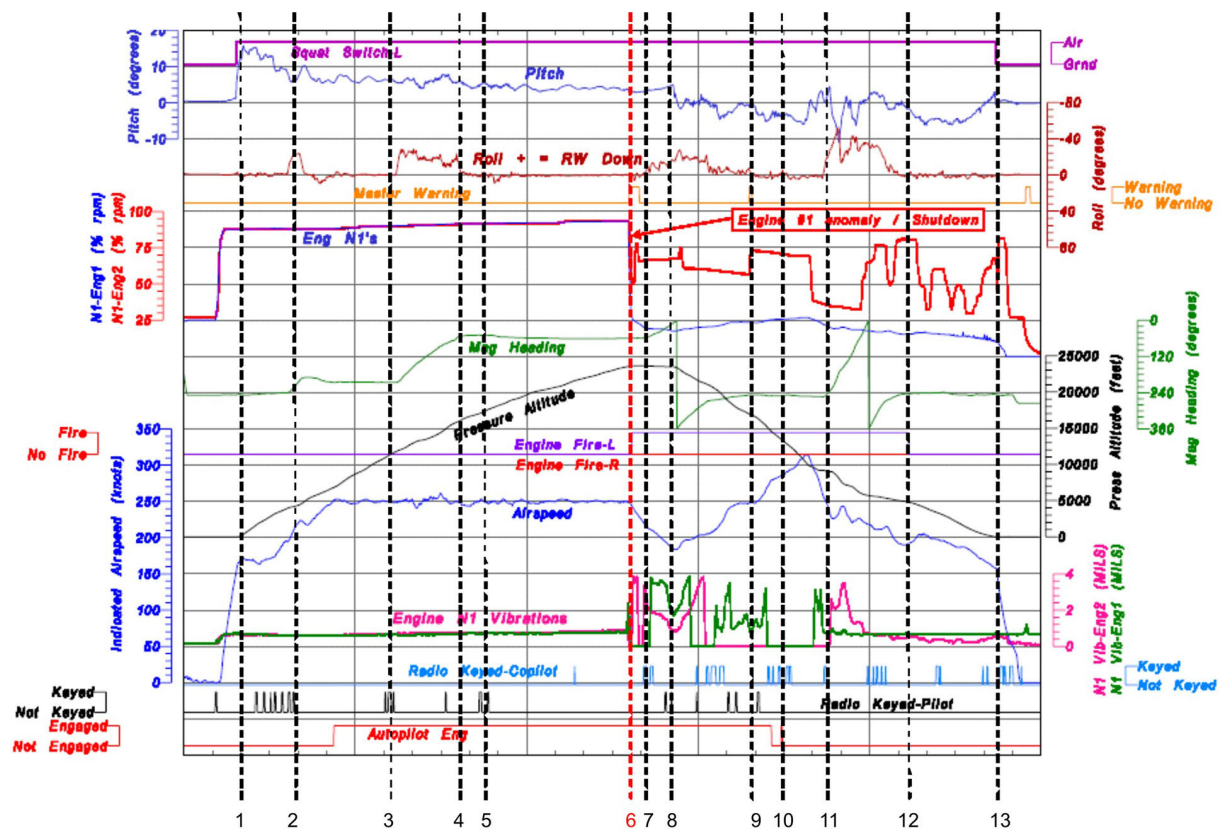
Figure 3. Complete flight: flight parameters, fire, N1 and N1 vibration advisories and autopilot setting

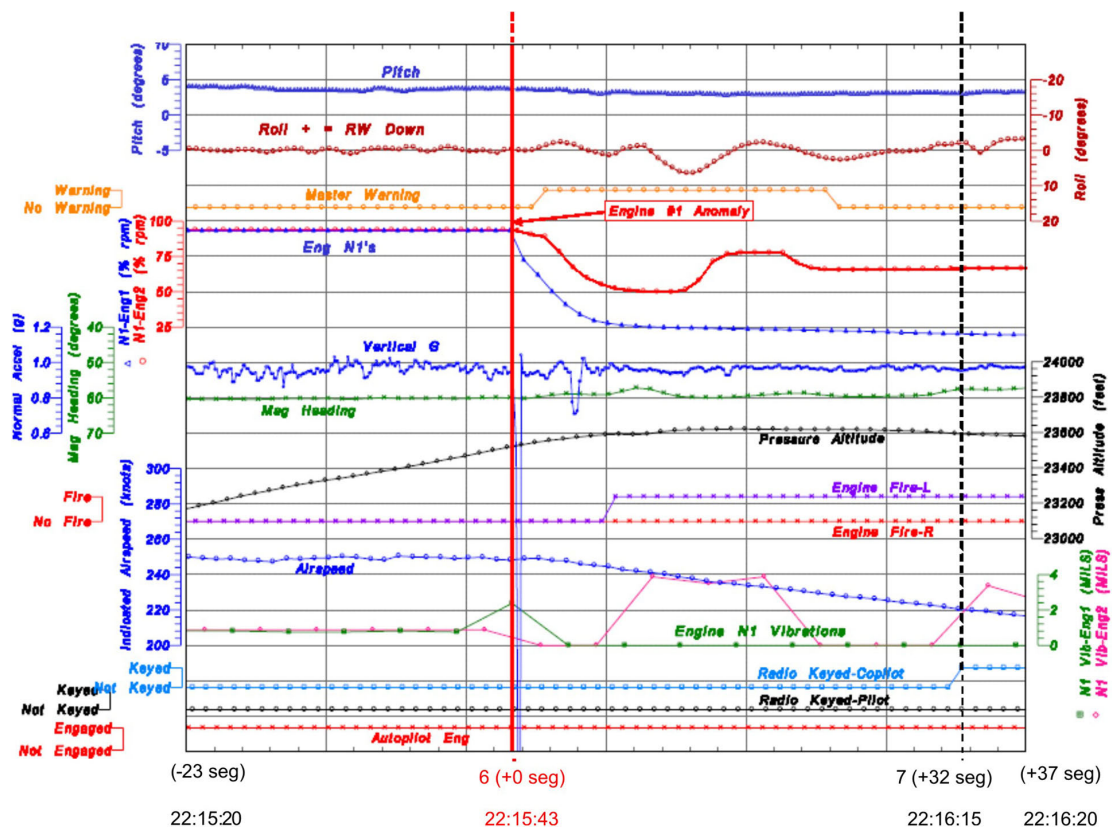
- Left engine N1 vibrations at 2.4 mils and vertical acceleration at -1.32g.
- At t = +1 second the left engine reverser unlocked and N1 started to fall.
- At t = +3 seconds the left engine low oil pressure was received and the fuel flow to the left engine dropped to zero.
- At t = +4 seconds lavatory smoke caution activated.
- At t = +7 seconds left engine fire warning activated.

Figures 4 and 5 show the progression of the engine failure parameters for one and two minutes, respectively.

Figure 4. Engine parameters during failure: 1 minute

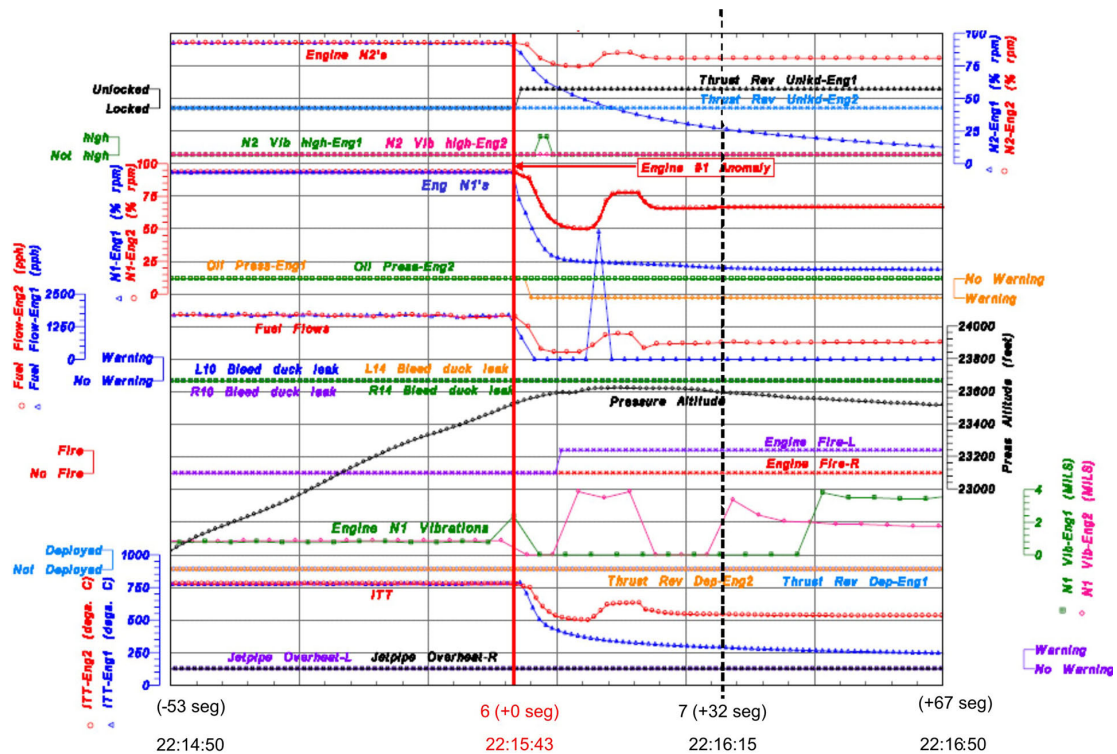
Figure 5. Engine parameters during failure: 2 minutes

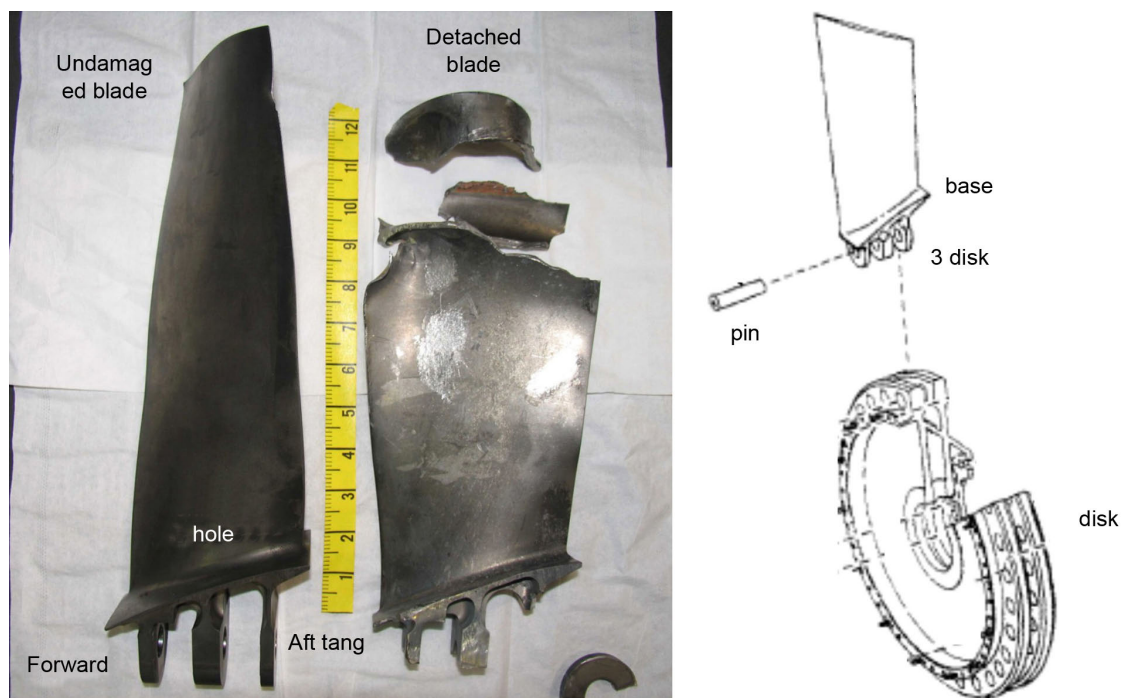
The blade detached due to a break in the tangs used to attach it to the fan disk (Figure 6) caused by a dwell-time fatigue crack. The point of origin was found in the middle tang, from where it propagated by dwell-time fatigue. The forward and aft tangs also showed fractures resulting from stress overload. The main section of the fractured pin, which was removed from where it had become embedded in the fan containment ring, had shear fractured and showed no signs of fatigue or of material defects.

The metallurgical and fractographic analyses revealed the presence of metallographic defects in the drilled surfaces on the middle tang and in the forging of the piece that reduced its dwell time fatigue-resistance properties. Specifically, extensive bands of

Figure 6. Detached number 11 blade

"aligned alpha colonies"<sup>1</sup> were observed, the grains of which were unfavorably oriented relative to the primary loading direction. In the separated blade, the presence of these colonies had given rise to the incubation of fatigue cracks. The composition of the material from which the blade had been manufactured conformed to design specifications and did not exhibit oxygen or nitrogen enrichment.

In general, the blades are manufactured from titanium laminate bars or billet with a diameter of between 2 and 3.5 inches. While reviewing the blade manufacturing processes of General Electric's four suppliers, it was noted that Teleflex utilized a larger diameter billet, higher forging temperatures (up to 37.7° C than the other manufacturers) and that the chemical composition of the material had the highest levels of aluminum content.

Also detected in the same crack initiation area was the presence of a layer where the grain was deformed and which General Electric attributed to the use of improperly

sharpened tools. It was noted that the processes for machining and reaming the tang holes did not specify the periodicity with which the tools used in this task were to be replaced.

The general engine failure initiated with the separation of the number 11 fan blade due to a dwell-fatigue fatigue crack. This blade separation resulted in a significant fan mass imbalance which resulted in high fan (N1) vibrations.

Based on their own internal investigation and as a result of the inspections conducted on their suppliers, General Electric adopted measures intended to reduce the aluminum content of the material used to manufacture the blades and to control the wear and replacement of the tools used to machine the tangs that attach the blade to the fan disk.
