**DATA SUMMARY**

Date and time	<b>Wednesday, 27 September 2006; 14:25 h (local time)</b>
Site	<b>Malaga Airport (LEMG)</b>

Registration	<b>EC-ELI</b>	<b>G-XLMB</b>
Type and model	<b>CESSNA 152</b>	<b>CESSNA CITATION EXCEL</b>
Operator	<b>Airman</b>	<b>Aviation Beauport</b>

**REPORT**

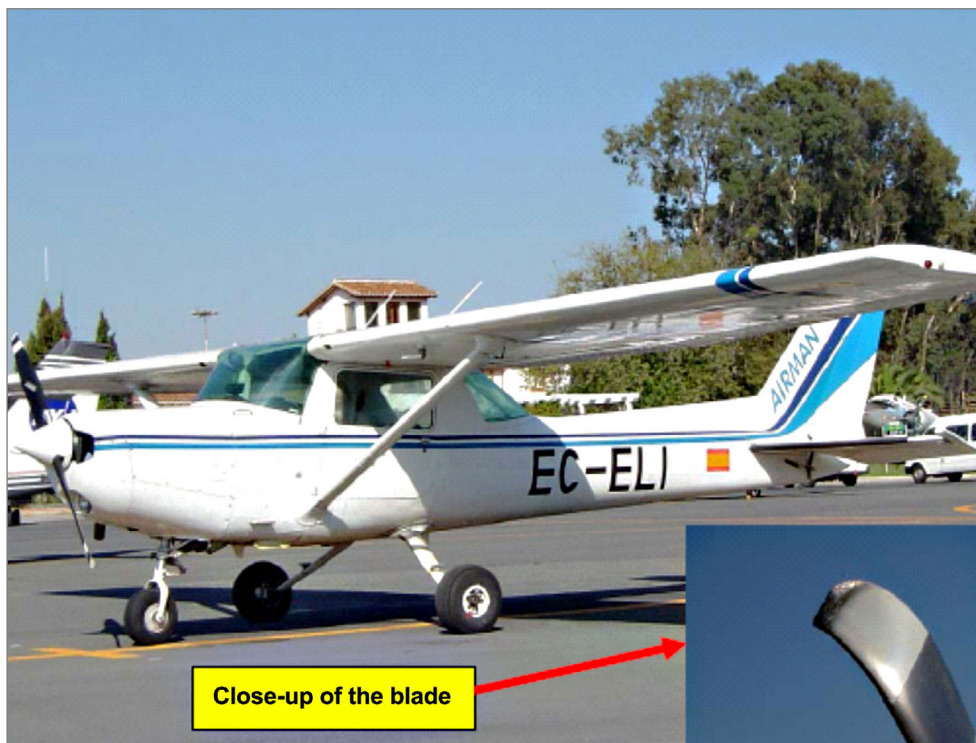
The Cessna 152 aircraft, registration number EC-ELI, was heading toward the parking apron at Malaga airport after having made a solo training flight from Granada airport and landing on runway 13. As the aircraft was entering the apron, the jet blast from an engine test being performed by a Cessna Citation Excel aircraft, registration number G-XLMB, caused the tail section of the Cessna 152 to lift up off the ground and rotated the airplane 90°. As the airplane dropped back down, the nose of the plane struck the ground, resulting in damage to the propeller.

Figure 1. Photograph of the aircraft and a close-up of the blade

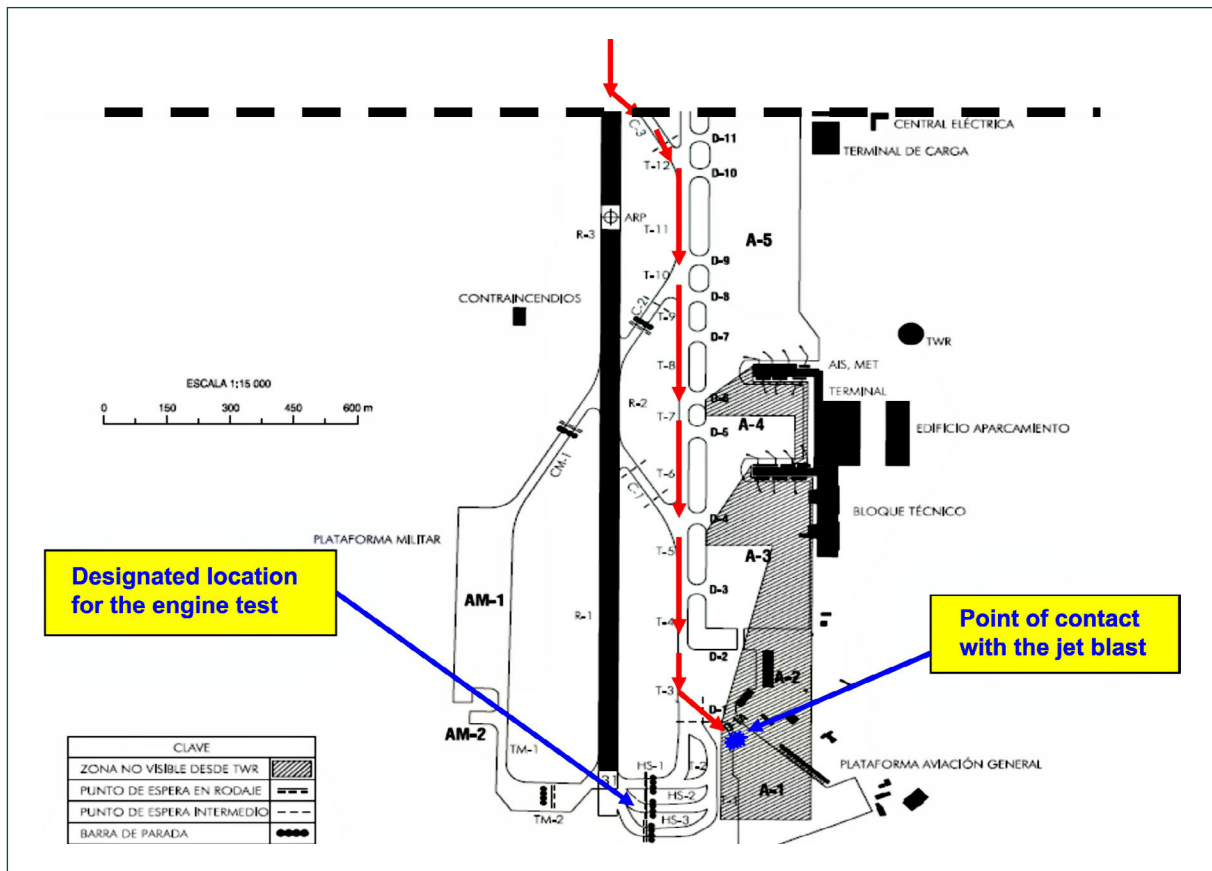
Malaga airport is located at coordinates 36° 40' 30" N and 4° 29' 57" W at an elevation of 15.9 m. The runway designations are 13-31. Figure 2 shows the layout of the airport with the path taken by the CESSNA 152 and the place where it was affected by the jet blast from the CESSNA CITATION. It also shows the designated point for carrying out a high power engine test with runway 13 in use.

Figure 2. Path taken by the airplane showing where contact was made with the jet blast
