## DATA SUMMARY

Date and time	Tuesday, 10 October 2006; 22:15 local time
Site	Seville Airport

Registration	EC-GRF
Type and model	AIRBUS A-320-211
Operator	Clickair

## REPORT

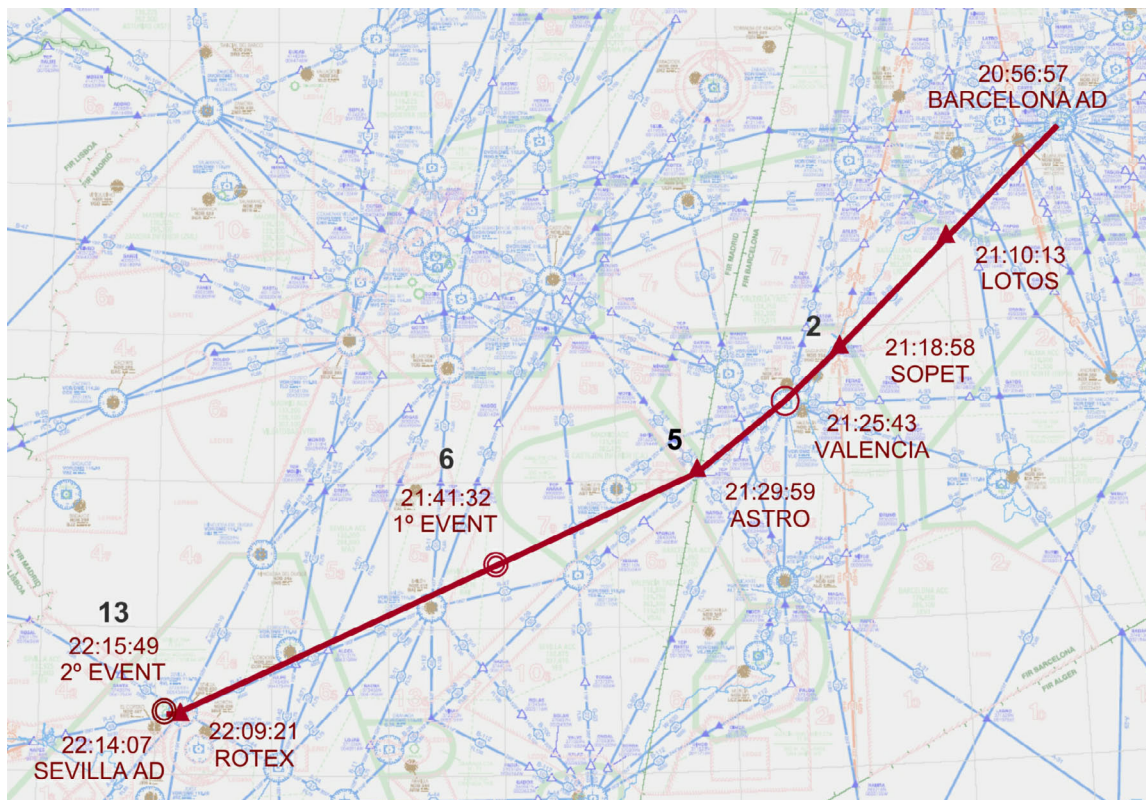
Figure 3. Flight path of aircraft EC-GRF

Figure 3 shows the route followed by aircraft EC-GRF, the times at which each point in the plan was passed, and the time at which the two events took place.

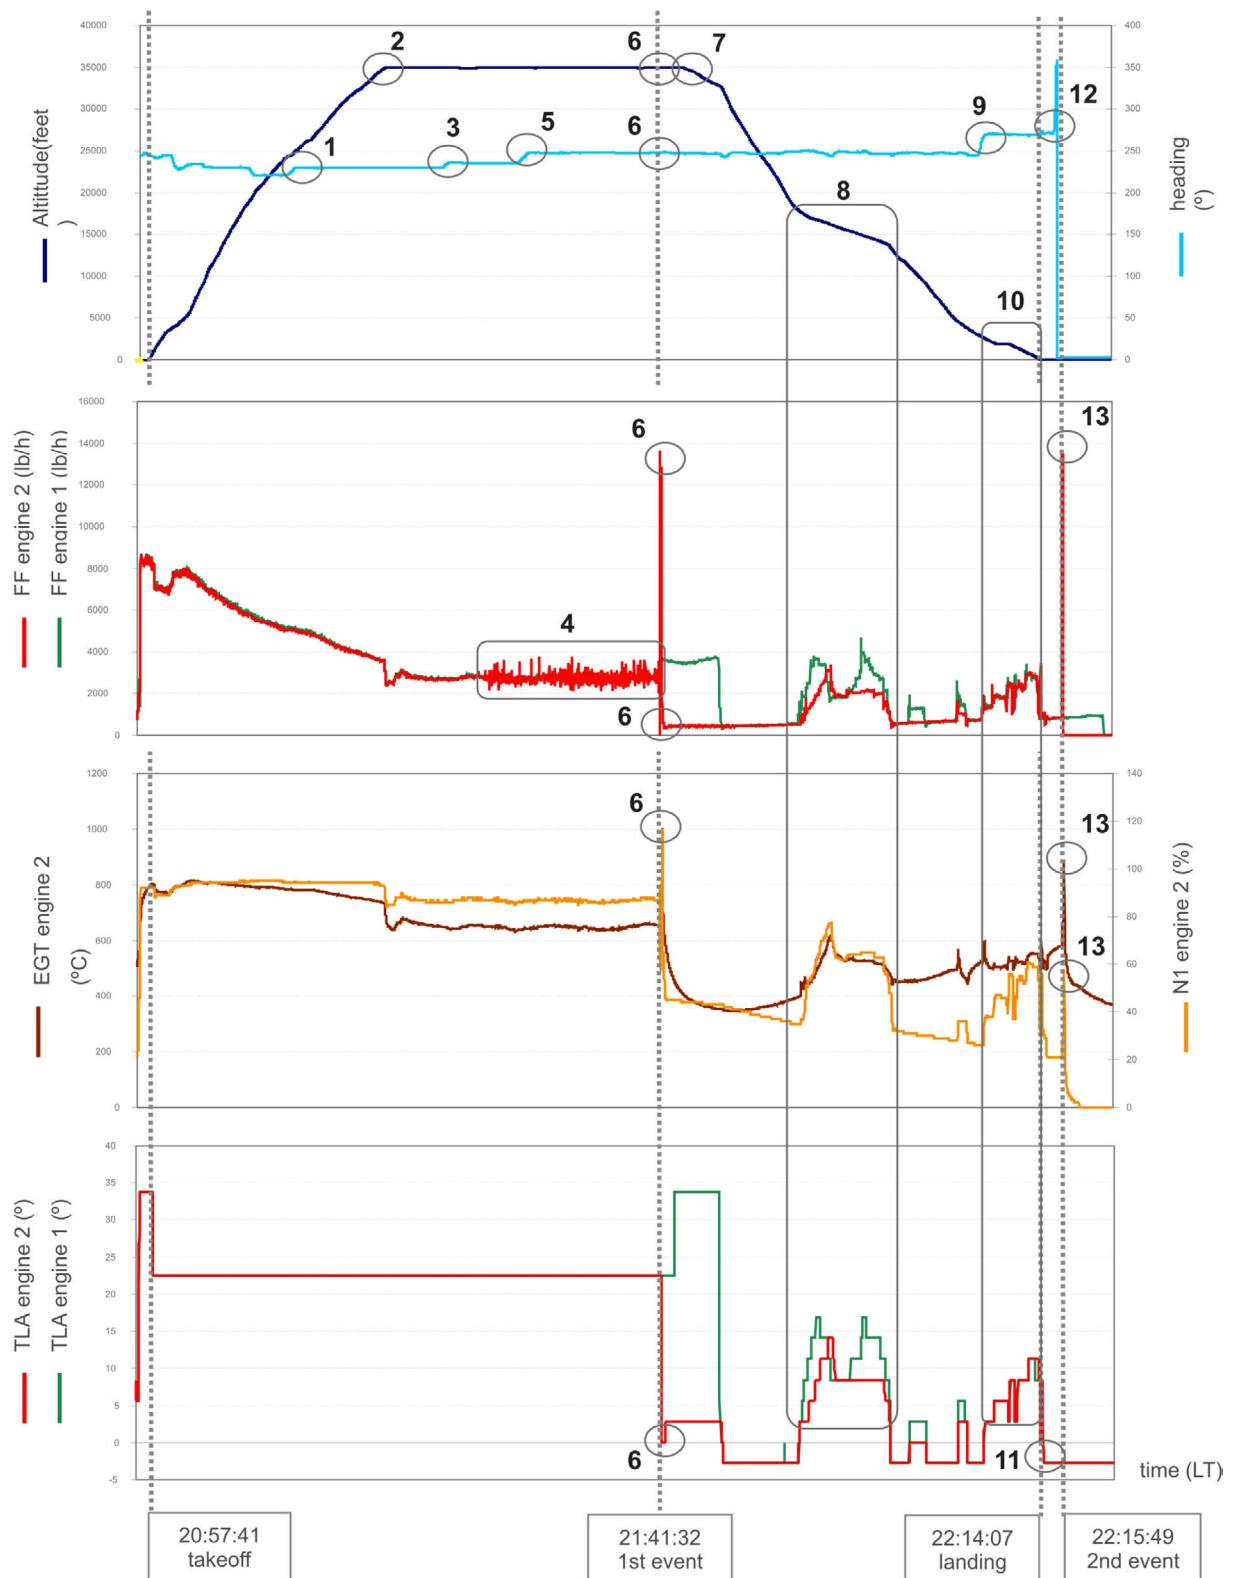
Figure 4. FDR data for entire flight Barcelona-Seville

The FDR data (section 1.6) indicated that the events of the incident resulted from an increase in the fuel flow inconsistent with the throttle input in the cockpit, which led to an inspection of the components associated with fuel control: the electronic control unit (ECU) and the hydromechanical unit (HMU).

Figure 4 shows a graph of the relevant flight and engine data as recorded by the FDR during the flight. Specifically, it shows altitude, heading, fuel flow (FF) in both engines (2 right and 1 left), EGT for the right engine (EGT engine 2), low pressure rotor rpm's for the right engine (N1 engine 2) and the position of both throttle levers in the cockpit (TLA engine 1 and 2).

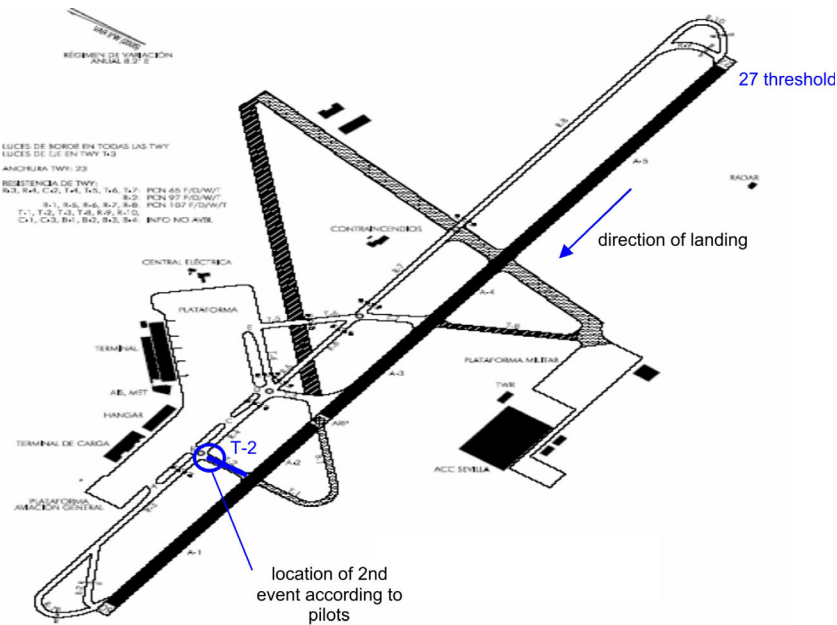
Figure 5. Seville Airport and location of 2nd event

Seville Airport has one asphalt runway in a 09-27 orientation. Exit taxiway T-2 is perpendicular to the runway and 2,500 meters away from the runway 27 threshold.

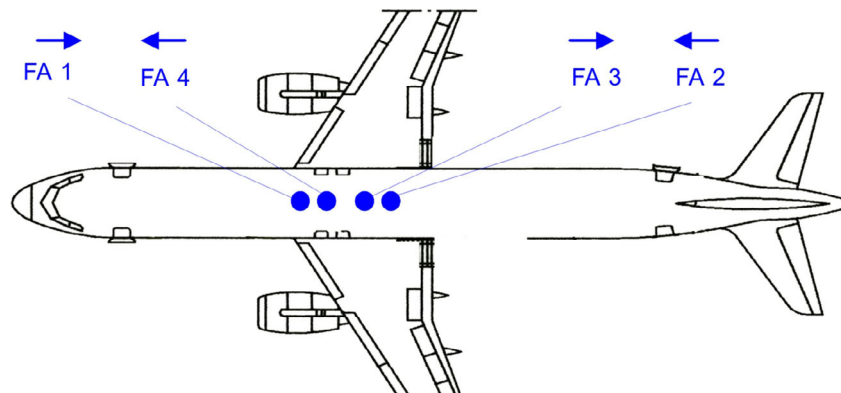
Figure 7. Position of the FAs during the first event

At the time of the first explosion she was looking to the front but she did not see the fire. They secured the carts and after FA-1 and FA-2 talked to the pilot, the purser told them to secure the cabin and that normal procedures were in effect. After the fire on the ground, she stayed at the front of the aisle, calming passengers who had gotten up to leave.

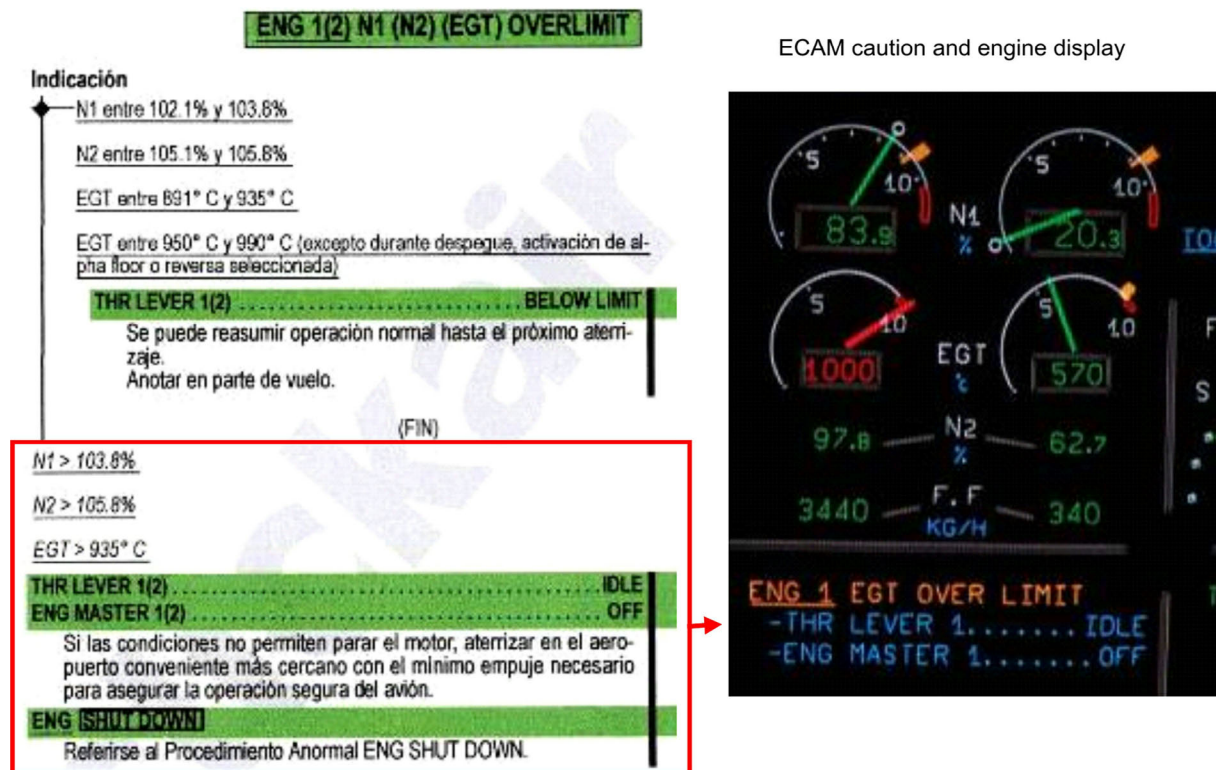
Figure 9. Procedure and indications on the ECAM for «EGT and N1 overlimit»

Each of the procedural steps appears automatically on the ECAM beneath the main engine parameters (figure 9). Each action is shown in blue and disappears upon execution.

The "EGT overlimit" procedure was partially carried out in that they performed the first step, which was to set the throttle to idle, but they did not perform the next step, namely to stop the engine and continue on just one engine. The procedure offers the option of not stopping the affected engine if not allowed by conditions, though in that case a landing must be effected as soon as possible. The duration of the CVR did not allow for the content of the conversations during the first event to be known, though in their statements both pilots expressed that they did not consider it necessary to stop the engine or head for another airport since the behavior of the engine led them to believe it was fine. While it is true that they were near the destination airport, they could have reached other airports in half the time. This action by the crew, the ATC communications and the crew's statements are better suited to the "ENG STALL" procedure.

**REC 54/07.** It is recommended that the operator, Clickair, guarantee the compliance of its cockpit crews with the procedures and messages displayed on the ECAM.

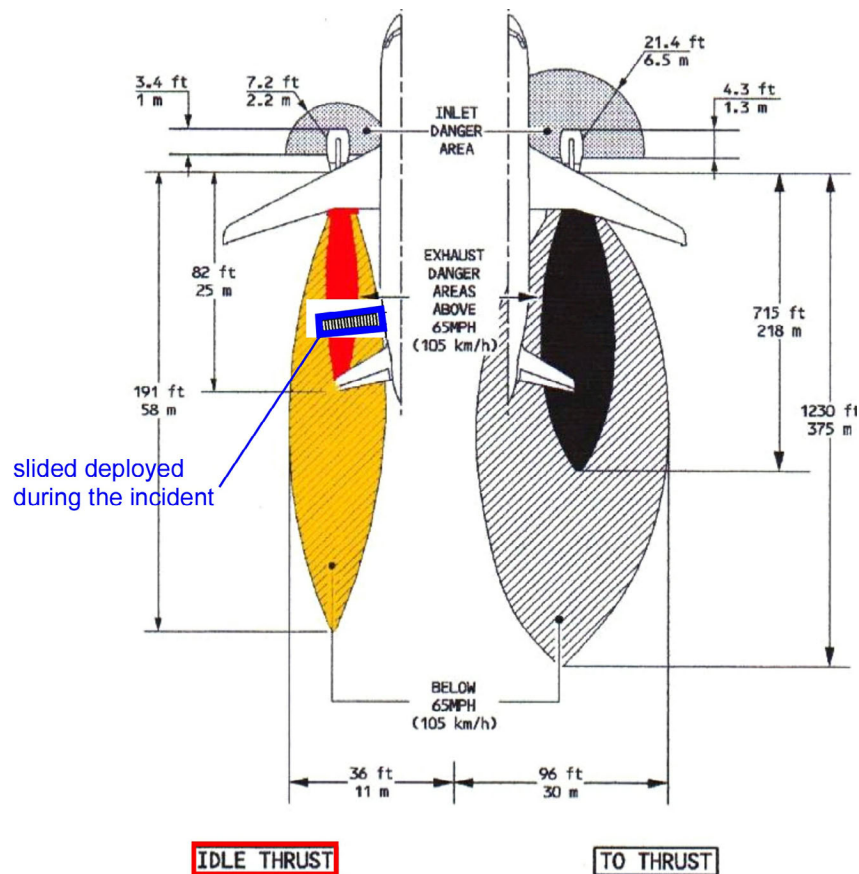
Figure 11. Area affected by jet blast with the engine at idle

The jet blast area for an engine at idle, as indicated in the Flight Crew Operations Manual for aircraft models A-319/320/321, is shown in figure 11, where the position of the deployed left rear slide is shown. The area in red is defined by the manufacturer as dangerous due to the presence of high temperature exhaust and speeds in excess of 105 km/h. The area shown in yellow is affected by gases below 105 km/h.

The impact of the high velocity and temperature engine exhaust for 3 minutes and 1 second is considered as the probable cause behind the puncture suffered by the slide, which rendered it unsuitable for use.

The final inoperative state of the slide, probably due to the jet blast, would have prevented its use should the situation have deteriorated and an evacuation become necessary. This would have left one fewer exit for disembarking the 163 passengers, increasing evacuation times and therefore the risk factor for said condition.
