Report A-061/2006

**Accident involving a Lancair FB320 aircraft,
registration OO-136, in Puértolas (Huesca),
on 17 October 2006**

COMISIÓN DE INVESTIGACIÓN
DE ACCIDENTES E INCIDENTES
DE AVIACIÓN CIVIL

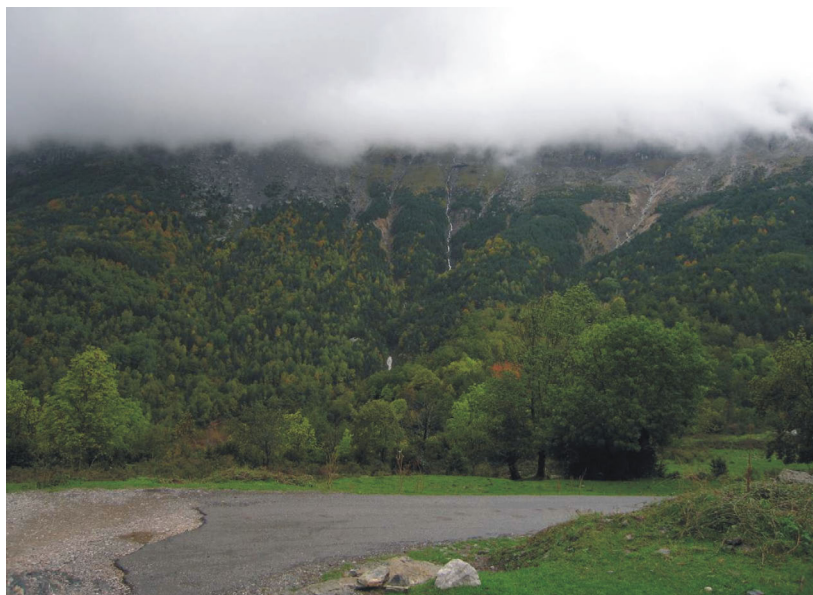
Figure 3. Picture of the accident site

In addition, eyewitnesses to the flight of the aircraft described the weather conditions as being similar to those shown below in the photograph of the hillside where the aircraft crashed, taken on the day following the accident.

The terrain where the aircraft fell slopes sharply and is covered by trees exceeding 15 m in height. It was not possible to determine the aircraft's attitude as it entered the treetops due to the height of the trees and to the difficult terrain. There were, however, no signs of severed vegetation in the vicinity of the wreckage.

The aircraft was found leaning against the left wing root, with the fuselage atop a tree which had broken near the base. Its trunk was abraded along a 5-meter long section due to contact with the wing. Also, the area from the instrument panel to the propeller was practically detached from and below the main fuselage section at a 50° angle with respect to the aircraft's longitudinal axis.

Other damage evidenced by the aircraft was localized to the wings. The right wing was destroyed and detached from the fuselage, and only one-third of the left wing remained attached. The propeller appeared to be intact with the exception of one of the three blades, which had broken under the weight of the engine. The aft half of the fuselage appeared undamaged.

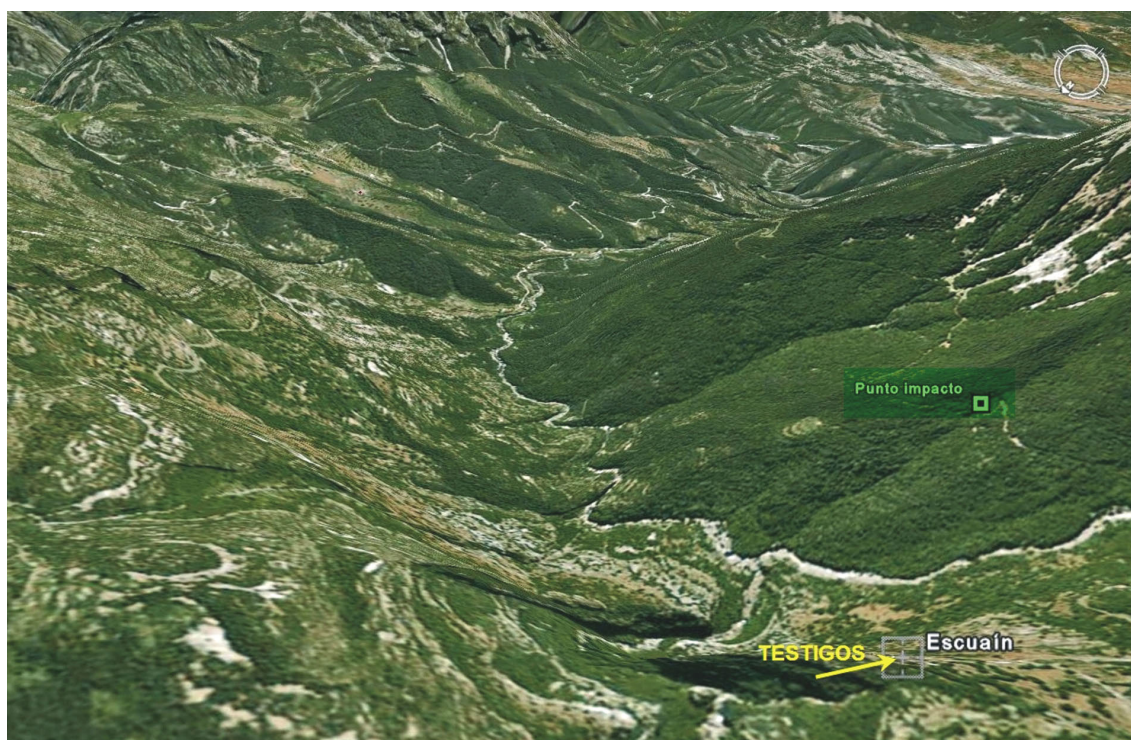
Figure 5. Escuaín Gorge general view

The final segment of the flight was observed by several local residents who were positioned in a vantage point from which they could widely see the Escuaín Gorge (see figure 5). Two of them stated not hearing any engine sounds and that the terrain was

at an altitude higher than the aircraft's. The flight was slow and unstable, "as if it were floating," as it traced out a turn to the right. The aircraft then dropped almost vertically against the top of the trees on the hillside.
