## Report A-062/2006

Accident involving  
a Piper PA-32 aircraft,  
registration D-EJTF,  
in Laguardia (Álava),  
on 17 October 2006

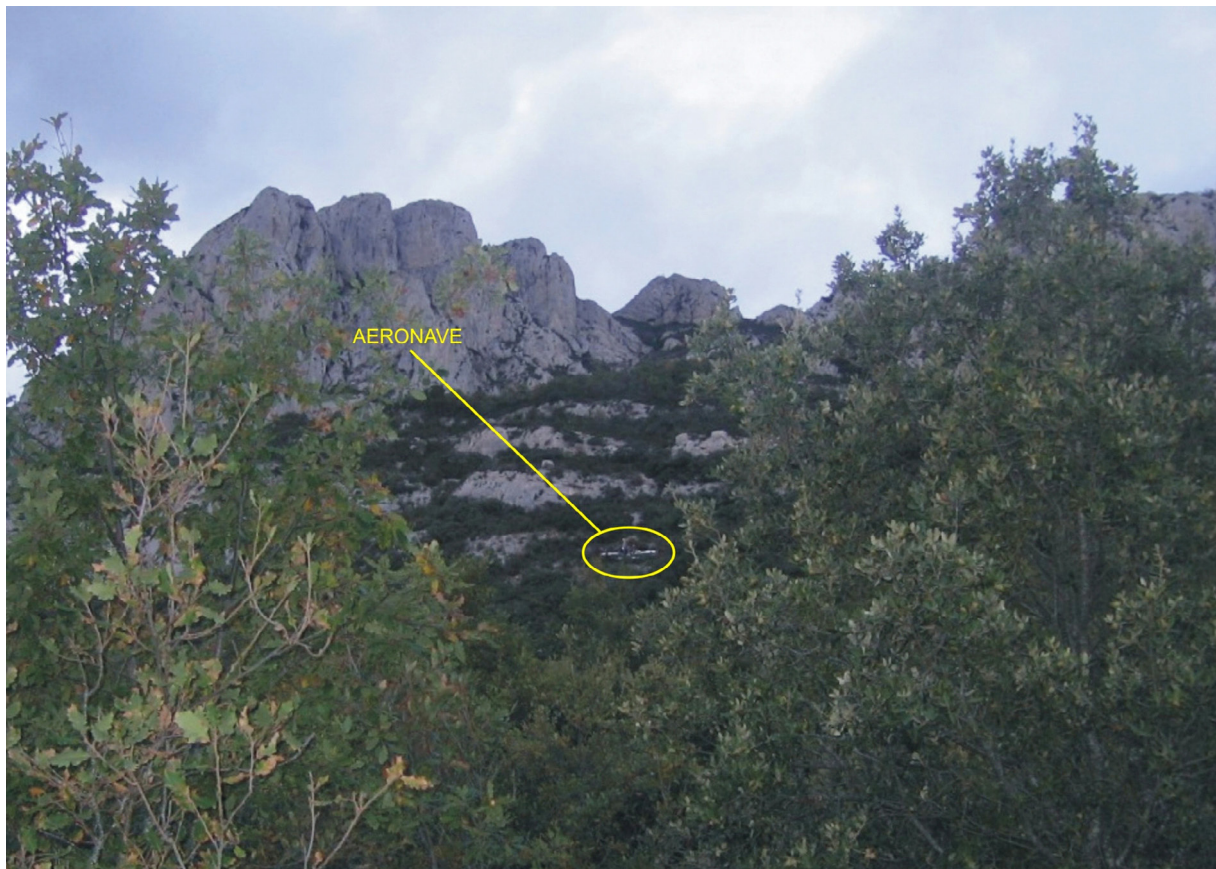
Figure 1. View of the accident site from the north of Laguardia

The aircraft wreckage was found at 19:20 local time on the south face of the Cantabria mountain range, at an elevation of 1,096 meters, in the vicinity of Mount "Cruz del Castillo," some 22 km away from Vitoria Airport.

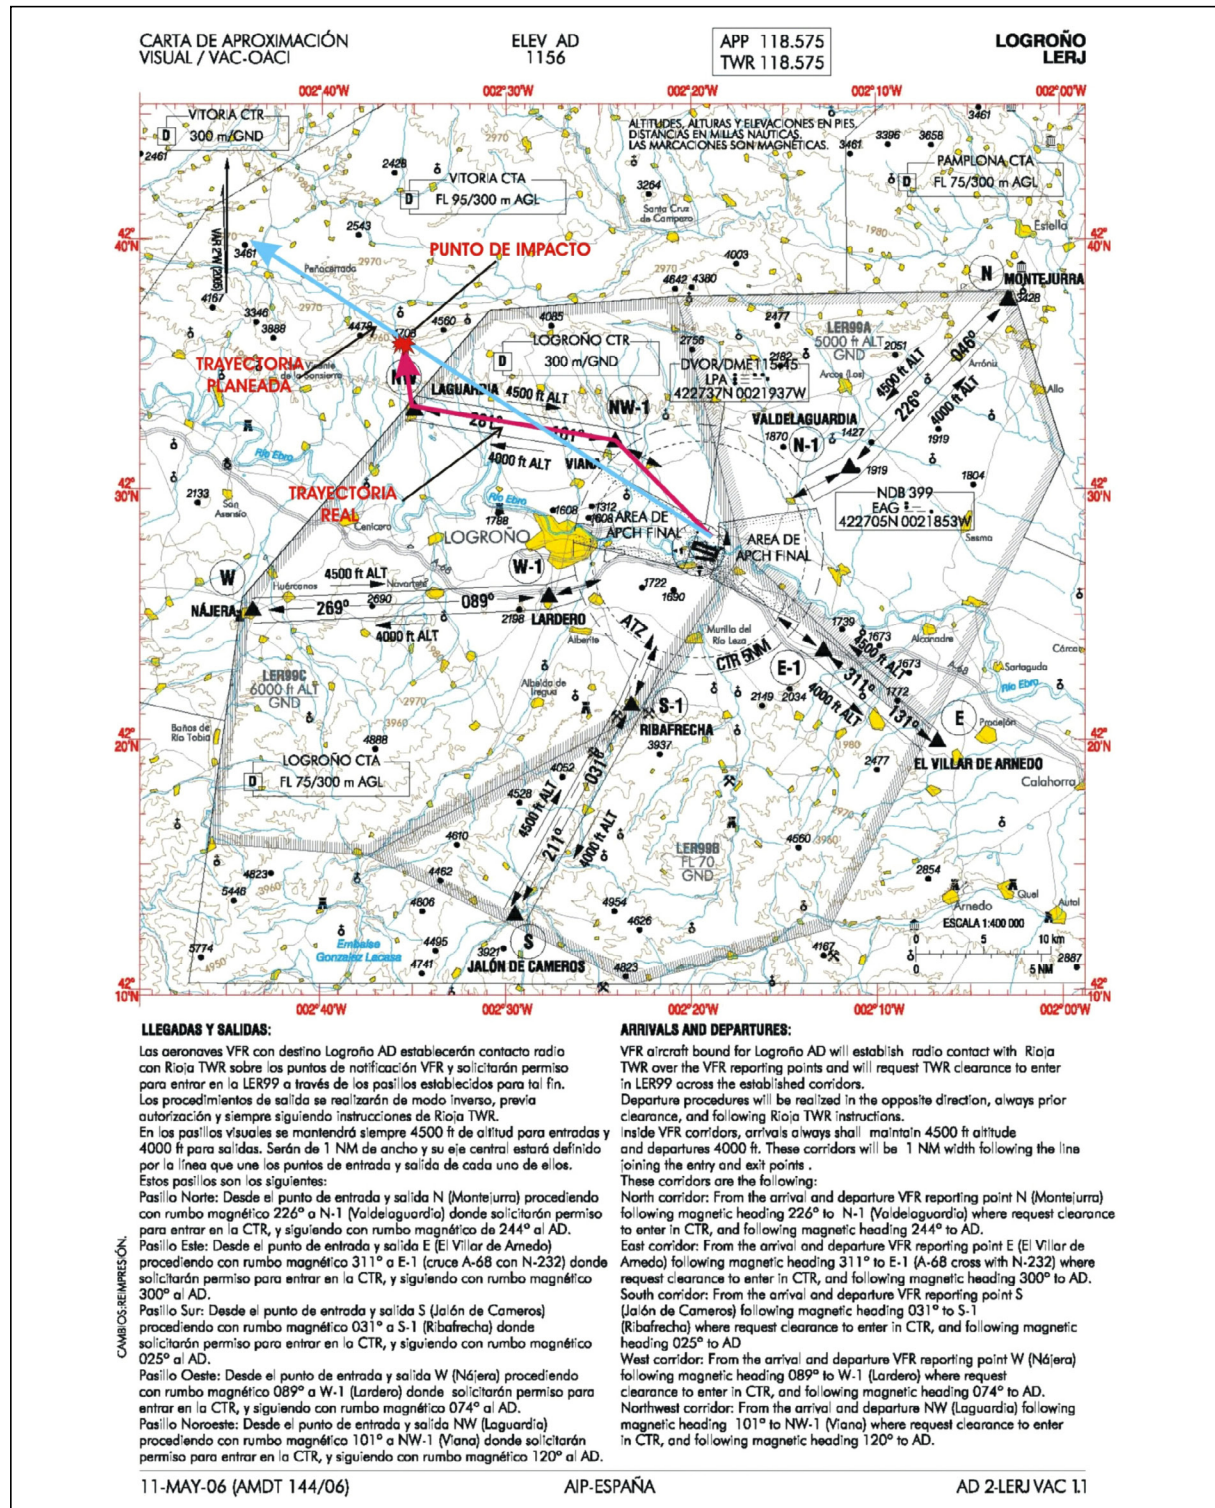
Figure 2. Visual chart for Logroño Airport

Seconds before impact, the aircraft may have started a turn to the left, perhaps to head toward point W at the entrance of CTR Vitoria or toward the VRA VOR. The turn was never completed since at the time of impact, the aircraft attitude indicated a roll to the left. The VFR approach procedures for Vitoria Airport are unremarkable, only requiring the pilot to contact the control tower to enter the CTR, maintaining a maximum altitude of 1,000 ft AGL and reporting crossing over points N (Amezaga), S (Peñacerrada) or W (Morillas).

The direct route from Logroño Airport to the VRA VOR would have entailed a left turn after takeoff of around 180° to a heading of 305° straight to the VRA VOR. This path would pass practically directly above Mount "Cruz del Castillo," which the aircraft eventually impacted. The elevation of this mountain is 4,708 ft.

Both trajectories are shown in Figure 2.

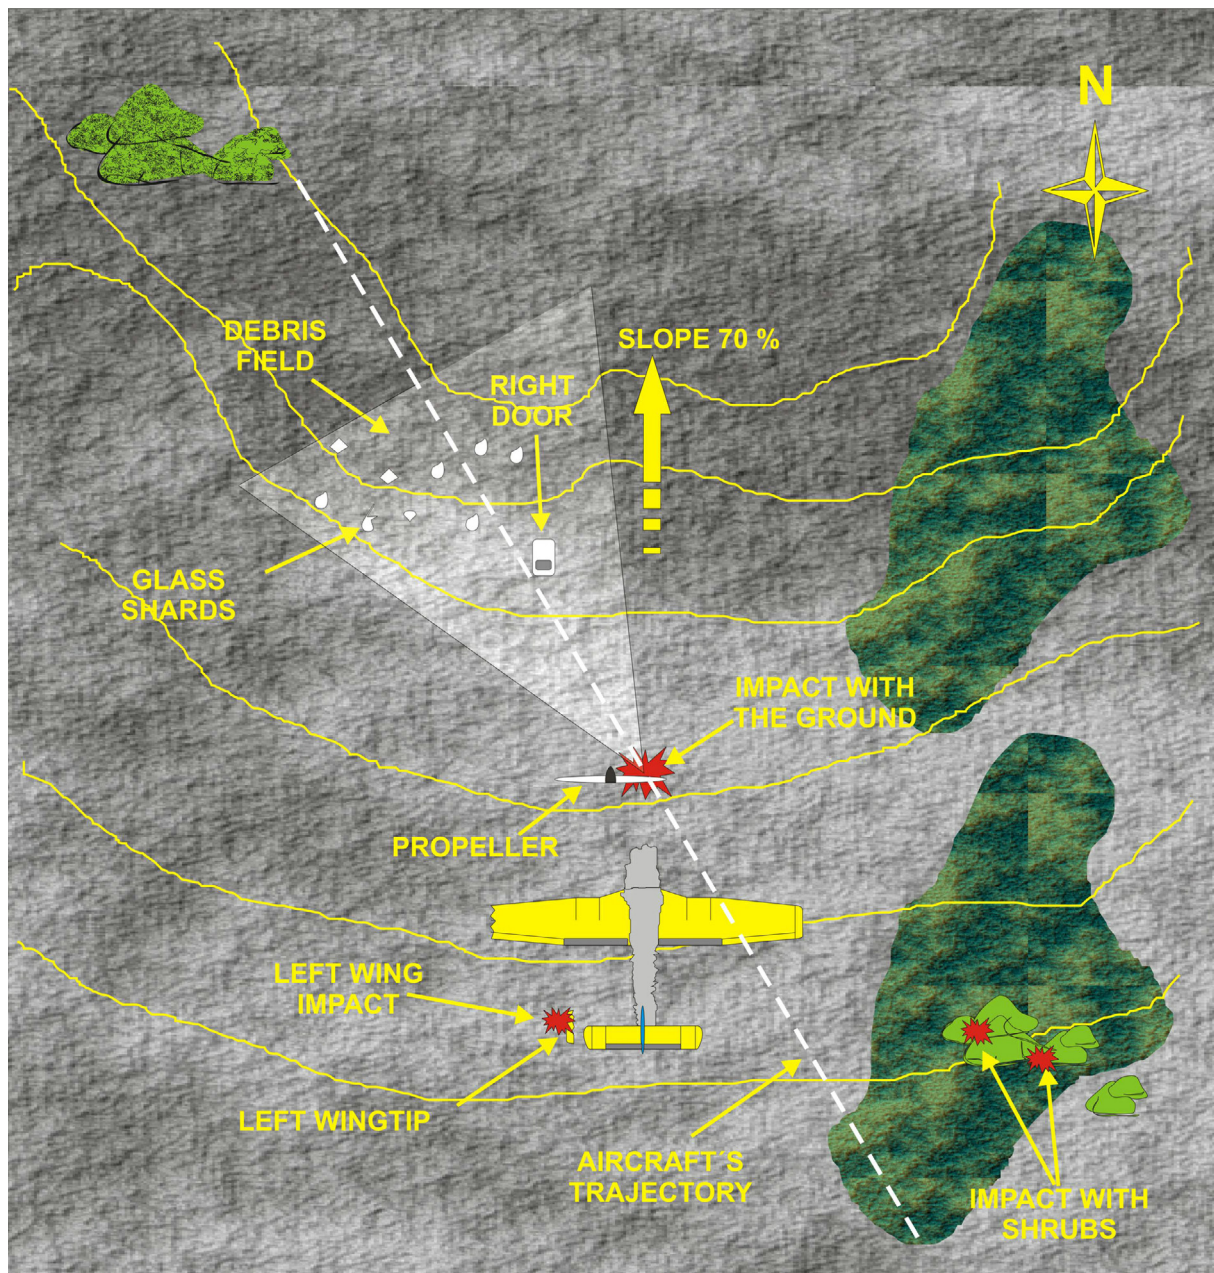
The aircraft impacted the south face of Mount "Cruz del Castillo" at a point situated at an elevation of 1,096 meters, and whose coordinates are 42° 35' 43.2" N 02° 35' 16.8" W. The area where the aircraft impacted has a steep gradient, on the order of 70%, ascending toward the north. Figure 3 shows a diagram of the wreckage distribution.

As shown, the propeller, which detached from the engine following the fracture of the crankshaft retaining bolts, was found some 3 meters in front of the main wreckage in an area that exhibited severe impact marks. All three blades were twisted and showed considerable damage, some involving a loss of material.

Figure 3. Diagram of the scattering of the wreckage

The main aircraft wreckage was 3 meters downhill from the propeller. It had been severely affected by the fire that broke out following the impact, and which consumed nearly the entire fuselage, sparing only the tail section. Both the cockpit instrumentation as well as the engine and flight controls were completely destroyed by the fire, which prevented their examination.

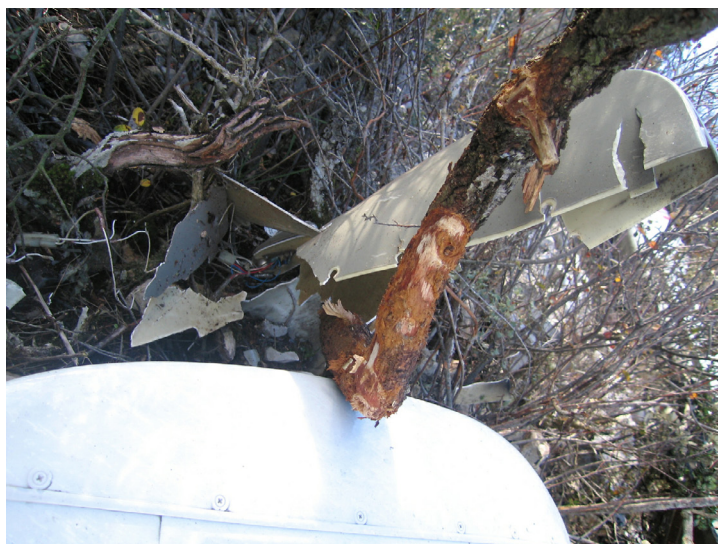
The left wing exhibited a bend resulting from the impact against the ground that affected part of the leading edge and most of the underside. The left wingtip had been torn off. The flap was deflected downward at almost a 90° angle with respect to the “up” position, and exhibited slight damage from the impact. Since the main wreckage slid a few meters down the mountainside, this may be what caused the flap to deflect downward. Its fittings were found in good condition and the flap moved freely. The aileron also exhibited impact marks and, like the flap, was still attached and could move freely.

The elevator was only slightly dented. It was attached to the fuselage and could be moved freely. The elevator tab was undamaged. The left wingtip was found just a few centimeters away from the edge of the left elevator, next to a shrub that showed impact marks along its lower part.

Figure 4. Left wingtip

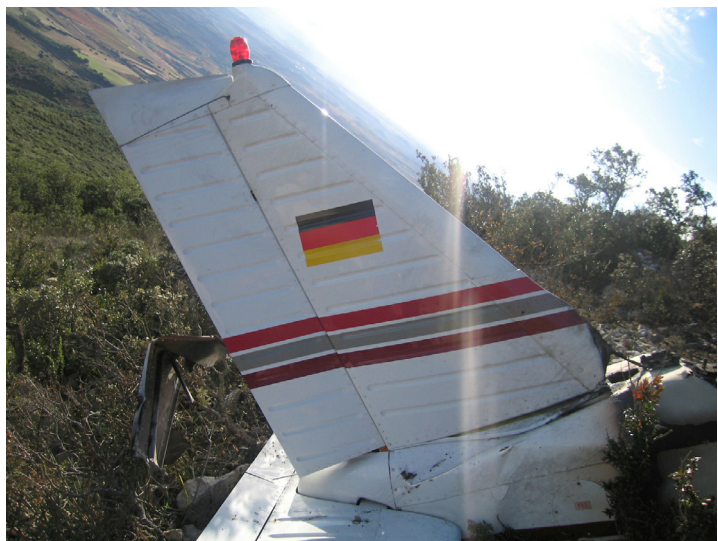
The tail section was not affected by the fire. The horizontal stabilizer was in its normal position and showed no evidence of damage from the impact. The rudder, also seemingly undamaged, was perfectly attached to the aircraft structure and could be moved freely.

**Figure 5.** Tail section
