## Report A-002/2007

Accident involving a  
De Havilland DHC8-300,  
registration PH-DMU,  
operated by Denim Air  
for Air Nostrum, at El Prat  
Airport (Barcelona),  
on 23 January 2007

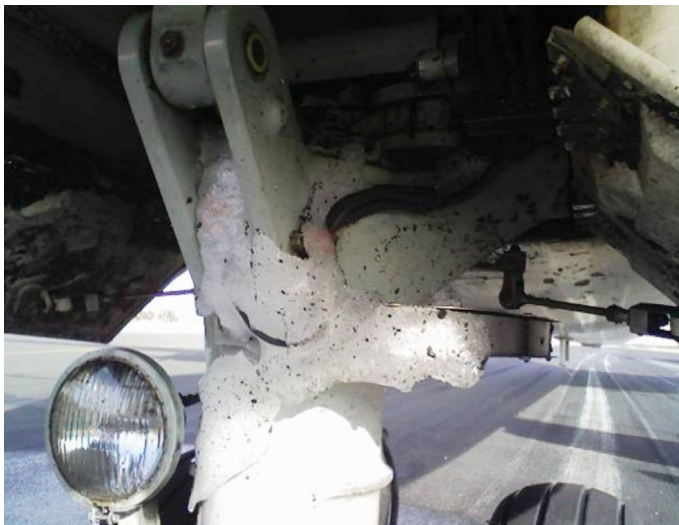
Figure 1. Picture showing ice in front gear wheel well

Approximately half an hour after the airplane was evacuated, the front part of the aircraft was lifted with a crane so as to remove the airplane from the runway. Once the airplane's nose was lifted, the alternate extension mechanism for the nose landing gear was activated in the cockpit, after which the gear lowered and locked correctly. During this operation, several 10-cm long pieces of ice fell to the runway from the nose landing gear wheel well. There was also a layer of ice over 5 cm thick on the nose landing gear wheel well doors and on the nose landing gear leg.

Three pieces of ice fell from the wheel well, weighing a total of 2 kg.

The cause of the accident was the inability to extend the front landing gear, which was jammed after slush, which had entered the wheel well while landing on a contaminated runway at Pamplona airport, froze into several pieces of ice.

- REC 13/10.** It is recommended that AENA clearly define in each airport's procedures the objective criteria for declaring a runway as not in service when it may be contaminated by ice or slush, along with who must make that determination.
- REC 14/10.** It is recommended that DENIM AIR instruct its crews and maintenance personnel on the importance of reliably checking that an airplane is free from snow, slush and mud, especially after taxiing on runways that may have been contaminated.
- REC 15/10.** It is recommended that BOMBARDIER study the possibility of modifying the gear design so as to avoid having contaminants penetrate the gear.
- REC 16/10.** It is recommended that BOMBARDIER define what it regards as the most effective way of inspecting the front wheel well so as to ensure that any contaminants that may be lodged inside can be detected.

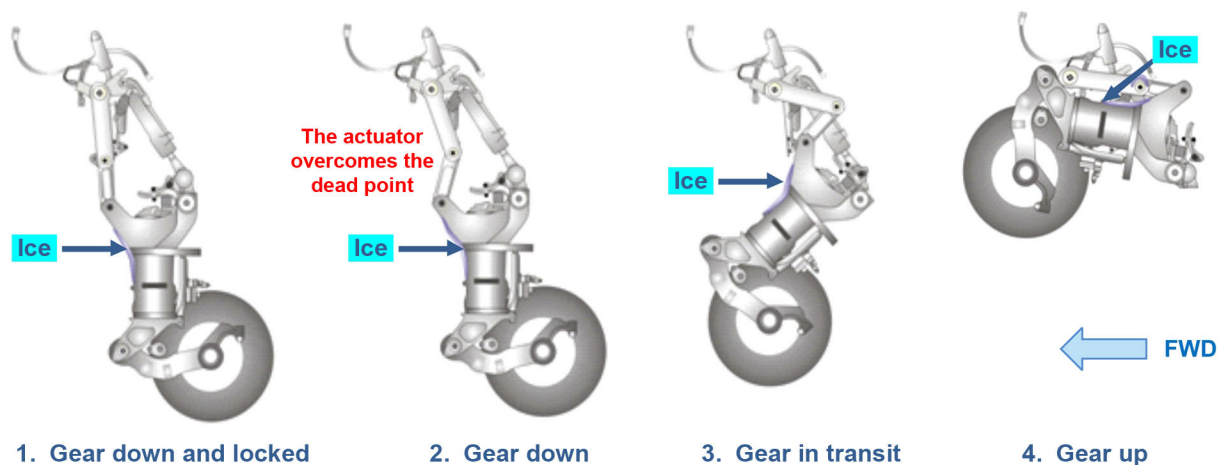
Figure 7. Sequence for retracting front gear

In considering the nose gear retraction sequence (Figure 7), we see that the body of the leg rotates forward as the drag strut bends, only to unfold again in an approximately horizontal position alongside the retracted leg, exactly in the area of the gear up locking

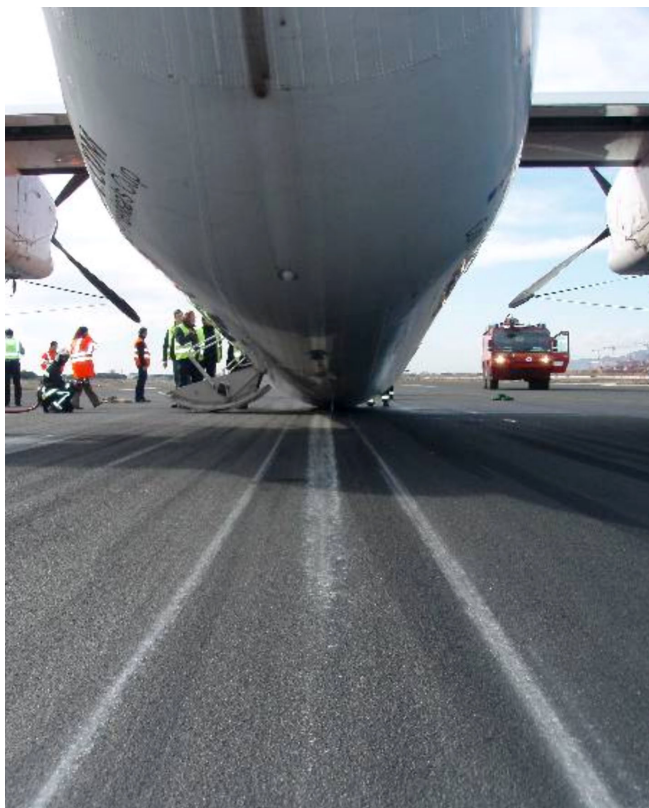
to those left by the main gear legs upon landing. Two parallel tracks were noted, however, some 214 m long and corresponding to the area of the front gear that had dragged on the runway, while supported by the heads of the actuators for the main doors of the front wheel well.

Another mark was found parallel to the above, wider and much shorter, indicating where the bottom part of the nose and the aft doors on the front gear had dragged along the runway.

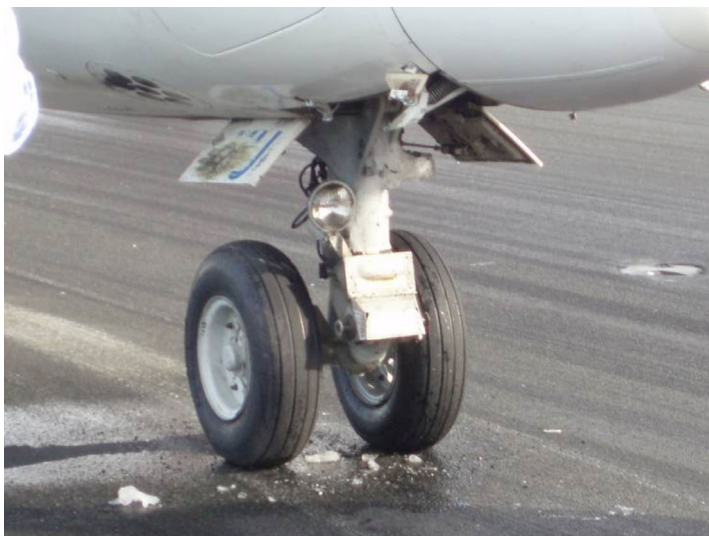
In light of the above considerations, the most likely scenario seems to be that as the airplane travelled over the slush at high speeds during the landing in Pamplona, the slush was thrown upward by the centrifugal force into the wheel well, where it then

The retraction of the gear proceeded normally, with the front wheels going into the wheel well with the doors closed. Inside the wheel well there were several sources of heat. The tires were very hot after taxiing, there was warm air being supplied from the cockpit, and the hydraulic lines and landing gear and door cylinders were also giving off heat. In an atmosphere with temperatures slightly above freezing, and aided by the heat emitted by the aforementioned components, the ice started to thaw and flow. The surface tension of the dirty thaw water held the water on the surface of the leg's aluminum alloy at a very low temperature. The transfer of the latent heat of fusion from the liquid water to the aluminum on the leg and to the surrounding air,

both of which were colder, froze the water once again, turning it into ice. The cooling was accentuated after takeoff once the airplane started to climb.

Figure 10. Detached ice

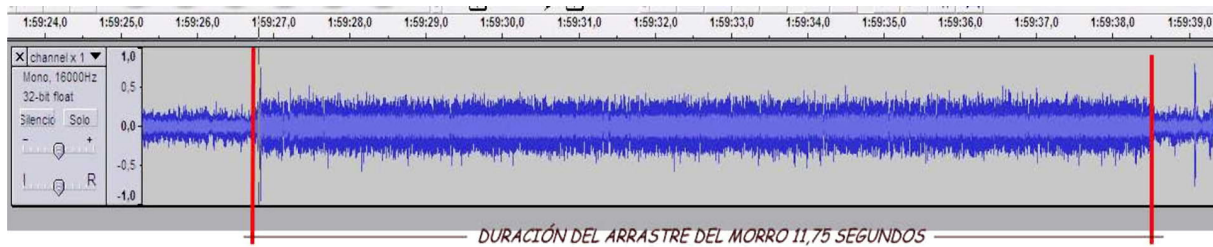
Figure 11. Sound spectrum of noise scraping runway

The drag marks left by the landing were 214 m long. The CVR recorded a drag duration of 11.75 s. Assuming a constant deceleration over the final few seconds of the landing run, it may be estimated that the nose dropped when the speed was approximately 70 kt. Figure 11 shows the frequency spectrum for the noise recorded as the nose was scraping the runway.
