Report A-003/2007

Landing in gear-up
configuration involving
a Bombardier CL 600-2B19,
registration EC-IBM, operated
by Air Nostrum, at Barcelona
Airport, on 24 January 2007

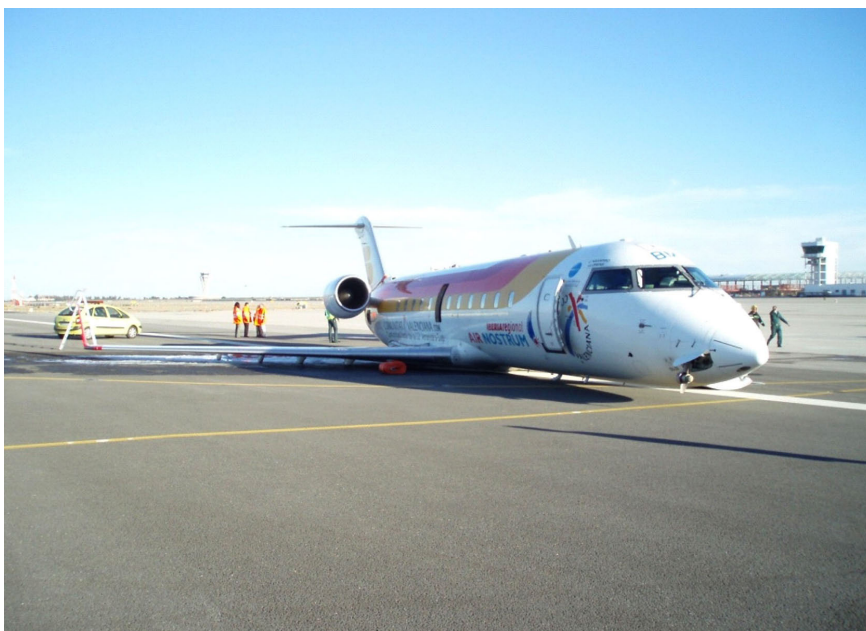
The first abrasion marks from the belly of the airplane on the surface of runway 25R were found 8 m to the left of centerline, past the point where the runway crosses runway 02/20, near high-speed taxiway B-A. The tracks continued all the way to the final stopping point over the left side stripe near runway V3. The aircraft slid on the runway a distance of some 1,900 m.

Figure 1. Aircraft state after the event

The distance from the runway 25R threshold to the first abrasion mark was 1,200 m.

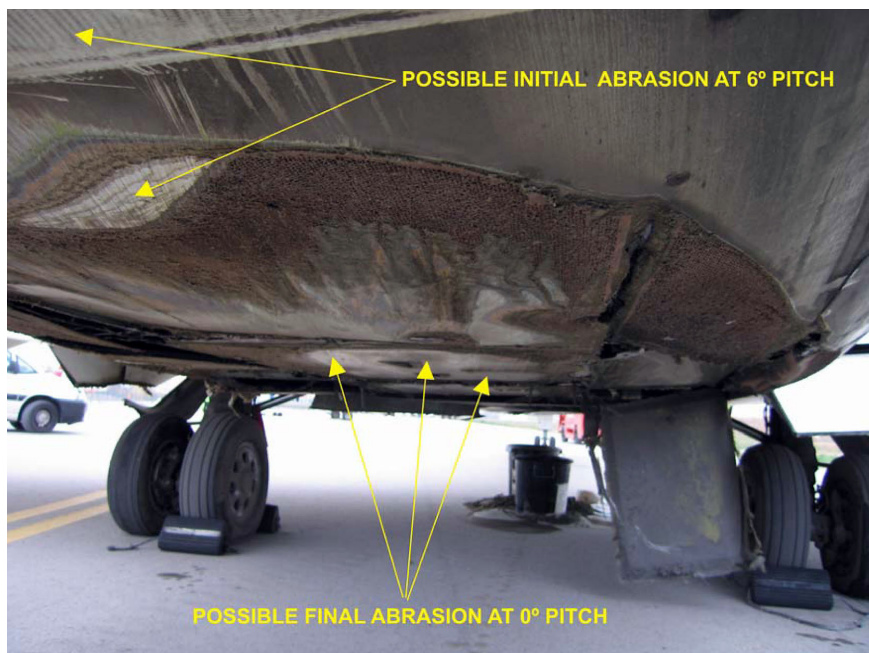
The aircraft frame maintained its integrity. Abrasion damage was noted on the belly and on the main gear doors and on the fairings of the flap actuators on the wings.

The aircraft slid on the runway resting atop the central wing box and the lower wing-fuselage fairings. There was impact damage to the rear fuselage structure affecting the skin, stringers and frames. Friction with the runway produced additional damage to the fairings, actuator spindles and to the flaps hinge boxes on both the left and right wings.

Figure 2. Abrasion marks, scrapes and distortions, on the aircraft belly

At a certain point during the run, when the crew realized that the gear had not been lowered, the lever was actuated to lower the gear, resulting in the abrasion of the doors and of the outboard tires on the main gear legs, which were damaged. Of course, the contact with the runway and the weight of the airplane kept them from lowering.

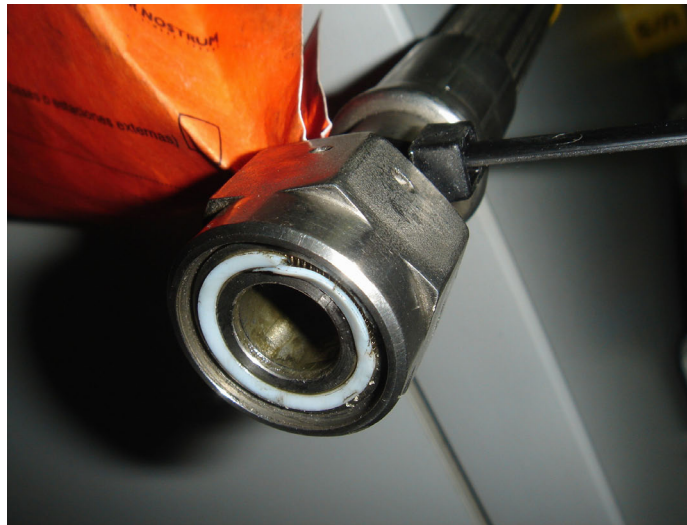
- During the inspection of the left wing, traces of water were only observed in segment no. 1.
- The amount of grease could be considered normal on all the shafts, the amount being considerably less on those of the left wing, though both were within the manufacturer's recommendations, which calls for a fine layer of grease.

- All the seals on the shaft ends were correctly installed and were in good conditions, except for the outboard end of the no. 3 right shaft (next to the no. 3 actuator), which, though situated in its housing, was abraded.

- All the shafts were inspected and found in good condition. All passed the leak test recommended by Bombardier in its SL 27-089. No leaks were detected.

Figure 3. Flexible drive shaft of flap

The investigation into the system and the inspection of the disassembled components revealed the presence of water, which was contaminating the grease that lubricated the flexible shafts, and even of the defective seal through which the water could have penetrated via shaft segment 4. After the exposure to low temperatures during the cruising phase, ice formed which seized the rotation of the flexible shaft which transmits the power necessary to extend the flaps.
